Report A-011/2006

Accident involving
a B737-600 aircraft,
registration 7T-VJQ,
at Seville Airport,
on 18 March 2006

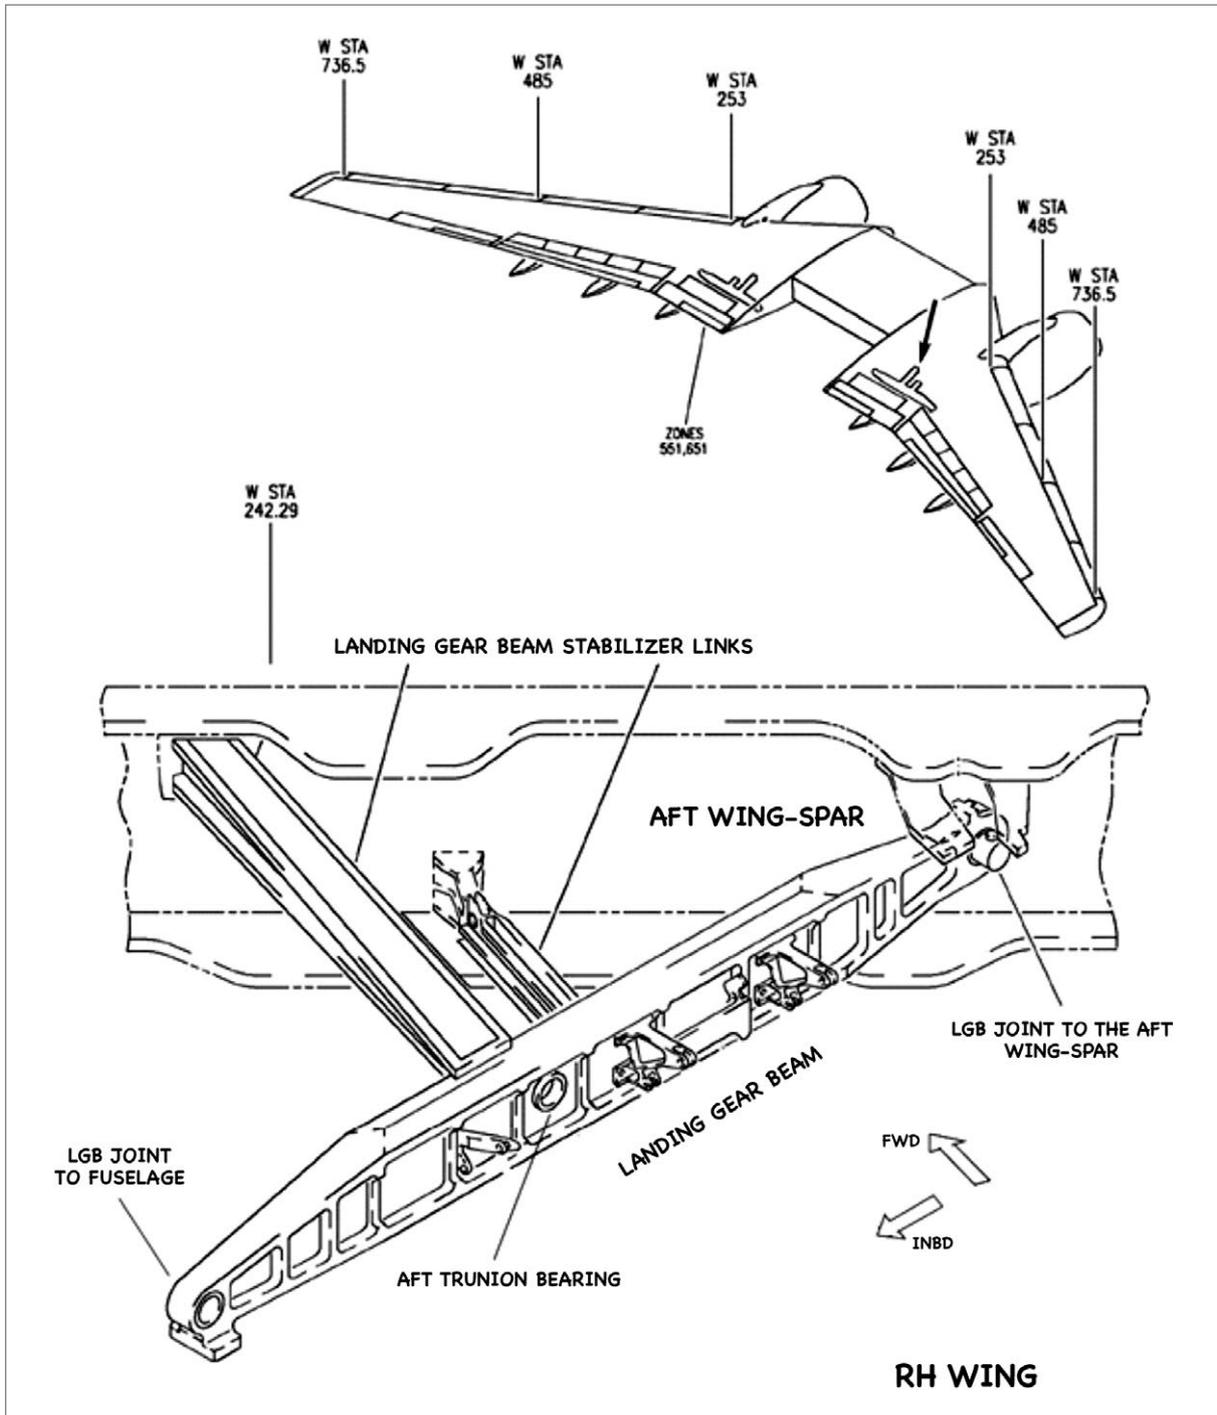
Figure 2. Aft support of MLG RH

- Significant damage to main landing gear beam.
- Broken trunnion bearing housing in the aft spar.
- Nose wheel axle bent and the tires on those wheels scuffed.

- The fusible pin that attaches the LGB to the aft spar failed due to a shear overload in the vertical direction. The hardness of the material was verified to satisfy the design specifications.
- The forward trunnion support was bent and there was a break in the outer race bearing consistent with a relative shift aft of the bearing's inner race.
- The side strut link was bent and the lower attachment lug was broken as a result of having bent backwards. The appearance of the fracture surfaces was consistent with an overload condition. The hardness of the material, checked during the analysis, was within specifications.

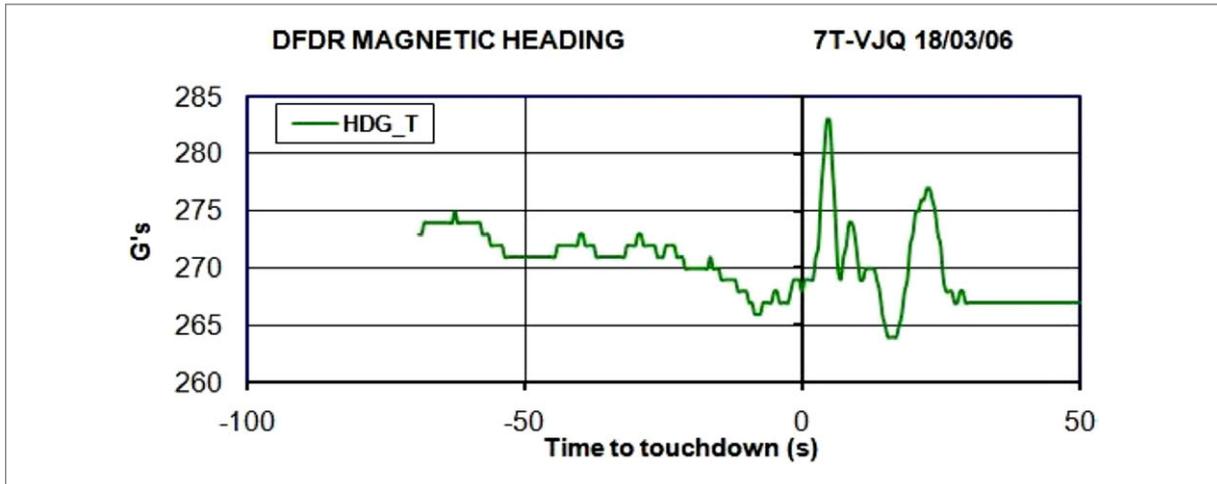
During the final glide, the aircraft's course oscillates around the 273° magnetic heading of the runway. Ten seconds before touchdown the airplane is facing some 6° left of the runway. During the landing roll, the aircraft suddenly turns ten degrees right at one point. The parameter for the commands input to the pedals, not shown, confirms that they were fully depressed in an effort to correct this deviation. The aircraft's final heading was 267°, that is, some 6° left of the runway orientation.

Figure 10. Airplane's magnetic heading

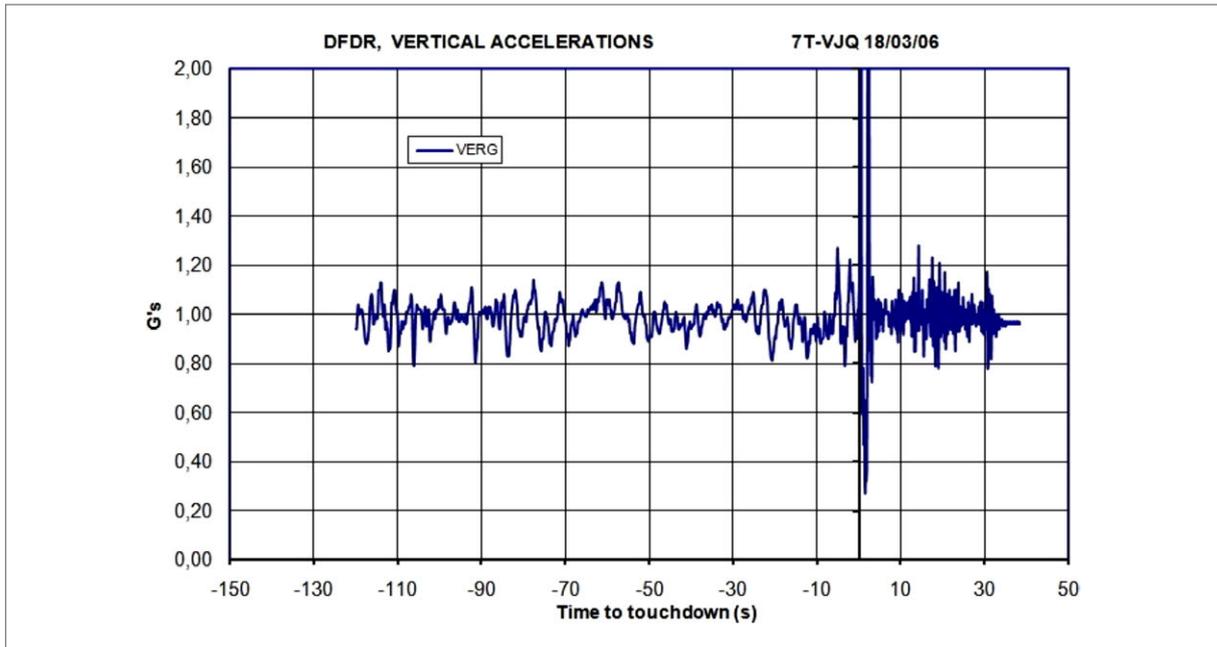
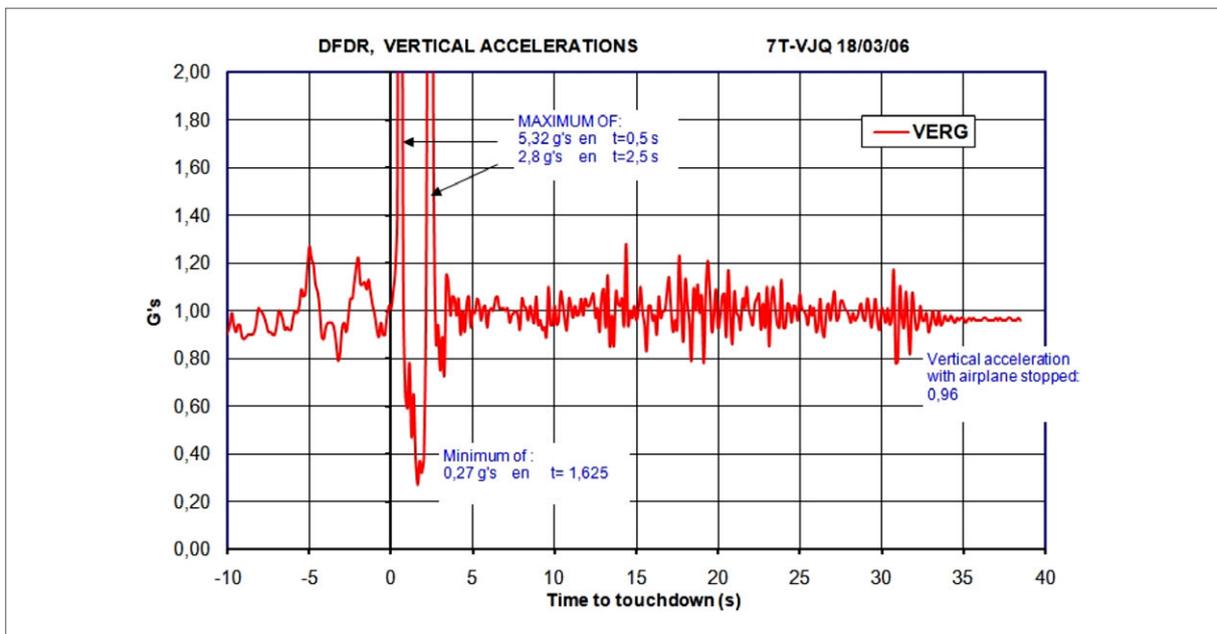
The vertical acceleration graph shows in-flight values of between 0.8 g's and 1.2 g's.

At the moment of touchdown, high values are reached, as discussed next in greater detail. The largest in-flight oscillations take place five seconds prior to touchdown. Following contact, the acceleration peaks at 5.32 g's and drops to 0.27 g's before rising again to 2.8 g's at $t = 2.5$ s.

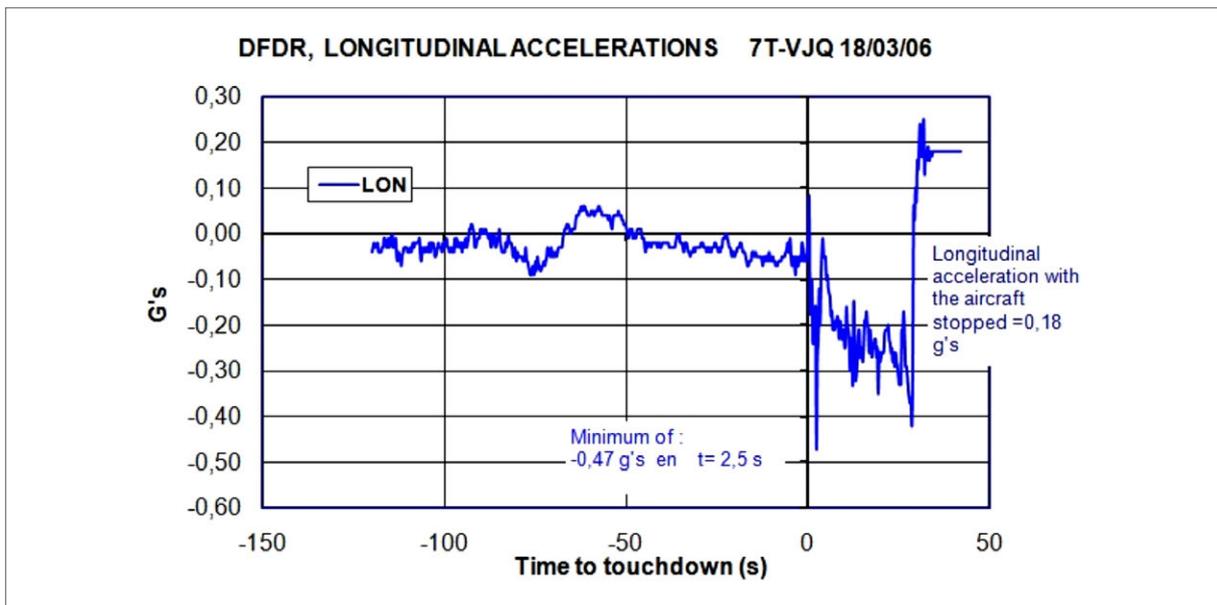
Two and a half seconds after touchdown, the longitudinal acceleration reached a momentary value of -0.47 g's, rising again after five seconds to a level of deceleration of -0.3 g's before the airplane reaches a full stop.

Figure 16. Longitudinal acceleration

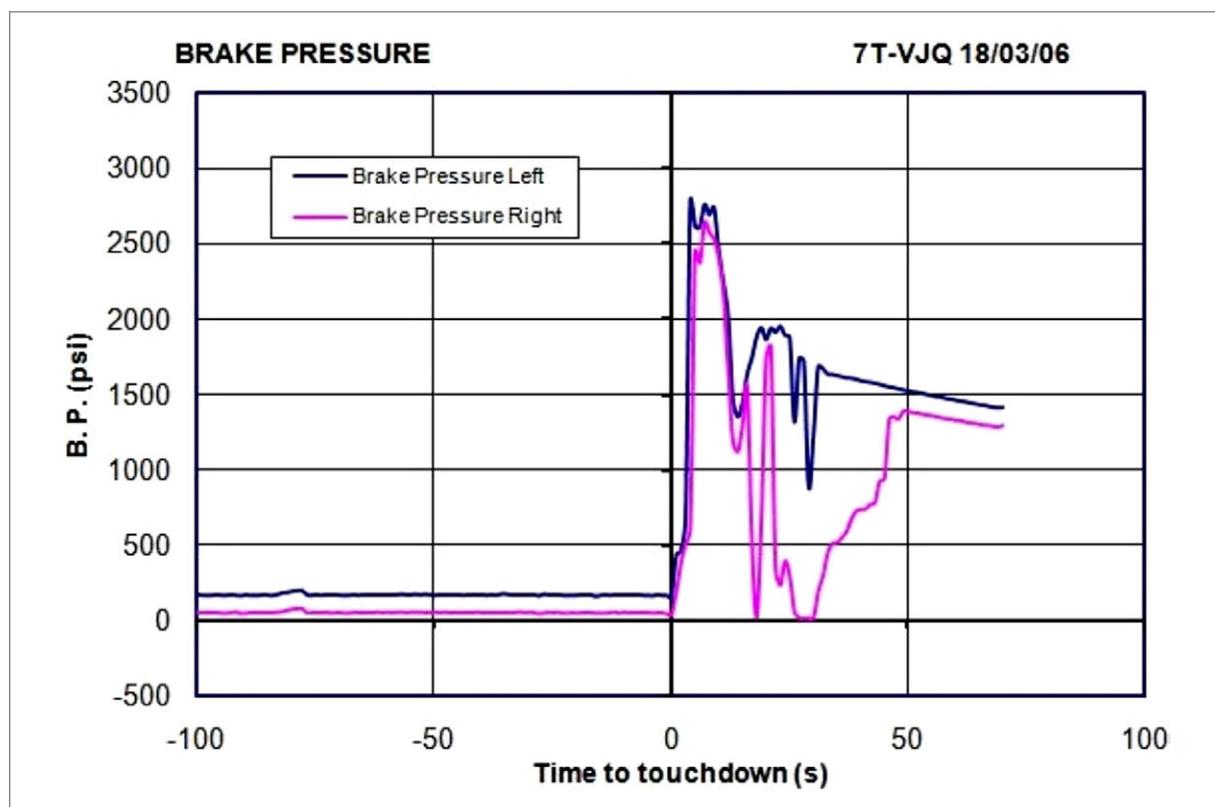
Figure 18. Brake pressure

The brake pressure increased as soon as the airplane made contact with the runway. Hydraulic pressure then began to drop, starting with system A.

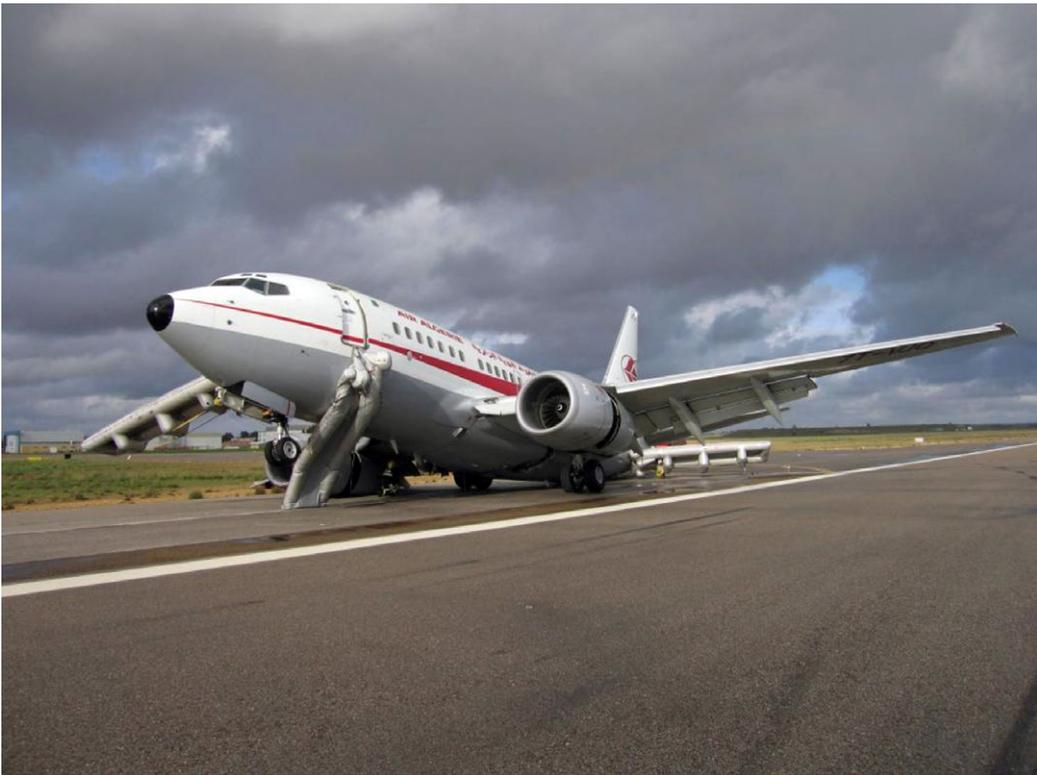
The exterior of the aircraft suffered localized damage to the right main landing gear leg and to the right wing near the area where it attaches to the fuselage.

Photograph 1. General overview of the aircraft
