Aircraft Accident Report

**Hail Encounter During Approach
Asiana Airlines Flight 8942
A321-100, HL7594
20 miles South East of Anyang VOR
June 9, 2006**

**Aviation and Railway Accident Investigation Board
Korea Ministry of Construction and Transportation**

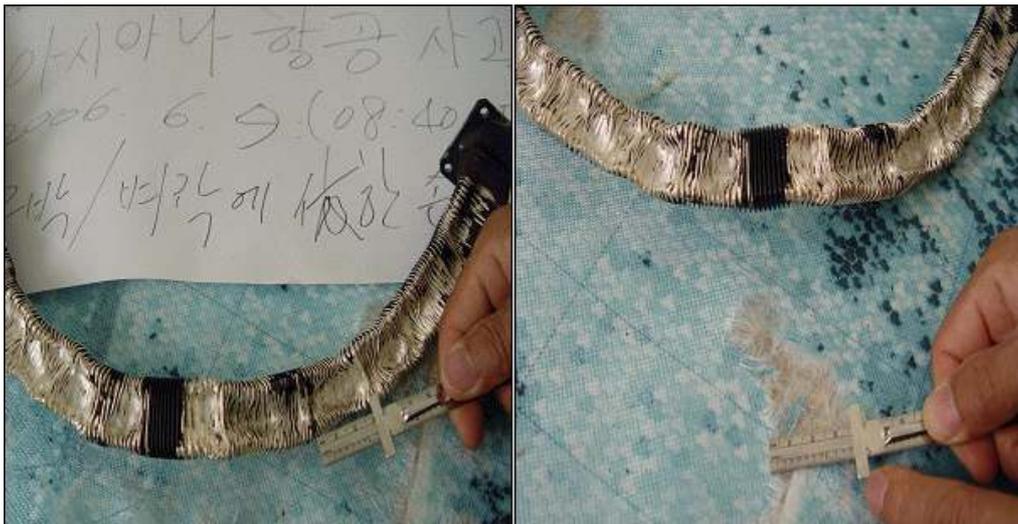
[Picture 17] Hail Size and Intensity

The hail size measured from the damage parts is approximately 2.0 cm or above in diameter inferring from the damaged mark on the Wave Guide connected to the radar antenna as shown in the Picture 17] and the hails hit in a thick dense. Considering the hail mark, it is estimated that the aircraft encountered with the hail under the cumulonimbus clouds.

The radar antenna was damaged by facing with the external environment installed the inside of the radome by detachment of radome. The antenna was still attached to the aircraft during flight after encountering with the thunderstorm and then fell on the runway due to impact upon landing.

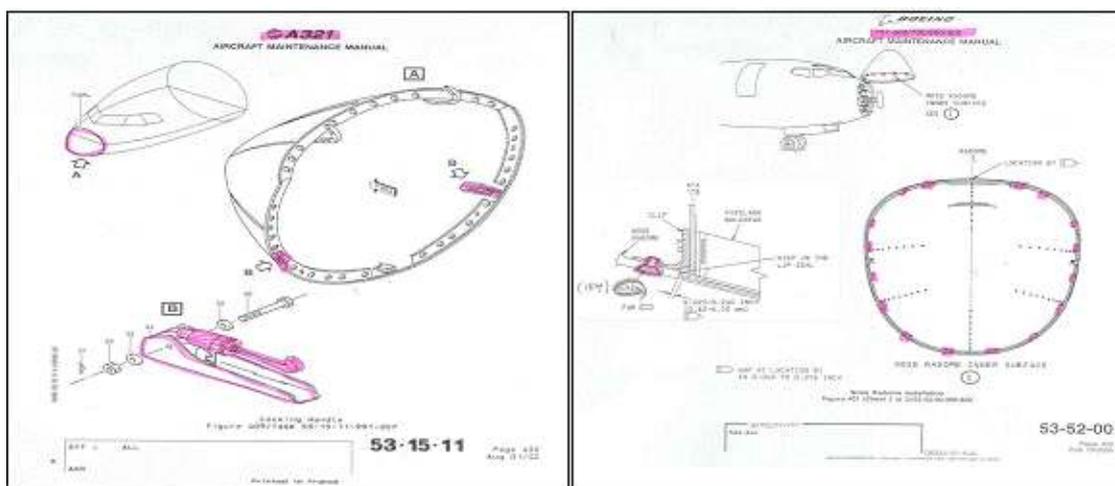
[Figure 20] Installation of Radome – Fix with 2 Latches (Left), Fix with 16 Bolts (Right)

The aircrafts of Airbus Series (A321, A330, A300-600) have two latches installed to the lower part of the radome at 4 o'clock and 8 o'clock direction; on the other hands, the aircrafts of Boeing Series (B737, B747, B777) have 6 or 8 latches installed on the circumference of radome in an even space and they are fixed by 16 bolts for B777 in order to protect the radome from detachment.

In this accident, the entire radome was detached from the aircraft, and similar case was investigated three times in the Airbus aircraft series. [Figure 20] shows the representative examples comparing the installation pattern of the radome between Airbus aircraft (A321) and Boeing aircraft (B777).

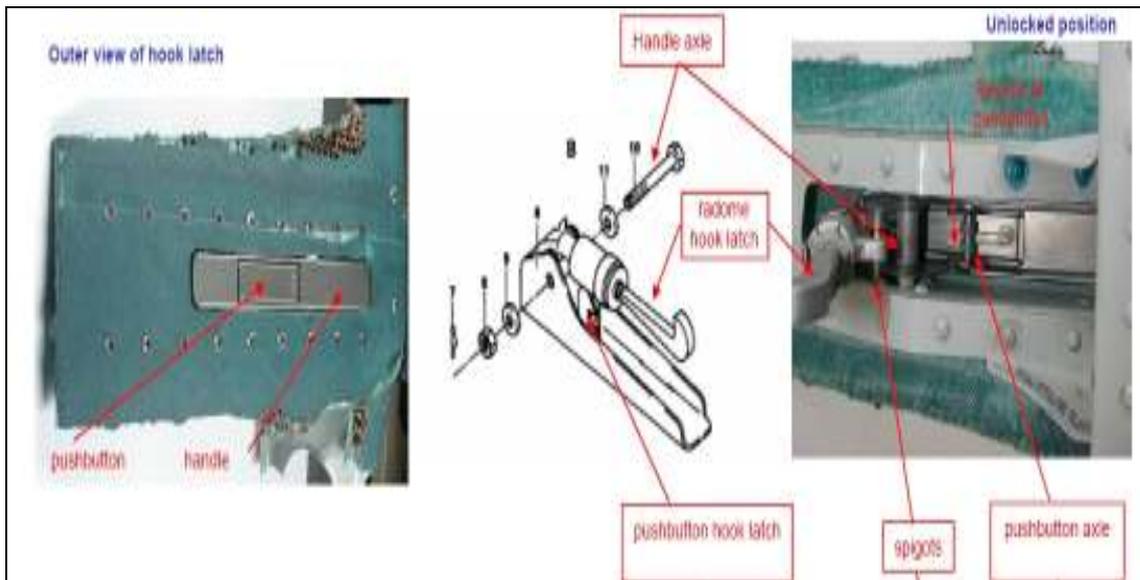
[Figure 22] Location of Hook Latch

In the unlocked position, the handle can be moved around the center of axle. The pushbutton latches are unlocked from the spigots on the radome hook latch. The return spring of pushbutton grips the radome hook latch making it align with the handle [Figure 22].

The hook latch moves along its axle. The left picture on the [Figure 22] shows the deformed pushbutton. The reason of deformation was that the high energy applied to the pushbutton. The direction applied was the direction of bent arrow. As shown in [Picture 22], the indentation of hook latch was by spigots.

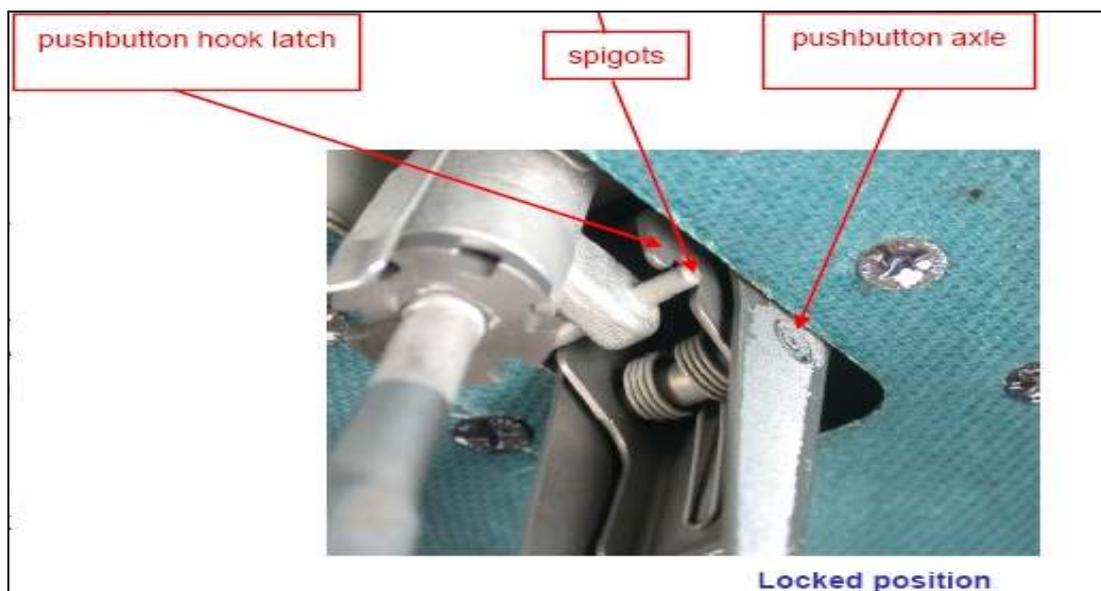
[Picture 19] Locked Position of Latch

In the locked position as shown in the [Picture 19], the pushbutton hook latches are hanged to the spigots. The pushbutton is directly connected to the radome hook latch. The handle has a same type of surface with the radome airframe structure surface.

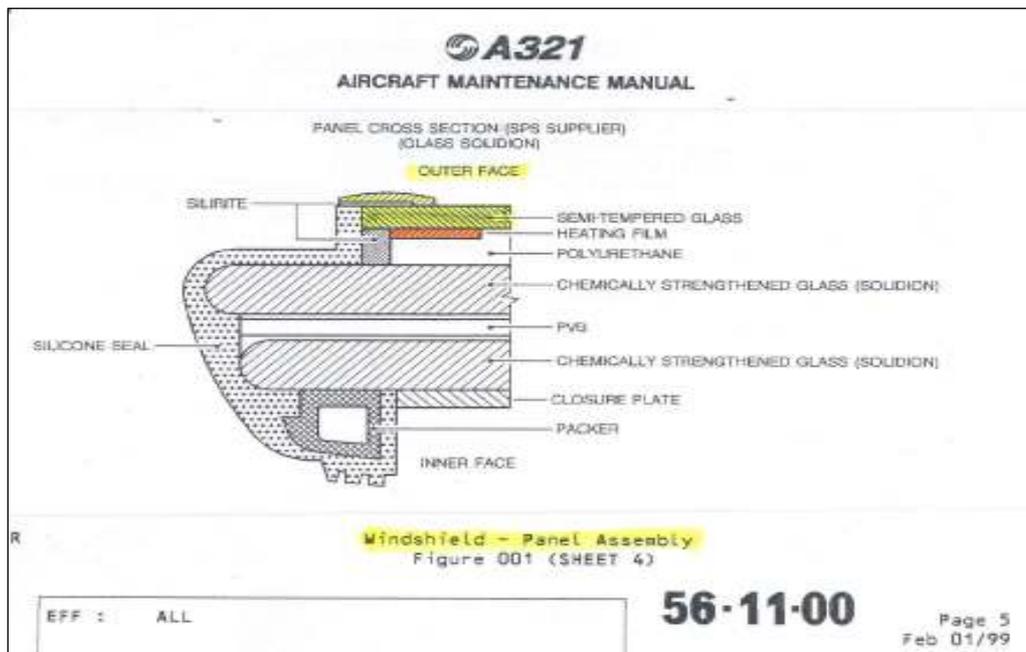
[Figure 23] Structure of the Aircraft Windshield

The size of the cockpit windshield shown in the [Figure 23] is 89.0 cm in width and 63.9 cm in height with a rhombic shape and its weight of 34.4kg and it is manufactured by “Saint Gobain Sully, France.”

When encountering with the thunderstorm, the windshield was damaged by the hail at 17:40:02 and the defect message of “left/right WINDSHIELD WHC” on MCDU^{81, 82} displayed and “ANTI ICE L+R WINDSHIELD” of the ECAM⁸³ warning message displayed. Inferring from these messages, it is estimated the Anti-Ice Switch of the aircraft was on the “ON” position.

Inferring from the damaged pattern of the windshield, it is estimated that the hails with 2.0 cm ~ 3.0 cm in diameter hit the outer face of the windshield heavily. It was sufficiently resisted from the wind outside since the inner face was not damaged; on the other hands, it was very difficult to secure the vision since the surface glass of the outer face was severely damaged.

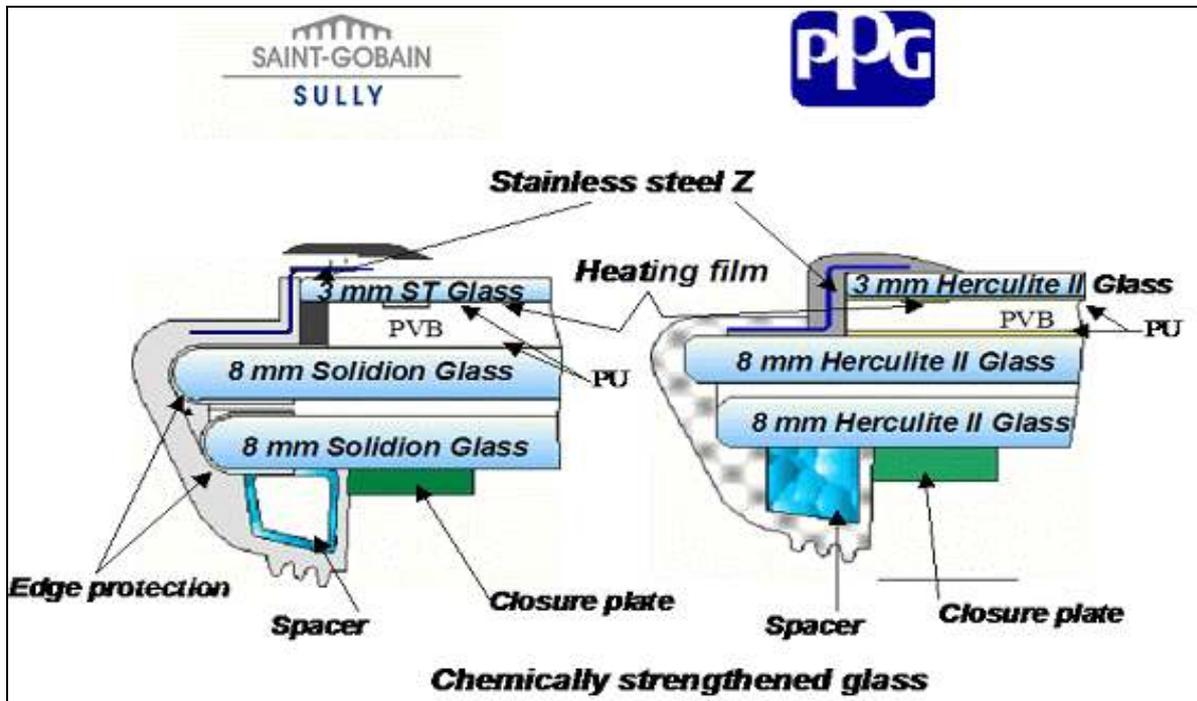
[Figure 24] Comparison of Windshield Manufactured by SGS (France) and PPP (USA)

A windshield currently used in the aircrafts is mainly manufactured by SGS (France) and PPP (USA) and it is composed of chemical composite glass and its strength and thickness meets the regulations. [Figure 24] shows the windshield comparison between two representative windshield

manufacturing companies of SGS (France) and PPP (USA) and it is verified that there is no difference found in size, strength and properties by the manufacturers’ technicians during the technical meeting.

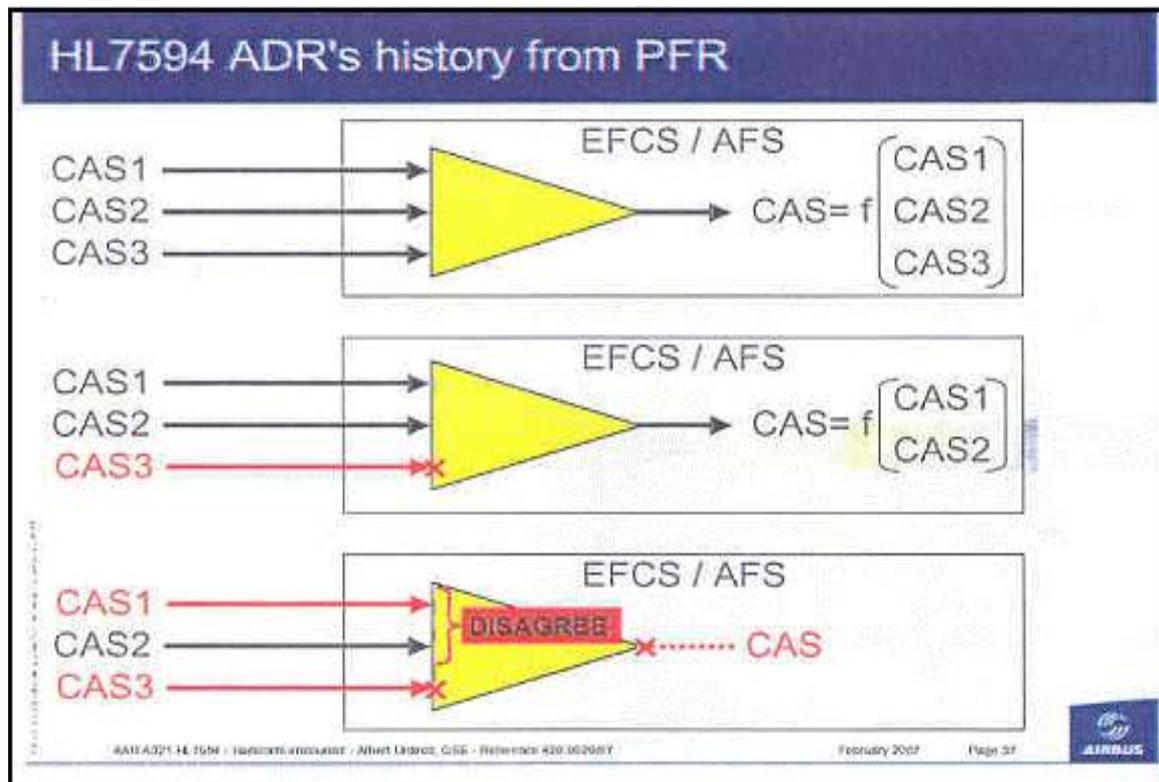
[Figure 25] Input Data to Weather Data INS (ADR)

It is presumed that the auto pilot system was disconnected by difference in speed input entering into the Air Data and Inertial Reference System (ADIRS) computer because of disturbance of air flow in the dynamic/static pressure pipe after detachment of radome and at the same time the inconsistency in speed was detected by the Flight Augmentation Computers (FAC) 1 and 2 which controls yawing.

As the radome was detached, there was a change increased aerodynamically by the change of the air flow in the direction of flight. There are three identical Air Data and Inertial Reference System Unit (ADIRU). Each of them computes and provides air data from the 3 probe sources to the users (including EFCS and AFS). When one of the sources differs from the 2 others, it is eliminated and systems compute airspeed with the 2 remaining sources. If then those sources also differ, system consider sources as unreliable. [Figure 25] is the diagram showing this procedure.

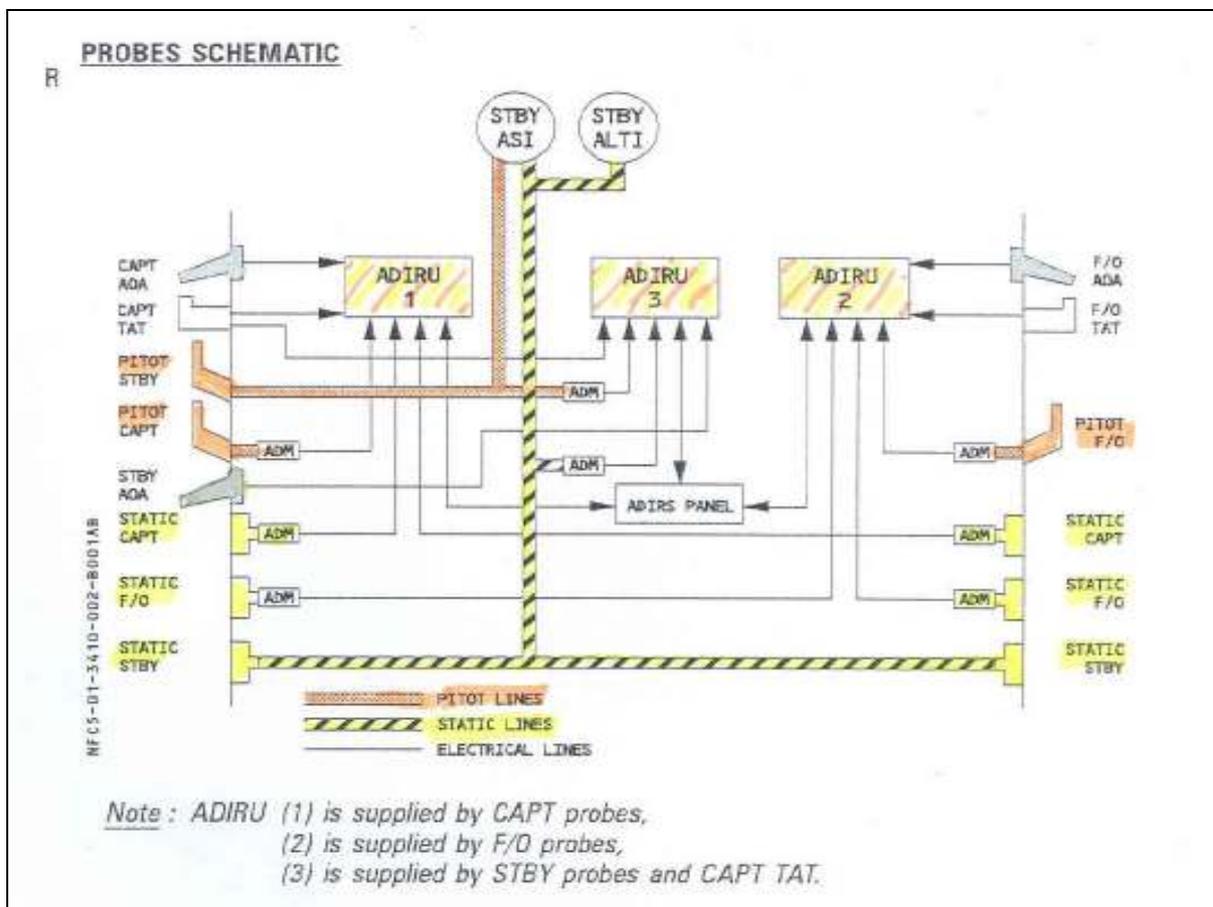
[Figure 26] Schematic Diagram of Probes

It is analyzed that the main cause of disconnection in the aircraft systems was that the essential probe could not detect the dynamic/static pressure accurately which was installed on both front sides of the aircraft as the air flow was scattered by not flowing smoothly due to detachment of radome from the airframe.

These probes detect the sudden change in air pressure and outside temperature as the outside air flow and then display them on the computer, speed meter and altimeter. [Figure 26] shows the schematic diagram of probes in relation with speed.
