Investigation Report

3X181-0/06
April 2010

Kind of occurrence: Accident
Date: 29 November 2006
Location: Mattsies
Type of aircraft: Fixed wing
Manufacturer/Model: Grob Aerospace / G 180A
Injuries to persons: Pilot fatally injured
Damage to aircraft: Aircraft destroyed
Other damage: Crop damage
Source of information: Investigation by BFU

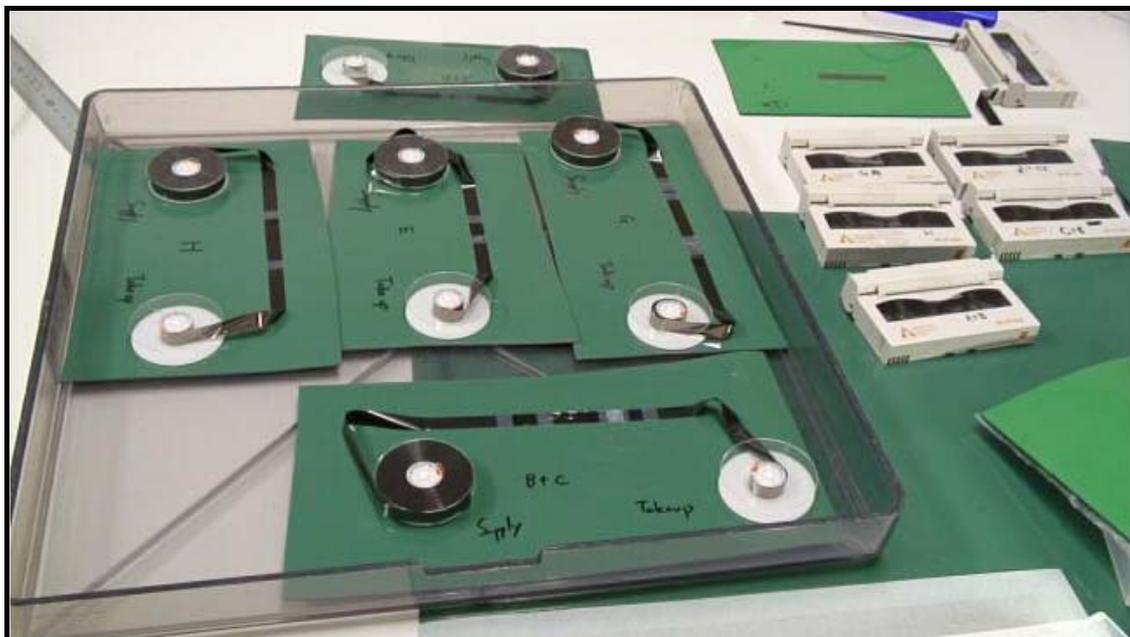
Diagram 8: Cassettes with prepared sections of magnetic tape

In addition, an attempt was made to extract data from the fragments (diagram 7). The fragments were carefully flattened and spliced with an undamaged tape, followed by an attempt to extract further data.

The damage was so severe, that it was not possible to extract data.

It was found that further data could be read out by changing the playback parameters. The reconstructed data are from the accident flight recording, but prior to take-off. The actual flight phase data was on the fragmented sections and was unreadable due to impact damage.

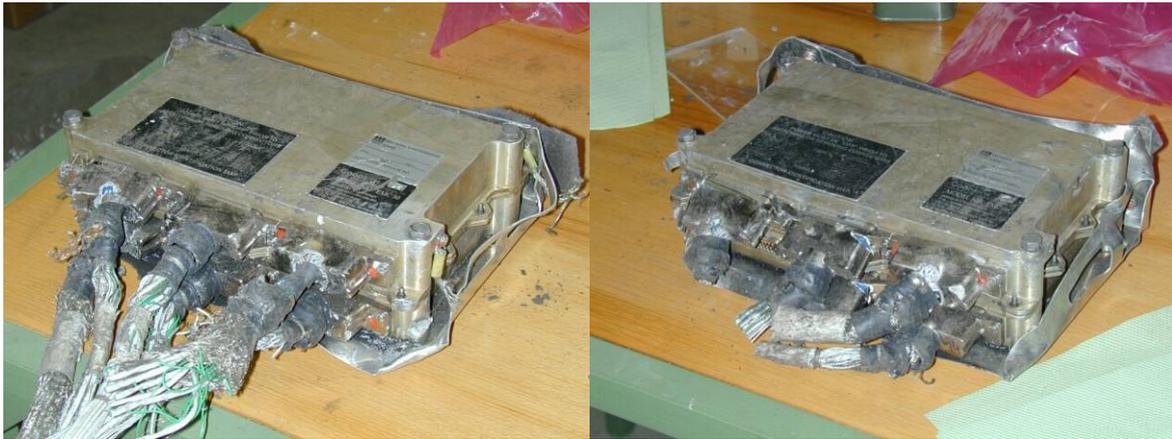
Diagram 10: The FADECs from the two engines

Both FADECs were recovered from the wreck with the intention of obtaining engine power data and any possible fault errors from non-volatile storage media.

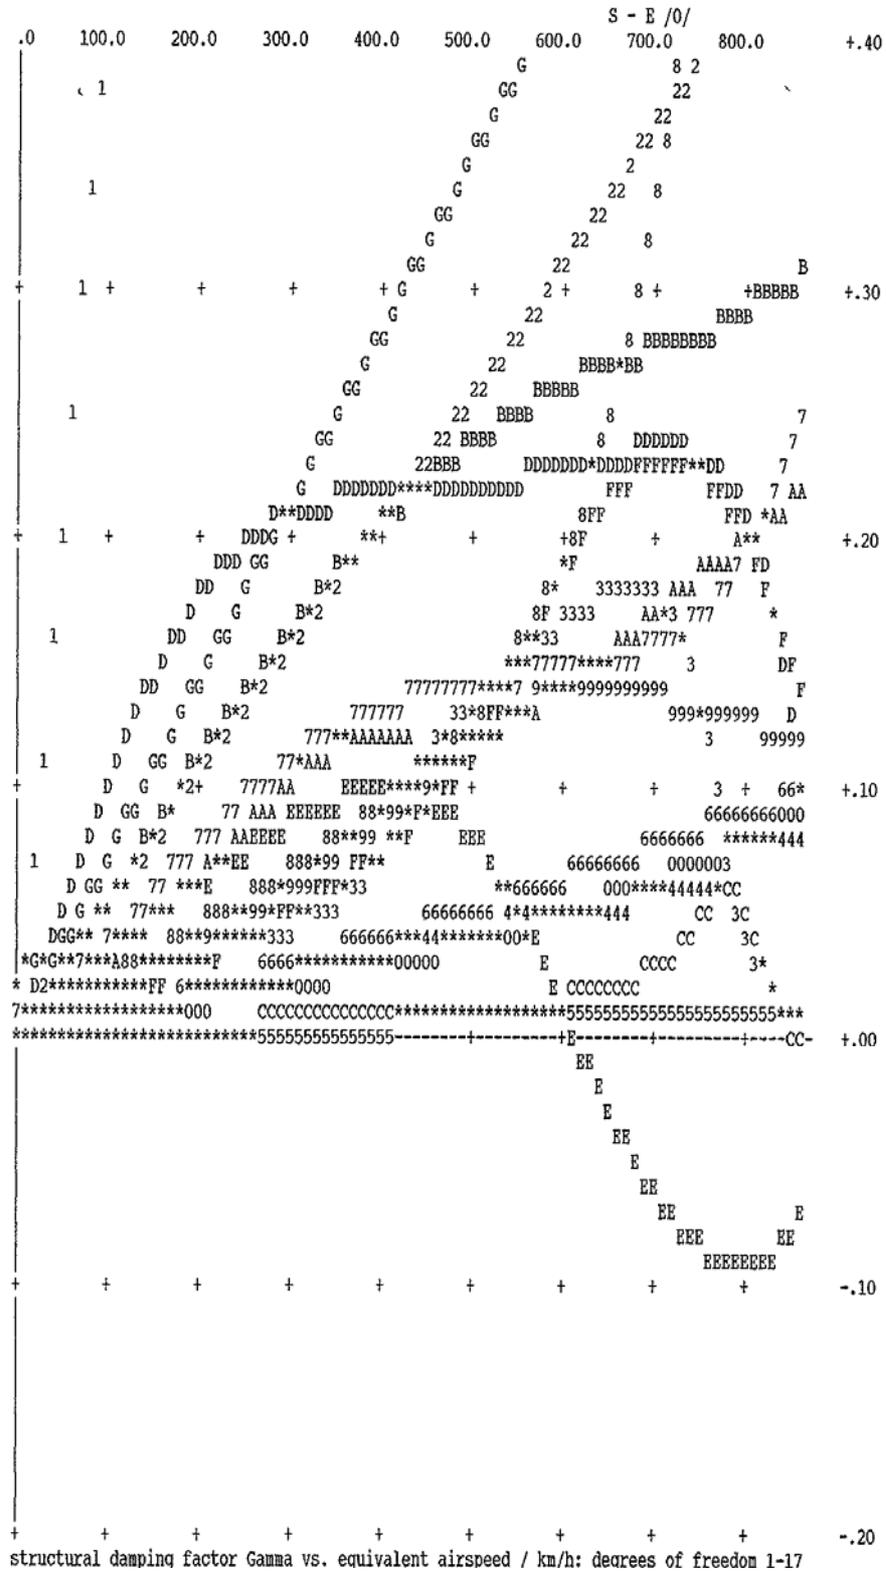
Damping curve: Symmetric Normal Mode 0 m

Analysis showed that above a speed representing 83% of the damping curve zero crossover point, the damping curve associated with the worst flutter condition could occur. The probability for this was approximately 0, but increased to 1 with approach to the speed at the zero crossover point. The range between 83 % and 100 % of the speed at the zero crossover point (in this case 261 kt (483 km/h) to 313 kt (580 km/h)) was identified as a critical speed range.

E = Curve of the elevator vibration against control column

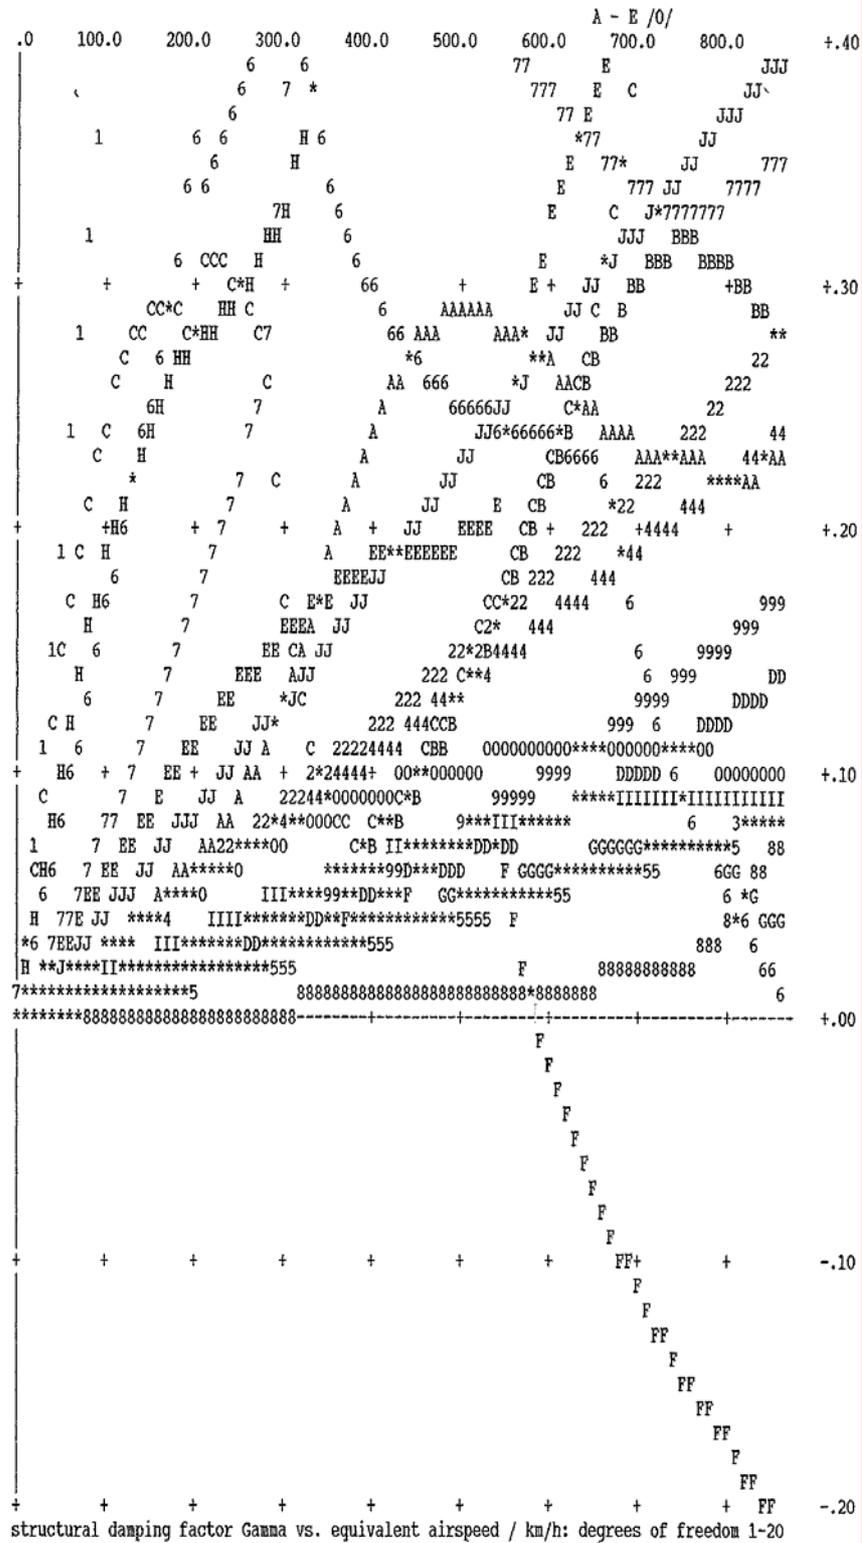
Damping curve: Asymmetric Normal Mode 0 m

F = Curve of elevator tip vibration against trim tab.
