# NATIONAL TRANSPORTATION SAFETY COMMITTEE

*Aircraft Accident Investigation Report*

**PT. Adam SkyConnection Airline (Adam Air)  
Boeing 737-300 ; PK-KKV  
Juanda Airport, Surabaya, East Java  
Republic of Indonesia**

**21 February 2007**

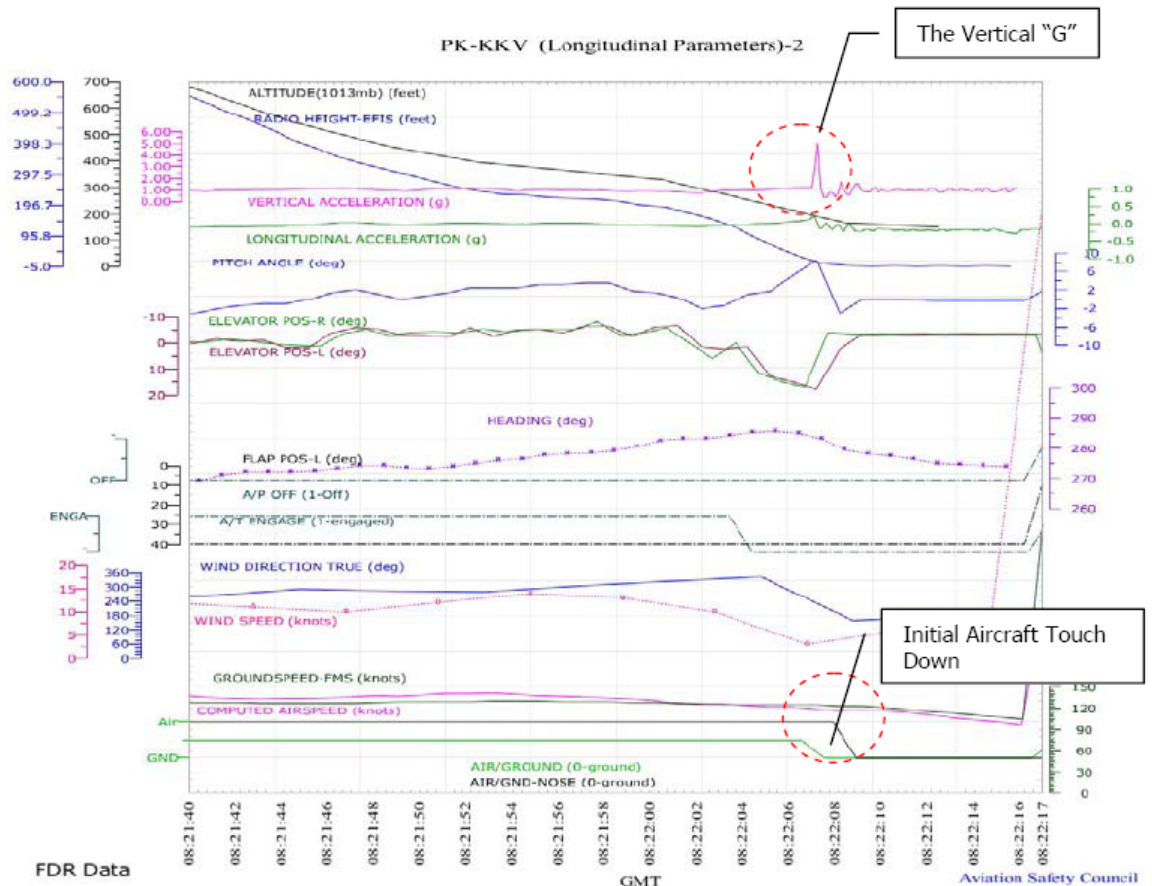
Figure 9: The DFDR readout

The DFDR data was downloaded at Aviation Safety Council, Taiwan under supervision of the NTSC investigators.

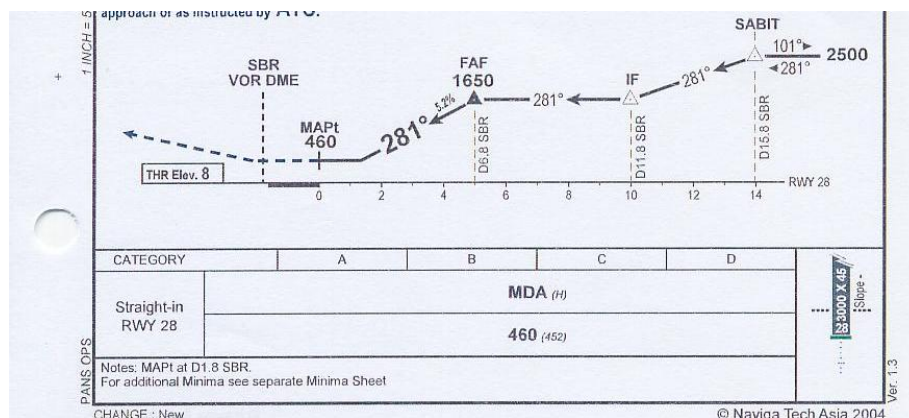
Figure 11: Descend profile VOR/DME approach runway 28 Surabaya

The flight crew discussed about initial approach altitude and approach descend point. This showed that both pilot did not familiar with the VOR/DME approach profile.

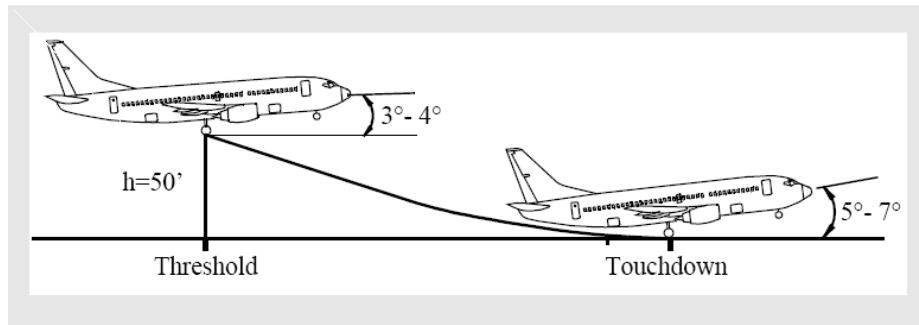
**Figure 13: The Boeing recommendation for aircraft attitude during approach**

The Boeing FCTM also recommended the attitude of the aircraft during the approach. It is recommends that during cross the threshold, the aircraft attitude is between 3-4 degrees up. While flare out for touchdown, the aircraft attitude is between 5-7 degrees up.

The rate of descent, the pitch attitude and late of flap selection to 40 were the indication that a stabilized approach criteria was not met. According to the Boeing FCTM, the go around should be initiated.
