Report 07-006, Hawker Beechcraft Corporation 1900D, ZK-EAK, landing gear malfunction and subsequent wheels-up landing, Woodbourne Aerodrome, Blenheim, 18 June 2007

Report 07-006

Hawker Beechcraft Corporation 1900D ZK-EAK

landing gear malfunction and subsequent wheels-up landing

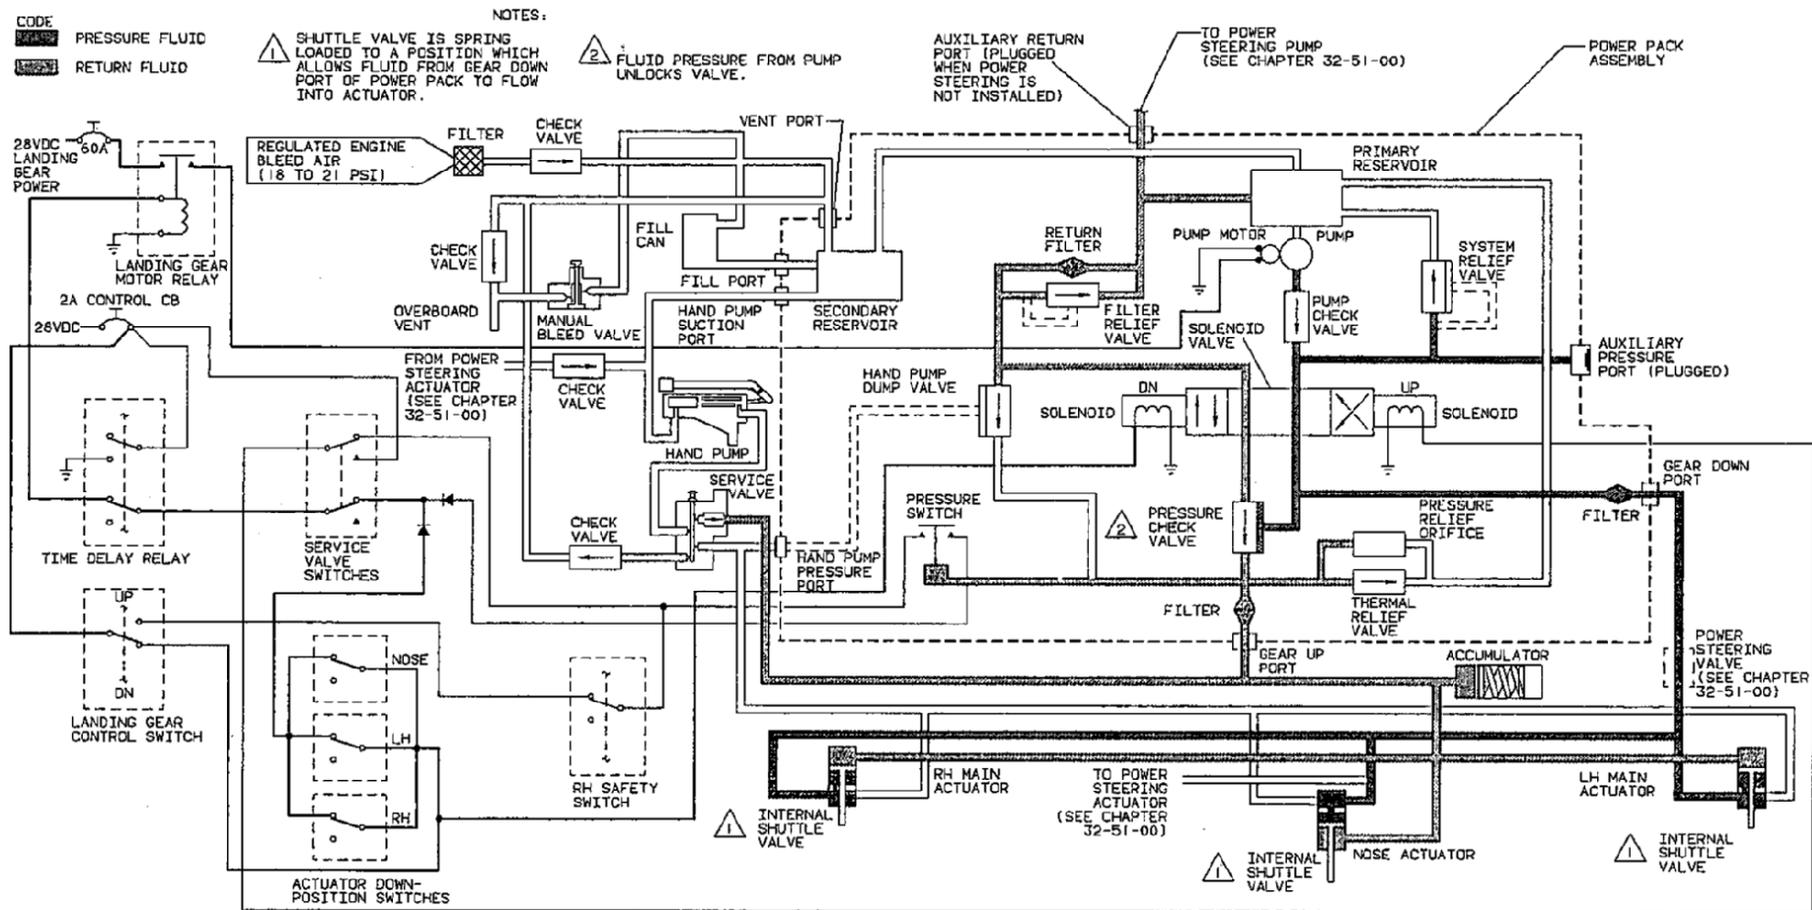
Figure 2
 Hydraulic landing gear diagram (normal extend mode)

- 1.4.4 The plumbing for normal landing gear extension ran to a shuttle valve located in the end cap of each actuator. Each shuttle valve was spring loaded to a position that allowed hydraulic fluid to flow into or out of the actuator cylinder. The retract mode plumbing was fitted to the opposite end of each actuator (see Figure 2).
