**Accident Investigation Board
Denmark**

Report

HCLJ510-000433

Accident to Bombardier DHC-8-400,
registration LN-RDK,
at Aalborg Airport (Denmark),
on 9 September 2007

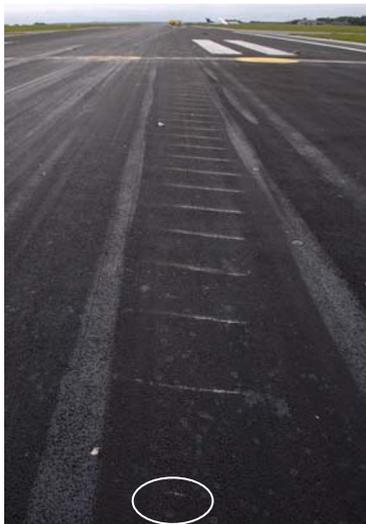
The witness marks - from the propeller - on the runway indicated that the three blades had departed the propeller almost instantly after impact with the runway and before the aircraft outer wing came in contact with the runway.

The first blade contact. All six blades did contact the runway.

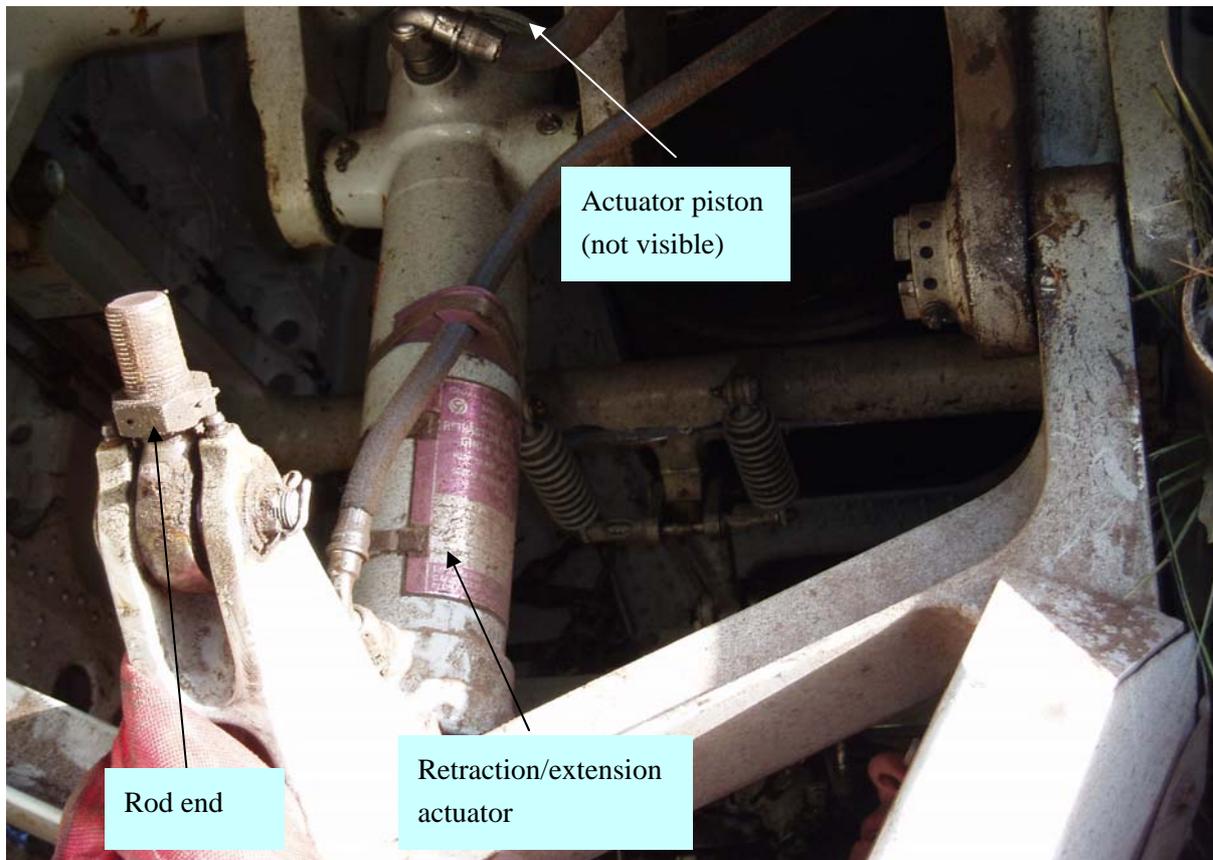
Fig. B. Right MLG retraction/extension actuator

The retraction/extension actuator was found with the rod end separated from the retraction/extension actuator piston rod. Due to its weight and mounting design the retraction/extension actuator was found up-side down (figure B).

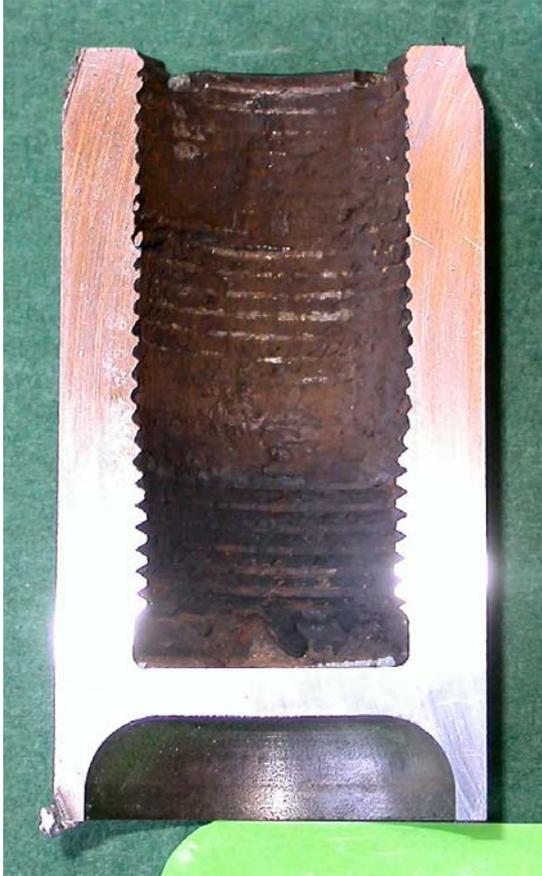
Figure 4: Higher magnification of Figure 3

The threaded end of the piston rod was sectioned longitudinally as shown in figures 3, 4 and 5. Figure 6 shows a section of the piston rod before and after cleaning. It was evident that the female threads were severely damaged and partly destroyed by corrosion. Figure 10 shows the appearance of threads in the non-engaged part of the thread. The contour of the non-engaged threads appears intact but upon closer view it was evident that corrosion had also occurred in these parts.

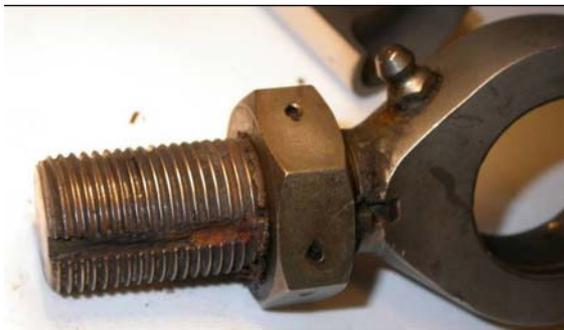
Figure 30: Rod end (as dismantled).

It was noted that the lock wire was intact and in place before dismantling. The lock nut could easily be moved on the rod end, but there was remarkably more resistance while unscrewing the rod end from the piston rod. The rod end threads shown in figure 30 appeared undamaged as did the piston rod threads at first glance from the outside. However, cleaning and longitudinal sectioning of the piston rod revealed some metal loss, figure 31. The left piston also features less corrosion at the position of the rod end key way as shown in figure 32. While corrosion attacks were obvious there was also evidence of some mechanical contact marks in the thread tops.

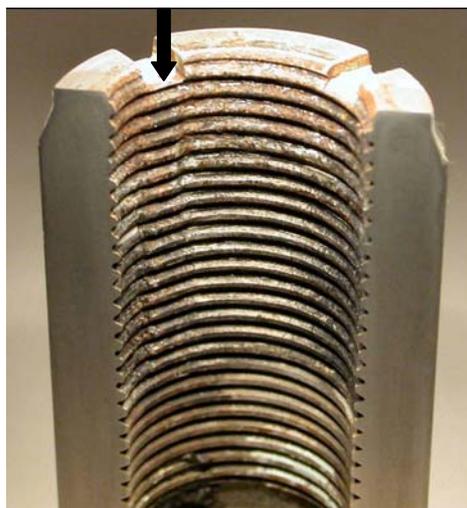
Figure 32: Overview of piston rod section showing less corrosion in the key way area (at arrow).

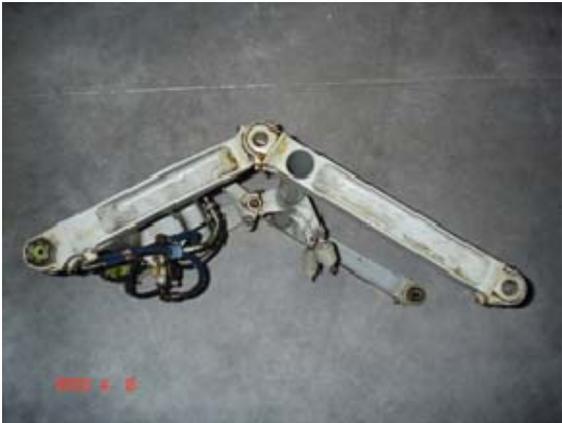
- Sequence 2, 3 and 4: The right MLG extended under undamped free fall conditions on approach to EKYT with sufficient kinetic energy to cause failure of the stabilizer joint lugs. This failure rendered the stabilizer incapable of safely locking the right main gear in the 'down' position, (indication of 'unsafe' gear was given).

Sequence 2: Gear in transit (Free fall).

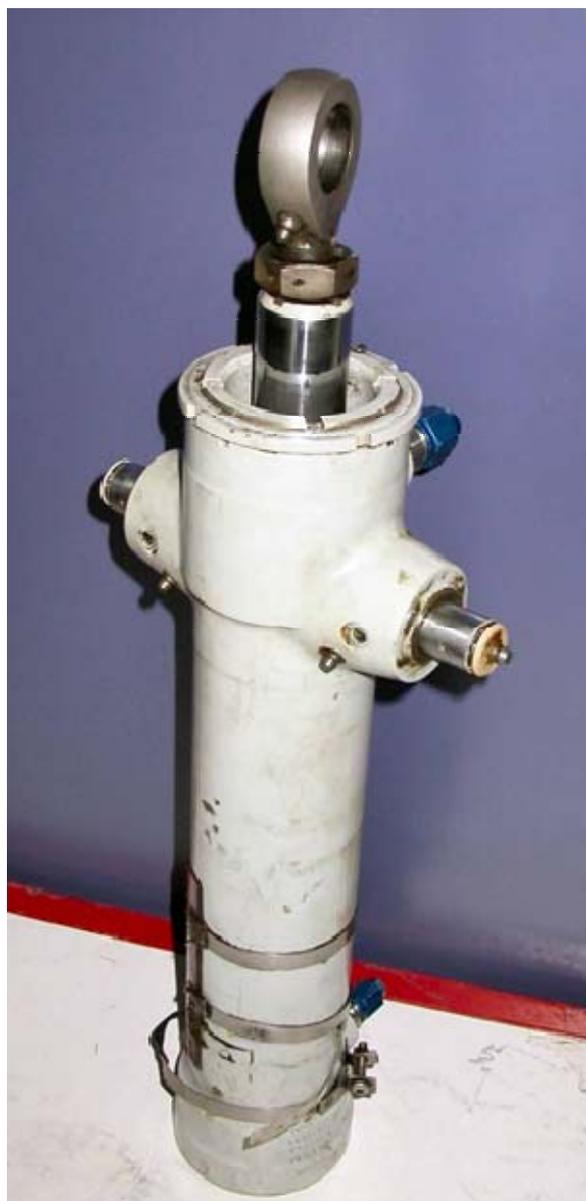
Figure 1: View of right hand retract actuator with piston rod and rod end at top.

Figure 1 shows a photo of the actuator and the piston rod end. Figure 2 shows close up views of the piston rod female thread and the rod end male thread in "as received" condition.

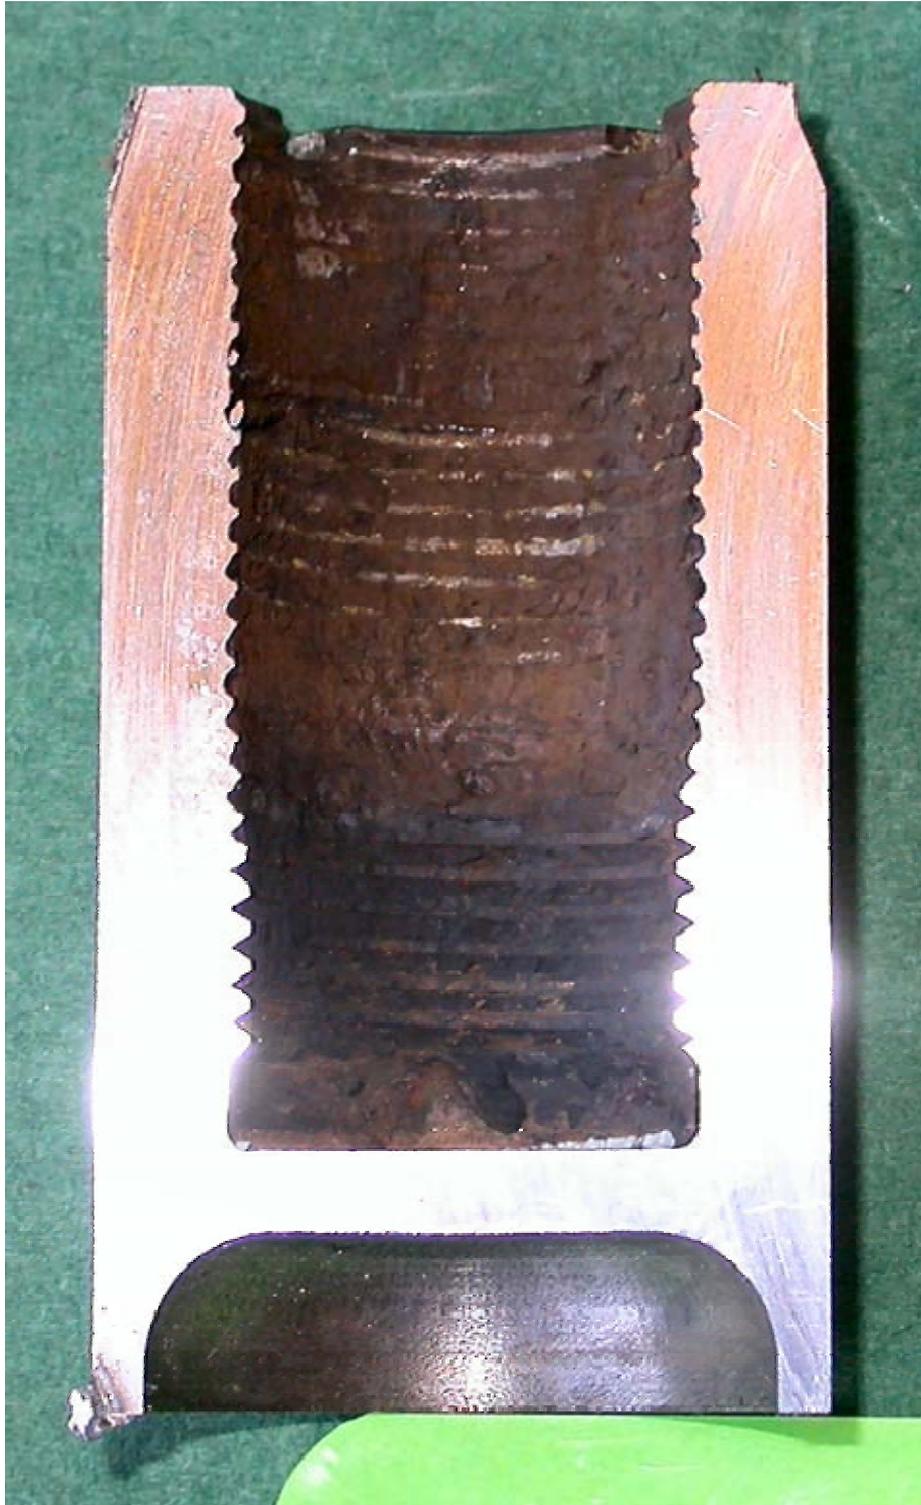
Figure 4: Higher magnification of Figure 3.

The threaded piston rod end was sectioned longitudinally as shown in Figures 3, 4 and 5. Figure 6 shows a section of the piston rod before and after cleaning. It is evident that the female threads were severely damaged and partly eaten away by corrosion. Figures 7 and 8 show a scanning electron microscope image and a longitudinal section through some of the severely damaged threads. Figure 9 shows tearing and shearing of the remaining thread profile tips at the mouth of the piston rod during final pull out of the rod end. Figures 10 and 11 show the appearance in the non-engaged part of the threads. The contours of the non-engaged threads appear intact but at closer view it is evident that corrosion has also occurred in these parts.

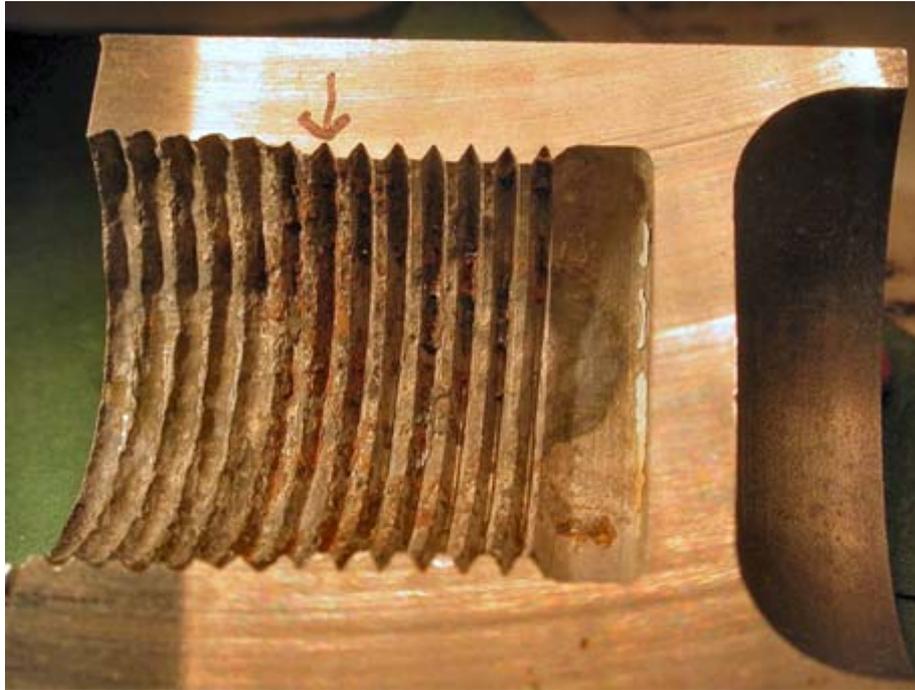
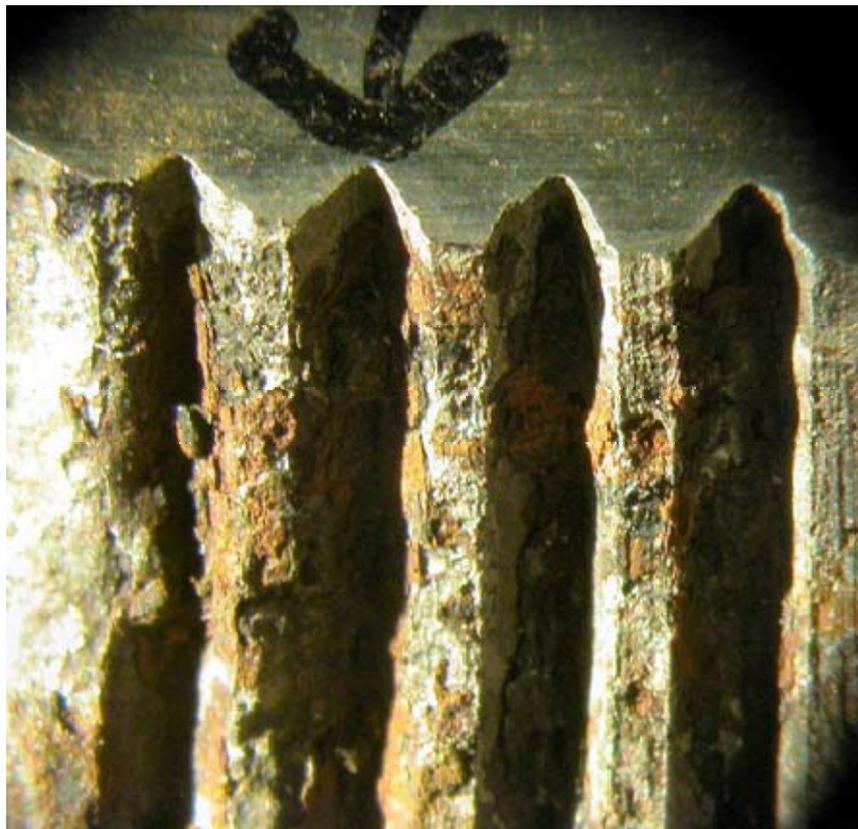
Figure 10: View of threads near bottom of piston rod. The arrow points to the last engaged thread.

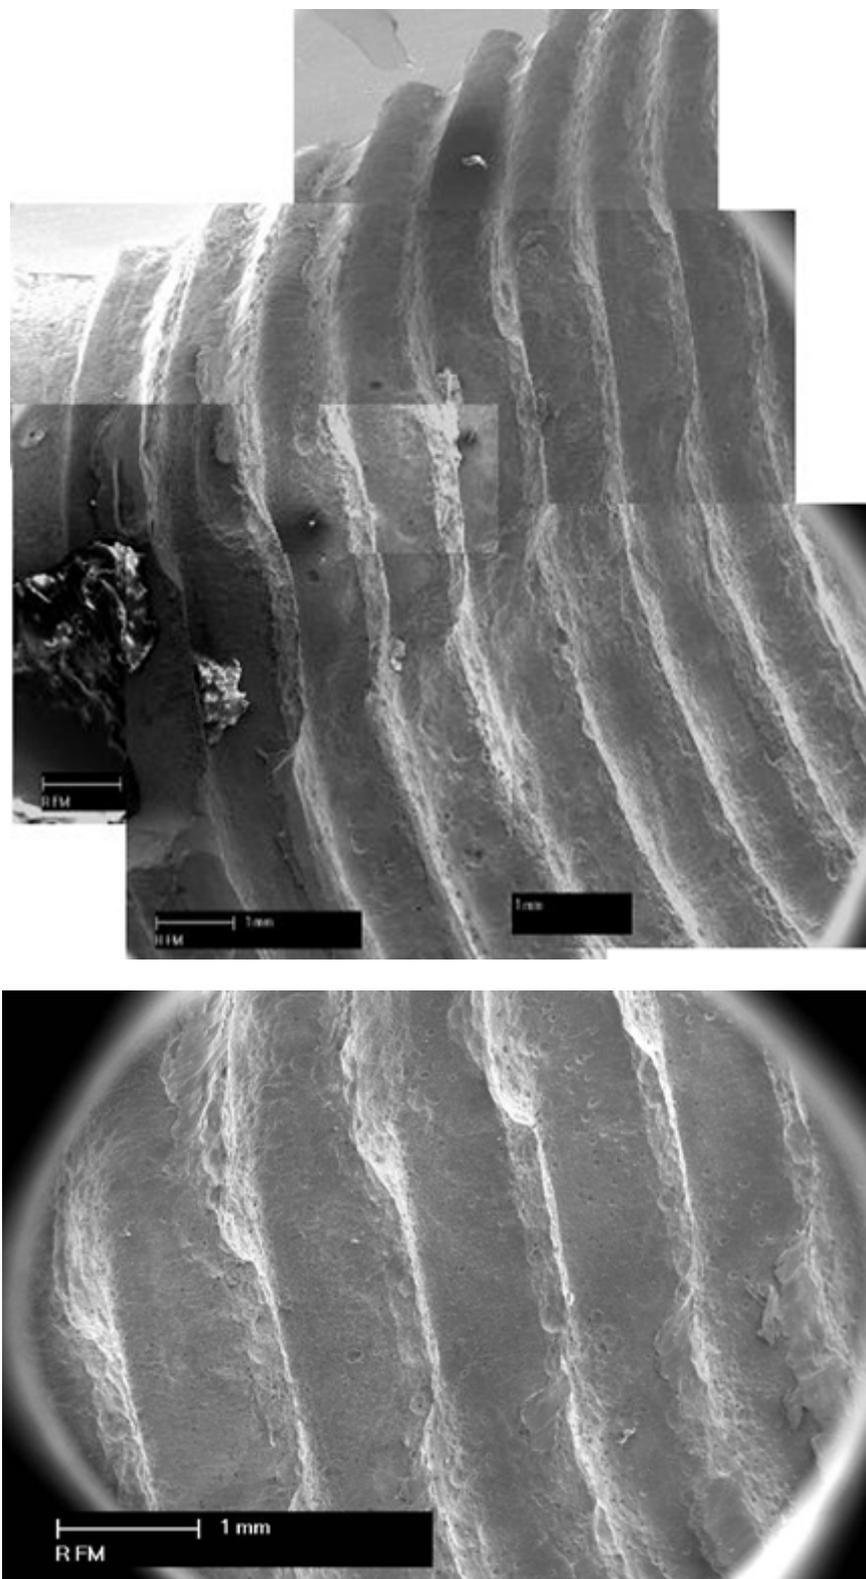
The thread areas coinciding with the position of the key way in the rod end (visible in Figure 3) are less attacked by corrosion, but corrosion attacks are still apparent, c.f. Figures 12 and 13.

Figure 13: Scanning electron microscope images of same area as in previous figure.

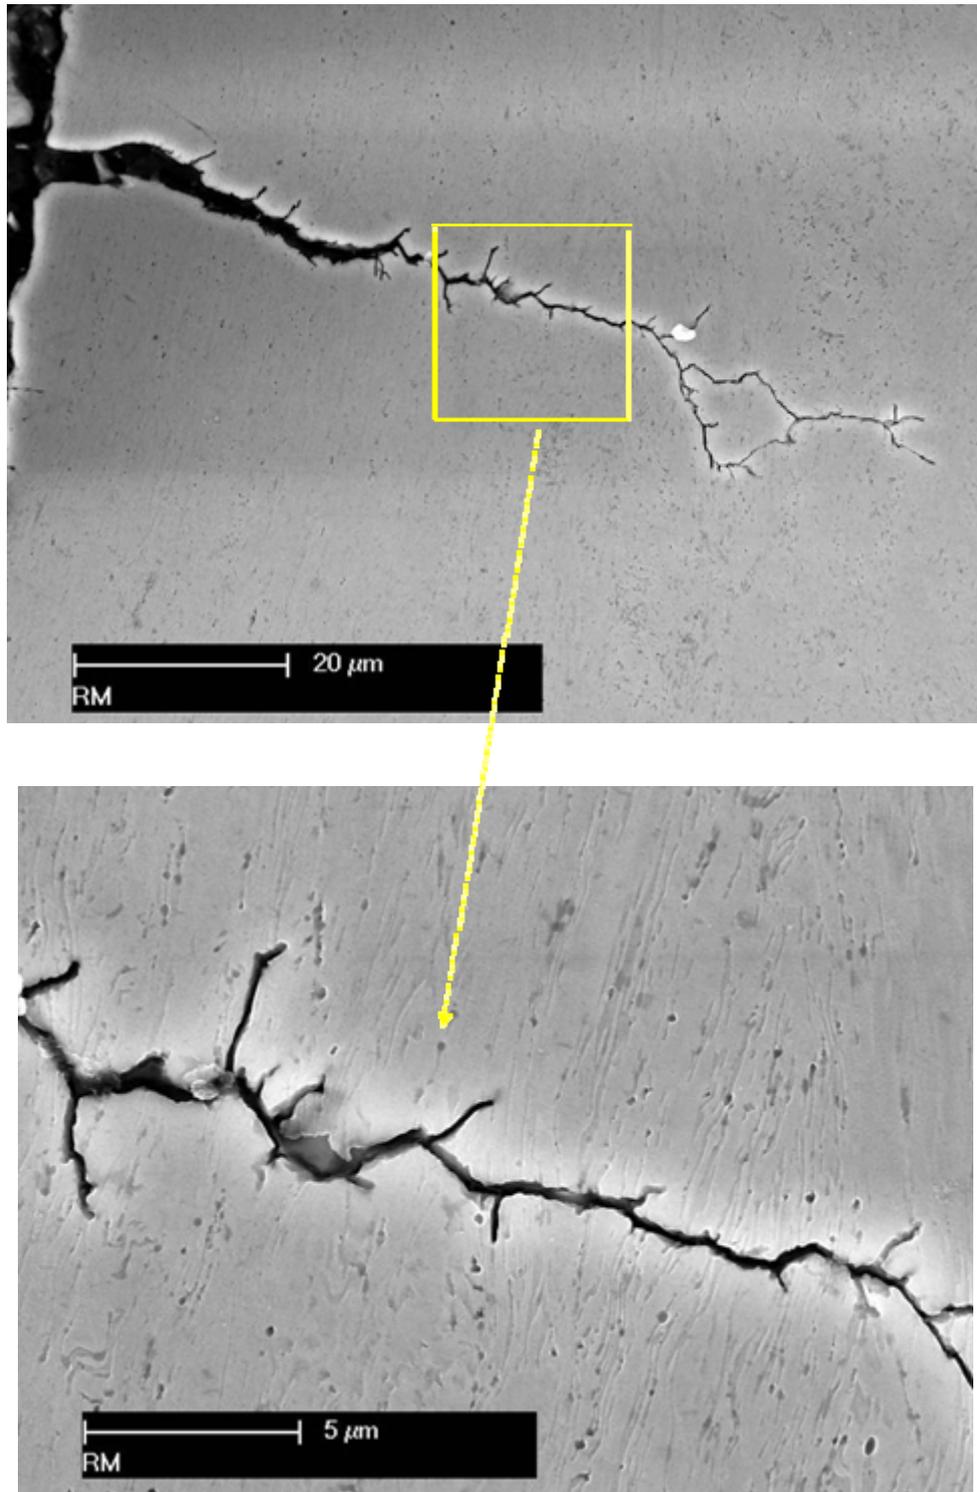
Figure 25: Higher magnifications of part of crack in Figure 24.

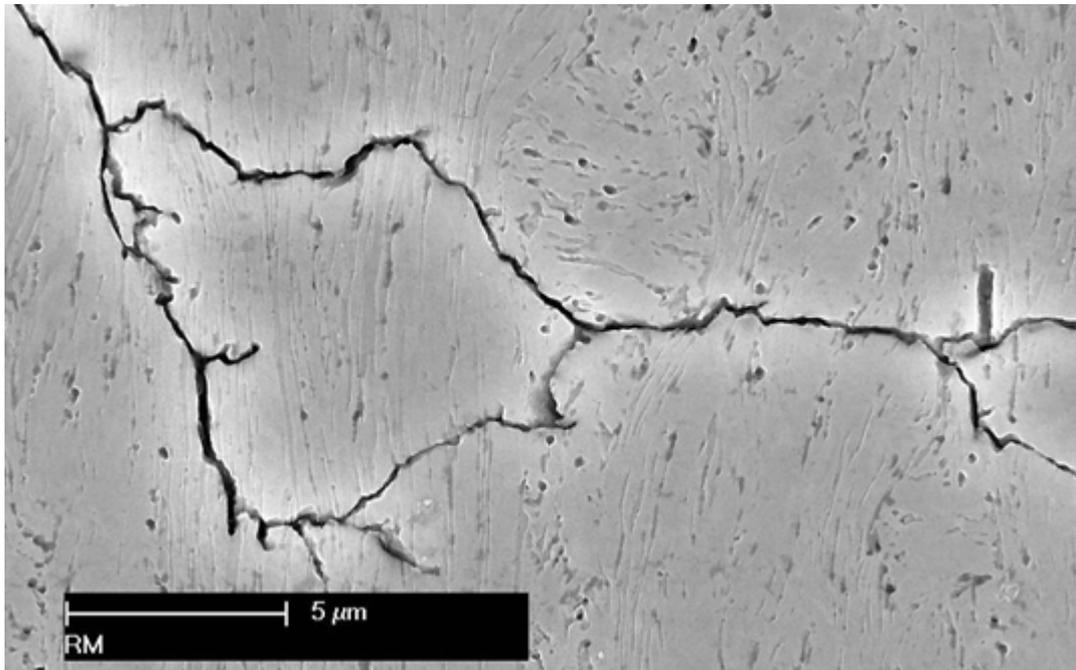
Figure 26: Higher magnification near crack tip.

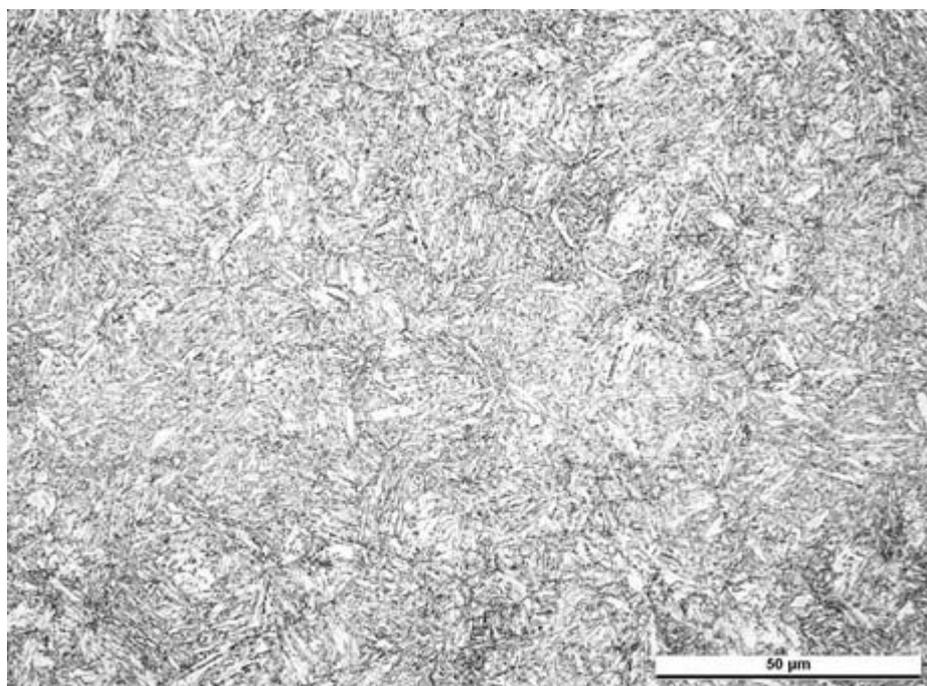
The piston rod and the rod end were analysed by emission spectrometry. The results are shown in Appendices 1 and 2. The rod material corresponds to 4340 material and the rod end is made of 12% Cr stainless steel with ~8% Ni. The microstructures are shown in Figures 27 and 28. It consists of tempered martensite in both cases. The Vickers hardness of the materials is ~ 420 for the piston rod and ~ 410 for the rod end.

Figure 27: Microstructure of piston rod material featuring uniformly tempered martensite.

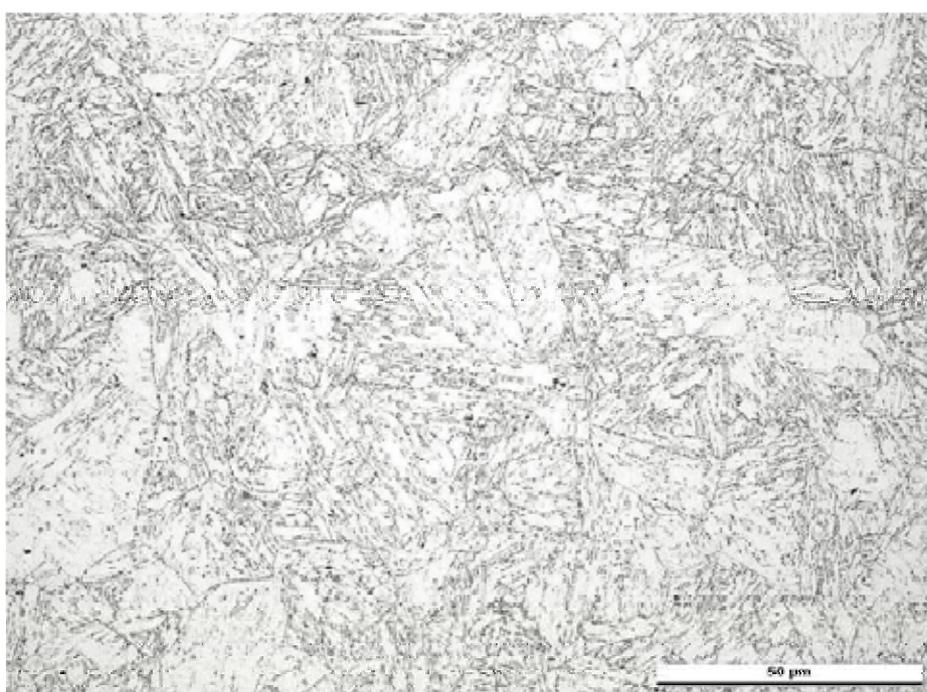
Figure 28: Microstructure of rod end material featuring uniformly tempered martensite.

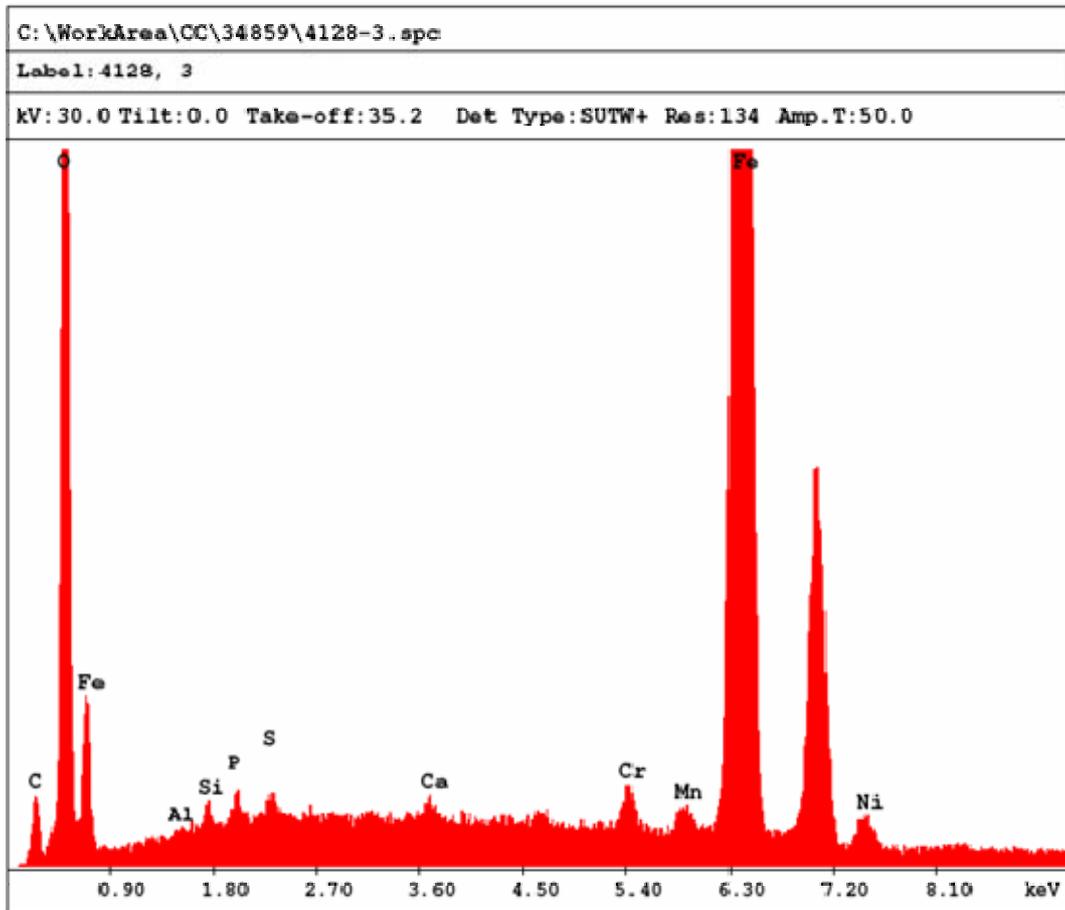
Corrosion products in the female threads were analysed by energy dispersive x-ray analysis in scanning electron microscope. The products consist mainly of Fe and O (iron oxide) with small amounts of Si, P, S and Ca, c.f. Figure 29.

Figure 29: Energy dispersive x-ray analysis of corrosion products retrieved from piston rod threads.

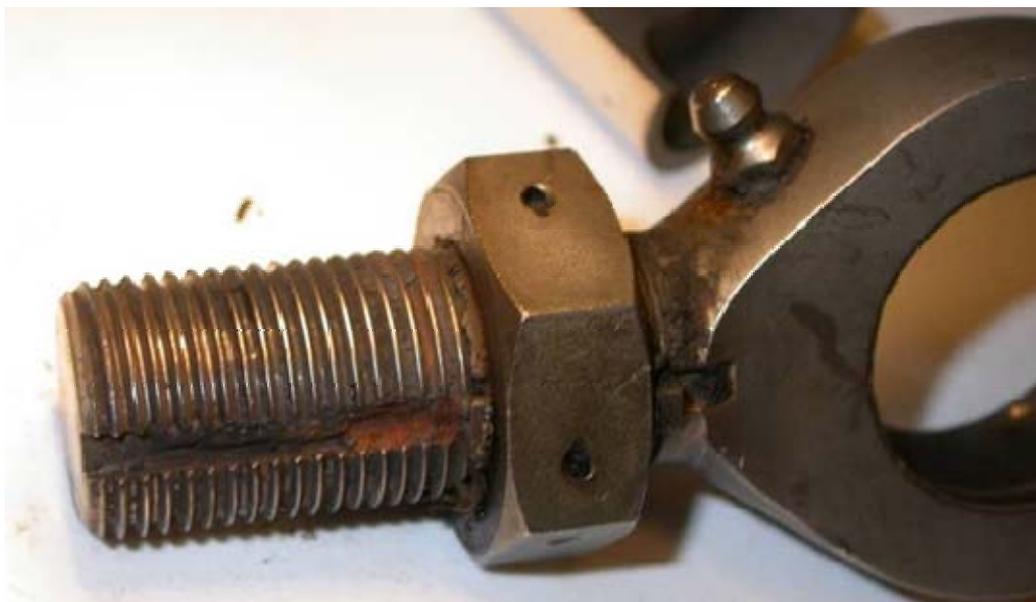
Figure 30: Rod end (as dismantled).

rod. The rod end threads shown in Figure 30 appear undamaged as did the piston rod threads at first look from the outside. However, cleaning and longitudinal sectioning of the piston rod revealed some metal loss, c.f. Figure 31. The left hand piston also features less corrosion at the position of the rod end key way as shown in Figure 32. Figure 33 shows the thread's appearance in more detail. While corrosion attacks are obvious there is also evidence of some mechanical contact marks in the thread tops.

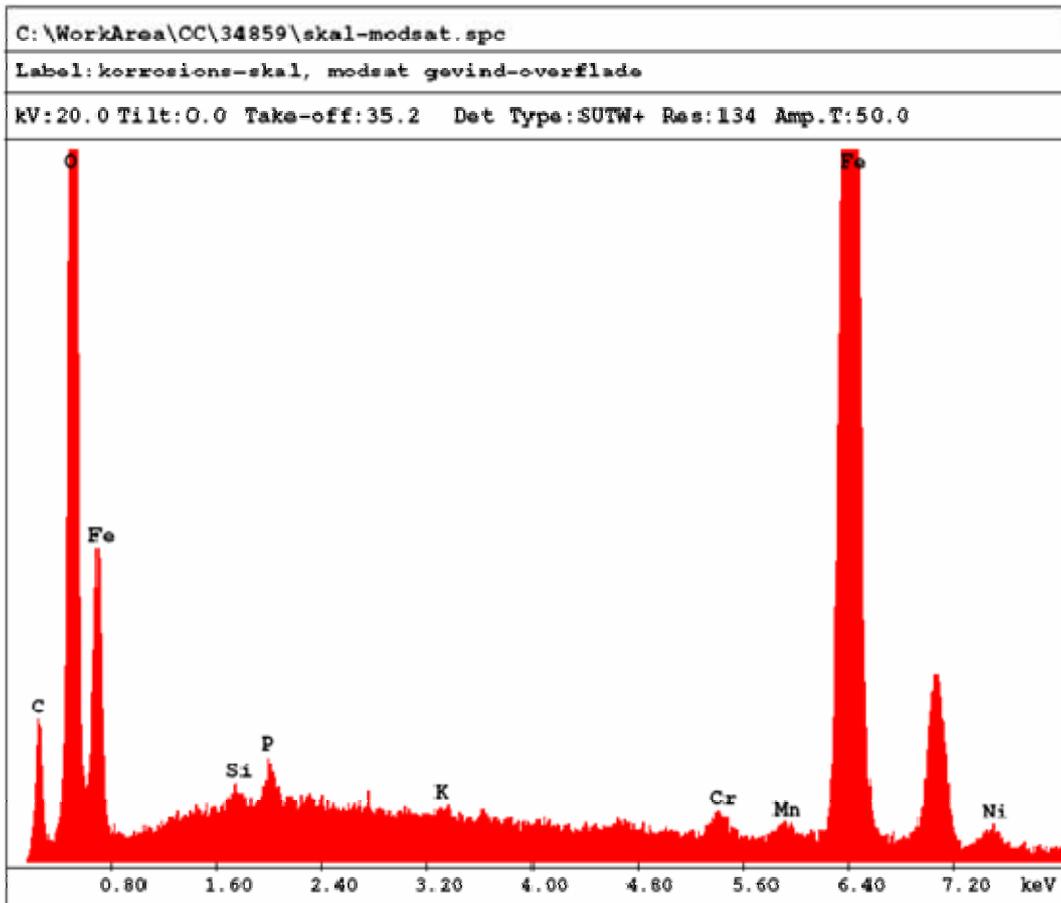
Figure 35: Energy dispersive x-ray analysis of brittle scales from rod end thread.

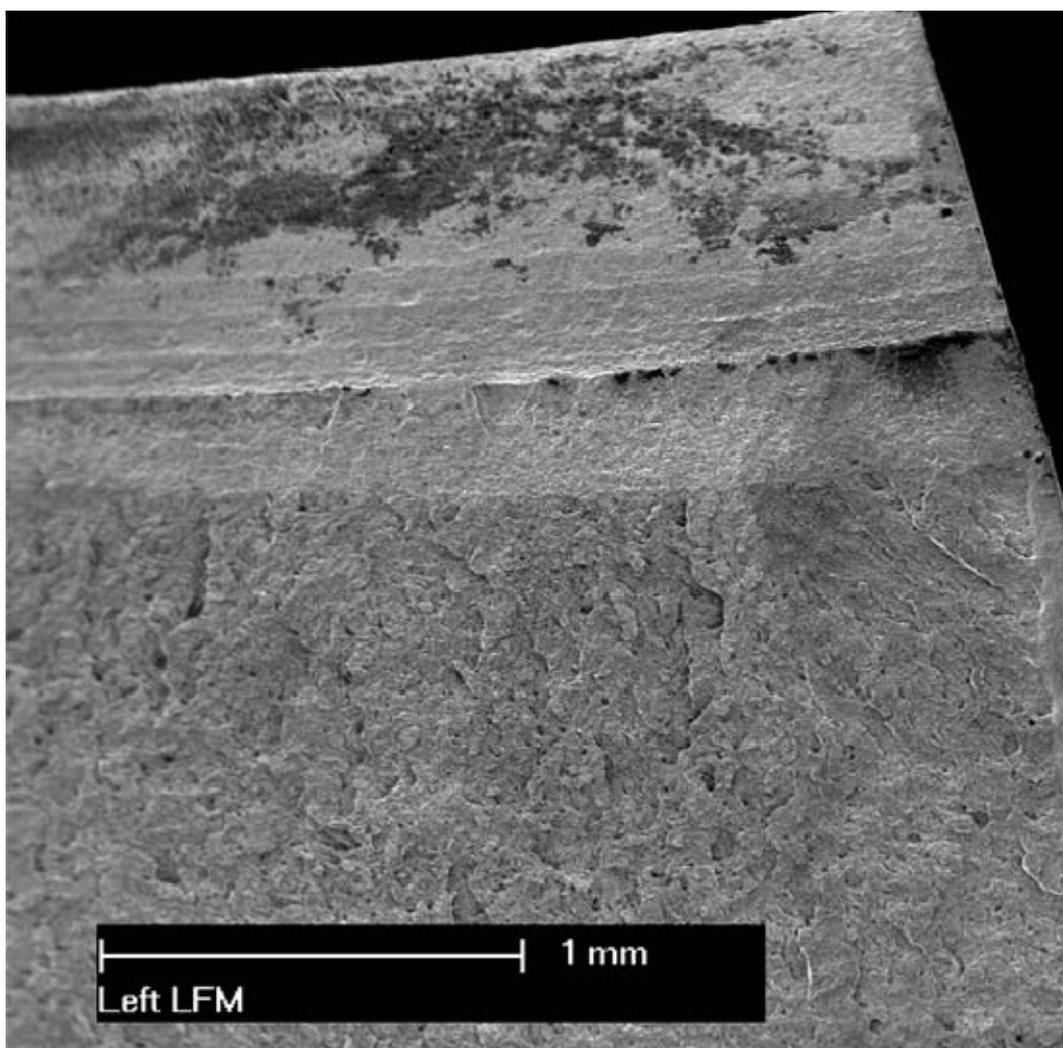
Figure 44: Scanning electron microscope image showing an overview of free-laid crack surface (opposite part to Figure 43).

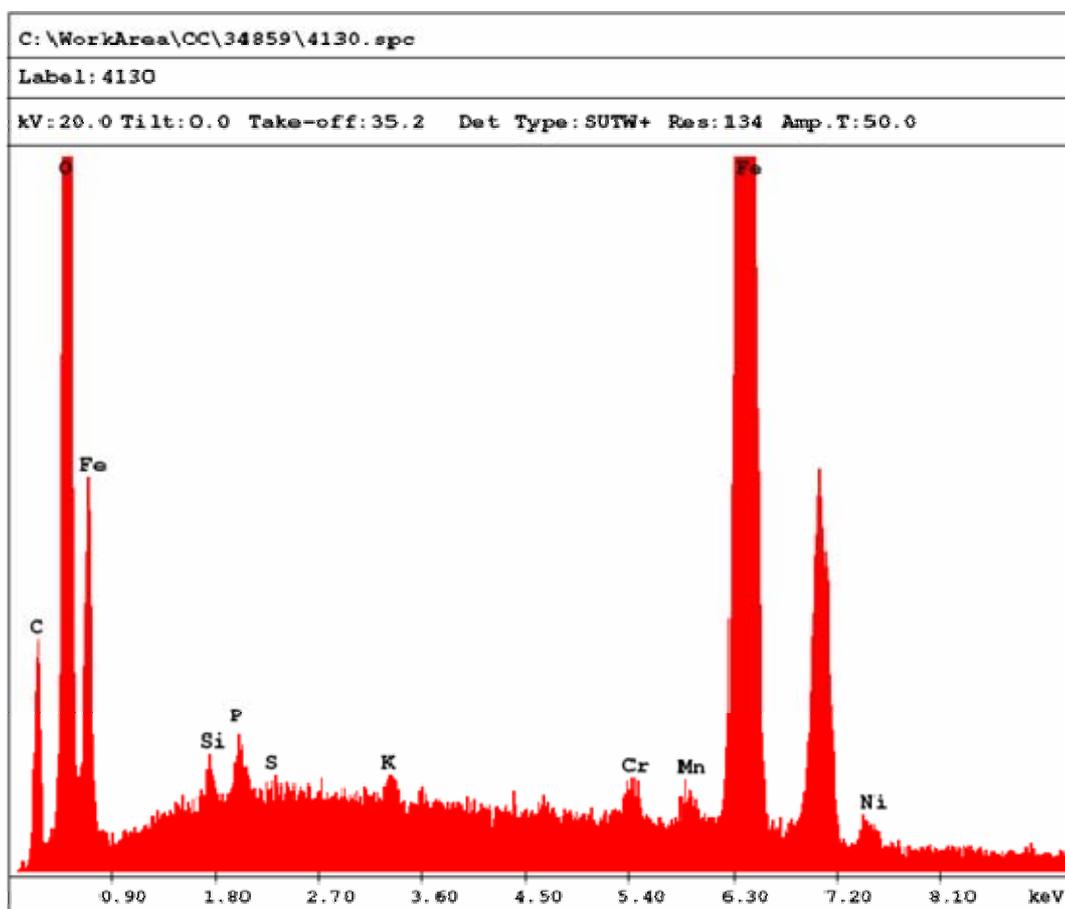
Figure 48: Energy dispersive x-ray analysis of corrosion products retrieved from key way in rod end.

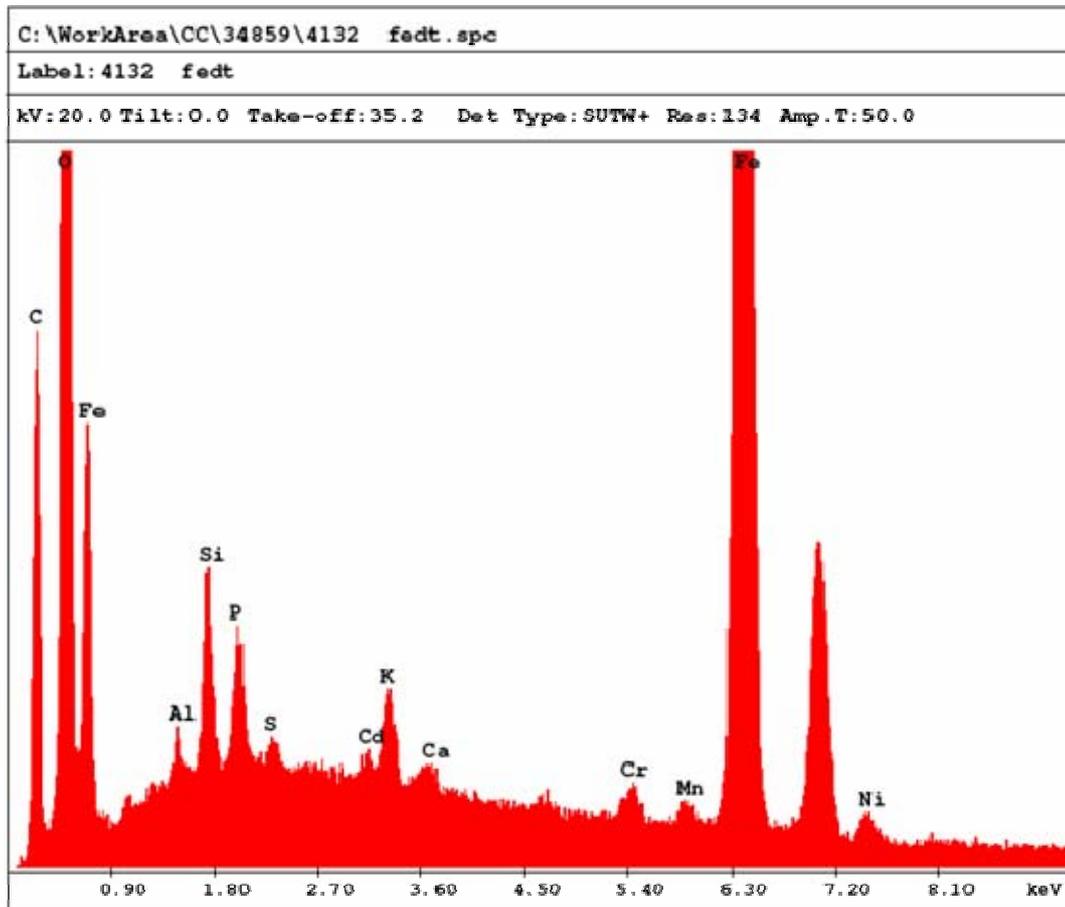
The corrosive environment is believed to be mainly condensed water that collects inside the threaded connection as a result of temperature and pressure variations. The presence of calcium, Ca, and potassium, K, in some of the corrosion products may signify that de-icing salts, e.g. calcium magnesium acetate and potassium chloride, could have contributed to the corrosive environment, but the small amounts and the lack of e.g. chloride indicate that the contribution was very modest. The lack of chloride in the greasy compound from the lock nut, Figure 49, could also suggest that potassium and calcium were integral constituents present in the grease.

Figure 49: Energy dispersive x-ray analysis of grease compound retrieved from out side lock nut area in rod end.
