**Accident Investigation Board
Denmark**

**Final Report
HCLJ510-000449**

Accident to Bombardier DHC-8-402
Registration LN-RDI
At Copenhagen Airport Kastrup (Denmark)
On 27 October 2007

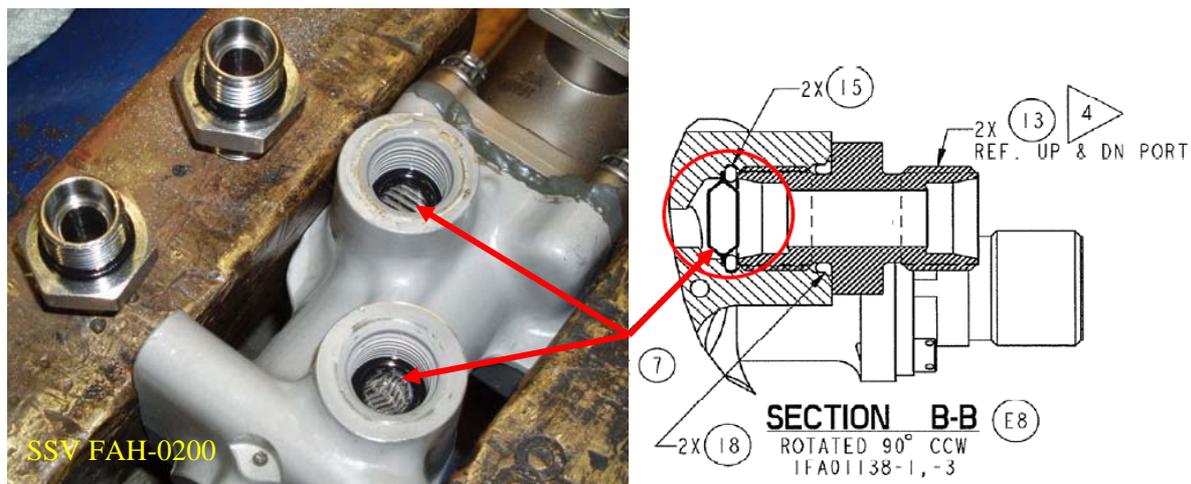
The SSV S/N FAH-0200 that replaced S/N FAH-0083 on the 16th October 2007 was examined without leading to any findings or remarks. The O-rings P/N NAS1611-110 and the filter elements were in place in both the up and down port of the valve as shown below.

The filter element (7) and O-ring (15) in place in the up and down ports of the valve.
The filter element and the O-ring are held in place by the union, flareless tube (13).

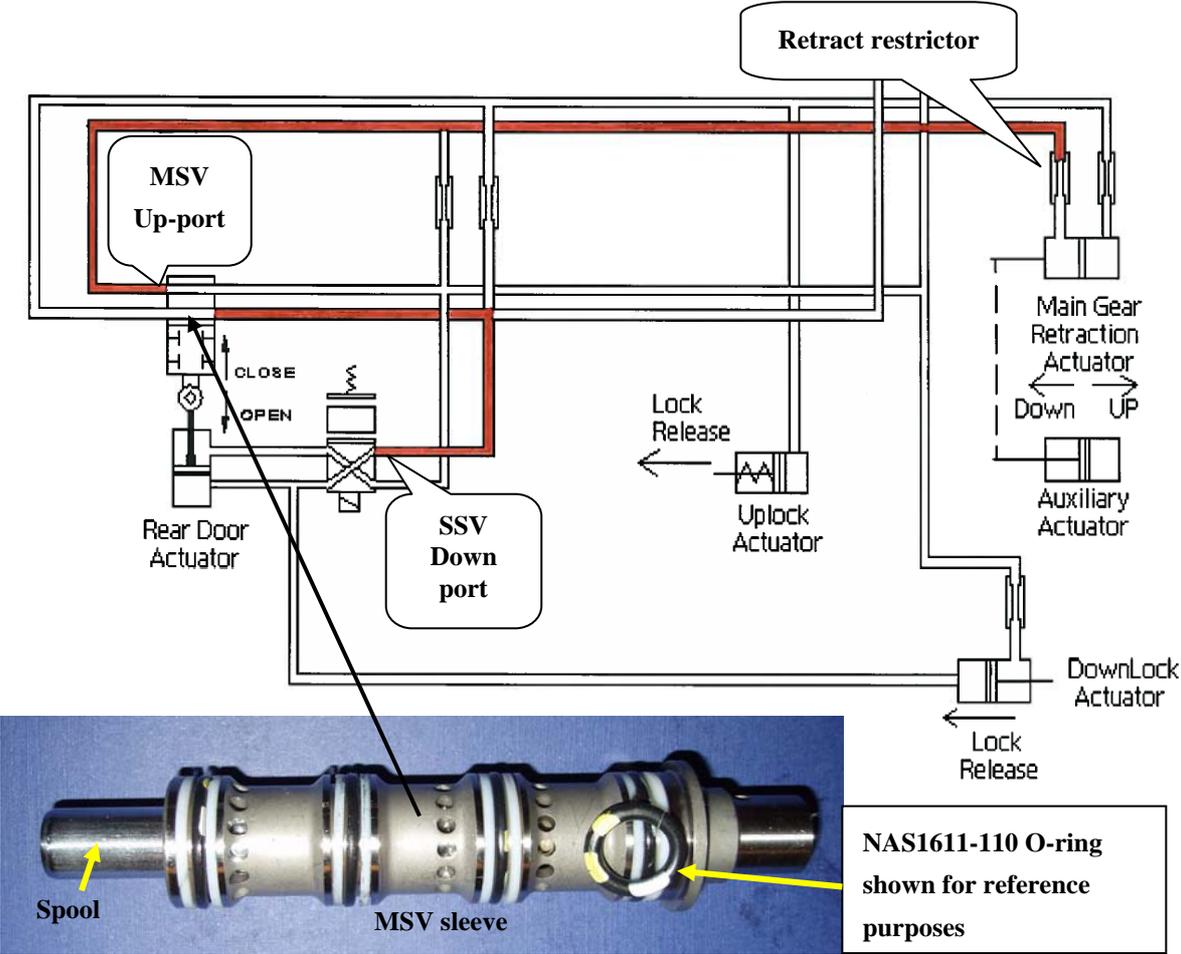
The review of the hydraulic system revealed that the rogue O-ring from the SSV down port was able to travel between the SSV and the MSV and between the MSV and the Retract Port Restrictor installed on the MLG Retraction/Extension Actuator. This is shown on the following drawing by red colored lines. The sleeve was removed from the MSV. It was determined that the diameters of the sleeve holes at the up and down ports were less than the diameter of the NAS1611-110 O-ring. Furthermore the space inside the sleeve is minimized by the moveable spool operated by the Rear Door Actuator (illustrated below).

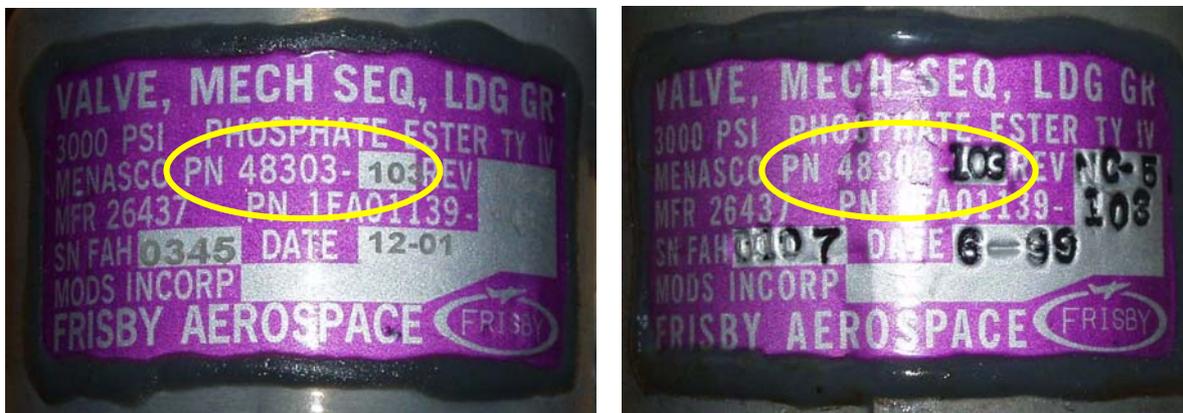
The identification plates fitted to the MSV's describe the valves as MSV Valve Body P/N 48303-103 regardless of the type of Unions/Reducers that were installed.

The following pictures show the identification plates fitted to the MSV S/N FAH-345 and FAH-0107.

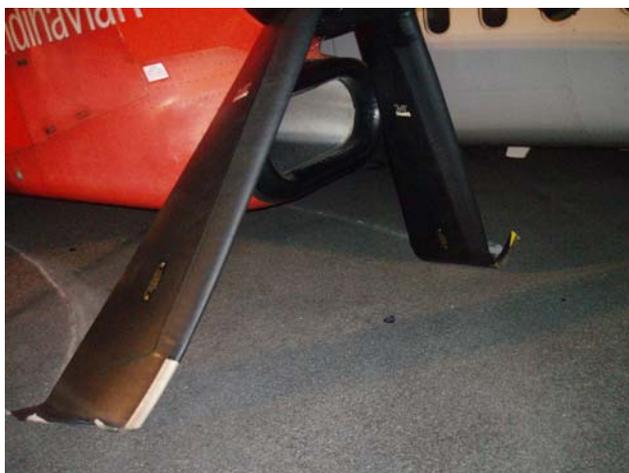
As mentioned in Section 1.12.1, the right engine was shut down by the flight crew before landing to minimize the risk of propeller blade or blade debris separation and penetration into the cabin area fuselage. Four propeller blades were damaged while skidding on the runway asphalt (following picture), but no debris separations from the engine or the non powered propeller occurred and the fuselage surrounding the cabin area was undamaged.

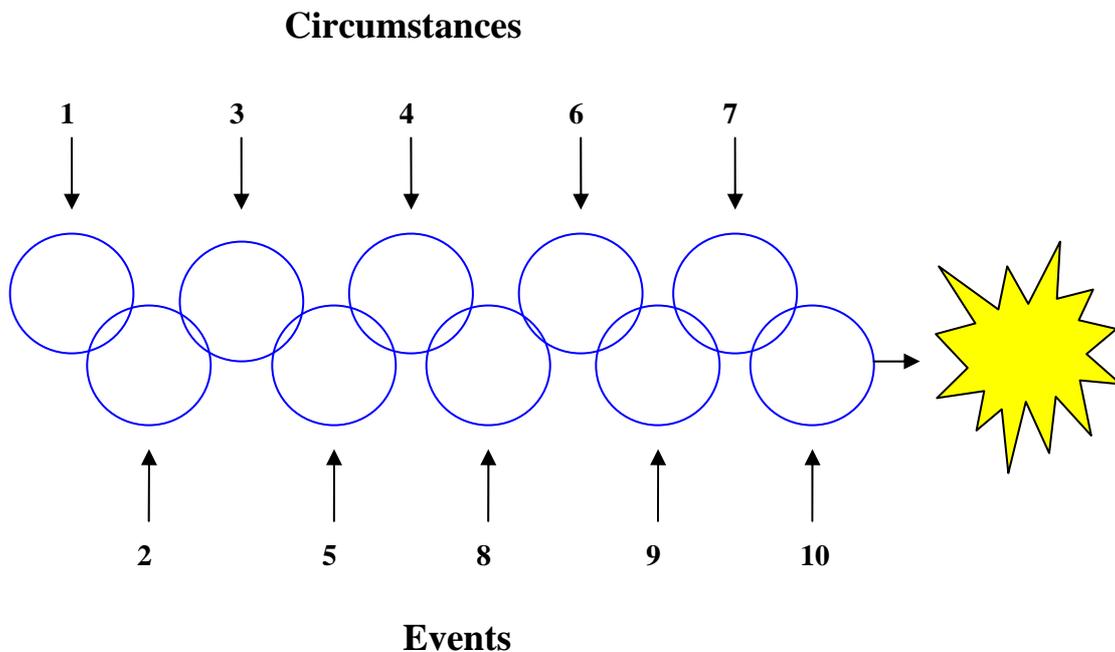
If the chain was broken by removing one of the chain-links (circumstance or event) in the chain leading to the accident this accident would not have occurred. For instance with reference to item number 3; if the operator had the MLG MSV P/N 48303-5 on stock this accident would not have occurred.

The numbers pointing at the chain refer to the number of the factors divided into circumstances and events.

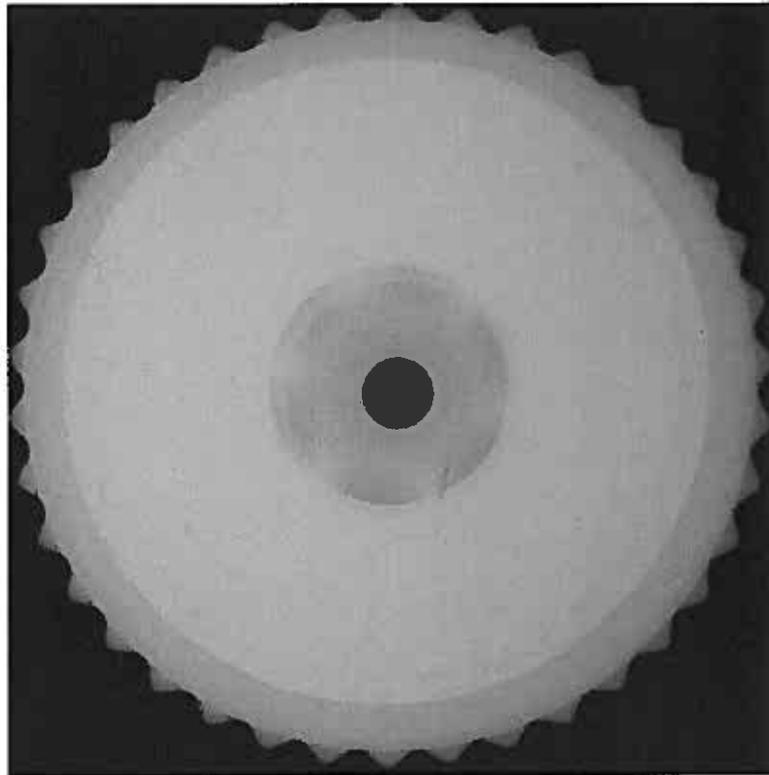
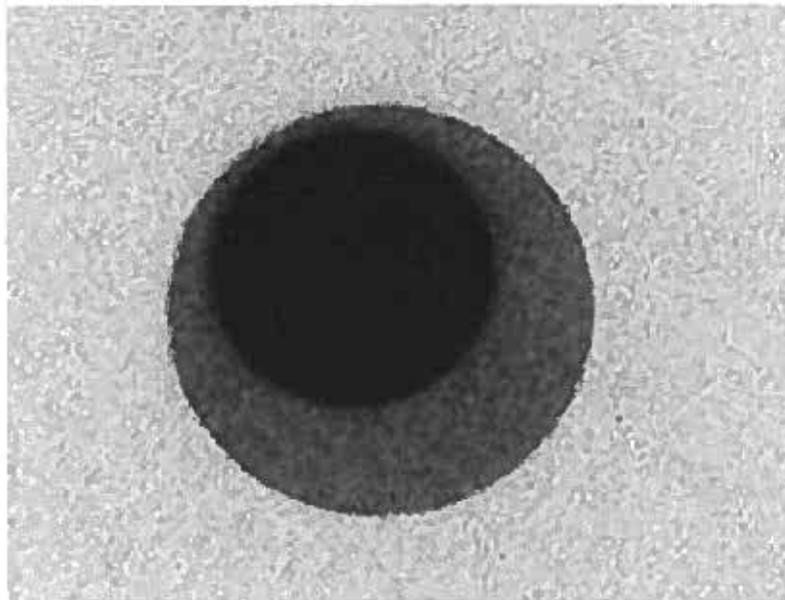
Figure 4: X-ray images of flow restrictor X-rayed in longitudinal direction from Port A. The lower image shows the two orifices at higher magnification.

The flow restrictor was x-rayed in axial and transverse directions using voltages ranging from 200 kV down to 25 kV. The x-ray images obtained at low voltages, Figures 4 and 5, did not reveal presence of any metallic particles or other x-ray absorbing material in the flow channels or orifices.

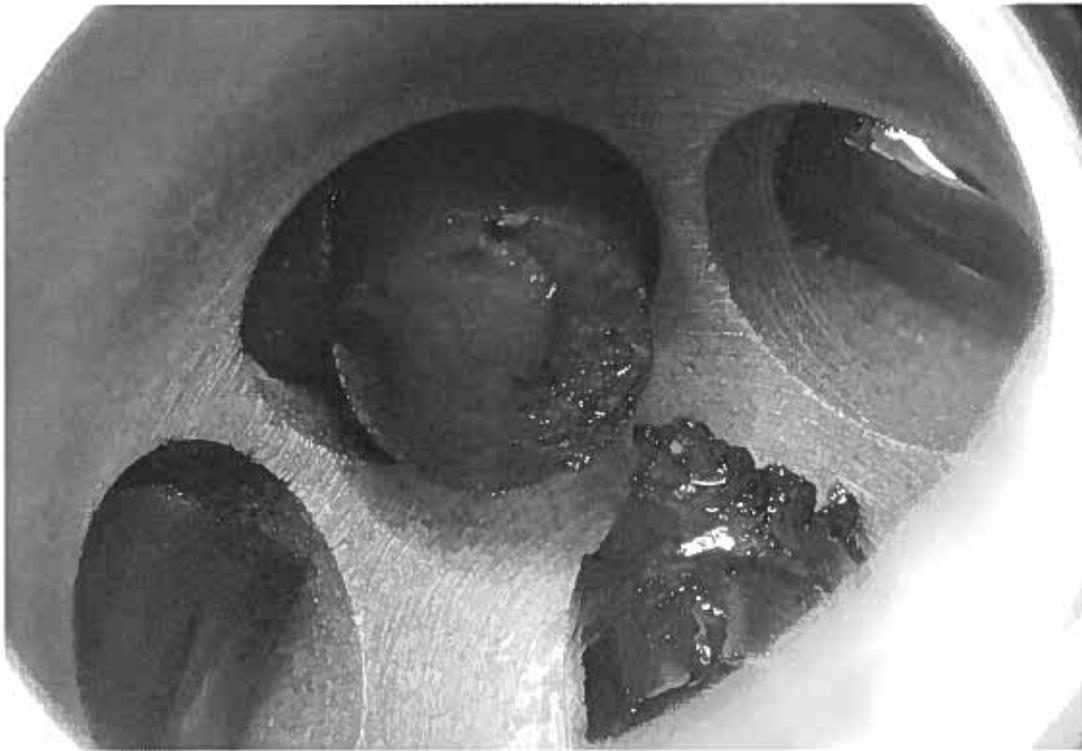
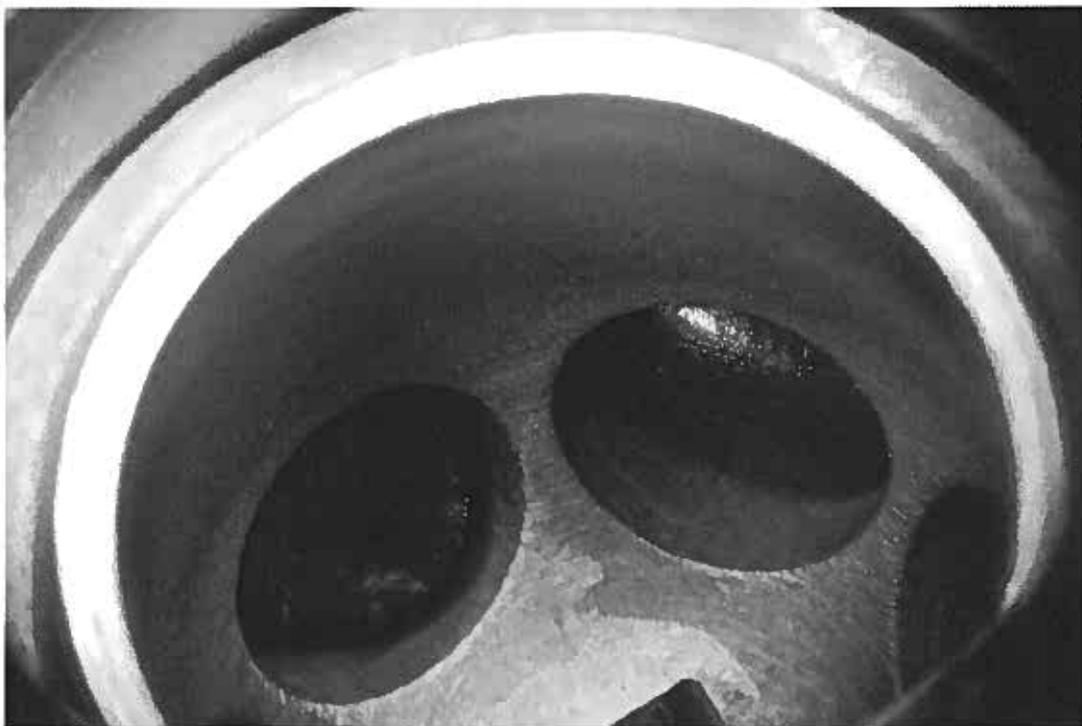
Figure 6: View from A port inside valve cone.

Disassembling the restrictor and removing the A port orifice allowed a view of the valve interior, c.f. Figure 6. A broken O-ring is partly emerging through one of the flow relief holes and the central orifice hole is blocked by a piece of O-ring material. In addition it appears that O-ring material is trapped between the valve cone and the housing thus blocking the flow relief holes. Forcing the valve cone out of the housing revealed 3 pieces of an O-ring, c.f. Figure 7. Together with a fourth piece that was easily plied free from the

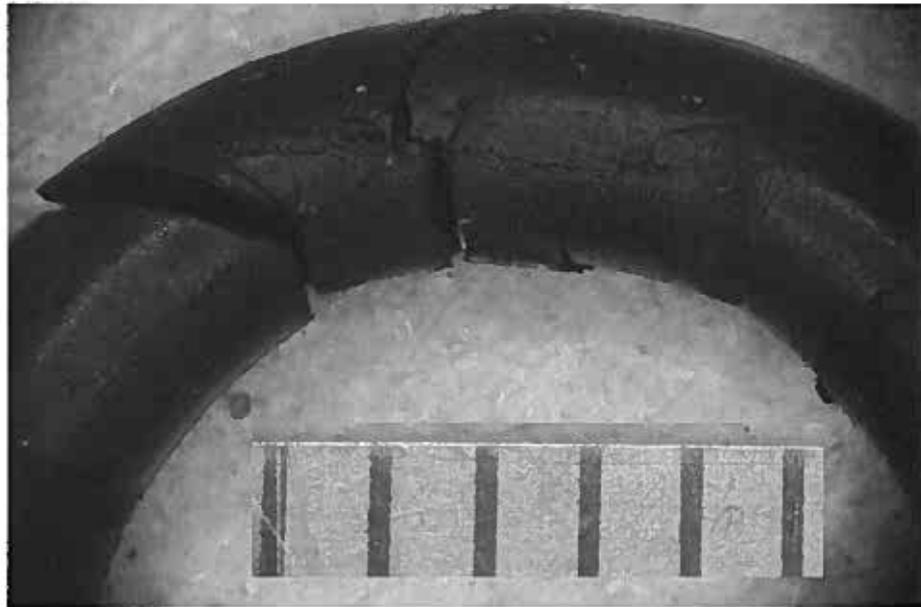
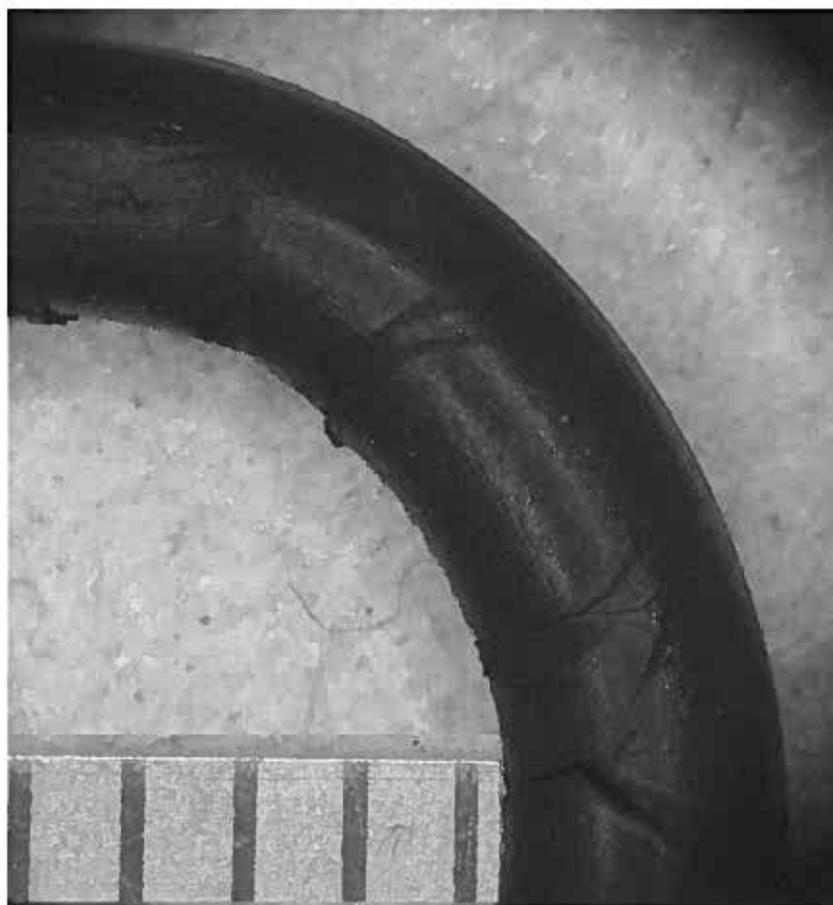
Figure 10: View of retrieved O-ring. Scale bar division is 1 mm.

The O-ring surface shows signs of being in intimate contact with the valve cone thus producing circular punch cuts in the O-ring corresponding to the size and spacing of the flow relief holes in the valve cone. Figures 10 to 13 show examples of the punch cuttings, and squeeze and chewing marks in the O ring surfaces. Some of the punch cuts are more than halfway through the O-ring as illustrated in Figure 14. The striation patterns in the free ends of the O-ring pieces shown in Figure 15 are evidence of stepwise progressing punch cuts.

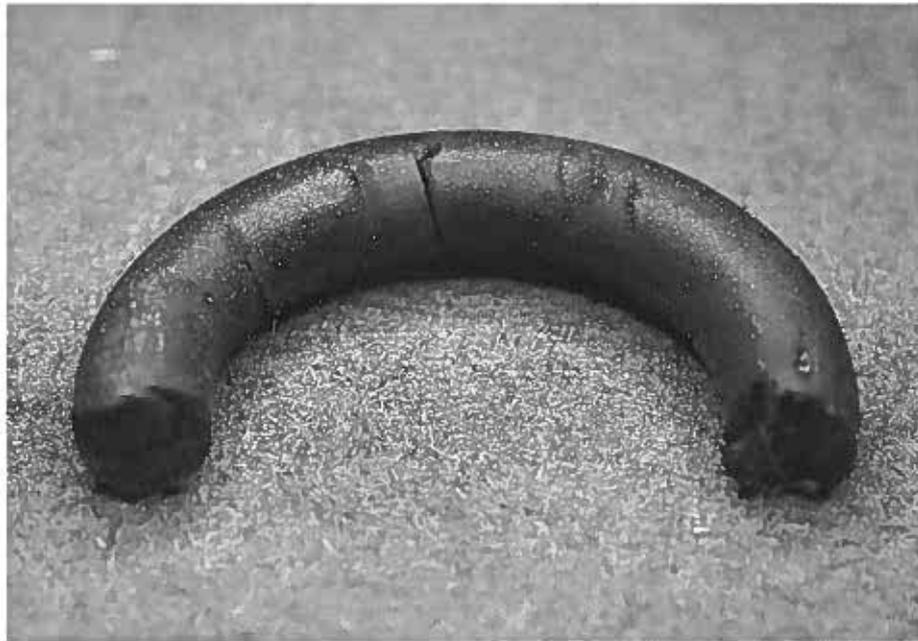
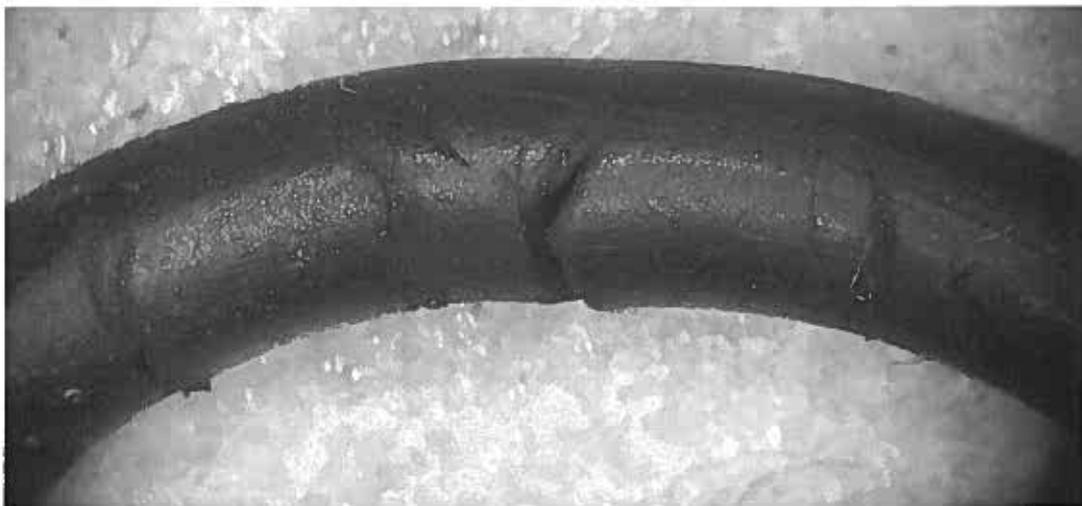
Figure 14: Illustration of punch cut depths in O-ring.

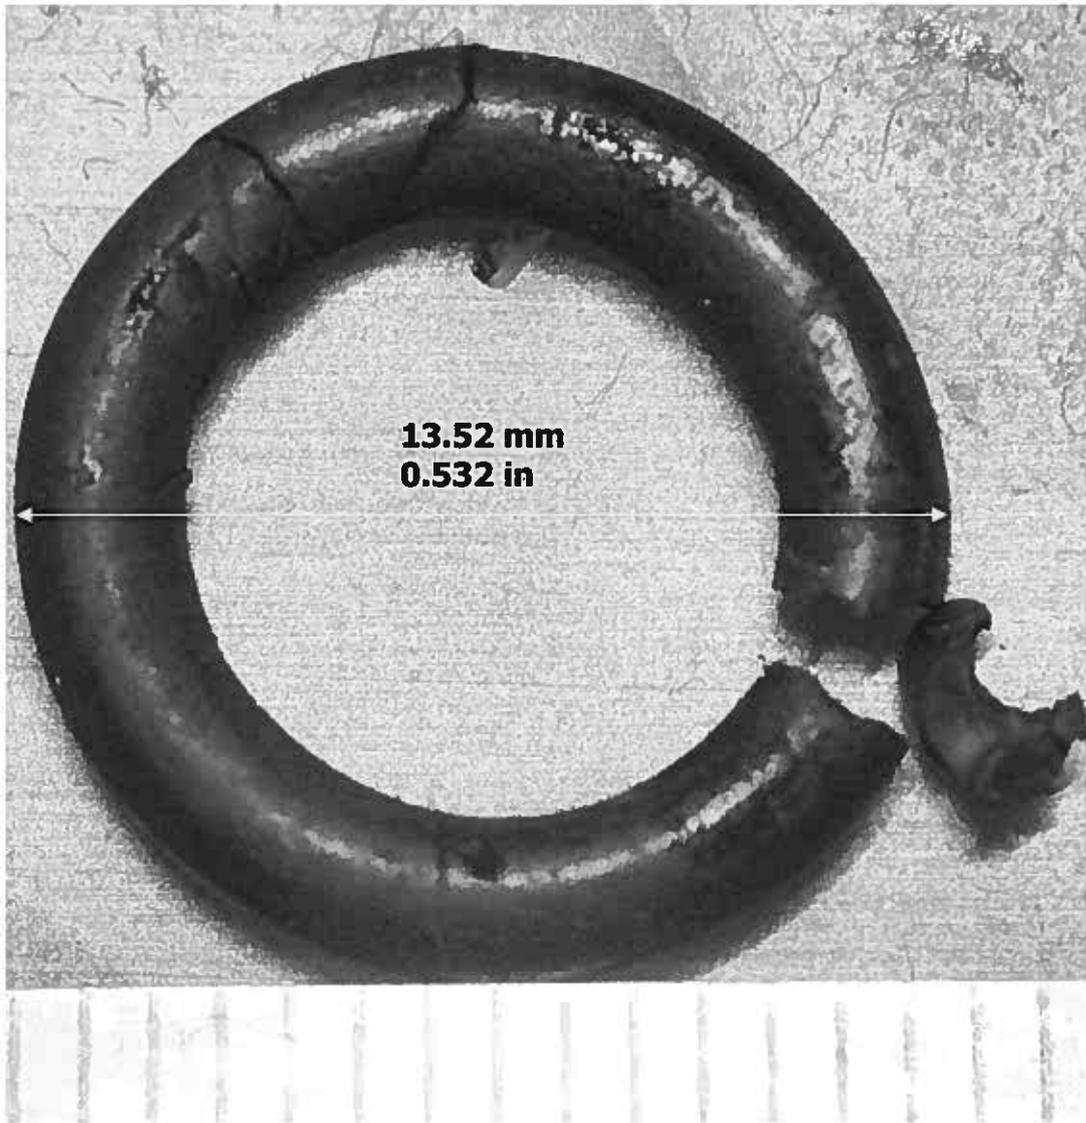
Figure 16: Reassembled O-ring. Estimation of outer diameter.

The dimensions of the O-ring as estimated in Figures 16 to 19 are:

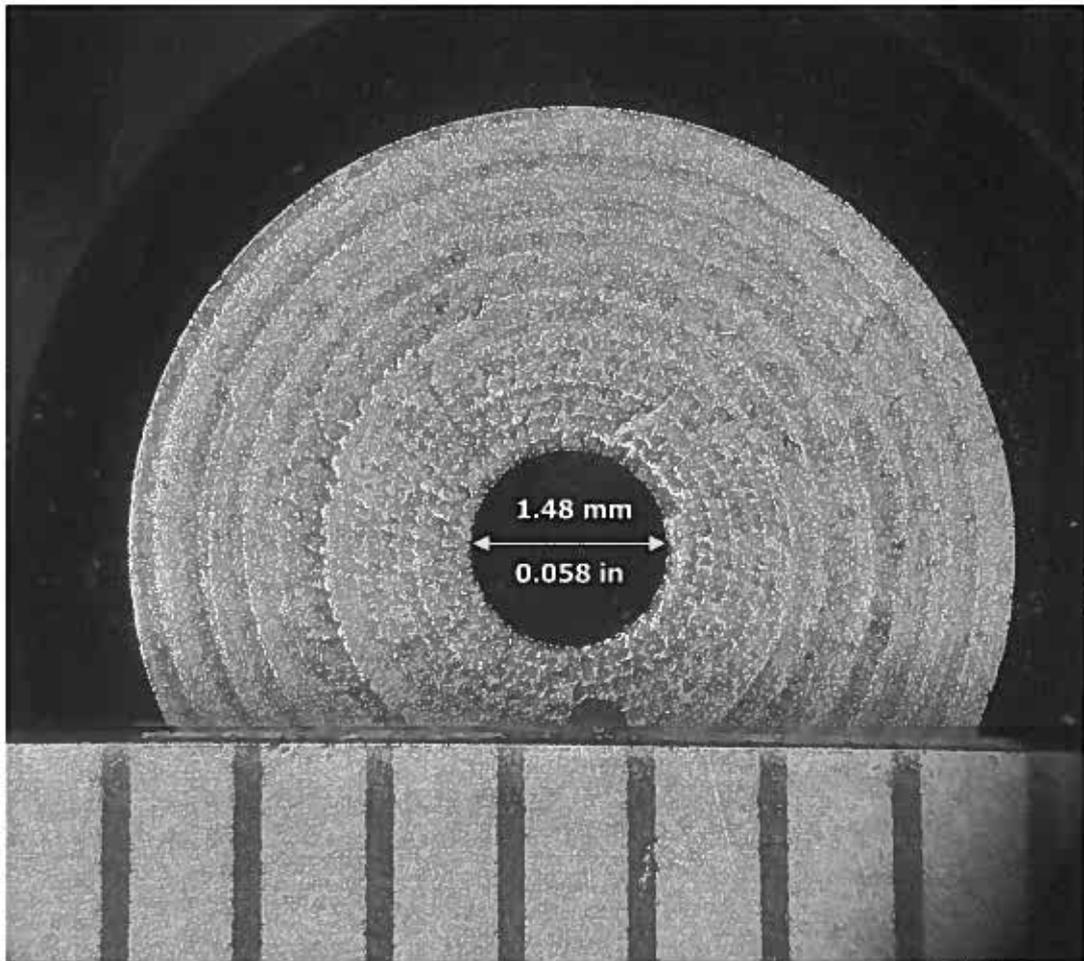
Figure 20: Estimation of valve cone orifice dimension.

The orifice dimensions as estimated from Figures 20 and 21 are:

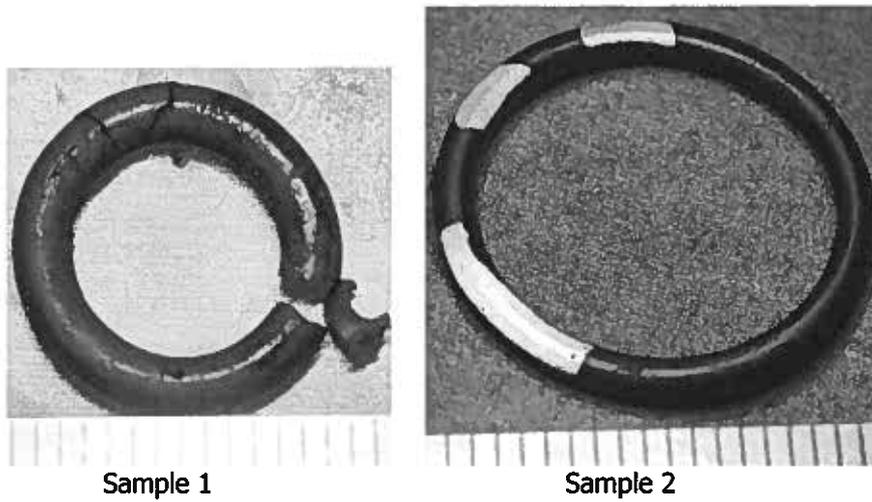
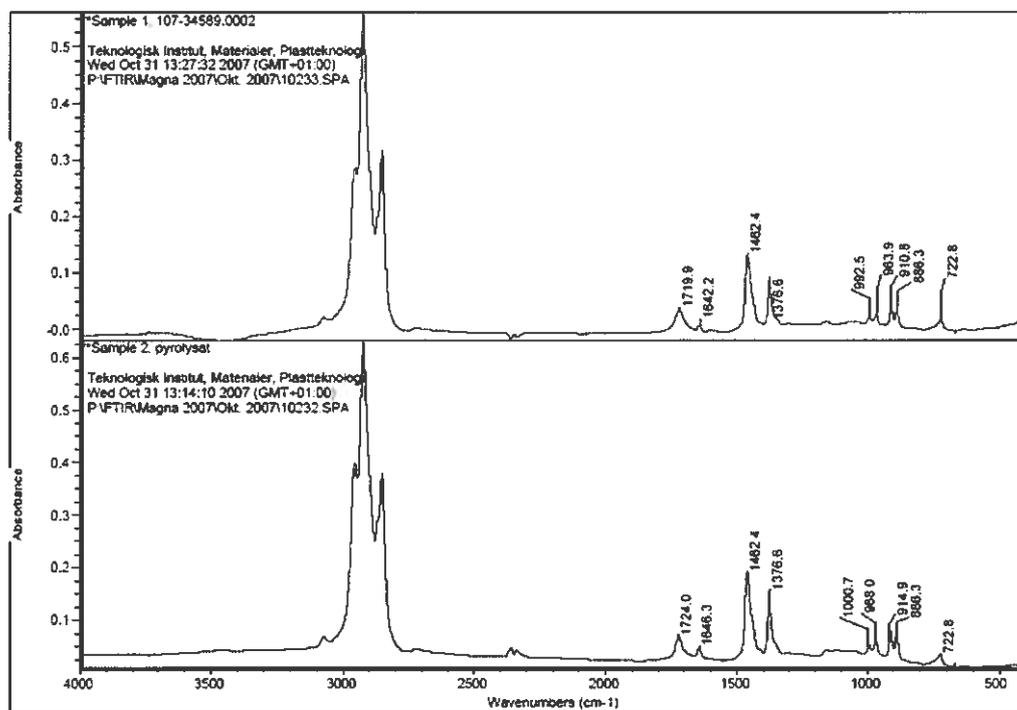
Figure 22: FTIR analyses of O-ring samples 1 and 2.

The composition of the trapped O-ring (sample 1) was checked against a reference O-ring material (sample 2), by means of Fourier Transform Infra Red spectrometry. The obtained FTIR spectra are shown in Figure 22. The spectra are quite similar and correspond to EPDM rubber (ethylene diene monomer rubber) as normally required for use in fireproof hydraulic fluids.

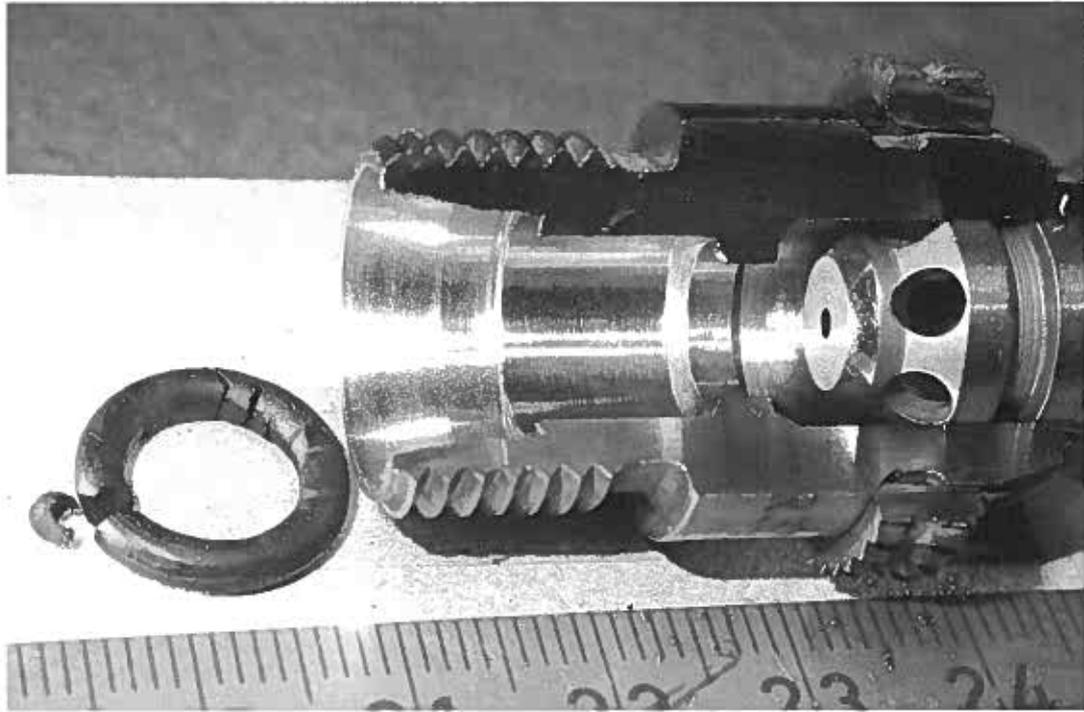
Figure 25 shows comparative sizes of the restrictor valve interior and captured O-ring. The O-ring cannot pass through either of the orifice holes. The only way it can end up where found is by travelling with the oil flow through the S port while the valve cone is open. It is not possible to determine whether the O-ring was intact but in our opinion, it arrived in one piece at least. As the valve cone closes the O-ring was caught between the valve cone and the housing. Consecutive opening and closing of the valve cone during retraction/extension of the main landing gear resulted in severe battering and chewing of the O-ring. It was partly punched through the flow relief holes in the cone and eventually some of the punch cuts resulted in division of the O-ring into 2 large and 2 small pieces. The stepwise growth of punch cuts is evidenced by the striation pattern visible in Figure 15. The smallest part of the divided O-ring was probably in the progress of being further subdivided when it made its way through one of the relief holes. Being captured in the cone interior between the two orifices the oil flow has caught the O-ring piece and forced it to block the orifice hole.

Figure 25: Comparative view of flow restrictor and O-ring.
