AIRCRAFT ACCIDENT REPORT AND EXECUTIVE SUMMARY

Reference:	CA18/2/3/8383	
Aircraft Registration	ZS-OEZ	Date of Accident	07 November 2007		Time of Accident	1400Z	
Type of Aircraft	B737-200		Type of Operation		Scheduled Domestic		
Pilot-in-command Licence Type		Airline Transport	Age	50	Licence Valid	Yes	
Pilot-in-command Flying Experience		Total Flying Hours	13860		Hours on Type	3277	
Last point of departure		Cape Town International Aerodrome (FACT).					
Next point of intended landing		O.R. Tambo International Aerodrome (FAJS).					
Location of the accident site with reference to easily defined geographical points (GPS readings if possible)							
On take-off Runway 01 at Cape Town International Aerodrome (FACT).							
Meteorological Information		Wind 340/20; Temperature 16°C; Visibility 3000 m; Light Rain; Cloud 800 ft Overcast					
Number of people on board	2 + 4 + 106	No. of people injured	0	No. of people killed	0		
Synopsis							
<p>During a take-off from Runway 01 at FACT, the right-hand engine separated from the wing. Following the engine separation, the aircraft continued to climb. The captain declared an emergency and his intention to land back on Runway 01. The aircraft w

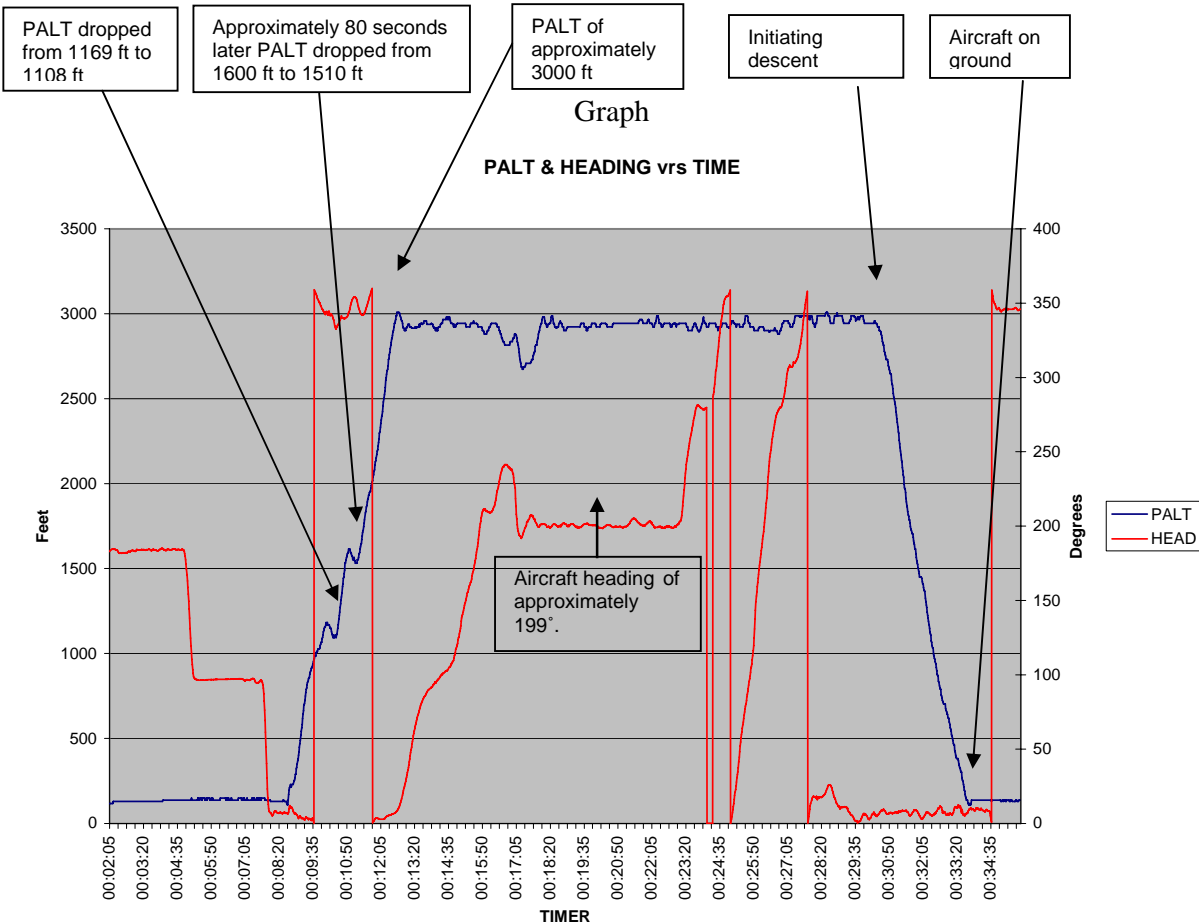
Graph – 1

The red line indicates the aircraft's heading and the blue line indicates the aircraft's pressure altitude (PALT) during taxiing and after take-off against minutes/seconds during taxiing, the flight and landing from Runway 01 at FACT.

- (i) The red line (heading) shows the aircraft taxiing to Runway 01 and the heading after take-off, and shows the aircraft's heading of approximately 199° after the aircraft had climbed to a PALT of 3000 ft and eventually at 349° before landing back onto Runway 01.
- (ii) The blue line (PALT) shows how the aircraft started its take-off roll and whilst climbing, the PALT dropped from 1169 ft to 1108 ft. Approximately 80 seconds later the PALT again dropped from 1600 ft to 1510 ft. The aircraft then continued to climb to a PALT of approximately 3000 ft and maintained this until descent.
