ATSB TRANSPORT SAFETY REPORT
Aviation Occurrence Investigation
AO-2008-026
Final

Loss of control
19 km SE Sydney Airport, NSW
9 April 2008
VH-OZA, Fairchild Industries
SA227 AC Metro III

Loss of control
19 km SE Sydney Airport, New South Wales
9 April 2008
VH-OZA
Fairchild Industries Inc. SA227-AC Metro III

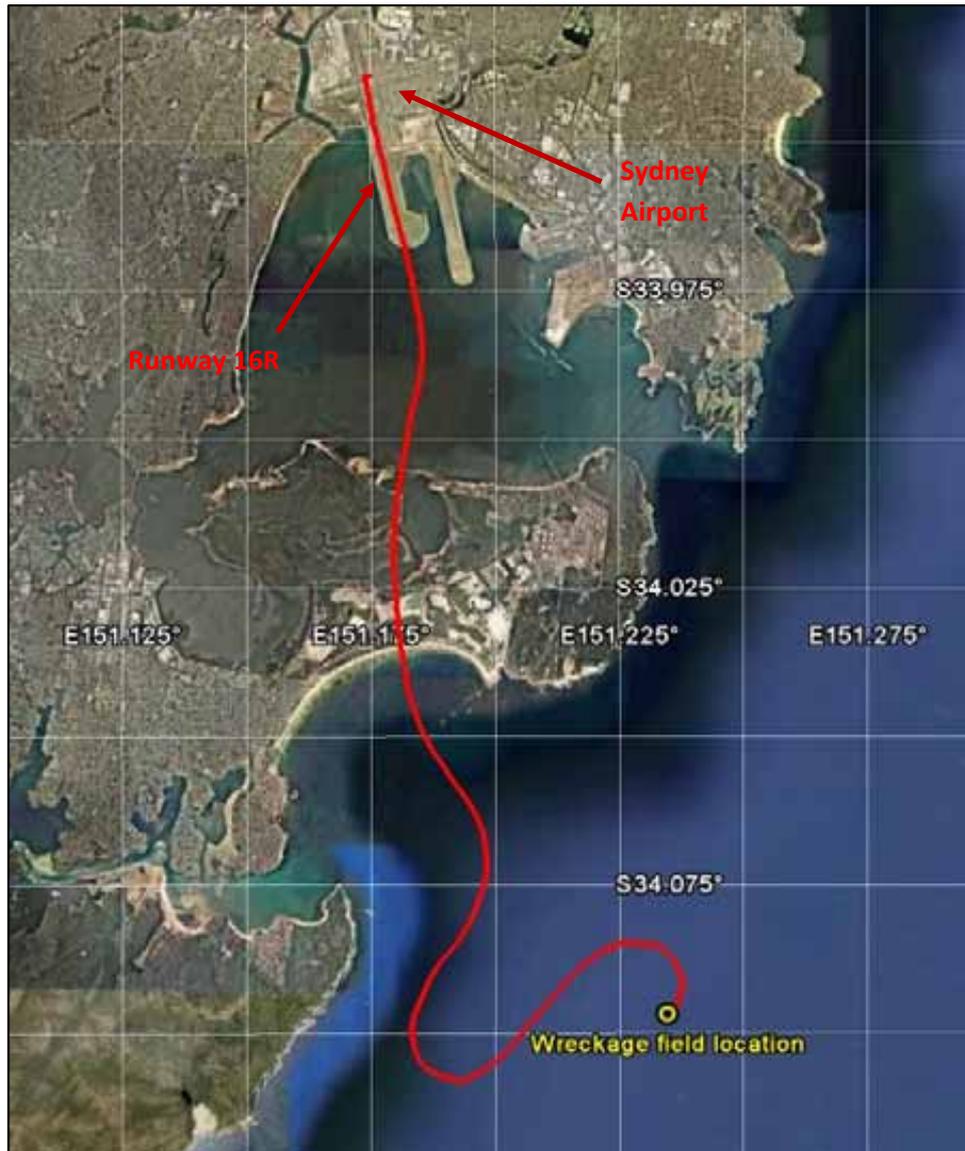
Figure 2: Radar track of OZA

Airservices radar data for the last portion of the flight showed that the aircraft commenced a right turn, then a left turn, followed by a descent, a climb, a right turn and a second descent before the radar returns from the aircraft ceased. The last recorded radar return indicated an altitude of 3,740 ft. The recorded radar data was overlaid onto a chart showing the aircraft's track from takeoff (Figure 2).

The radar data confirmed that during the climb after takeoff, the pilot was following a standard Sydney Curfew Two Departure (see the section titled *Aerodrome Information*), and that the aircraft was climbing at a rate of about 1,200 ft/min. Following the takeoff and notification by the departures controller of radar contact, the radar data indicated that:

- the aircraft deviated left and right from track
- the aircraft was levelled at around 3,000 ft for 30 seconds, although cleared by ATC to climb to flight level (FL) 170⁴
- the aircraft then reached an altitude of 3,140 ft and, soon after, descended rapidly at an average rate of 8,400 ft/min to 1,540 ft
- the descent was arrested and a climb initiated at an average rate of 8,400 ft/min

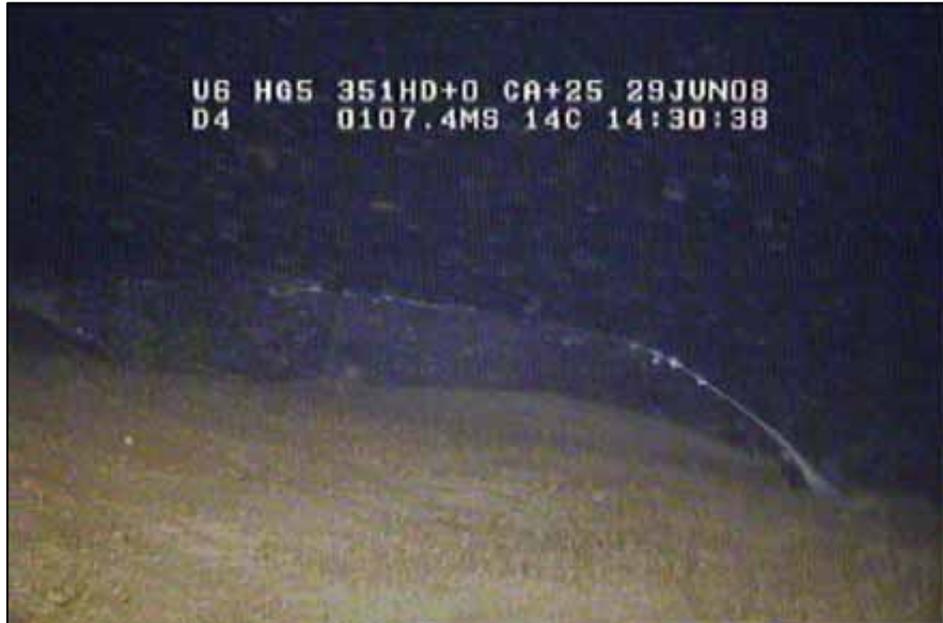
Figure 5: Propeller blade on the ocean floor as displayed on the ROV monitor

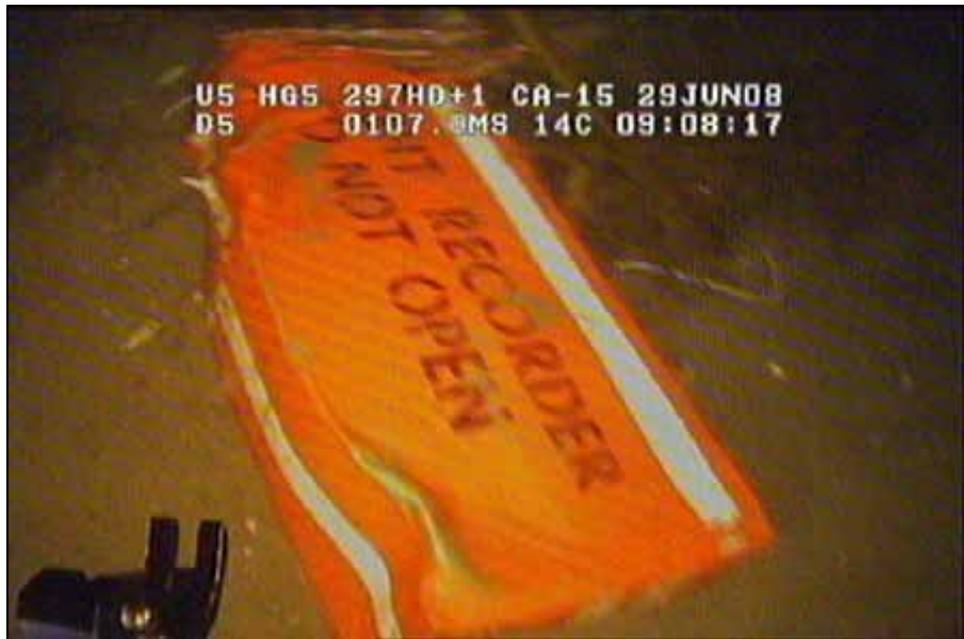
No data from the flight was able to be recovered from either of the aircraft's FDR or CVR (Appendix B).

Figure 7: FDR on the ocean floor as displayed on the ROV monitor

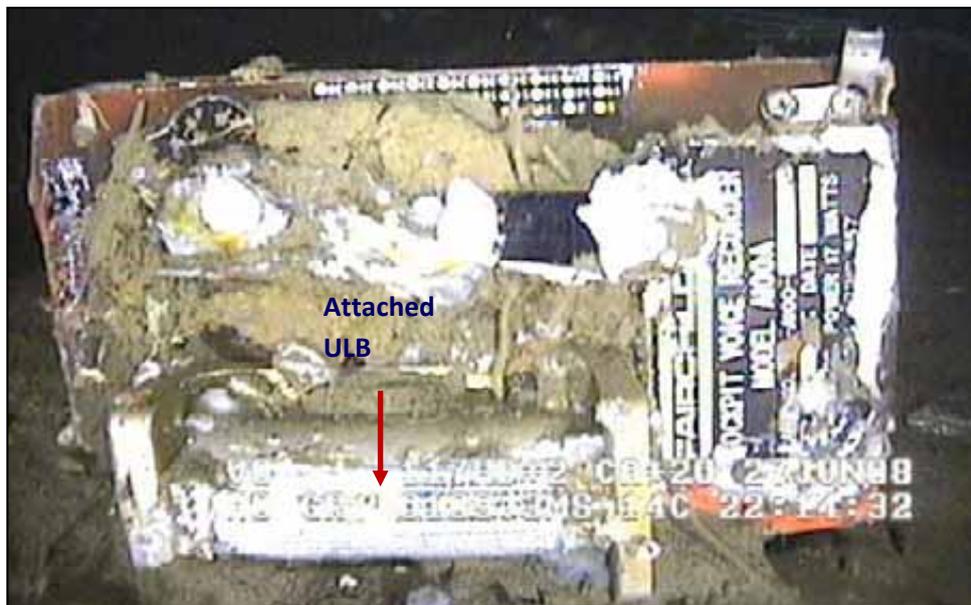
Figure 8: CVR on the ocean floor as displayed on the ROV monitor

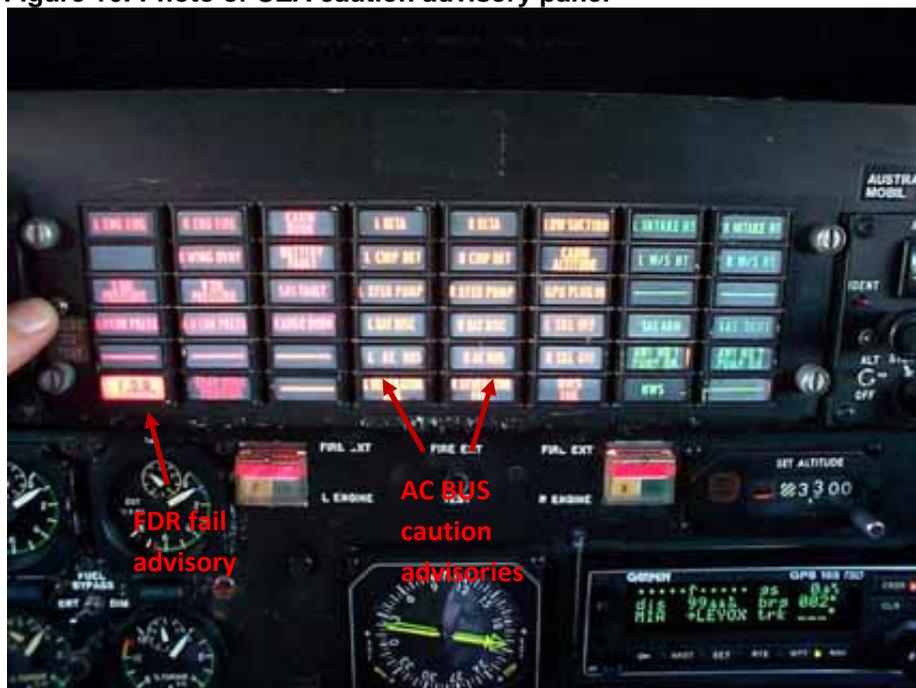
Each 115 VAC bus also powered a bus failure relay. If electrical power was lost to the respective bus, the bus failure relay relaxed and the caution advisory light illuminated. Illumination of one AC fail (L or R AC BUS) light was usually an indication of an AC bus tie circuit breaker failure.²¹ Illumination of both the L AC BUS and R AC BUS lights was usually an indication of an AC power source failure, typically an inverter failure. The L AC BUS and R AC BUS light capsules each included two light globes for redundancy (Figure 16).

Figure 16: Photo of OZA caution advisory panel

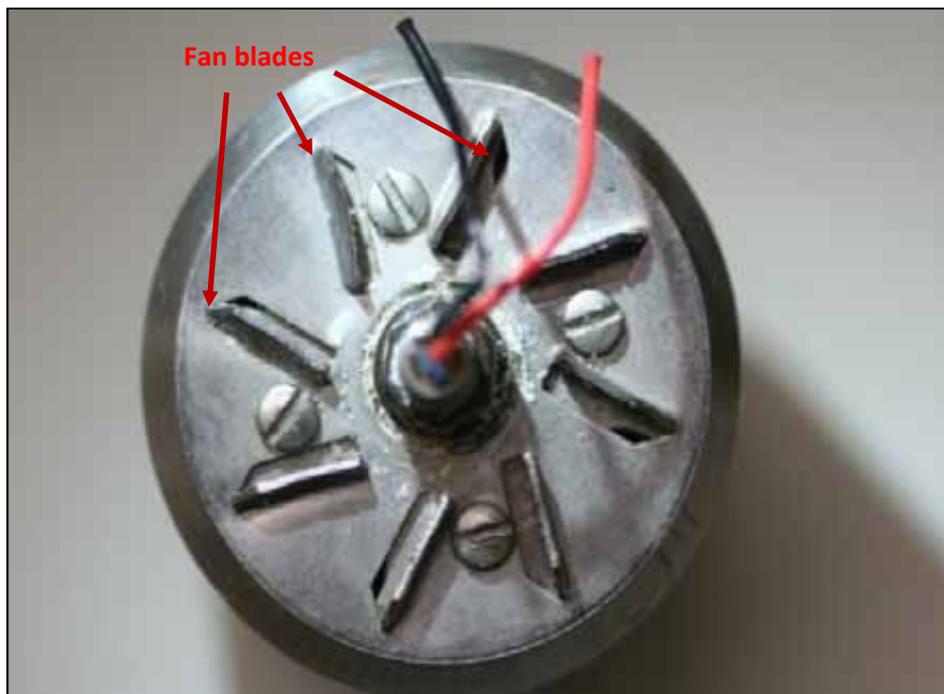
Figure 20: Gyroscope rotor fan blades

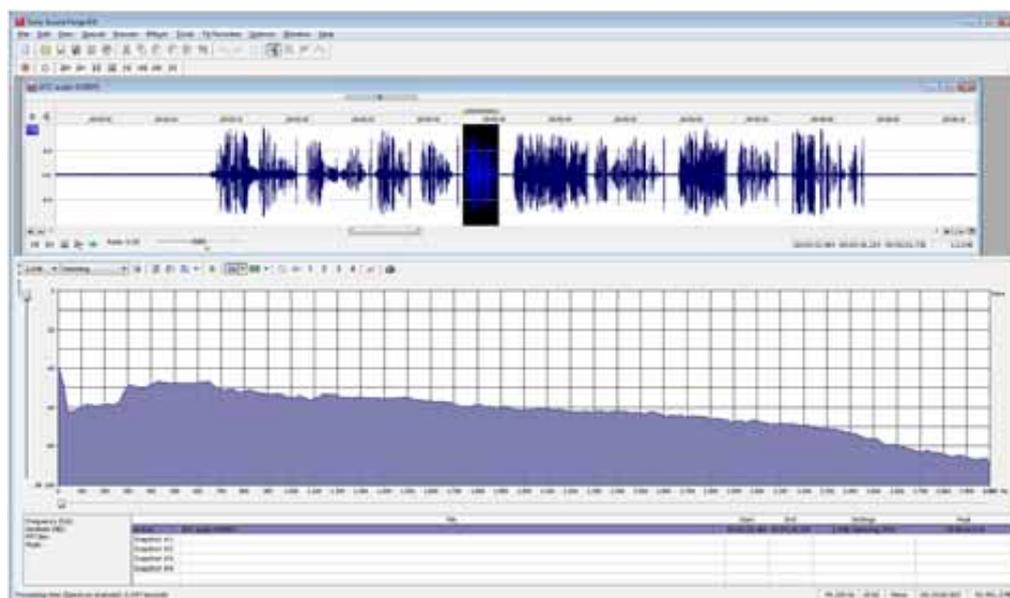
There were no corresponding interference frequencies in any of the recorded transmissions from the pilot of OZA (Figure 21).

Figure 21: VHF radio transmissions - OZA

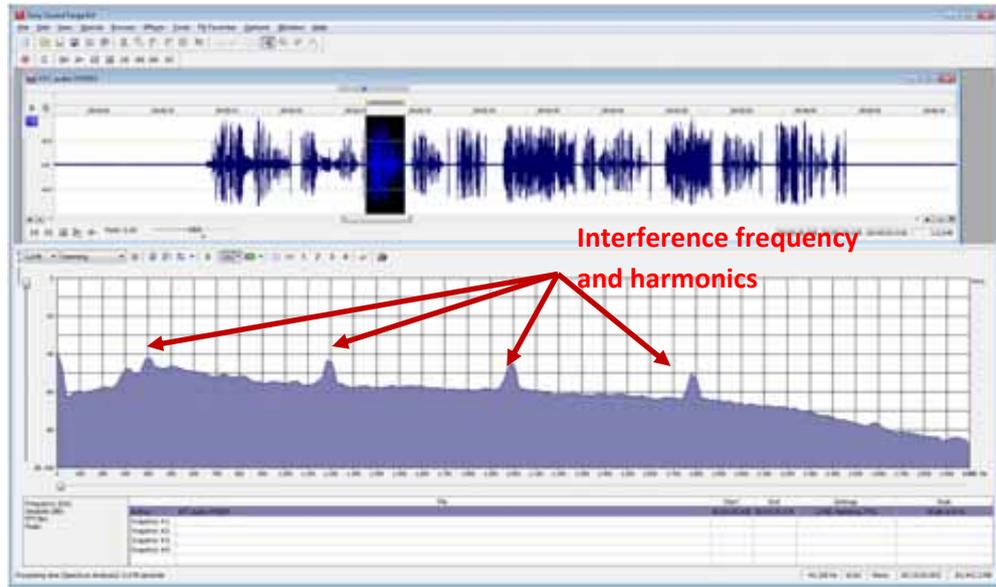
An examination of the radio transmissions from VEU at Canberra showed that the interference at frequencies 397, 1,193, 1,992 and 2,788 Hz was only present when the aircraft's AC power supply was selected ON (Figure 22).

Figure 22: VHF radio transmissions - VEU

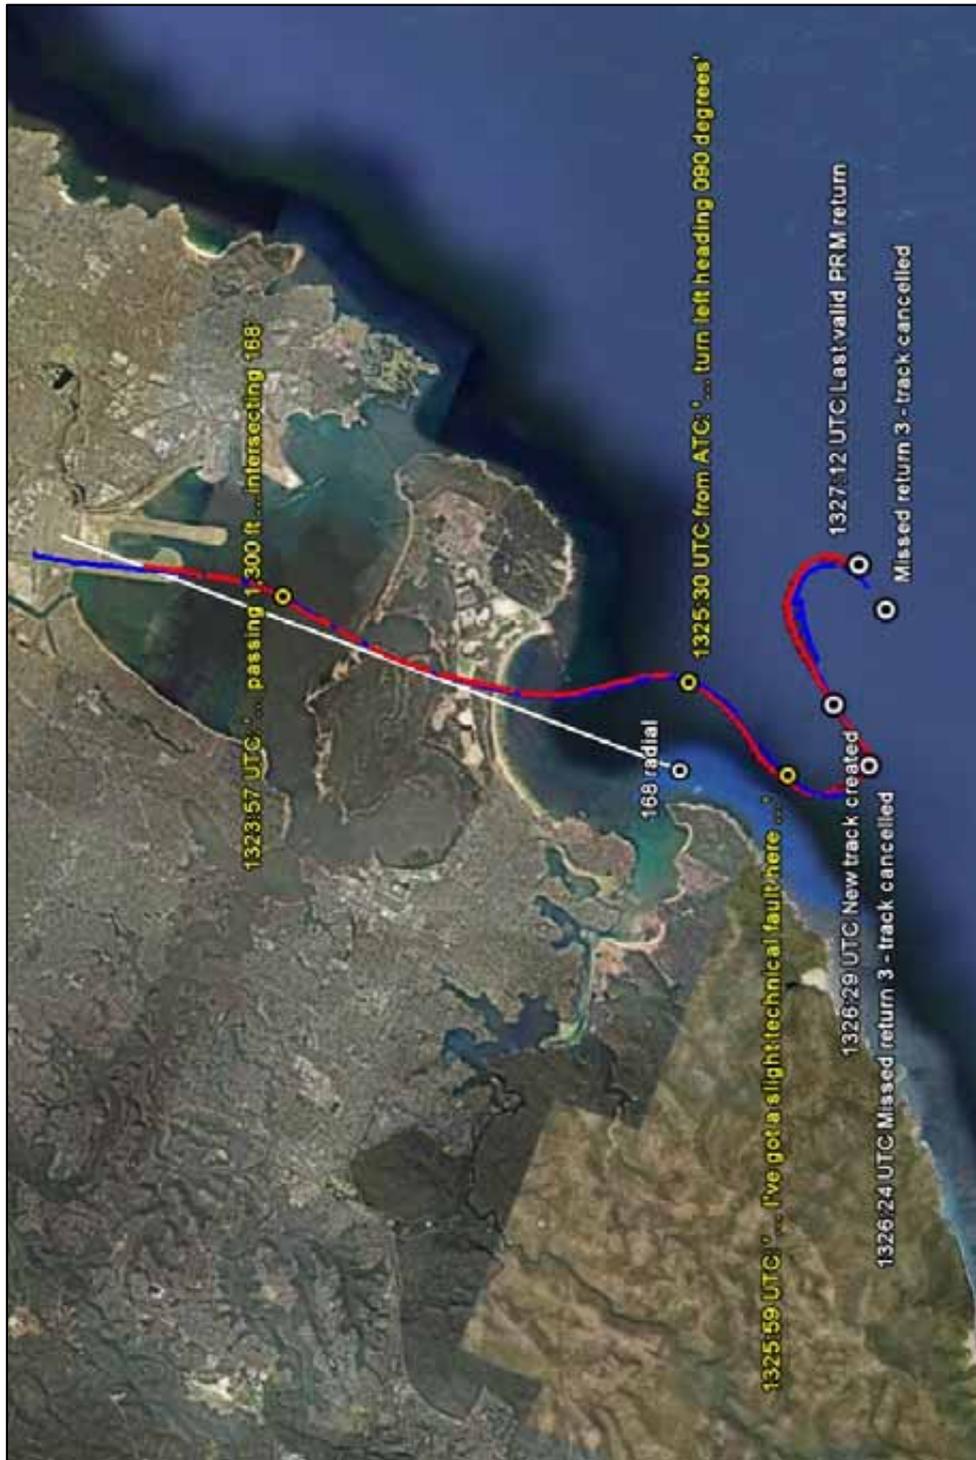
Figure A-6: Radar tracks (Sydney TAR – blue, PRM – red)

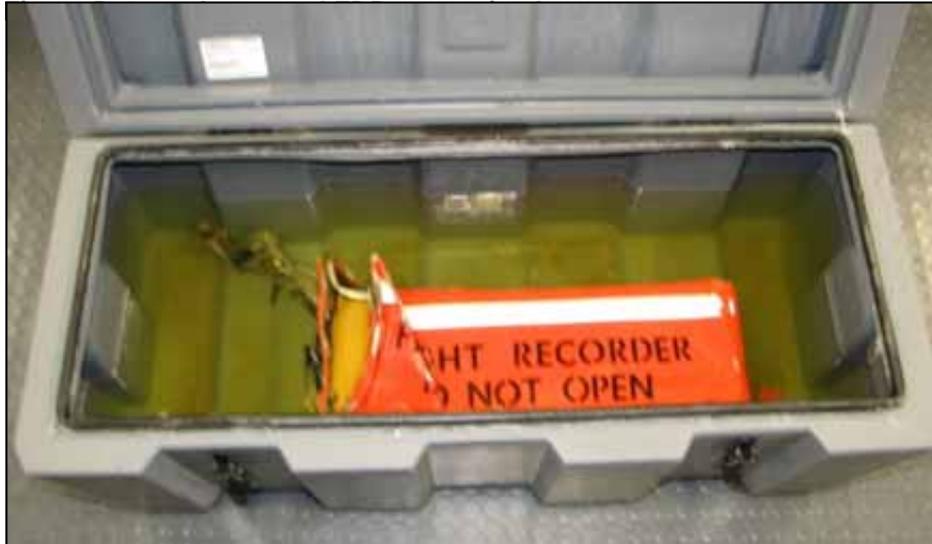
Upon opening of the container, the FDR was found to be immersed in water, as-packed (Figure B-4).

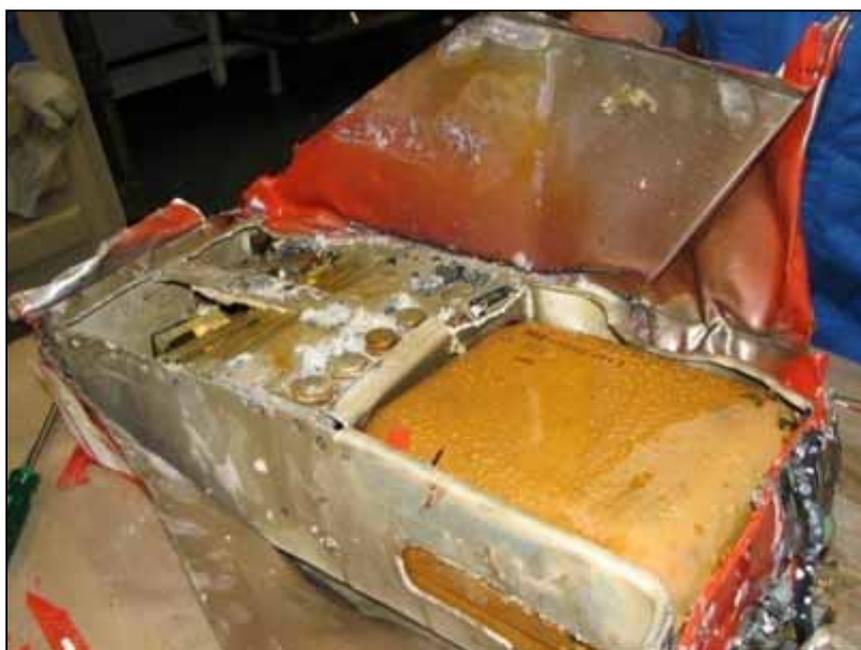
Figure B-6: VH-OZA's FDR during disassembly showing the crash protected enclosure and associated electronics

The FDR had been subjected to substantial impact forces and saltwater immersion, which had resulted in extensive damage to the recorder, including a fracture of the crash-protected enclosure and wiring damage. Some discolouration of the external paint was observed. Analysis of the paint discolouration was the subject of a separate materials examination (see Appendix C). The recorder was dismantled (Figures B-6 to B-12) and the recording tape was extracted from the crash protected enclosure for replay.

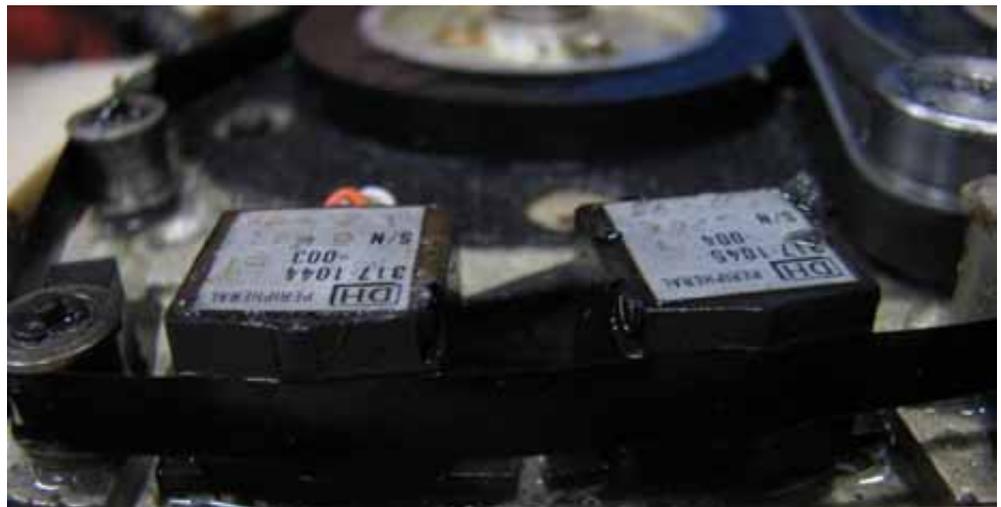
Figure B-11: Tape adhesion to tape transport heads

At the location where the tape had stopped and the tape had adhered to the heads (at about 3,900 secs from one end of the tape and 7,400 secs from the other) the tape signal strength was reduced across all tracks (Figure B-14). During the analogue to digital conversion, the recovery stalled and had to be restarted. The recovery was restarted after the reduced signal strength location, resulting in approximately 33 seconds of data⁵² per track not being recovered at this point. The damage to the tape at this location was considered to be a consequence of magnetic tape and head corrosion damage due to water immersion for over 2 months.

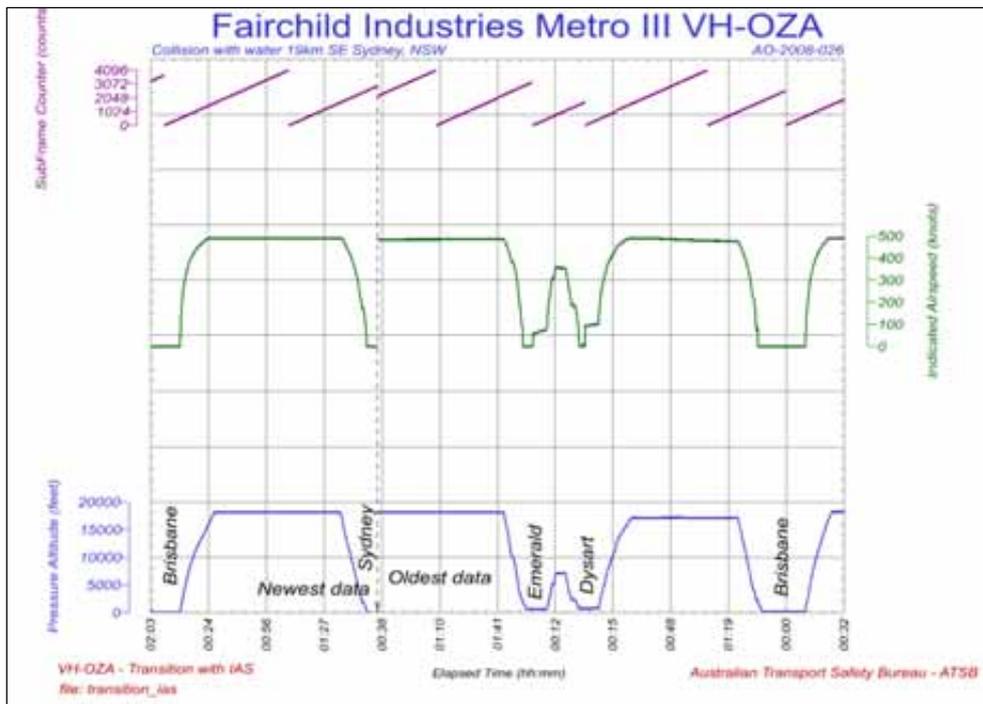
All parameters recorded on the FDR were serviceable, with the exception of indicated airspeed (IAS). The IAS was recorded at an unreasonably high value, and increased as the aircraft climbed until the top of climb, where it remained steady during the cruise. The IAS reduced during descent. The IAS therefore changed in conjunction with altitude or static air pressure only. This characteristic was evident across the entire FDR recording.

Figure B-15: Plot of airspeed and IAS over a number of flights

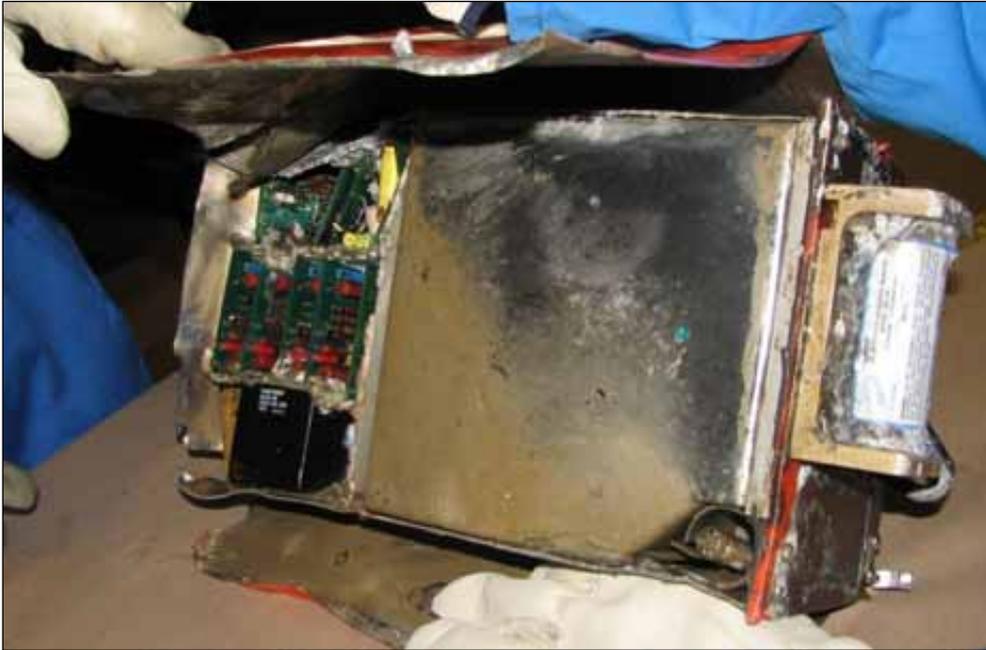
Figure B-23: VH-OZA Cockpit voice Recorder during disassembly showing the crash protected enclosure and associated electronics

The CVR had been subjected to substantial impact forces and saltwater immersion, which had resulted in extensive damage to the recorder. The recovered CVR was identified from the manufacturer's data plate as a Fairchild model A100A CVR, part number 93-A100-80, serial number 55650 (Figure B-22). The maintenance records for VH-OZA confirmed that this CVR was fitted to VH-OZA at the time of the accident.

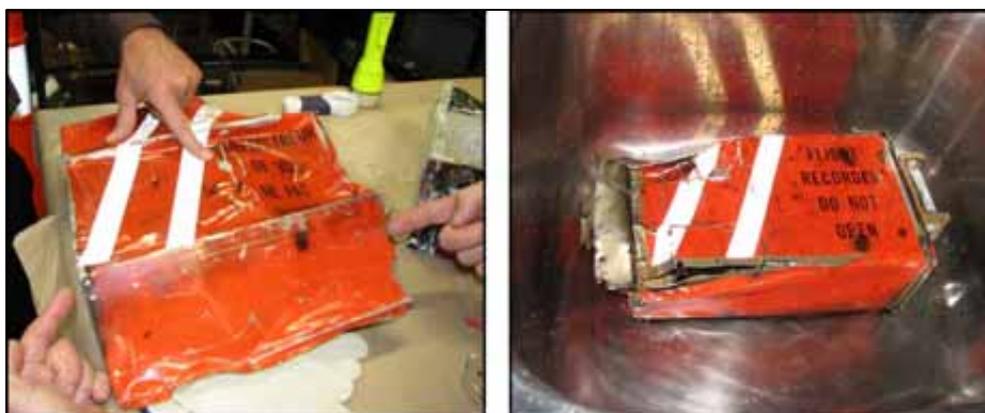
Both recorder units were transported to the ATSB's Canberra engineering facilities for download and analysis of the recorded data. During the initial physical disassembly of the recorders, it was noted that the external casings of both displayed unusual, localised areas of darkening and discolouration of the external paint coating. As a result, specialists from the ATSB's Technical Analysis branch were consulted and a technical investigation of the discolouration was undertaken.

Figure C-1: FDR (left) and CVR (right) as received by the ATSB

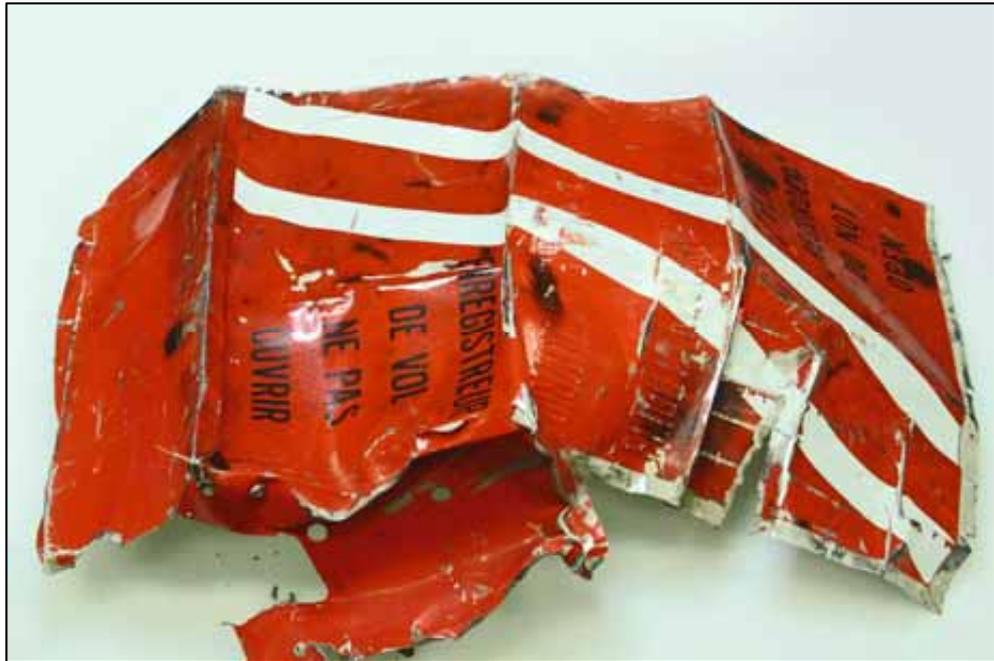
While the unit displayed obvious damage resulting from the accident impact, it was noted that isolated and localised areas over the external surfaces of the CVR outer case were also discoloured; the regions ranging from dark brown to black in discrete patches (Figure C-2). The FDR casing displayed similar effects. Manufacturing data for the CVR indicated the unit to have been painted with an enamel based compound, formulated to the *International Orange* paint code #12197.

Figure C-2: Disassembled CVR external case

On the basis of the ATSB's knowledge and understanding of the accident scenario, it was considered most likely that the discolouration of the FDR and CVR cases resulted from the short-term exposure of the units to the effects of a flash-fire or explosion that ignited upon impact of the aircraft with the water. The physical violence of the impact would have produced ideal conditions for such an event, with any spray of atomised fuel from ruptured fuel tanks being ignited from exposure to damaged electrical systems or hot engine components.

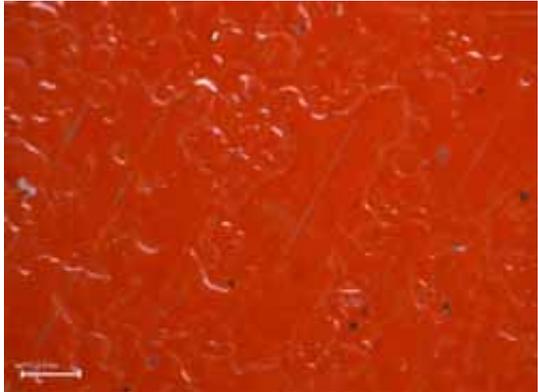
Micrograph showing a smooth, uniform red paint surface with a fine, granular texture. A small white scale bar is visible in the bottom-left corner.
250 °C	60 sec

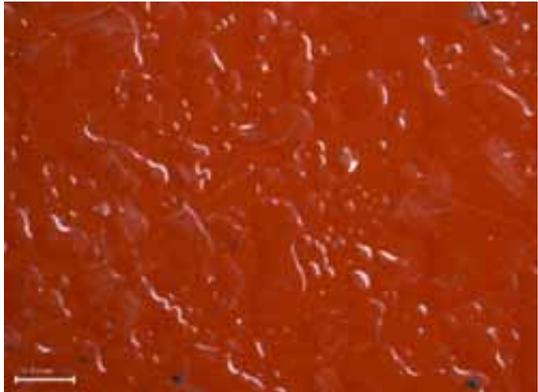
Results from the testing under program (A) showed that the paint readily changed colour and darkened from the original *International Orange*, to a brown/black shade after exposure to elevated temperatures. At temperatures around 350 to 375°C, a marked change in the paint colour was observed; by 400°C the paint had blistered and turned completely black.

Micrograph showing a red paint surface with a more pronounced, irregular texture compared to the 150 °C sample. Some white, fibrous or crystalline structures are visible. A small white scale bar is visible in the bottom-left corner.
350 °C	60 sec

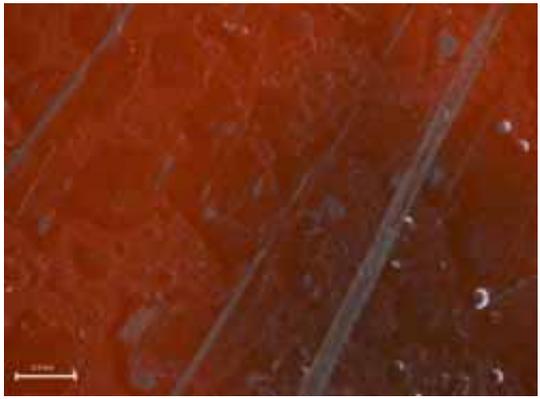
Temperature	Exposure	Observed paint change
375 °C	60 sec

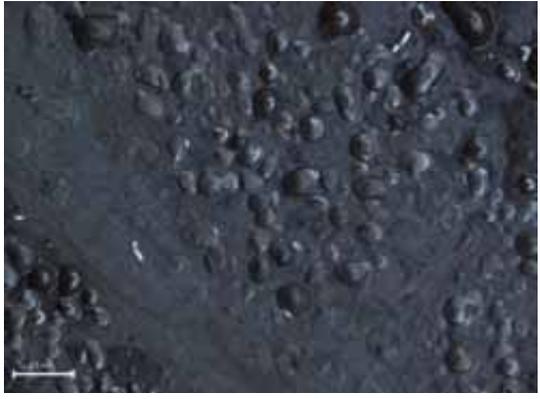
400 °C	60 sec

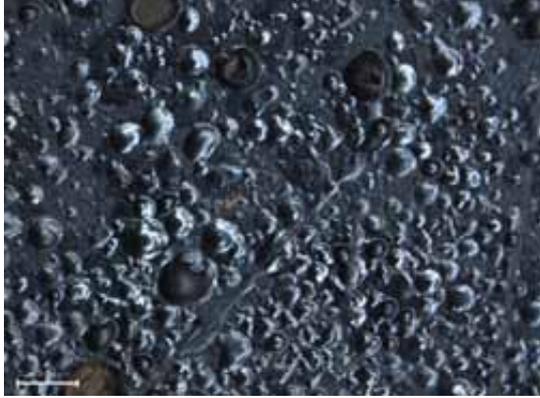
450 °C	60 sec

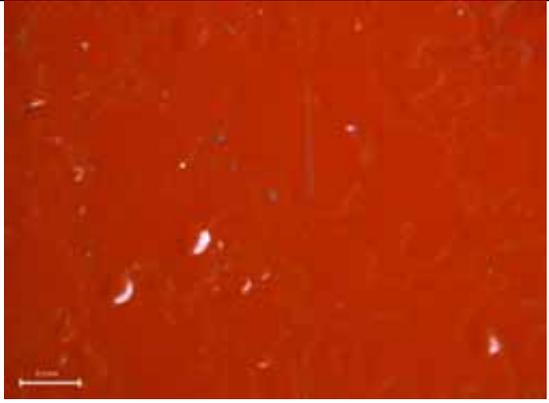
Temperature	Exposure	Observed paint change
1,000 °C	5 sec

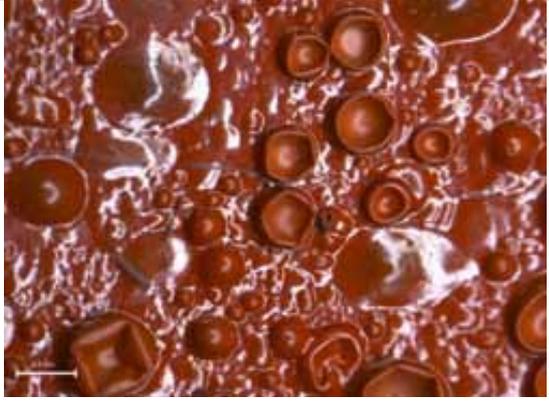
Results from the testing at 1,000°C under program (B) found that the paint changed in appearance after 7 seconds of exposure. Obvious blistering and lifting of the paint followed rapidly.

1,000 °C	7 sec

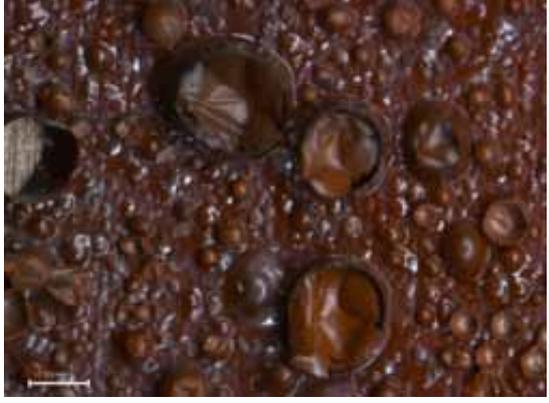
1,000 °C	10 sec
