CIAIAC

Report A-032/2008

Accident involving a McDonnell
Douglas DC-9-82 (MD-82)
aircraft, registration EC-HFP,
operated by Spanair,
at Madrid-Barajas Airport,
on 20 August 2008

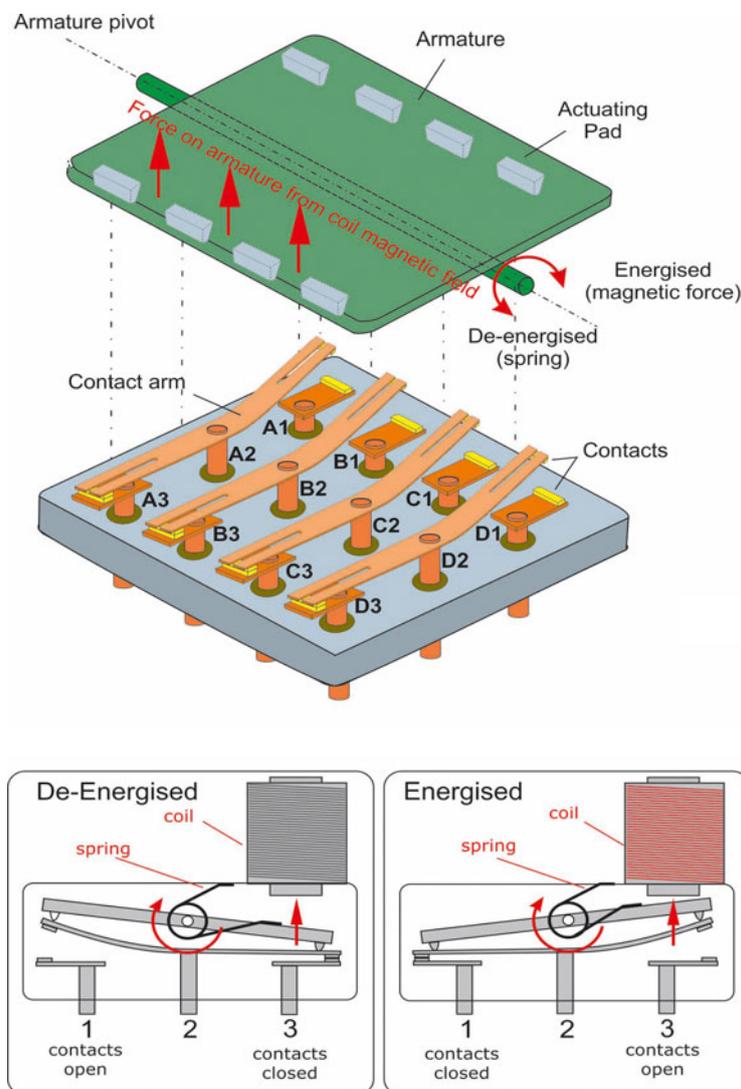
Figure 4. Interior of R2-5 relay

The left group of relays includes the so-called R2-5 relay, which is an electromechanical component manufactured by the Leach Corporation, part number (P/N) 9274-3642. The R2-5 relay is fed directly through the K-33 breaker. From the R2-5 relay, the power is distributed, among others, to the R2-58 relay, which provides information on the airplane's ground-flight condition to the stall warning system, and to the R2-308 relay, which is part of the approach idle system. The R2-5 relay transmits the ground-flight condition to the following four systems:

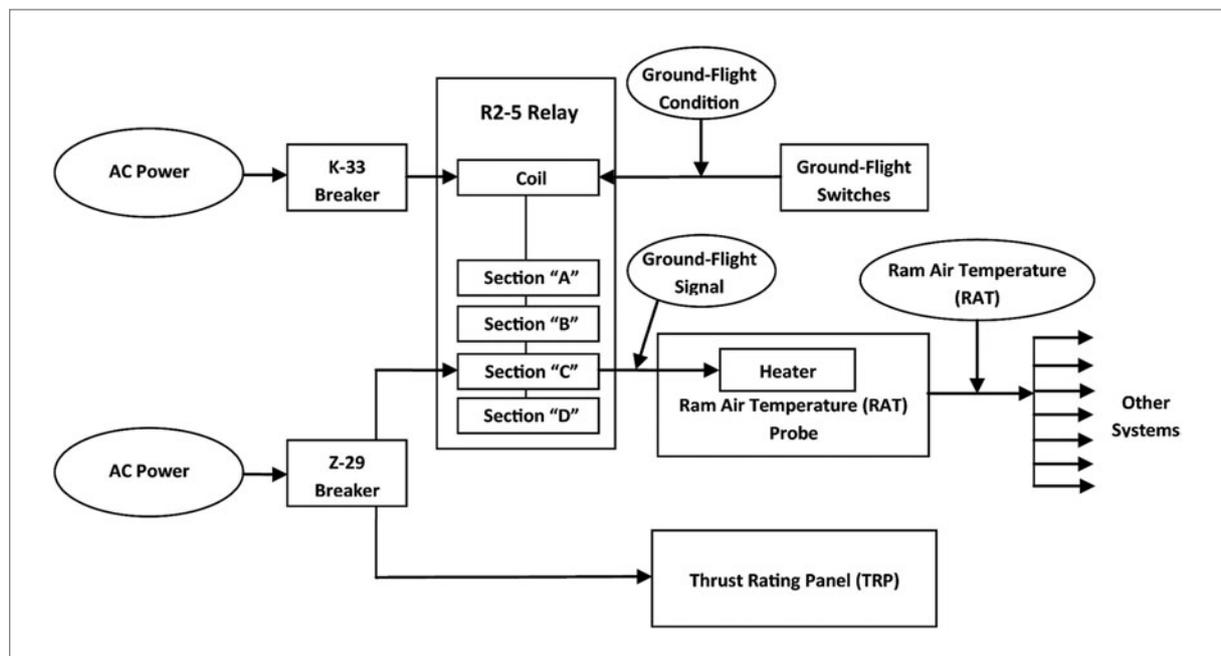
Figure 5. Diagram of RAT probe heater

The probe temperature reading is displayed on the central flight instrument panel, in the top part of the system display panel (SDP). If the system is not working properly and the heater is on with the aircraft on the ground, the probe will measure abnormally high temperatures while on the ground, far above ambient.

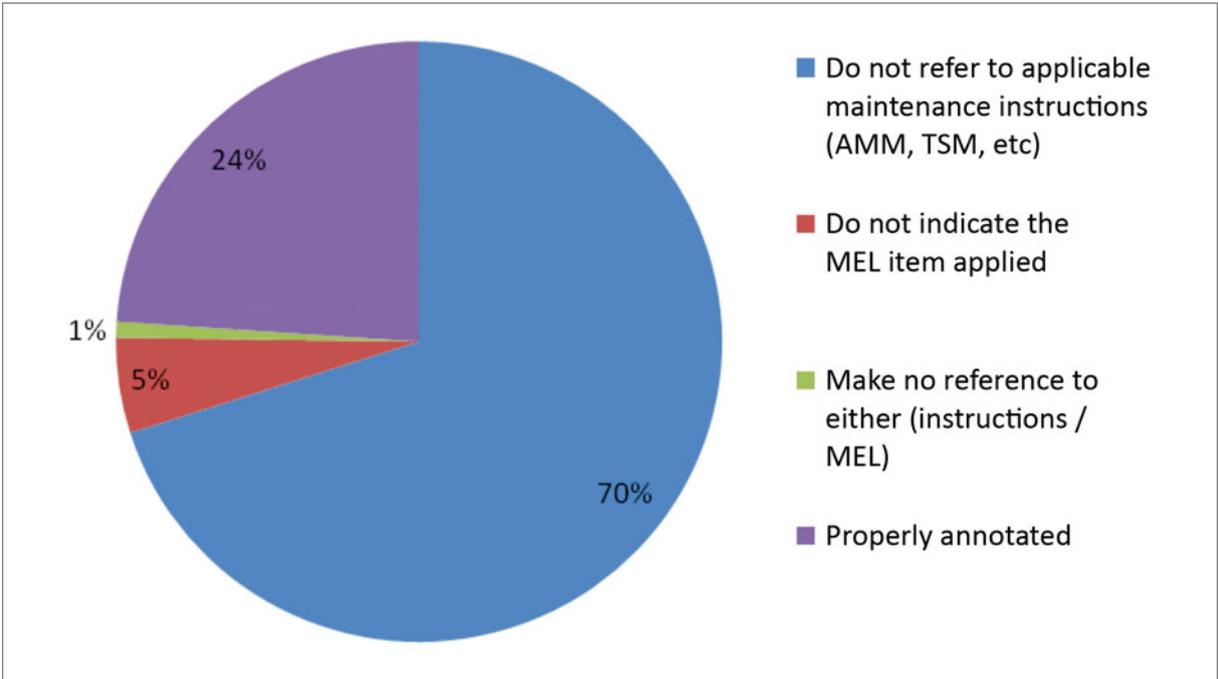
Figure 7. Breakdown of the findings of the logbook study (for period from 21 February – 20 August 2008)

As part of the investigation, the information contained in the ATLB for the six months before the accident (from 21 February to 20 August 2008) was compiled and analyzed. The study excluded those entries that made reference to daily and pre-flight inspections.

An analysis of the remaining entries contained in the logbook revealed the following:

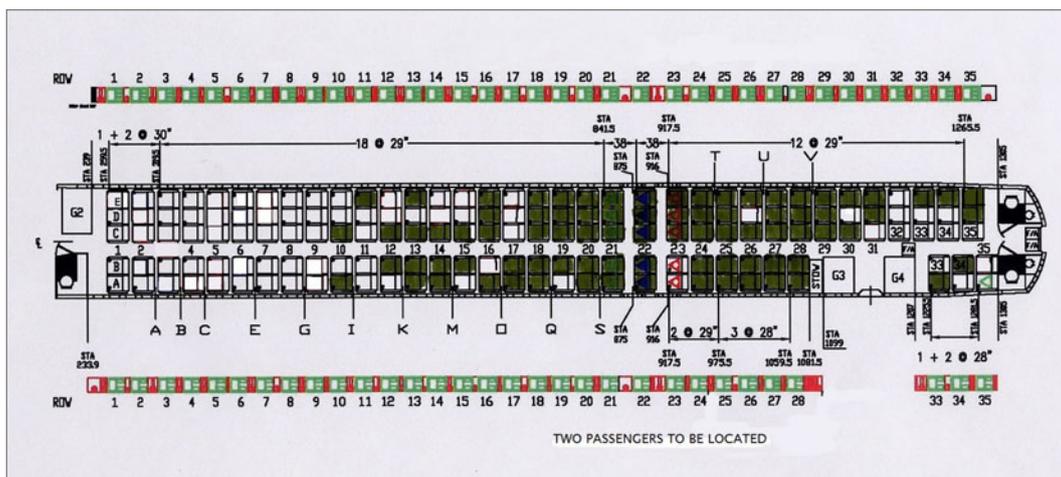
Figure 15. Seating arrangement of burn victims

Autopsies were conducted on all those who perished in the accident. Of the 154 mortal victims (148 passengers and 6 crew), the forensic analyses revealed that 119 (73%) were directly affected by the fire (to varying degrees). Figure 15 shows the position on board the aircraft of all those who died primarily from burns. Of the 35 (27%) remaining victims, the causes of death were: 32 from traumatic injury, 2 from drowning in water and 1 from smoke inhalation.

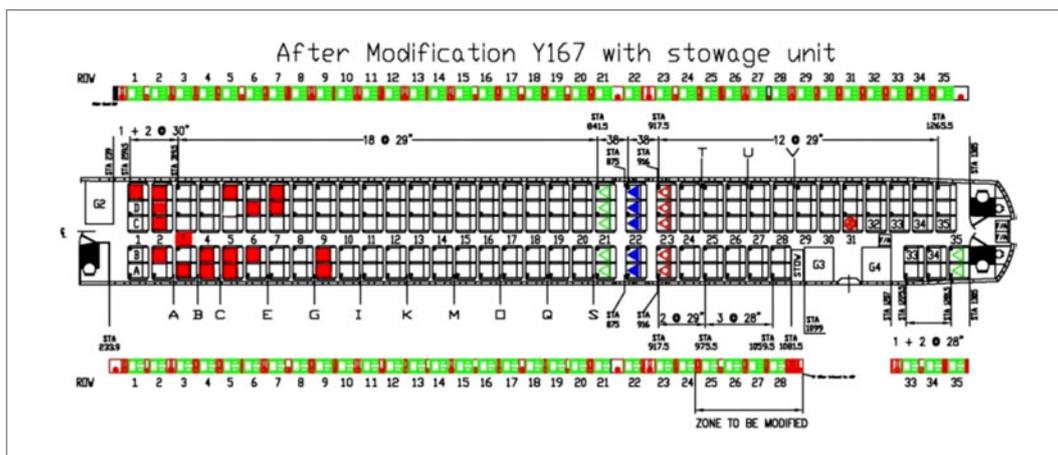
Figure 16. Location of survivors

A total of eighteen (18) people survived, three (3) of them minors. They were seated between rows 1 and 9 in the passenger cabin (see Figure 16). Their injuries derived from traumas with various complications, depending on the organs affected. Two of them were affected by the fire, one due to smoke inhalation and the other with burns to the arm. The last patients left the hospital on 24 October 2008. One of the patients had to be transferred to the National Hospital for Paraplegics in Toledo, from where she was released on 30 April 2009.

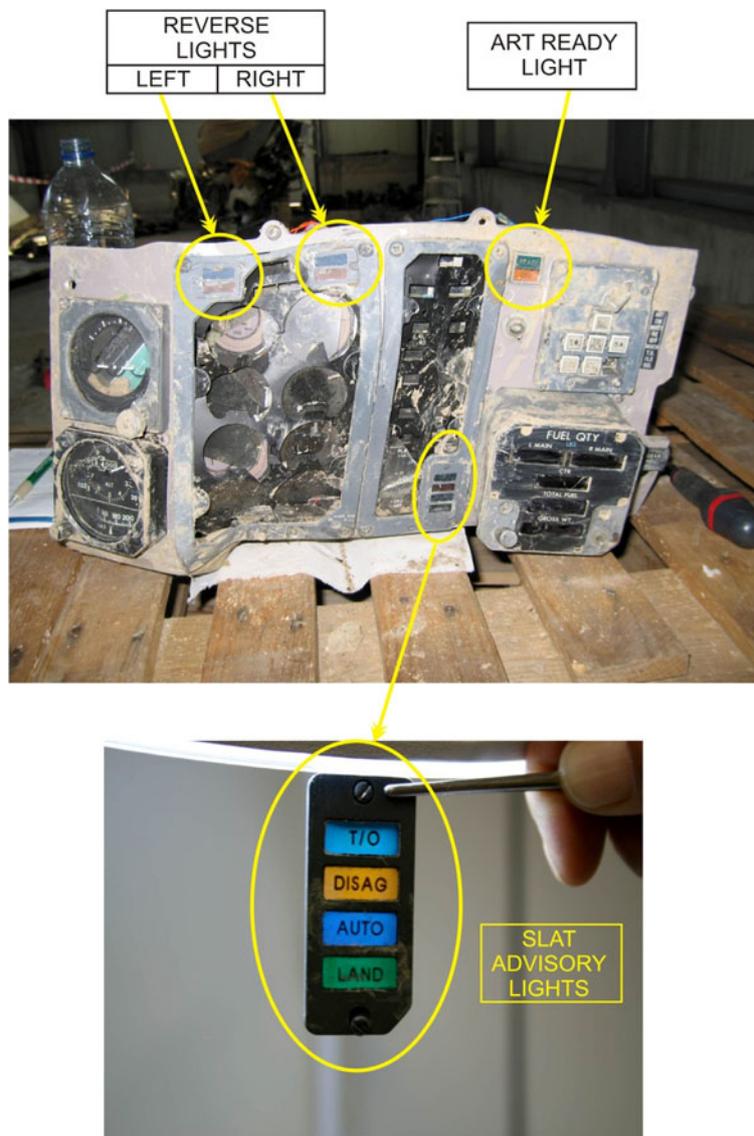
Figure 22. Center instrument panel

The lights were recovered from the center instrument panel (see Figure 22), which was heavily damaged by the impact.

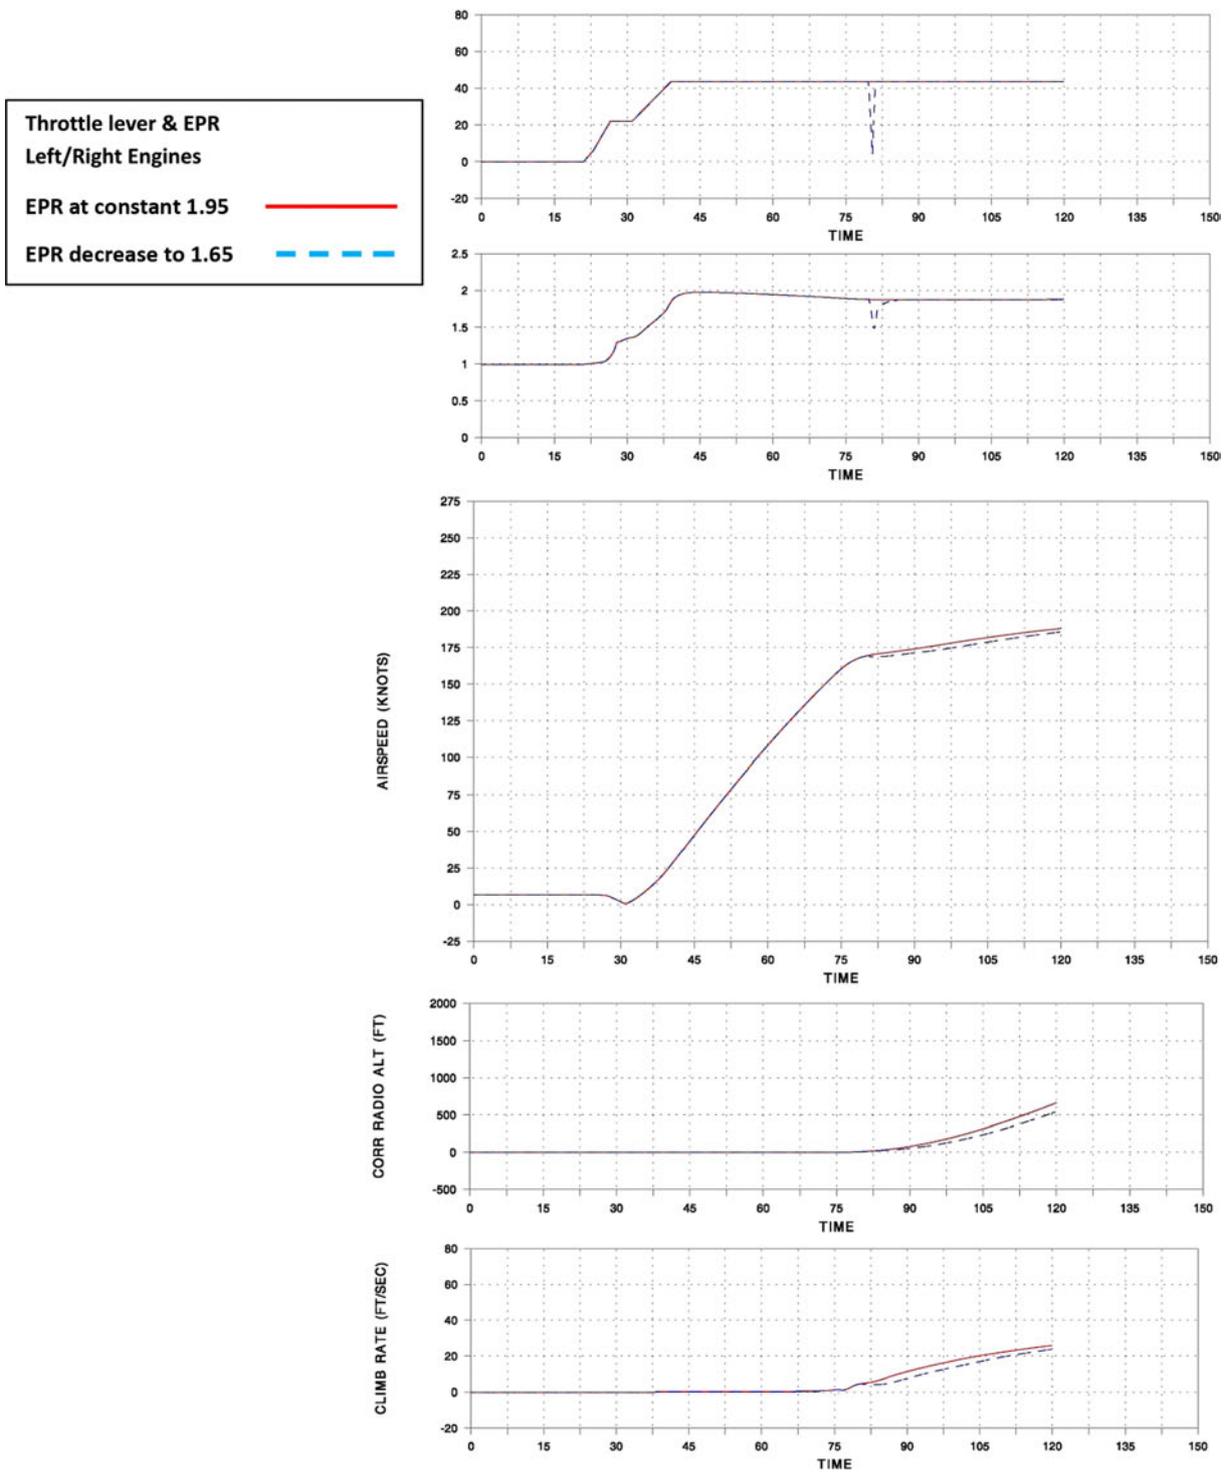
Figure 26. Effect of momentary reduction in EPR from a constant 1.95

The effect of momentarily reducing thrust is more noticeable if cases 1 and 2 are compared. Retarding the throttles hampers the airplane's performance versus maintaining power constant, but only barely, acting to lower speed and the rate of climb (see Figure 26).

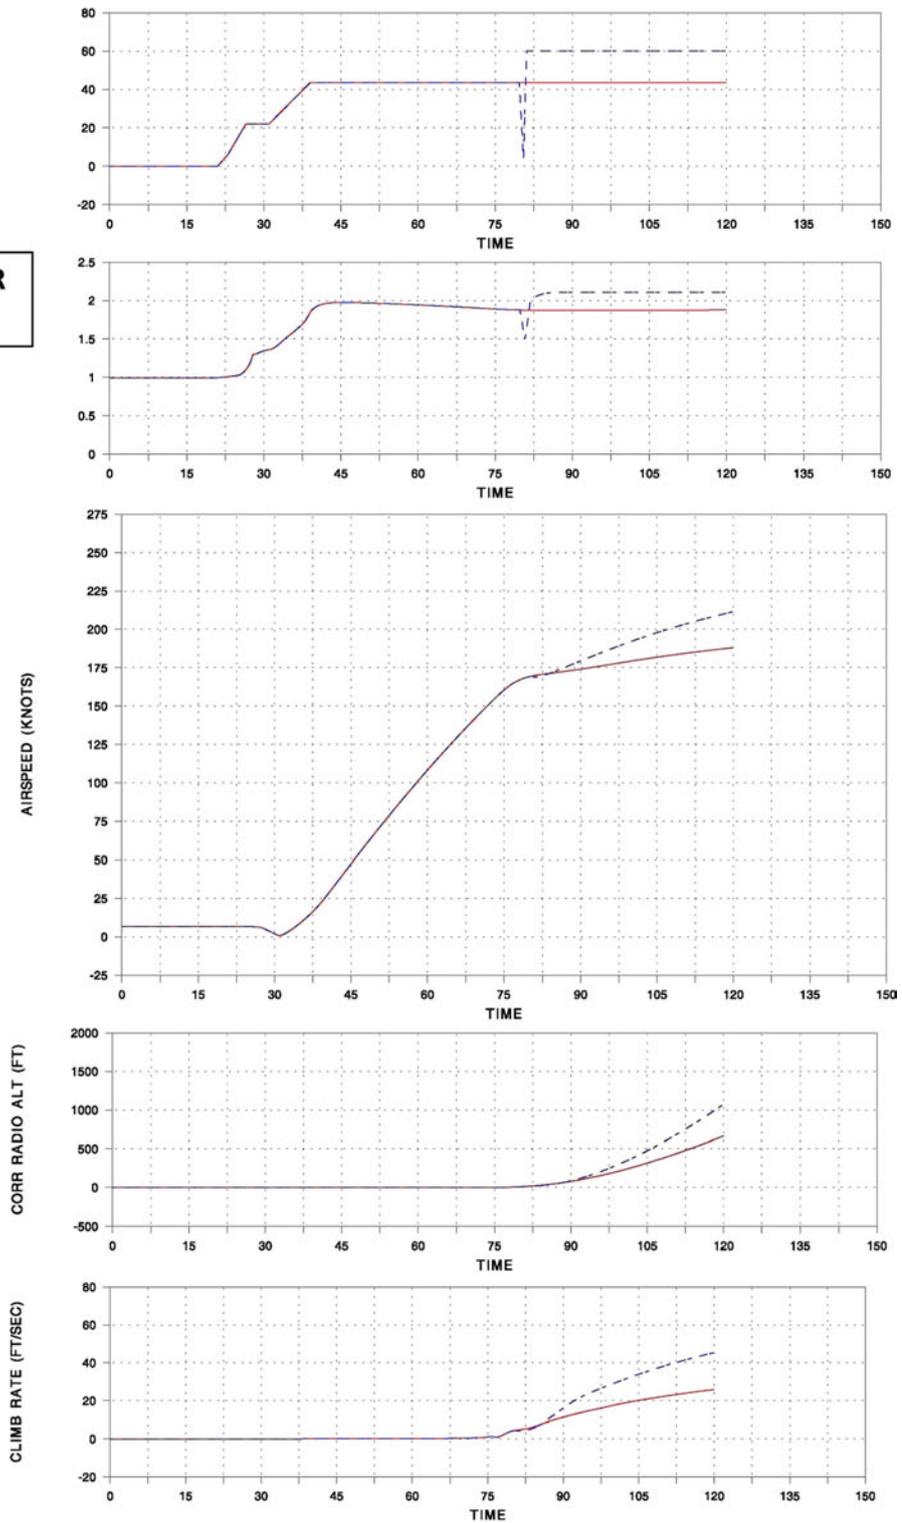
Figure 27. Effect of momentary power reduction to EPR of 1.65 and then increase to EPR of 2.20

1. Considering constant EPR takeoff thrust of 1.95 in both engines, corresponding to the calculated dispatch value for an 11°/MID configuration.
2. Starting with a constant EPR takeoff thrust of 1.95, then reducing thrust momentarily to EPR 1.65 and increasing it again to the initial EPR value of 1.95 in both engines (Figure 26).
3. Considering the real EPR values recorded on the DFDR, which include a momentary drop in EPR from 1.95 to 1.65 and then an increase to an EPR of 2.20 in both engines (Figure 27).

The simulations showed that the effect of lowering thrust and increasing it immediately as happened in the accident (case 3) was slightly beneficial to the airplane's performance in comparison to maintaining a constant takeoff thrust setting for 11°/MID (case 1). The airplane's speed and rate of climb in the accident scenario were greater than those that would have resulted had the throttles not been moved.
