FINAL
KNKT.08.08.12.04

Aircraft Serious Incident Investigation Report

PT. Sriwijaya Airline
PK-CJG
Boeing Company 737-200
Sultan Thaha, Jambi,
Republic of Indonesia
27 August 2008

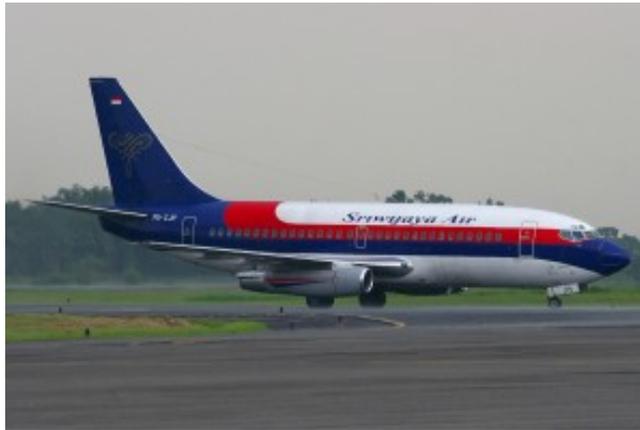
Figure 1: Archive photo of the aircraft

On 27 August 2008, a Boeing 737-200 aircraft, registered PK-CJG, was being operated on a scheduled passenger service from Soekarno-Hatta International Airport, Jakarta to Sultan Thaha Airport, Jambi¹ with flight number SJY 062. On board the flight were two pilots, four flight attendants, and 124 passengers (Figure 1).

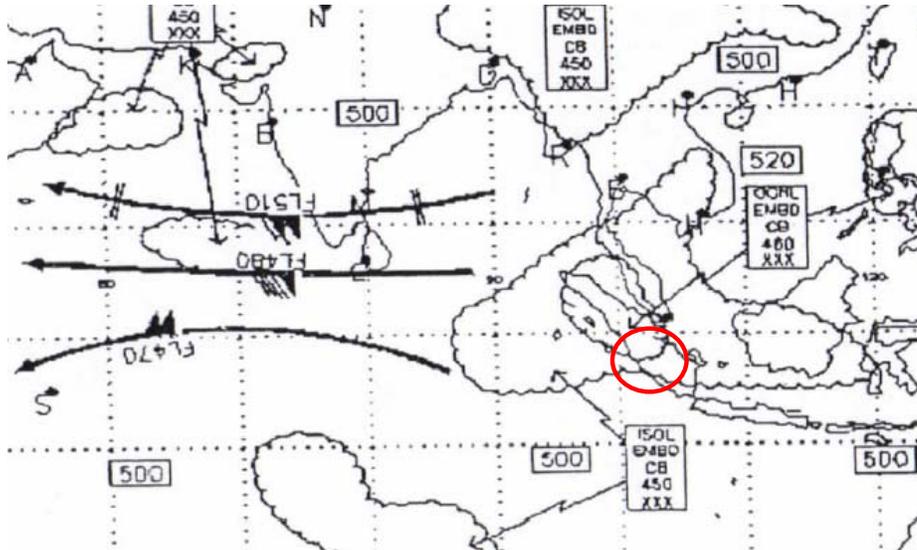
Figure 4: Weather Chart issued by WAFC on 27 August 2008

The weather forecast issued by World Area Forecast Centre (WAFC) London that was valid for FL 250 - 630 on 27 August 2008. The red circle shows that there was significant cloud formation over Jambi (Figure 4).
