**INTERSTATE AVIATION COMMITTEE**

**FINAL REPORT**

Type of occurrence	Accident
Aircraft type	Airplane, Boeing 737-505
Registration	VP-BKO (Bermuda)
Registered owner	ARN 737 Limited, Clarendon House, 2 Church Street, Hamilton HM 11, Bermuda
Operator	Aeroflot-Nord Airline, Russia
Regional Aviation Authority	Arkhangelsk Regional Office, FTOA
Place of Occurrence	Russian Federation, near Bolshoye Savino Airport, Perm (N57°58,255', E056°12,632')
Date and Time	13 September 2008, 2310 hrs UTC, local time 0510 hrs, 14 September 2008.

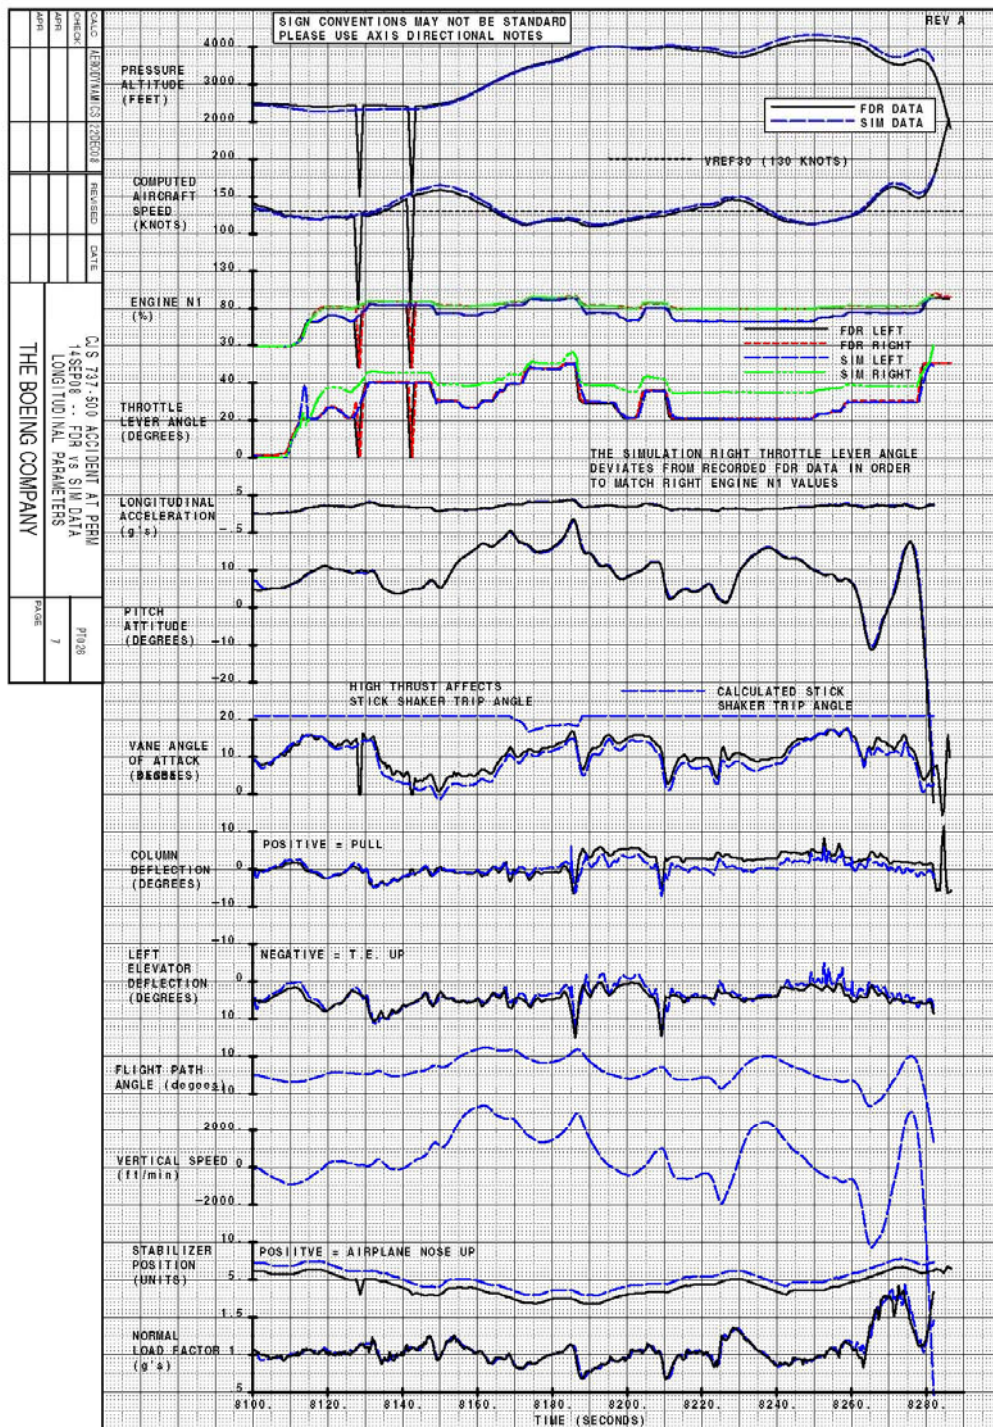
## FDR and Simulation Pitch

The charts below compare the simulation and FDR parameters (the timeline shows relative time). On the basis of these charts and also of the kinematical analysis, the investigation team arrived at the following conclusions:

- The stability and controllability characteristics in the accident flight matched the aircraft type characteristics;
- There was no indication of external forces (turbulence, windshear, etc.) that would affect the aircraft;
- As the IAS decreased, the thrust split required greater wheel to stabilize the aircraft position, however the required wheel was significantly lower than the available;
- During the upset situation no angles of attack were recorded that would exceed the stick shaker AOA.

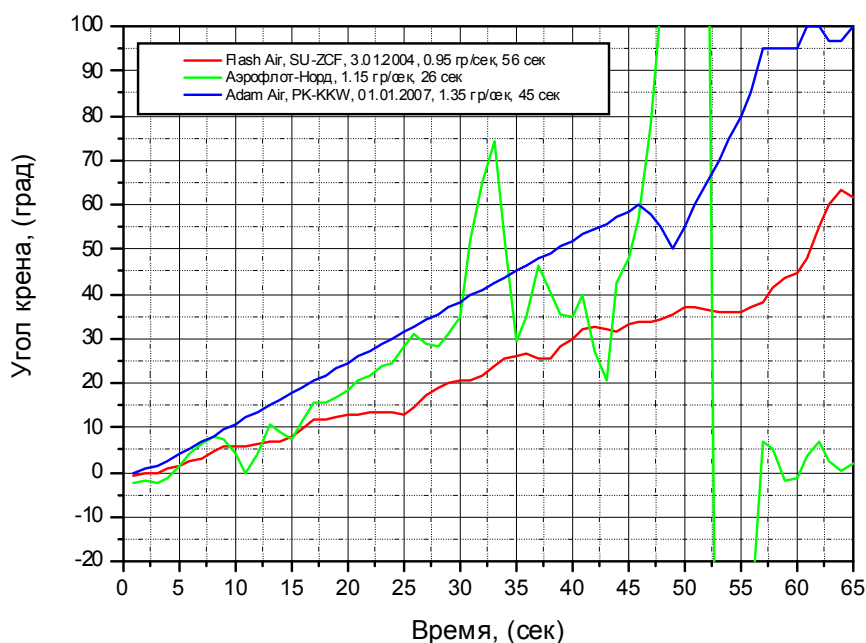
In the course of the investigation the investigation team studied several previous cases of spatial disorientation in flight. The chart below shows comparative data regarding slow banking of Boeing 737 type aircraft during the upset (with reference to average rate of banking), followed by more rapid banking as the crews reacted (all the cases ended up in accidents). For convenience, absolute values of bank angles are given in the charts and the initial magnitudes of bank angles are taken as zero references.

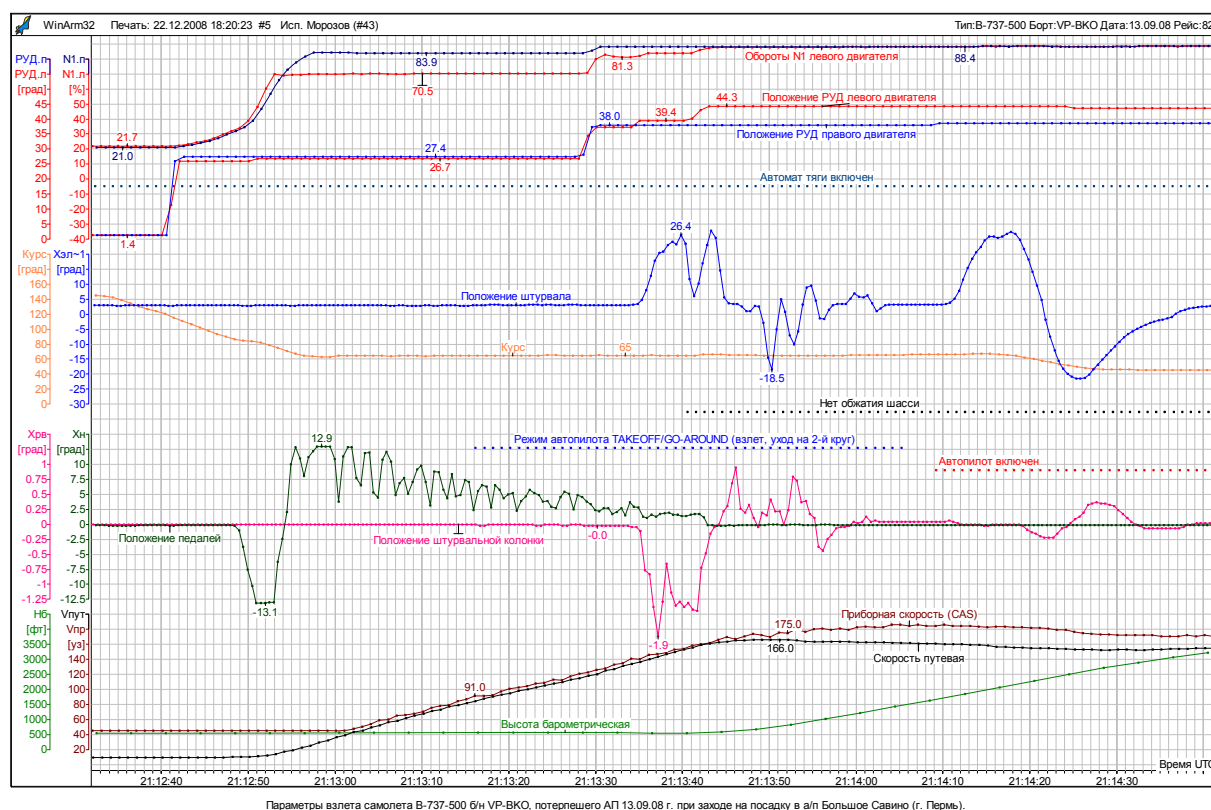
In fact the crew did not follow any of the SOP recommended procedures. The actual flight parameters are shown in the chart below.

The increase in thrust was done 55 degrees before lining up; the throttle position was matched at 27 degrees TLA within 2 seconds, which led to thrust increase up to 70.5 % N1 left and 84% N1 right within 17 seconds. The mentioned thrust split resulted from the right engine mistrim described above. It should be noted that such engine control method at takeoff is extremely dangerous, as if the mode is changed asymmetrically, a significant yaw moment appears due to a large split, which can lead to runway excursion if the runway friction factor is low (RWY is wet or slippery)<sup>44</sup>.

Probably at the same moment the PIC handed control over to the Co-pilot<sup>45</sup>, as the full left rudder was used first to enter the takeoff course and then full right rudder was applied to compensate the yaw moment caused by thrust asymmetry.

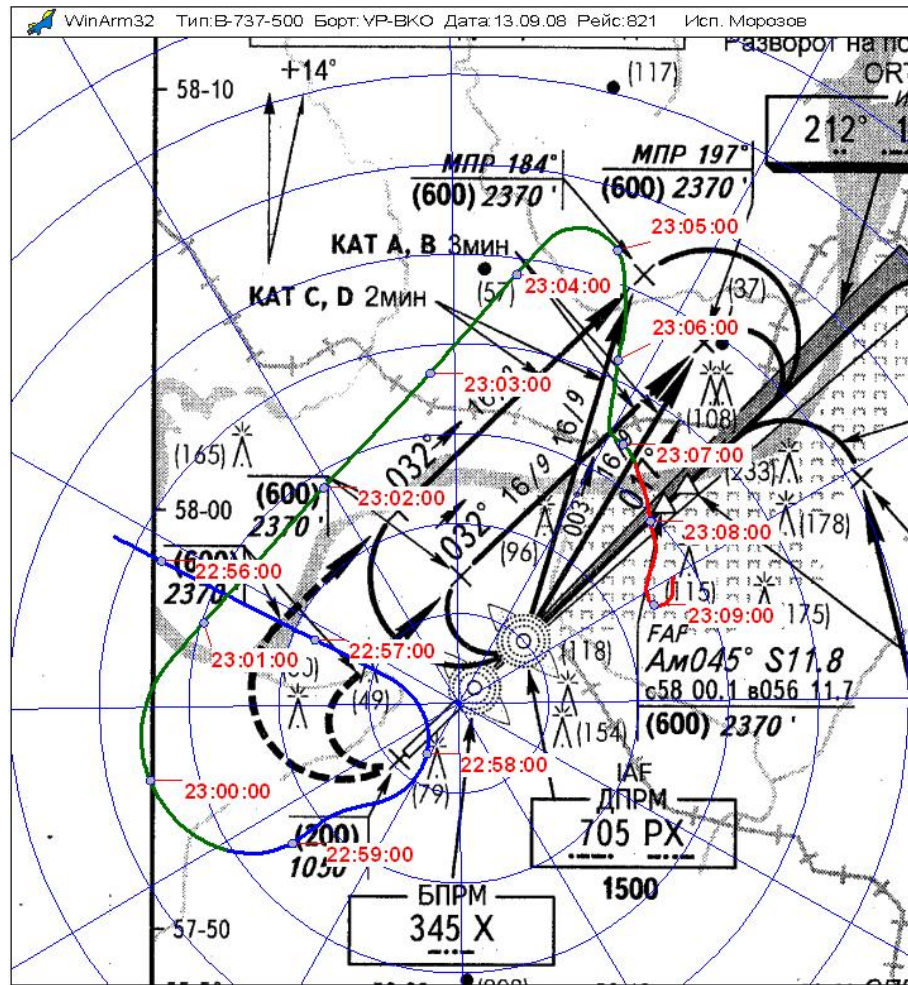
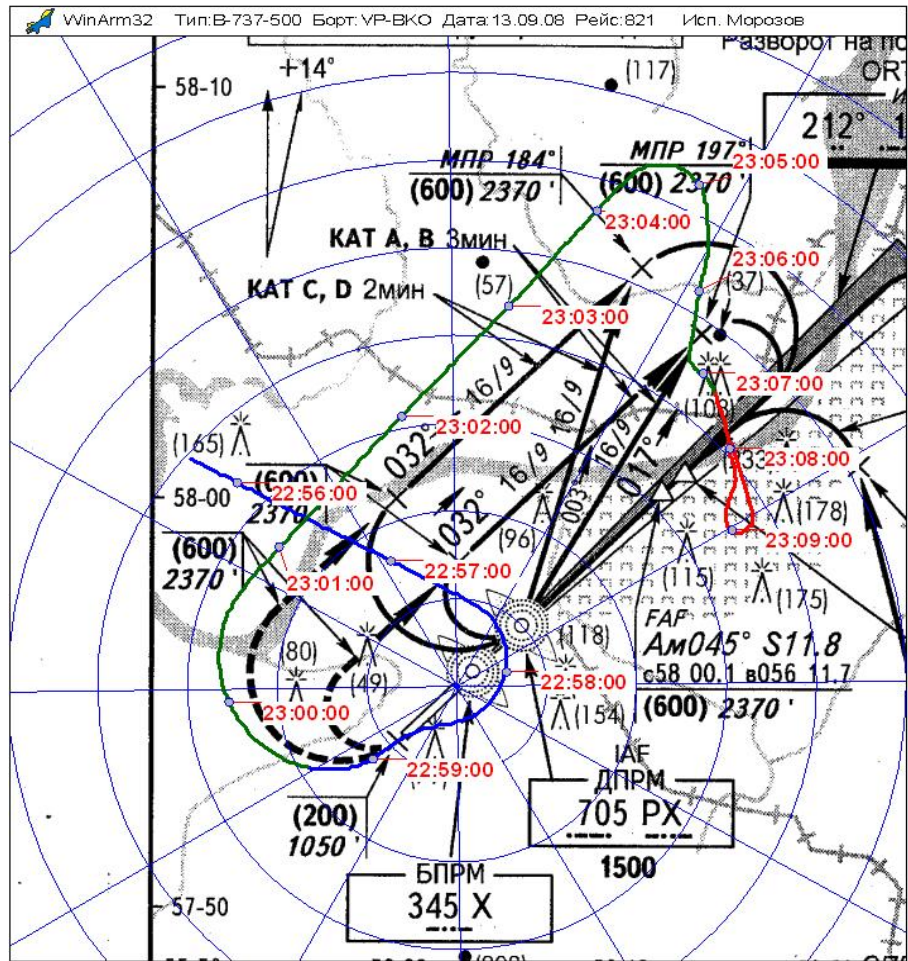
The aircraft was maintaining 2700 m. By that time the error in the FMC aircraft positioning was over 4.5 km. Such an error was caused by the natural drift of the IRS during the flight as well as the initial error made by the crew while entering the aircraft position during the alignment, and also by the inability to correct the positioning via the GPS or with the help of signals from nav aids which are not present along the flight route or at the destination airport. The crew should have observed the warning IRS NAV ONLY.

The chart below shows the actual flight path (left-hand chart), that goes approximately through the runway center and also the path that the crew saw on the navigation display (right-hand chart), that goes through the PX outer marker. The difference between the actual aircraft path and the one observed by the crew, taking into account the Controller's instruction to proceed via the marker, assumes that the crew did not use the ADF to monitor their position, nor did they tune the frequency of the outer marker.
