AIRCRAFT INCIDENT REPORT AND EXECUTIVE SUMMARY

Reference:	CA18/2/3/8597	
Aircraft Registration	ZS-NXH	Date of Incident	18 December 2008		Time of Incident	1119Z
Type of Aircraft	King Air 200		Type of Operation	Charter		
Pilot-in-command Licence Type	Air Transport	Age	23	Licence Valid	Yes	
Pilot-in-command Flying Experience	Total Flying Hours	1900		Hours on Type	400	
Last point of departure	Mafikeng Aerodrome (FAMM)					
Next point of intended landing	Lanseria Aerodrome (FALA)					
Location of the incident site with reference to easily defined geographical points (GPS readings if possible)						
On Runway 06L at Lanseria Aerodrome (FALA)						
Meteorological Information	CAVOK, Wind: 090/10kts, Temperature: 28, Due Point:06, QNH:1019					
Number of people on board	2 + 2	No. of people injured	0	No. of people killed	0	
Synopsis						
<p>On 18 December 2008 the SACAA was informed of a King Air 200 aircraft that just had a landing gear collapse during landing on Runway 06 at FALA. The SACAA investigators were dispatched to FALA and they arrived within an hour following the accident.</p> <p>Onsite visual inspection of the aircraft revealed no visible failures thus the aircraft was recover

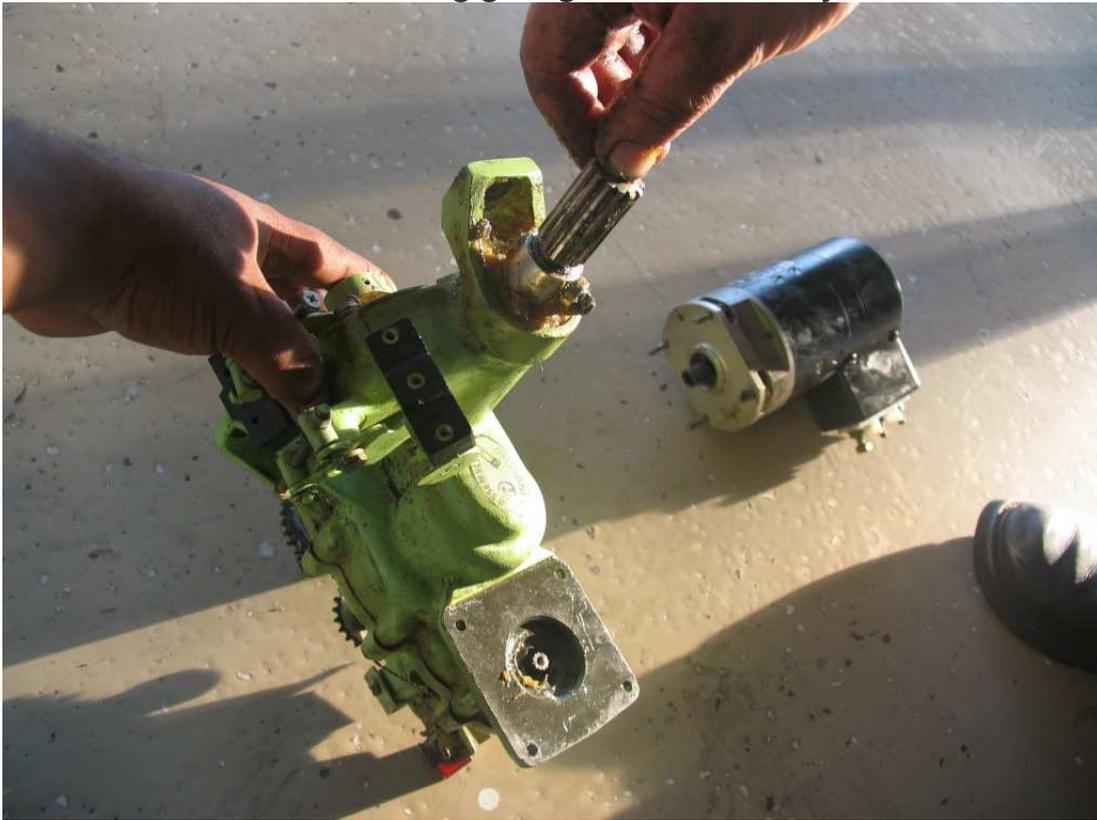
Photo 6: Illustrates the landing gear gearbox assembly and electrical motor.

1.16.4 During investigation of the landing gear motor there were no defects found.

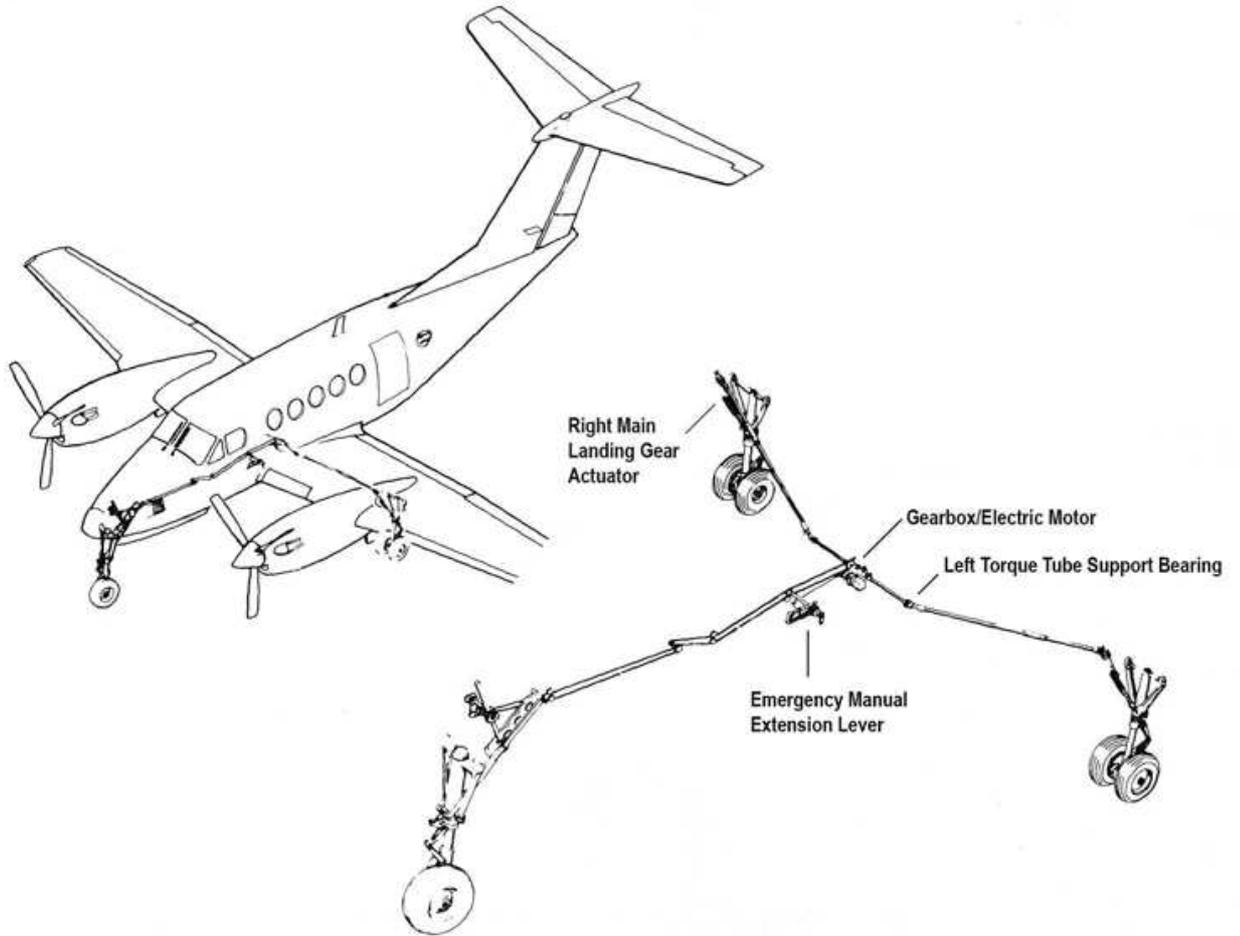
Photo 9: Illustration of the mechanical landing gear system from the Super King Air 200

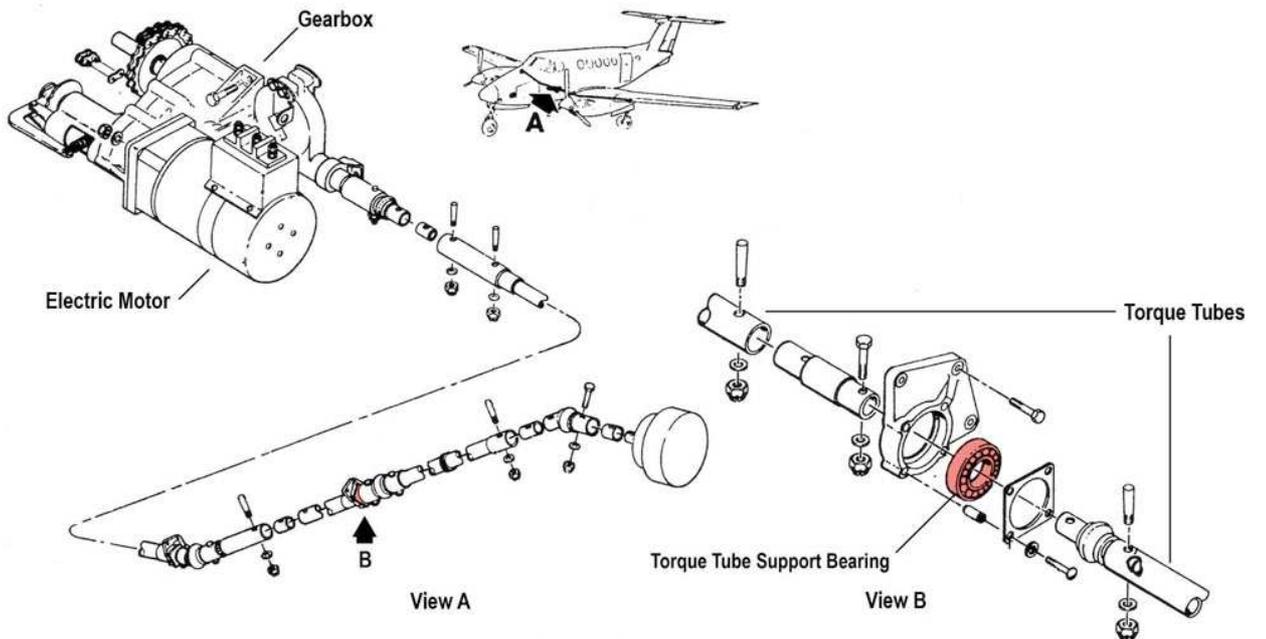
Photo 10: Illustrated part breakdown of the main gear retraction mechanism detailing the torque and gearbox arrangement.

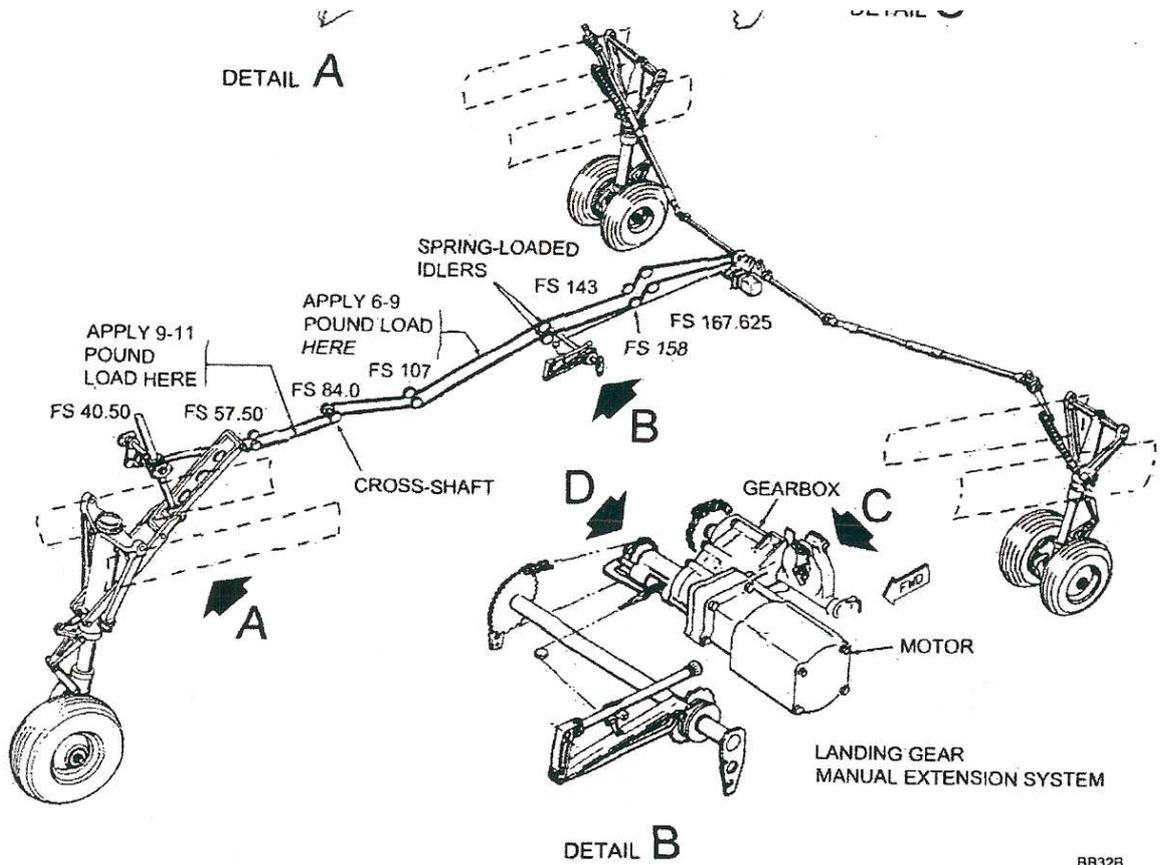
Photo 11: Illustration of the mechanical landing gear system with the emergency from the King Air 200
