Final Report No. 2074 by the Aircraft Accident Investigation Bureau

concerning the accident involving
the Marcel Dassault/Bréguet Aviation Falcon 10/100, registration VP-BAF
operated by Laret Aviation Ltd.
on 12 February 2009
Samedan Airport, municipality Samedan/GR

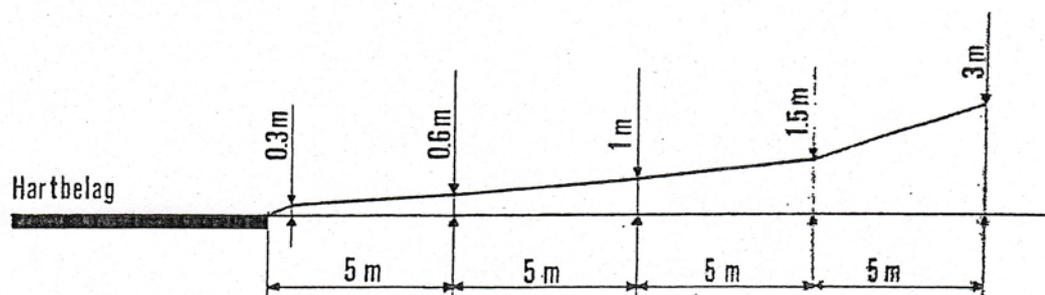
Zulässige Schneehöhe entlang der Pisten, Rollwege und Abstellflächen

[Permissible snow height along runways, taxiways and parking areas]

Vielleicht finden Sie diese allgemeine Richtlinie für Ihre Verhältnisse übertrieben. Wir möchten es in diesem Fall Ihnen überlassen, die für Ihre Gegebenheiten zweckmässige Schneeverteilung festzulegen. (...)"

[You may find this general guideline excessive for your conditions. In this case we would like to leave it to you to specify appropriate distribution of snow for your circumstances.]

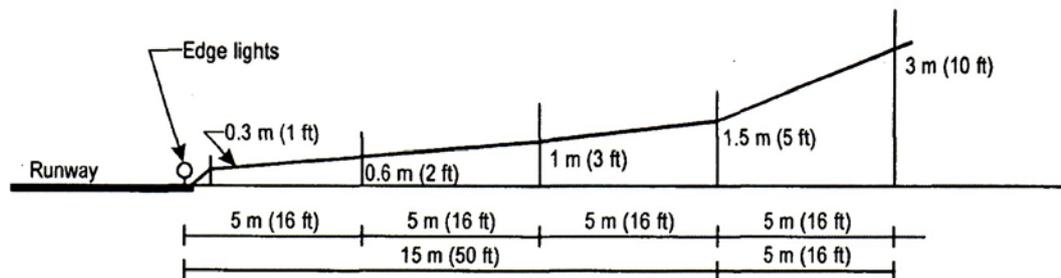
Figure 7-1. Maximum height of snow profile"

"The height of a snowbank on an area adjacent to a runway, taxiway or apron should be reduced so far as is practicable so as to provide wing overhang clearance and preclude operational problems caused by ingestion of ice into turbine engines. Figure 7-1 shows the maximum snow height profile allowable during initial snow-clearing operations on such area. This is the desired profile that should be obtained after snow has ceased to fall and after time and conditions permit clearance equipment to be diverted from higher priority work. When conditions permit, the profile shown in Figure 7-1 should be reduced in height in order to facilitate future snow removal operations and to reduce the possibility of snow ingestion into jet engines. Complete removal down to ground level should be the aim in areas where snow removal equipment can work, such as on shoulders.

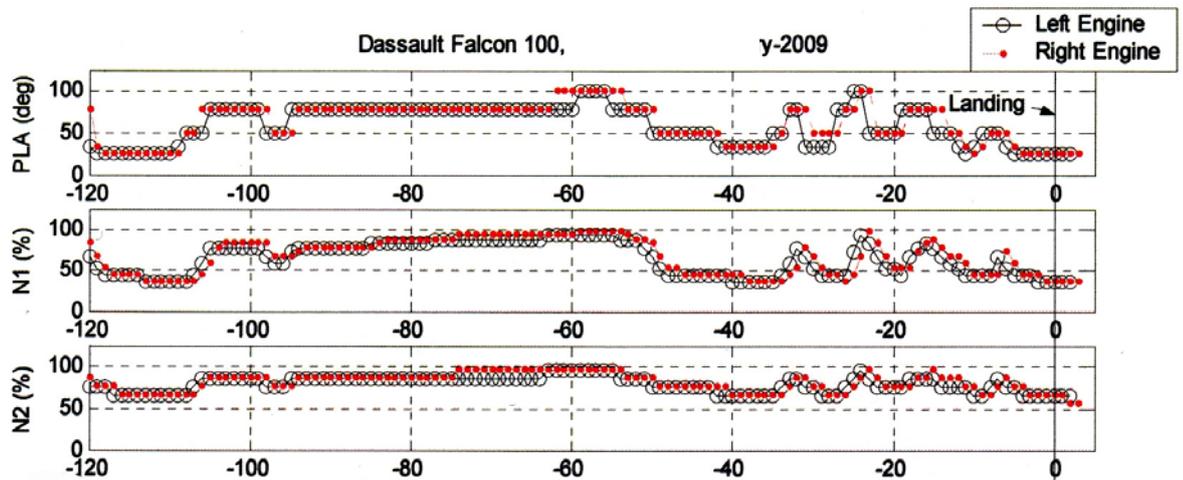
Figure 7: Power lever angle (PLA), N1 and N2 during the last 120 seconds

The two graphs below, from the manufacturer's report, show the progression of the two speeds N1 and N2 as a function of the position of the respective power lever angle (PLA).

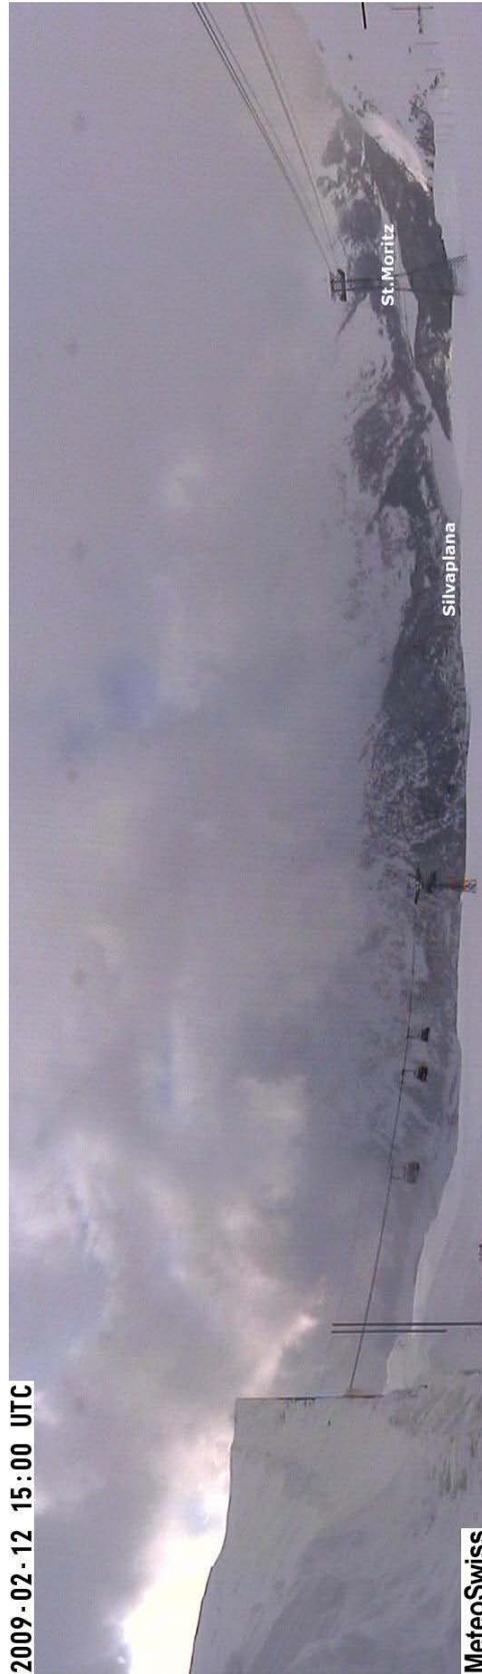
2009-02-12 15:00 UTC

Visibility at 15:00 UTC. At this time the aircraft VP-BAF was east of Piz Güglia, between Silvaplana and St. Moritz, on an altitude of about 11 000 ft AMSL. Afterwards the crew flew a first 360° to the left, a 180° turn to the south and to the south each and three further 360° to the left (cf. Annex 2 and 3).

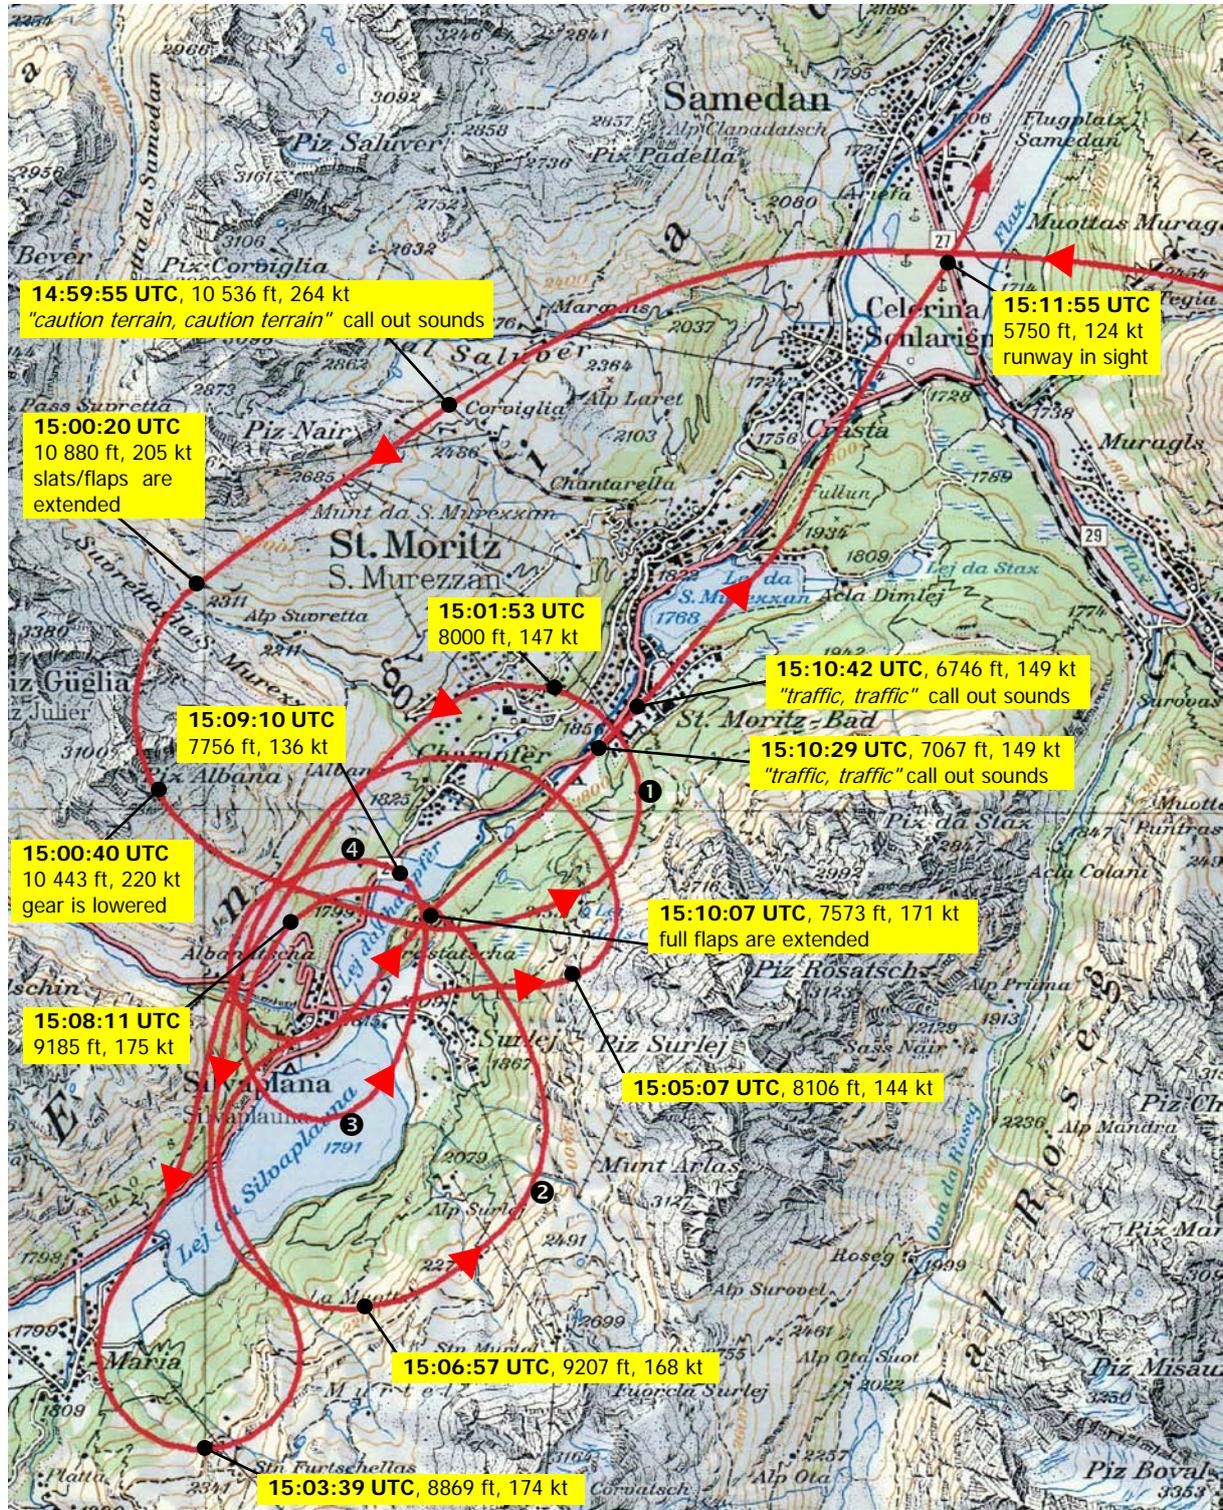
Annex 2: History of the flight of aircraft VP-BAF

The speed information corresponds to ground speed. Given the prevailing wind, it can be concluded that the speed indication in the cockpit (indicated air speed – IAS) deviated from this by a maximum of 4 kt. The altitude information corresponds to the calculated altitudes according to the mobile GPS device.

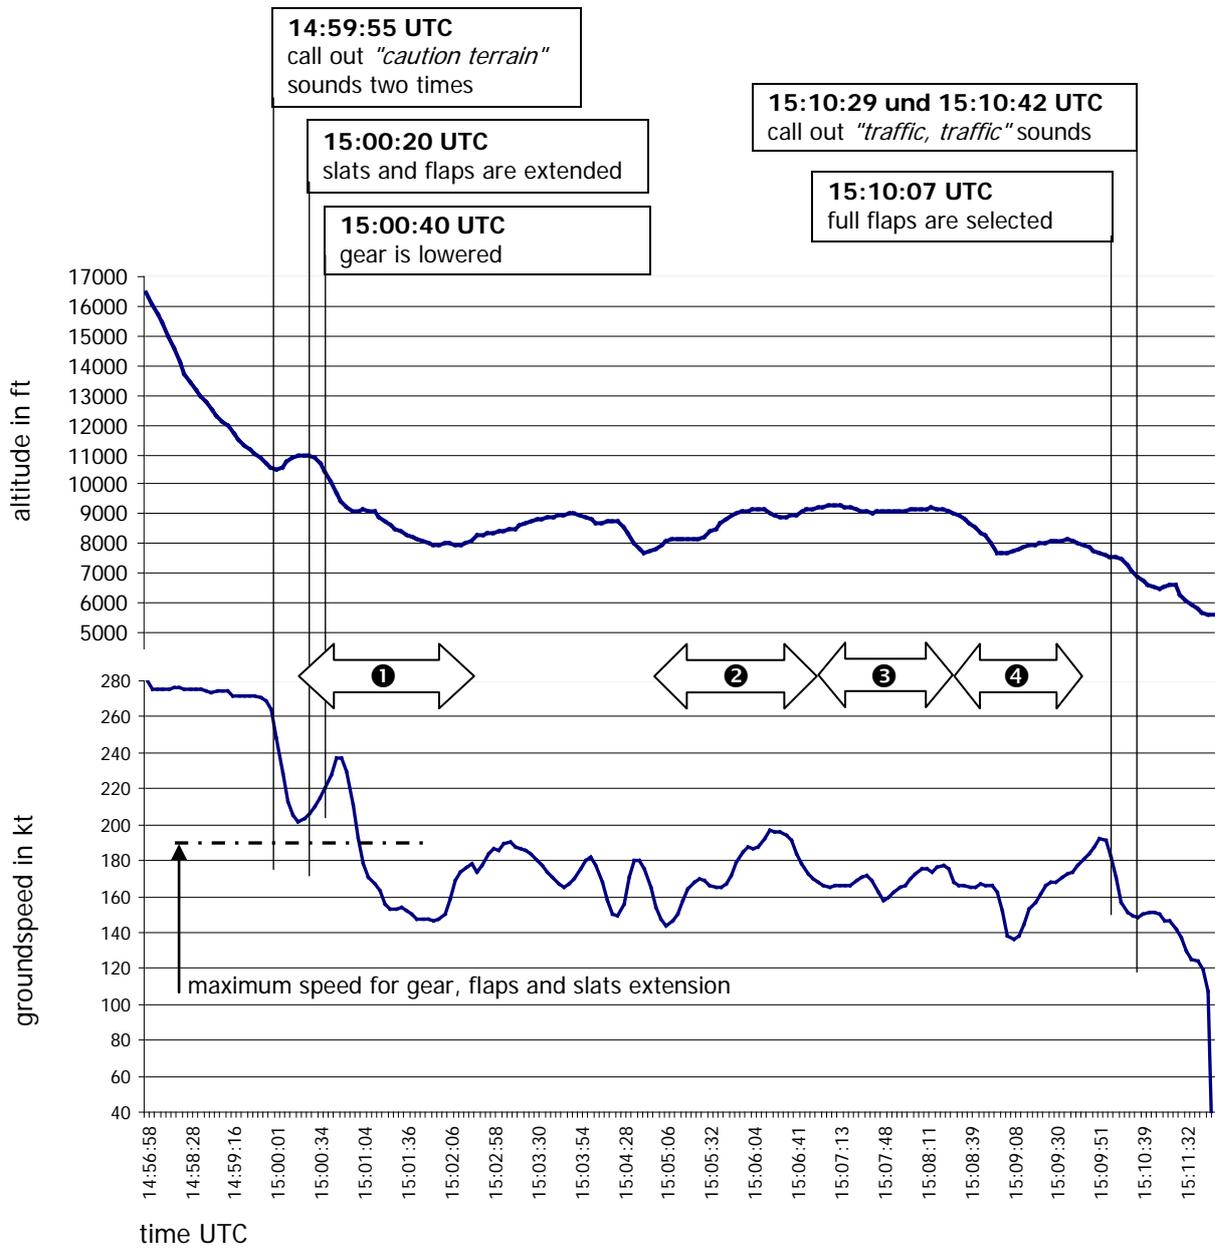
Annex 3: History of the flight regarding altitude and speed

- ❶ first 360° to the left
- ❷ second 360° to the left
- ❸ third 360° to the left (maximum bank angle 45 degrees)
- ❹ fourth 360° to the left (maximum bank angle 50 degrees)
