Report 09-004, Britten Norman BN2A-Mk III Trislander, ZK-LOU loss of engine
propeller assembly, near Claris, Great Barrier Island, 5 July 2009

Report 09-004

Britten Norman BN2A-Mk III Trislander

loss of engine propeller assembly

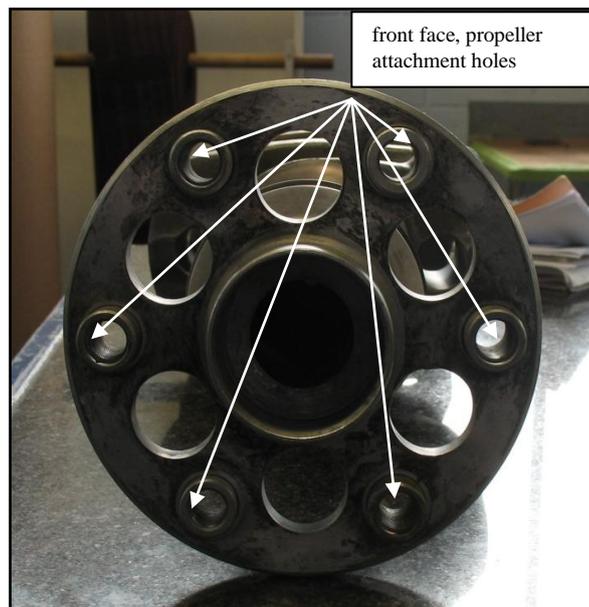
Figure 4
A serviceable crankshaft flange with lightening holes

The crankshaft had an end flange that contained 6 lightening holes separated by web spokes [see Figure 4]. The crankshaft also had a pair of counterweights at the rear to act as vibration dampers.

The crankshaft bearing surfaces were corroded in places, most obviously at the location of the forward main bearing where the corrosion was concentrated on one side of the shaft surface. Some scoring of the nitrided bearing surfaces was also evident.
