SOUTH AFRICAN CIVIL AVIATION AUTHORITY  
(SACAA)

## FINAL REPORT

### **Jetstream Aircraft 4100 ZS-NRM: Loss of control after engine failure and misidentified engine shutdown after take-off from Durban Airport, South Africa on 24 September 2009**

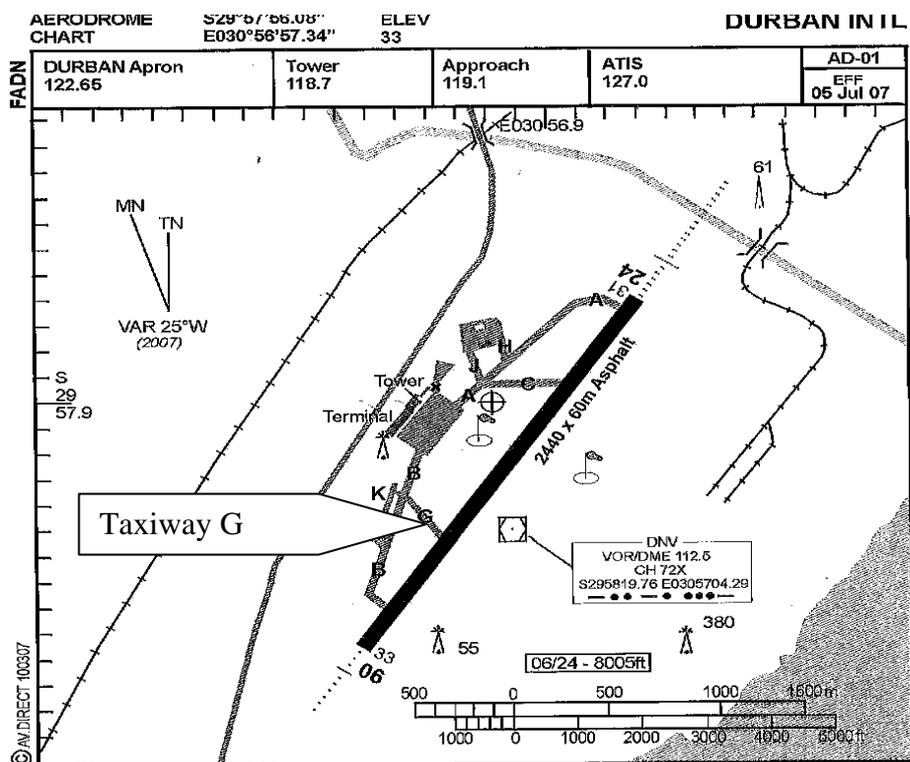
Figure 2. Durban International Airport.

1.1.5 The tower controller later stated that the aircraft was still on the runway and in the vicinity of the intersection with taxiway G when he became aware of smoke coming from it. He could not, however, make out exactly from which part of the aircraft the smoke was coming from.

- 1.1.6 The technician on the ground in parking bay A4 reported watching the accident aircraft take off. He stated that the takeoff roll appeared uneventful but that just after rotation there was “a large cloud of black smoke that erupted from the right-hand engine”. During the climb, the smoke changed colour to a whitish-brown and diminished in volume. As the aircraft crossed the end of the runway, it appeared to yaw to the right and then started to lose altitude. It then veered suddenly to the left, rapidly losing altitude, before disappearing from view.
