AAIPU# A09-01471

AIRCRAFT ACCIDENT REPORT

DASSAULT SUD FAN JET FALCON
N28RK

MATTHEW TOWN, INAGUA, BAHAMAS
DECEMBER 17, 2009

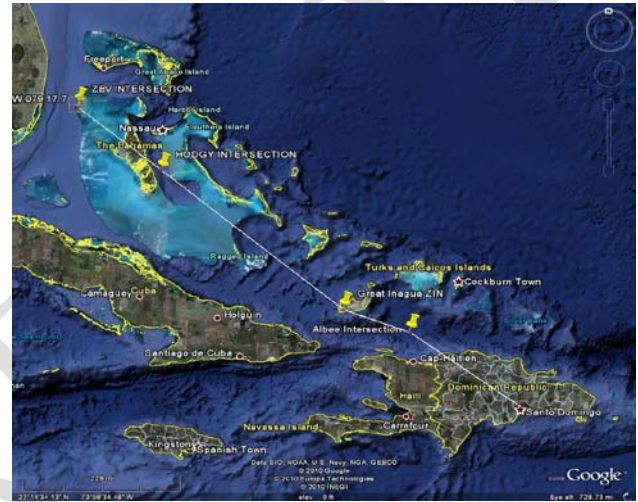
Figure 2 - Flight Path MDJB to ZBV

The accident occurred approximately 6 mile off the filed flight path.

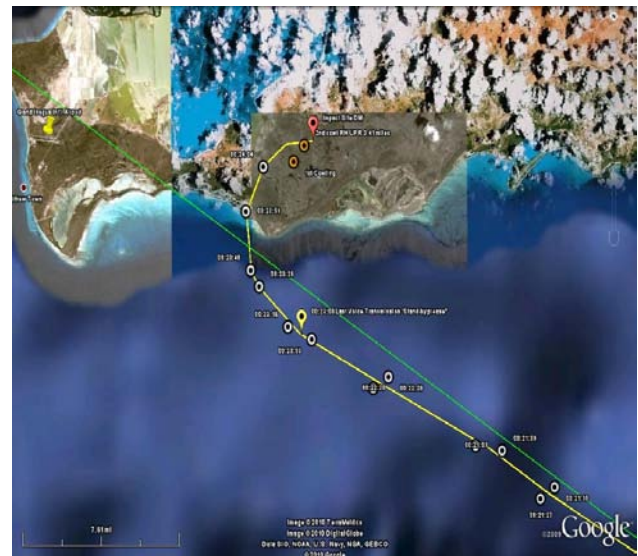
Figure 3 Aircraft Tracking based on radio communication

—ATC records and instructions were for the aircraft N28RK to maintain 28,000 ft (FL280). The aircraft transponder was reported as inoperative. It begun a rapid descent, with no report of an emergency declared or mayday call out. Investigation of the crash site indicates the airplane made contact with the terrain at a high rate of speed and approximately a 45 degree angle. The aircraft was destroyed on impact.

Based on radio communications (figure 3) N28RK was level at FL280 when it began a rapid descent and turned off course and ended up crashing in the National Park at Great Inagua.

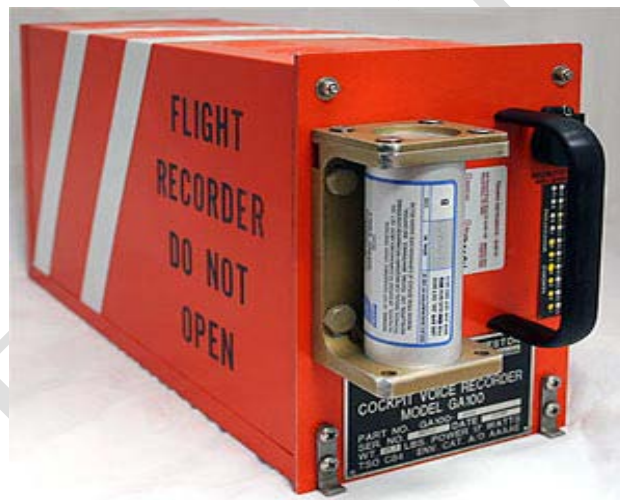
Figure 8 - Cockpit Flight Recorder (CVR) Model GA100 similar to the model installed in N28RK

Successive searches of the area did not locate the internal parts of the CVR. The housing of the CVR was recovered; however the internal components were never recovered. Photo following showed the extent of damage sustained by the CVR.

Due to the unavailability of the recorder the last moments of what took place will not be known.
