AIRCRAFT ACCIDENT REPORT AND EXECUTIVE SUMMARY

Reference:	CA18/2/3/8793	
Aircraft Registration	ZS-ZOC	Date of Accident	13 June 2010		Time of Accident	0900Z
Type of Aircraft	Swearingen SA 226 TC Metro II		Type of Operation		Charter Flight	
Pilot-in-command Licence Type		Airline Transport	Age	37	Licence Valid	Yes
Pilot-in-command Flying Experience		Total Flying Hours	6900.00		Hours on Type	400.0
Last point of departure		Lanseria International Airport (FALA)				
Next point of intended landing		Polokwane Airport (FAPP)				
Location of the accident site with reference to easily defined geographical points (GPS readings if possible)						
On Runway 24R at Lanseria International Airport (FALA), at GPS reading: S25°56.151 E027°55.757						
Meteorological Information		Surface Wind:030°/5 kts , Temperature: 17°C, Visibility: >10 km, Cloud base: Nil, Cloud cover: Nil ,				
Number of people on board	2 + 13	No. of people injured	0	No. of people killed	0

AIRCRAFT ACCIDENT REPORT

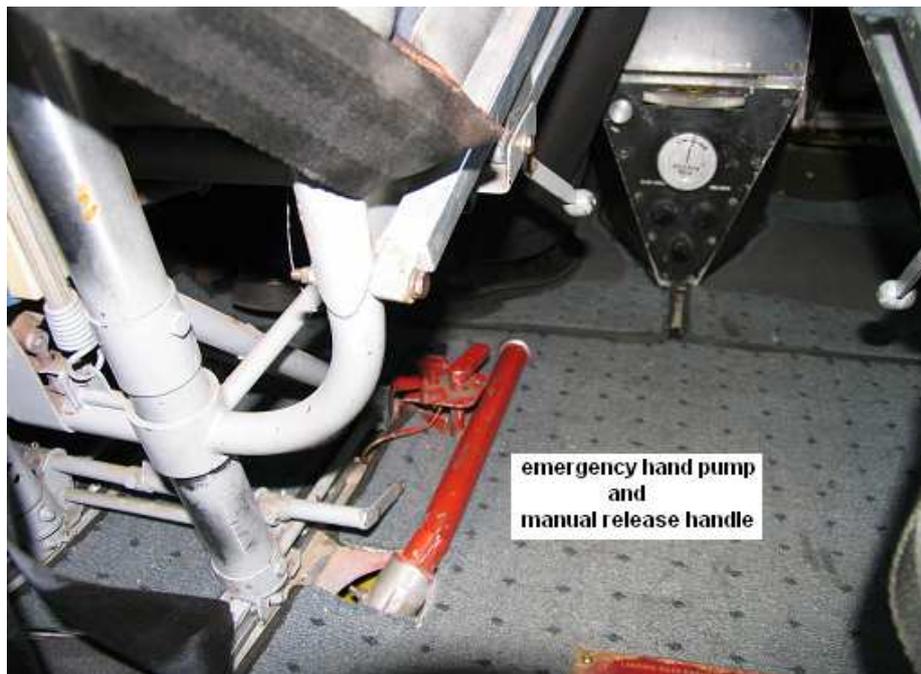
Figure 9 shows the emergency landing gear extension system.

- (iv) *In cases where a problem occurs with the landing gear not extending, an emergency hand pump and manual release system is provided. The manual release handle is located on the cockpit floor on the left hand side of the co-pilot seat.*

- (v) *The operation of the manual release handle releases the landing gear up locks and, with the same action, opens a bypass valve in the power pack. Opening the bypass valve allows fluid to return to the reservoir and bypasses the filter and the selector valve. The manual release system must be actuated prior to hand pump operation. During hand pump operation, fluid is directed to one actuator for each gear. The pressure produced by the hand pump in the system will cause that the gear extend. The manual release system will also permit free fall operation of the gear in the event all hydraulic fluid is lost.*
