<p>Permanent office of investigations of aviation Accidents/Incidents</p>	<p>FINAL REPORT OF TECHNICAL INVESTIGATION ON THE ACCIDENT OF THE CRJ-100 PLANE, REGISTER 4L-GAE</p>	<p>Page 1</p>
---	---	-----------------

**INVESTIGATION REPORT OF ACCIDENT
INVOLVING GEORGIAN AIRWAYS AIRCRAFT
CRJ-100ER (4L-GAE)
AT KINSHASA'S N'DJILI AIRPORT
DEMOCRATIC REPUBLIC OF CONGO (DRC)
ON 04 APRIL 2011**

Investigation report of accident involving Georgian Airways CRJ-100ER (4L-GAE), which occurred at Kinshasa's N'DJILI Airport, Democratic Republic of Congo (DRC) on 04 April 2011.

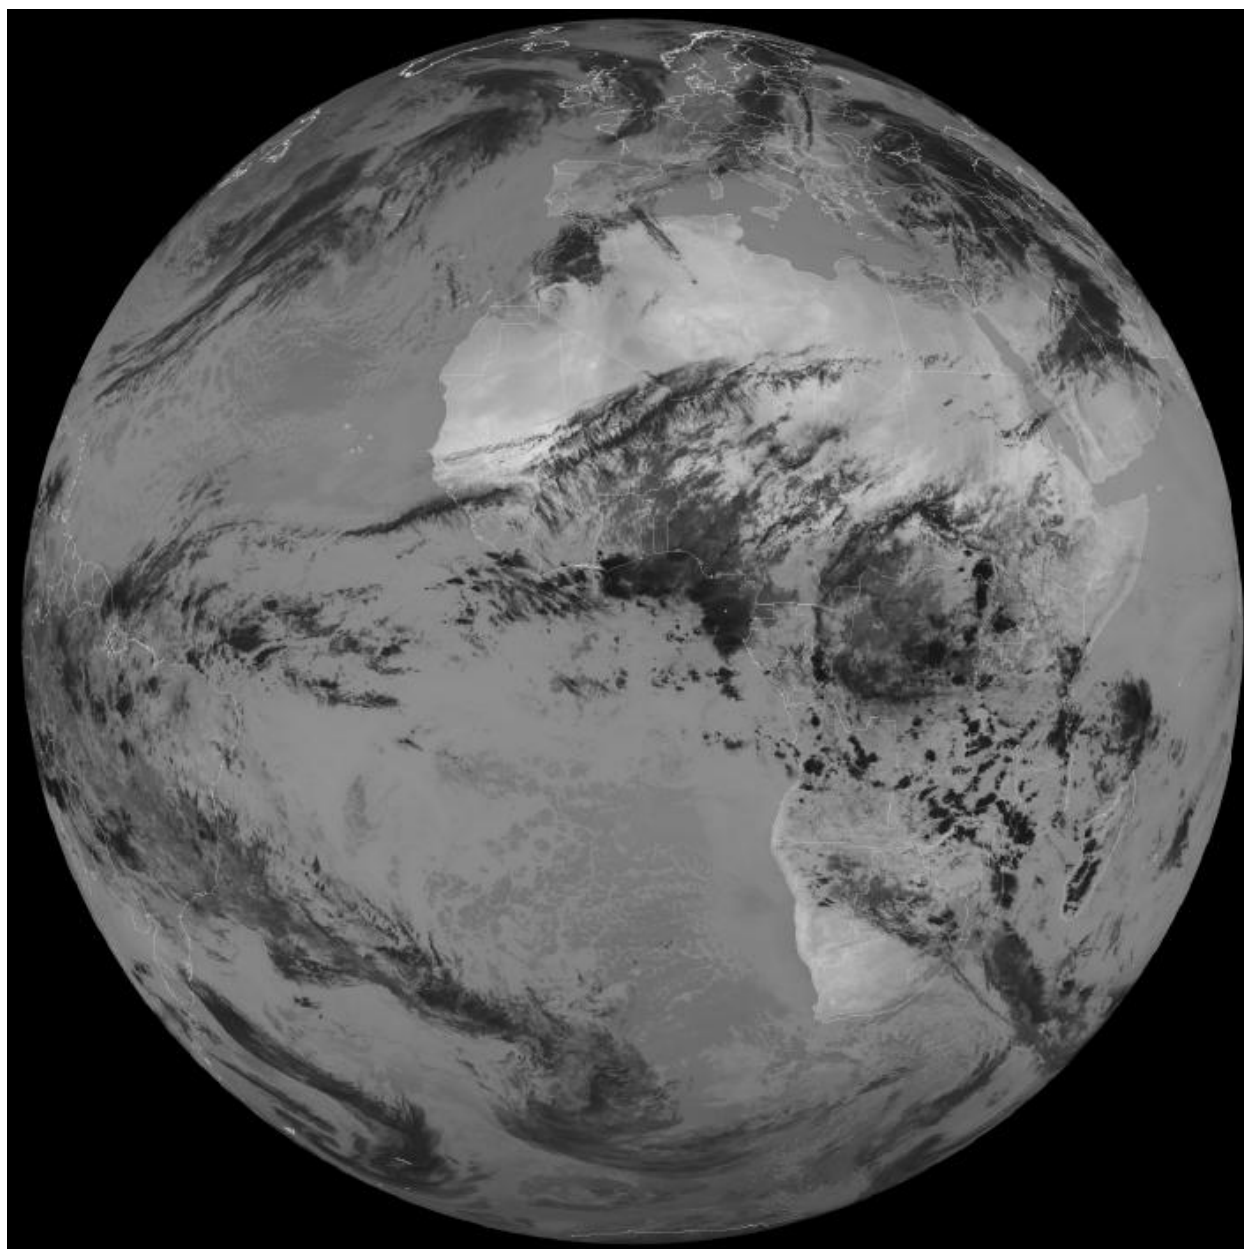
EUMETSAT Infra-Red images used to analyze weather over Kinshasa on 04/04/2011:

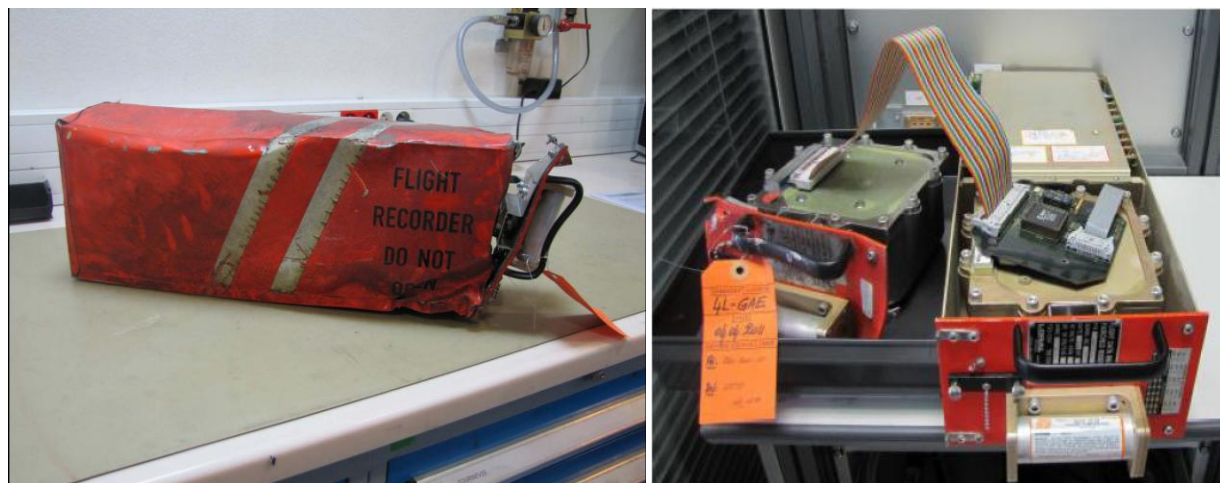
The aircraft was equipped with a Fairchild F1000 Flight Data Recorder and a L3 Com A200S Cockpit Voice Recorder. The recorders were deciphered at Bureau d' Enquetes et d'Analyses (BEA) at Paris in May 2011. Flight Data Recorder had suffered damage during the accident and direct download of data was not possible. BEA used alternate procedures to download data from the FDR. The data was later transferred electronically to Transportation Safety Board, Canada which took the lead in analysis of data,

The FDR was able to provide good information about the sequence of events leading up to the accident. Downloaded Data indicated that all aircraft systems were functioning normally and no technical failures were recorded during the flight.

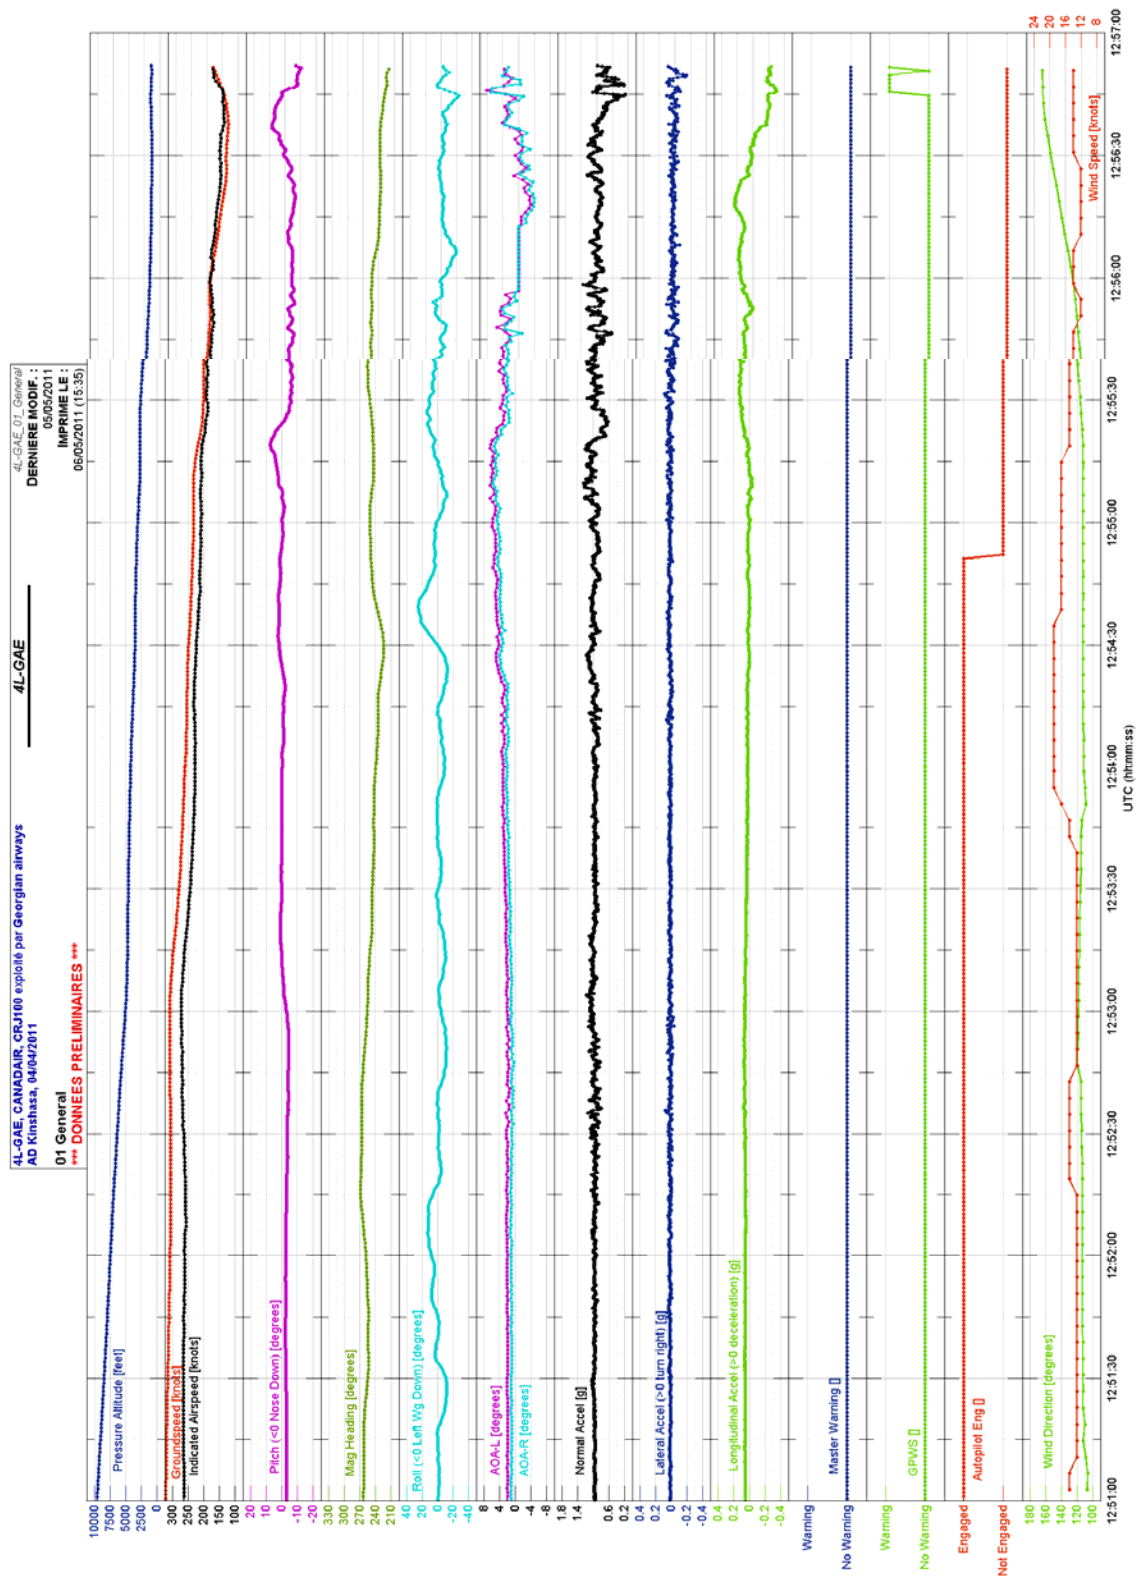
FDR READOUT

At 1256 45, the co-pilot could be heard exclaiming in an abusive/graphic slang (at this stage, FDR data indicates that the aircraft was affected by the severe weather phenomenon which caused the aircraft to pitch down in a short time).
