# Aircraft Serious Incident Report

**In-Flight Engine Shutdown**

**A330-300, HL7553**

**26 May 2011**

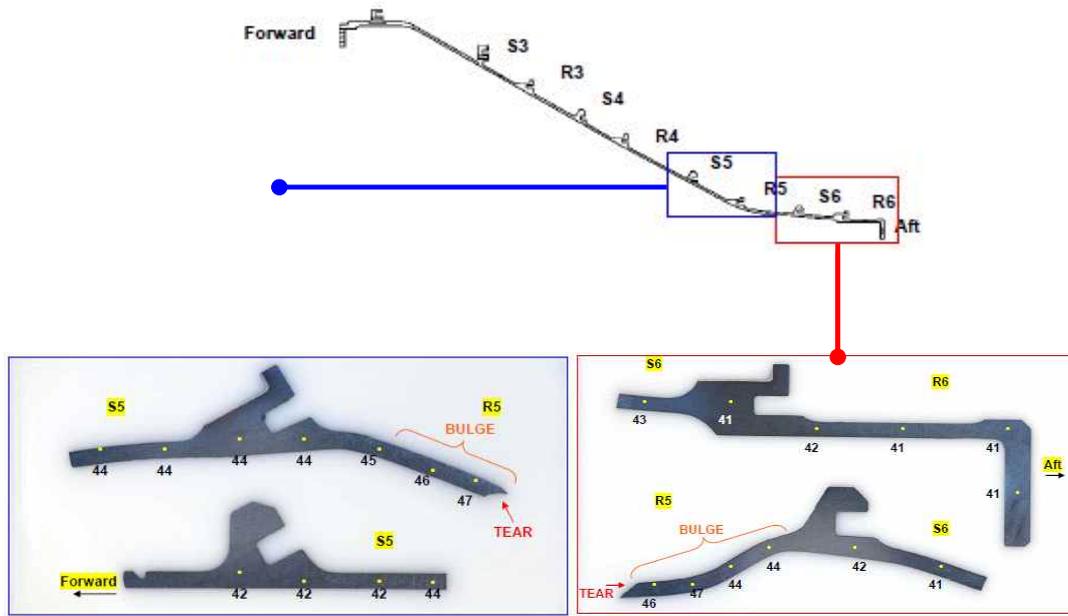
[Figure 36] Hardness Values of the LPT Case (No.: HRC Value)

As shown in [Figure 36], hardness measurement of the 5th- and 6th-stages of the LPT case, and the aft flange revealed that it ranged between 41 - 47 HRC, which met the AMS 5707 specification requirement<sup>27)</sup>. Hardness was at the higher end of the range within the bulge, which was, however, within the allowable range.
