COMMAND OF AERONAUTICS
AERONAUTICAL ACCIDENT INVESTIGATION AND
PREVENTION CENTER

FINAL REPORT
A - Nº 019/CENIPA/2013

OCCURRENCE: ACCIDENT
AIRCRAFT: PR-NOB
MODEL: L410
DATE: 13 JULY 2011

This is the Final Report of the 13 July 2011 accident involving the model L410 aircraft, registration PR-NOB. The accident was classified as inflight engine failure.

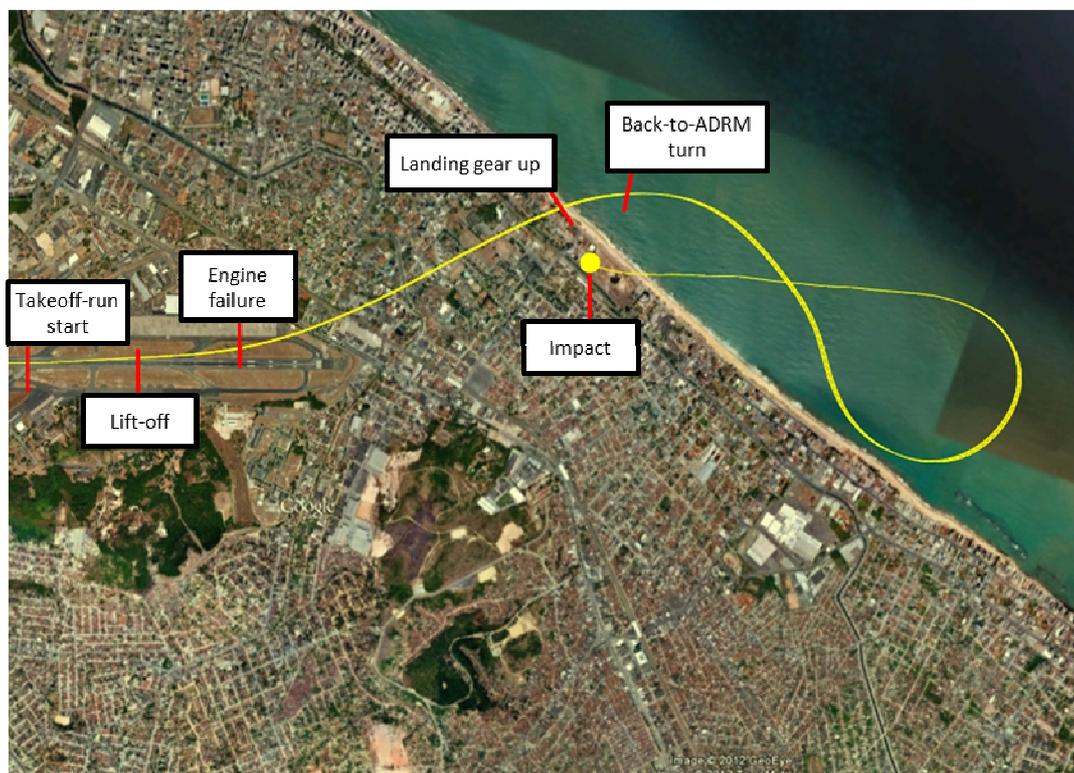
Figure 1 - Profile of the flight trajectory according to the flight data recorder.

The aircraft made a deviation to the left, out of the trajectory, passed over the coastline, and, then, at an altitude of approximately 400ft, started a turn to the right over the sea (Figure 1).

After about 90° of turn, upon getting close to the coast line, the aircraft reverted the turn to the left, going farther away from the coast line.

After a turn of approximately 270°, it leveled the wings and headed for the airport area. The copilot informed, while the aircraft was still over the sea, that they would make an emergency landing on the beach.

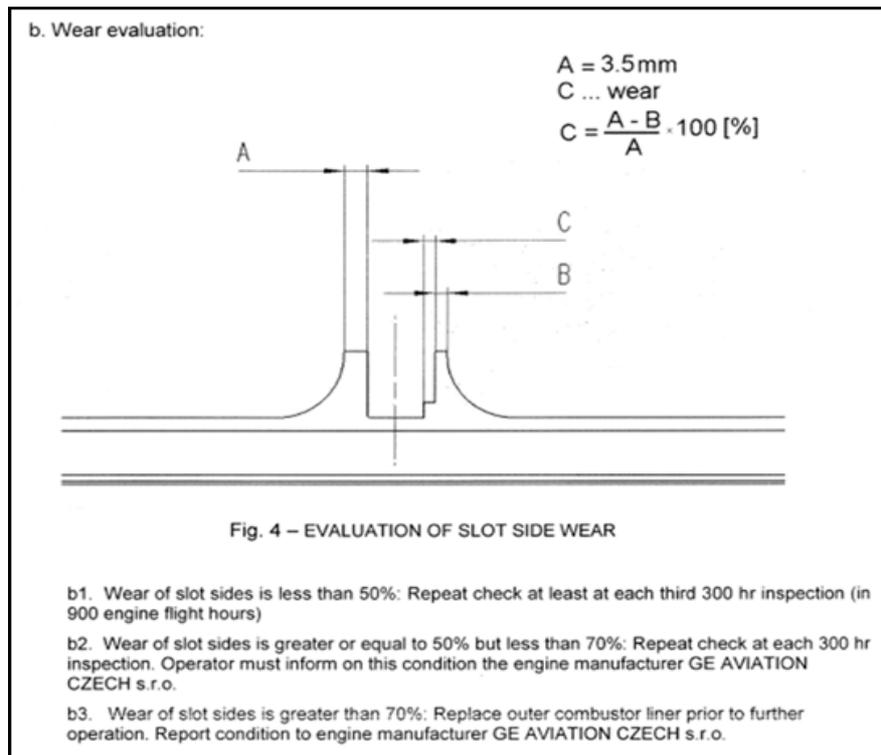
Figure 2 - Service Bulletin M601E/40R-1.

The bulletin contained manufacturer's instructions concerning the execution of a boroscopic exam during the inspection of 300 hours, as well as the actions that had to be taken according to the test results (Figure 2), namely:

- Wear less than 50% - repeat boroscopic exam at least in the third subsequent inspection of 300 hours, i.e., a maximum 900 flight hours after the last boroscopic exam;
- Wear greater than or equal to 50% but less than 70% - repeat verification at every inspection of 300 hours, reporting the fact to the engine manufacturer, and
- Wear greater than 70% - replace the combustion chamber support before the next operation of the aircraft, reporting the fact to the engine manufacturer.

Upon compliance with the service bulletin, the maintenance personnel found it necessary to change both PR-NOA engines, with approximately one year of operation, and a TBO below 3,000 hours, on account of internal wear of the combustion chamber support, and also on account of corrosion at high temperatures in the engine hot section.

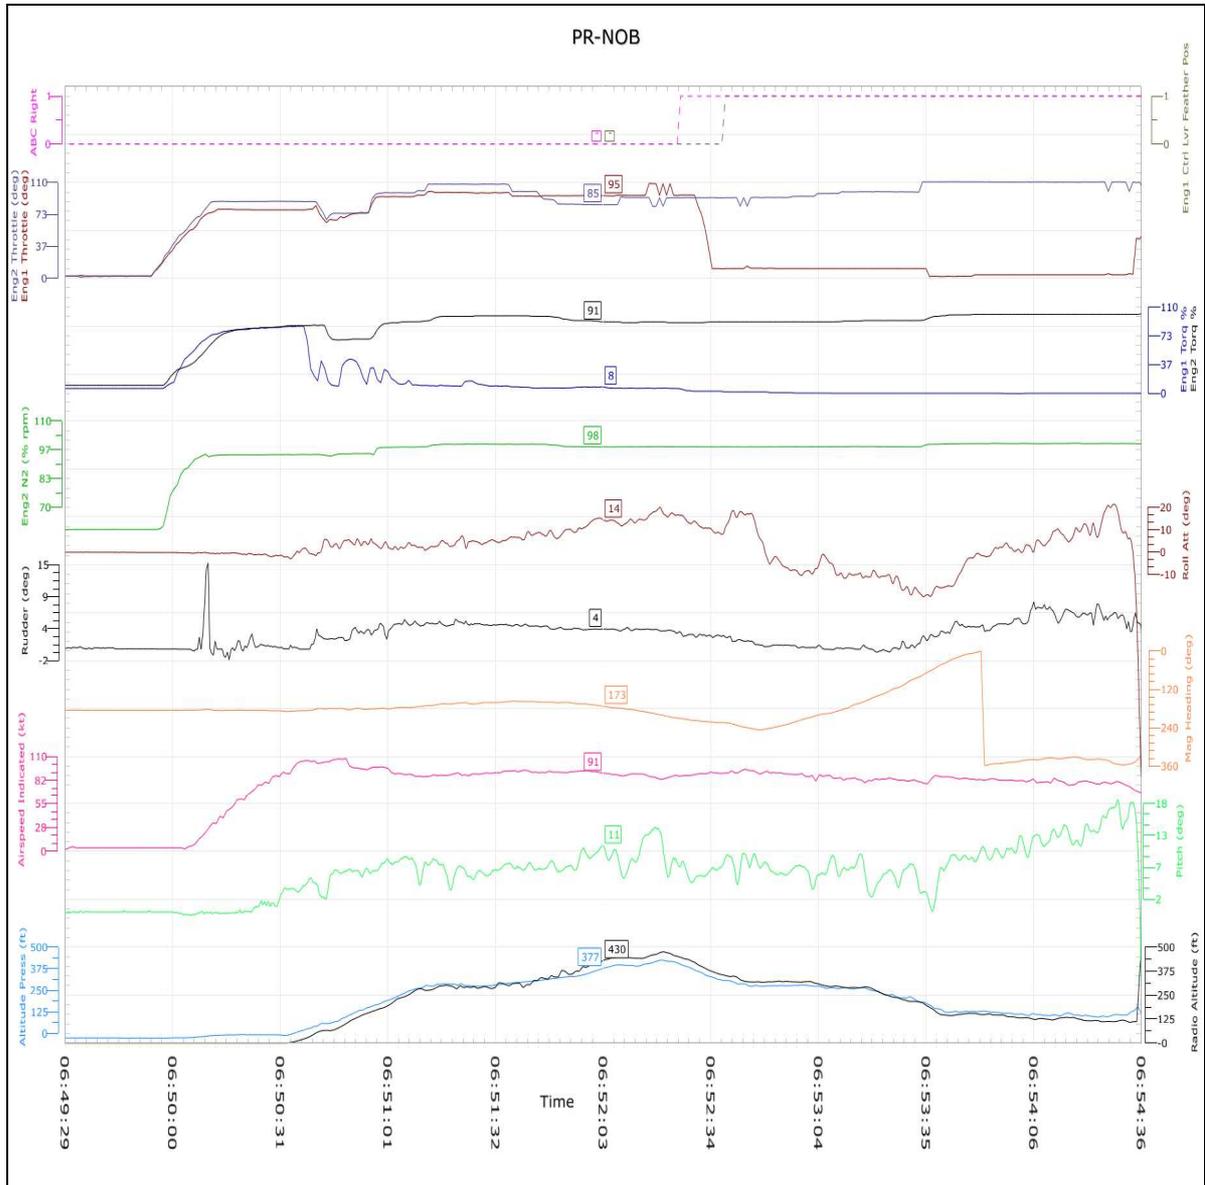
Figure 8 – Flight 4896.

The graphs below show the main parameters for the aircraft performance evaluation.

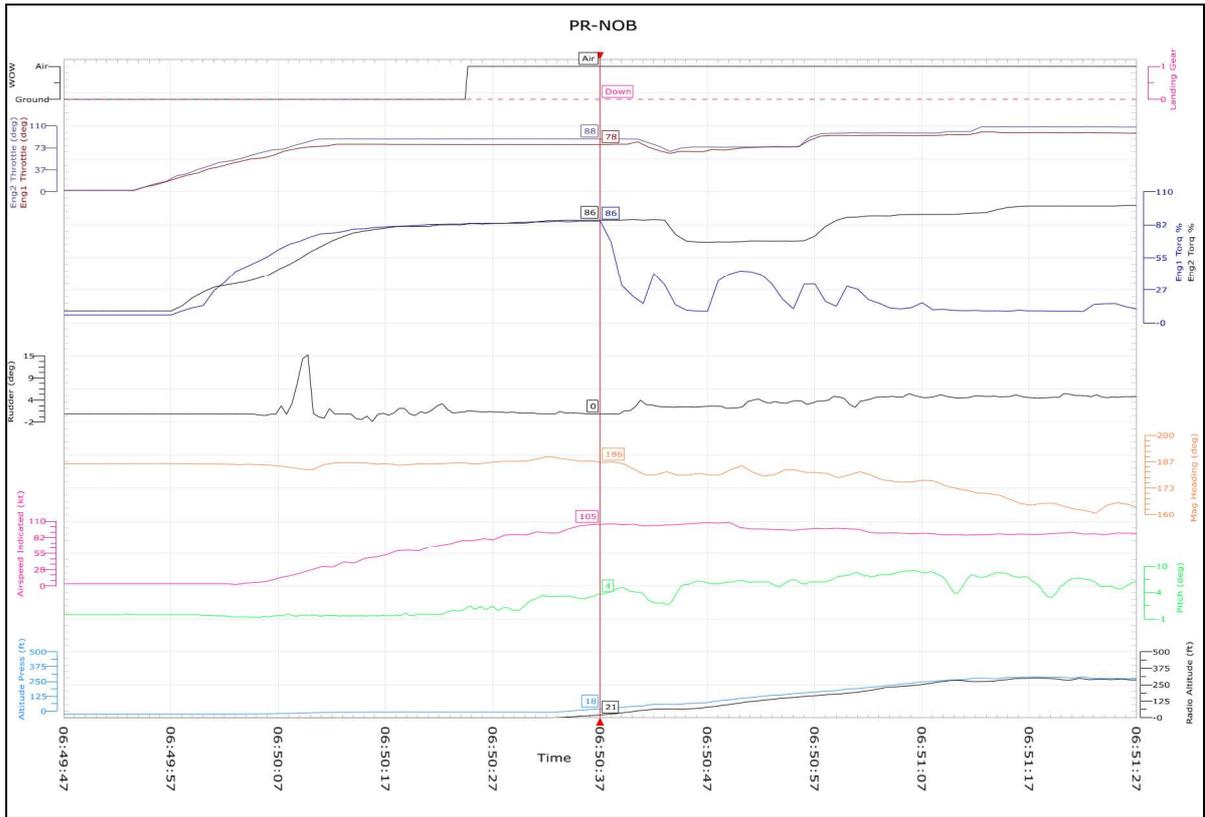
Figure 9 – The moment of the left engine failure.

When the aircraft got airborne during the takeoff, the left engine failed. The crew proceeded on a single engine departure. In the attempt to return for landing, an inflight loss of control occurred, and the aircraft crashed into the ground.

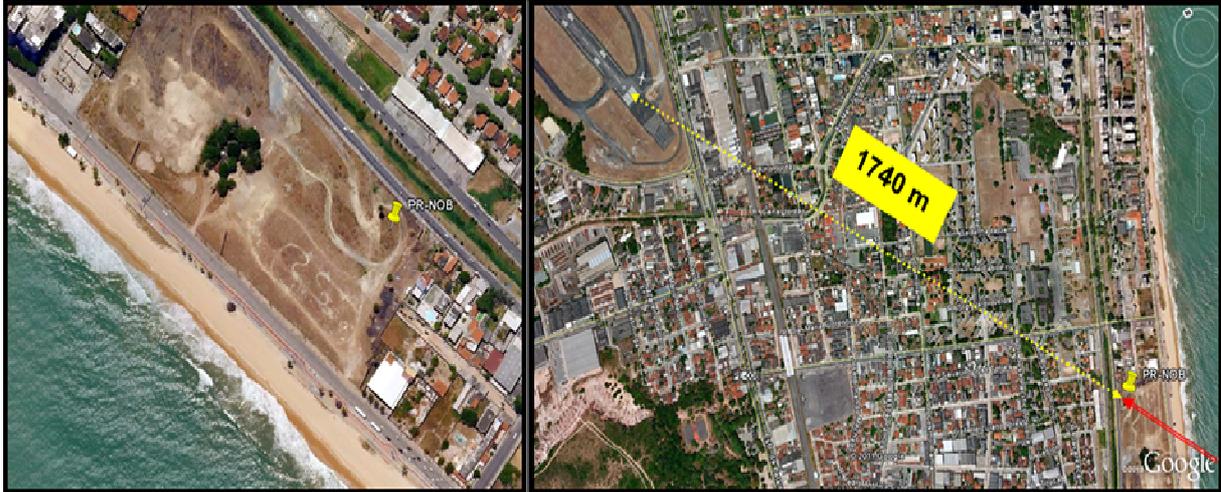
Figure 18 – Aerial view of the point of impact, and its position in relation to runway 36.

The aircraft crashed in an area without buildings, between the avenues of Boa Viagem and Visconde de Jequitinhonha, at the coordinates 08°09'08" S and 034°54'34" W, at a distance of 1,740m from the runway 36 threshold (Figure 18). There was a raging post-impact fire, and the aircraft was completely destroyed.

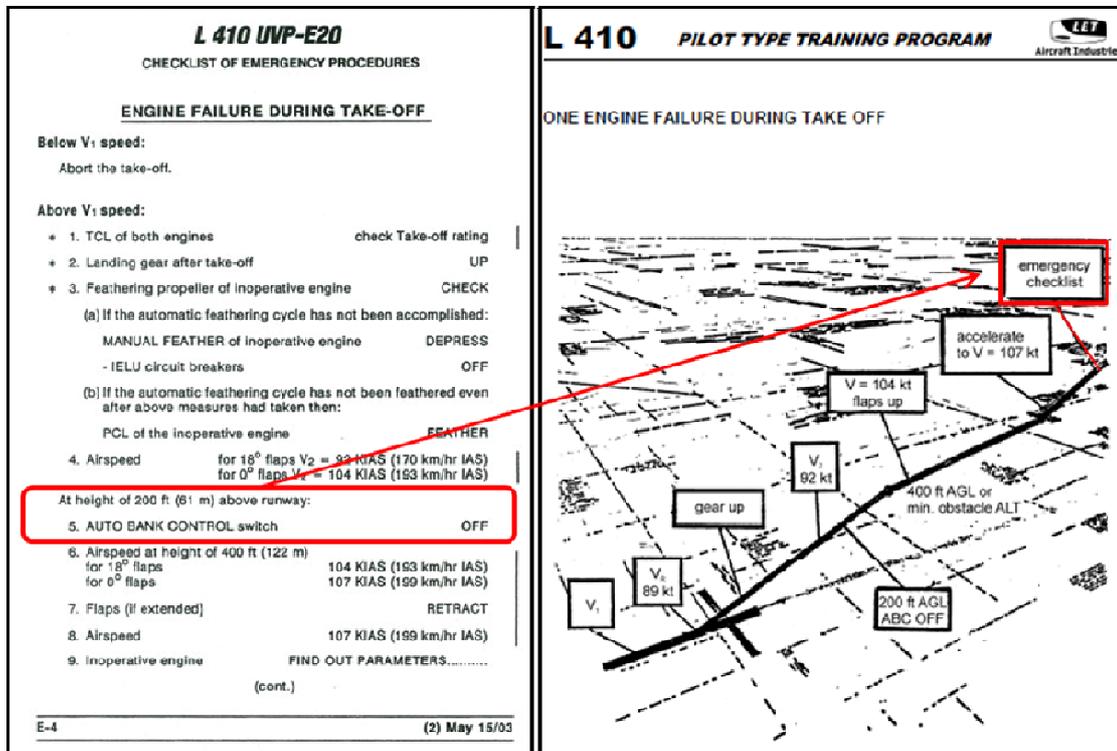
Figure 36 – Conflict between the checklist and the Training Program.

- d) On page E-4, the checklist shows the item 5 (“AUTO BANK CONTROL switch OFF”) to be implemented at 200ft above the runway, without marking it with an asterisk (therefore, not treating it as vital/urgent). The manufacturer’s Training Program, in turn, when presenting the single-engine takeoff flight profile (Figure 36), establishes the reading and compliance with the checklist only after the speed of 107 kt is reached, with the aircraft above 400ft AGL; and

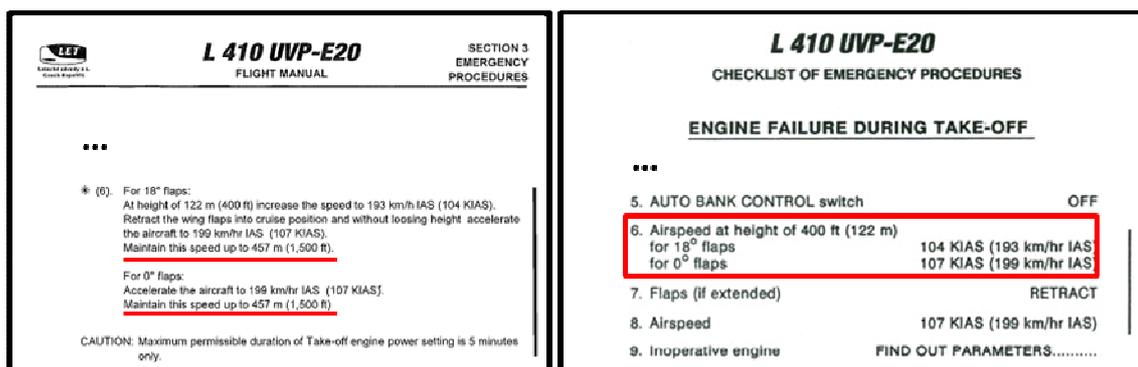
Figure 37 – Altitude of 1,500ft is not indicated for the speed of 107kt.

- e) On page 15, the AFM indicates a climb up to 1,500ft, maintaining 107 KIAS, while on page E-4 of the checklist there is not any reference to 1,500ft (Figure 37).

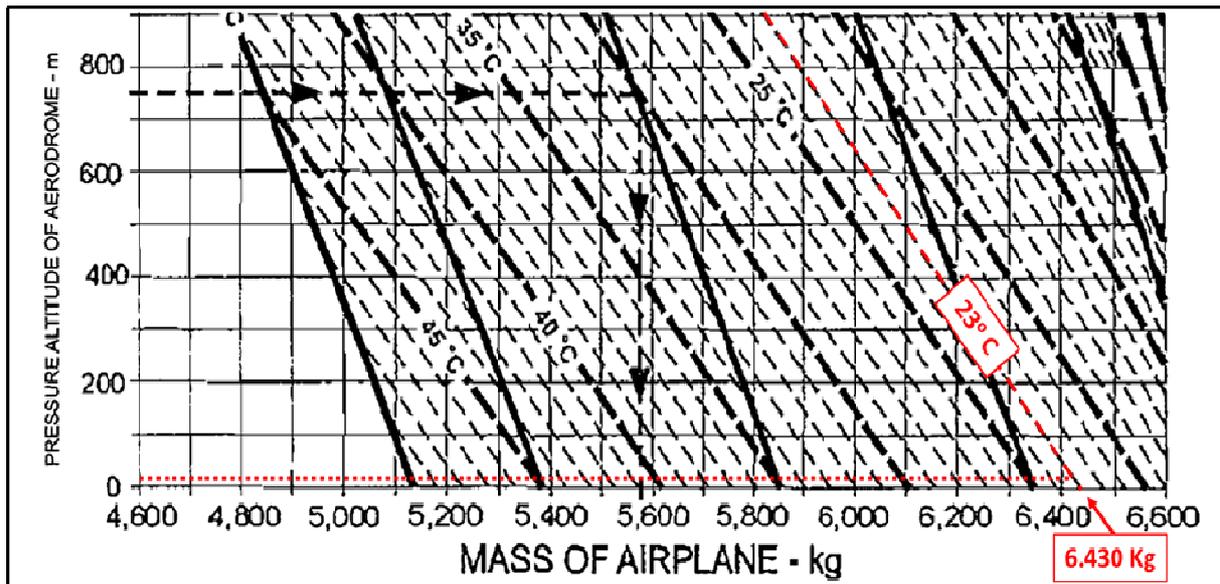
Figure 39 – Maximum takeoff weight according to the AFM graph, page 12a, figure 5-6a.

The calculation made from the graph of the figure 5-6a, page 12 of the AFM, Section 5 (Figure 39), indicated a maximum takeoff weight of 6,430 Kg for the second segment.

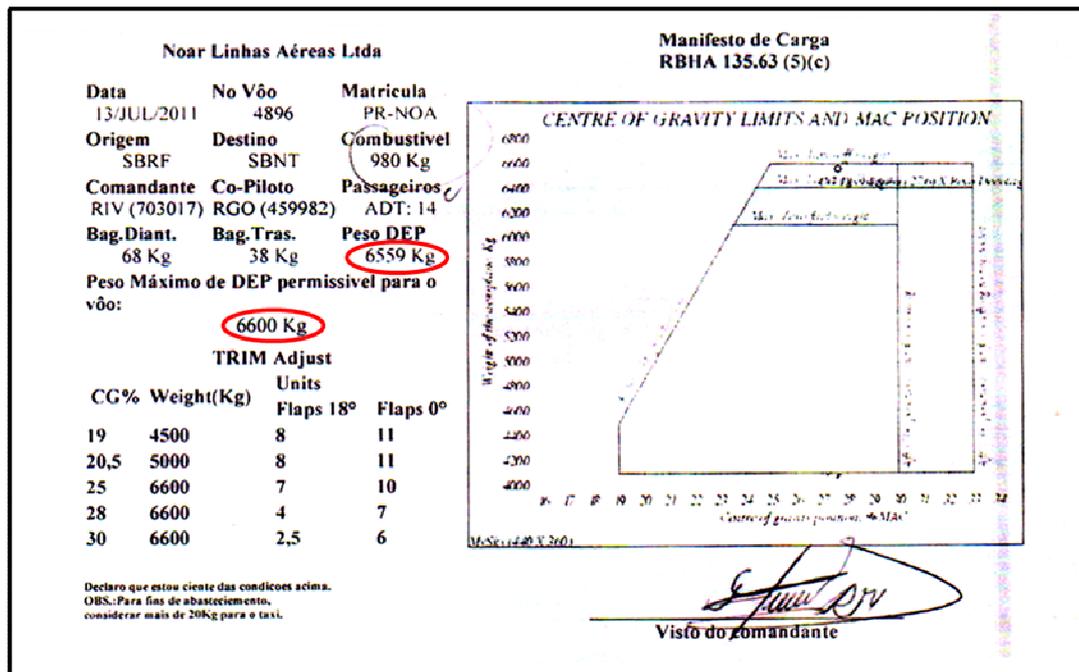
Figure 42 – Cargo Manifest of the NOAR Flight 4896, 13 July 2011.

Therefore, in the environment conditions observed at the takeoff time, the maximum takeoff weight for Flight 4896 was 6,430Kg.

According to the aircraft cargo manifest dispatch (Figure 42), the maximum takeoff weight allowable to the flight was presented as 6,600Kg, therefore 170Kg above the one calculated by means of the AFM tables. The takeoff weight written in the cargo manifest was 6,559Kg.

Although the registration PR-NOA had been written in the cargo manifest, it was in fact used for the dispatch of the PR-NOB, since there had been a change of aircraft in relation to the initial programming.

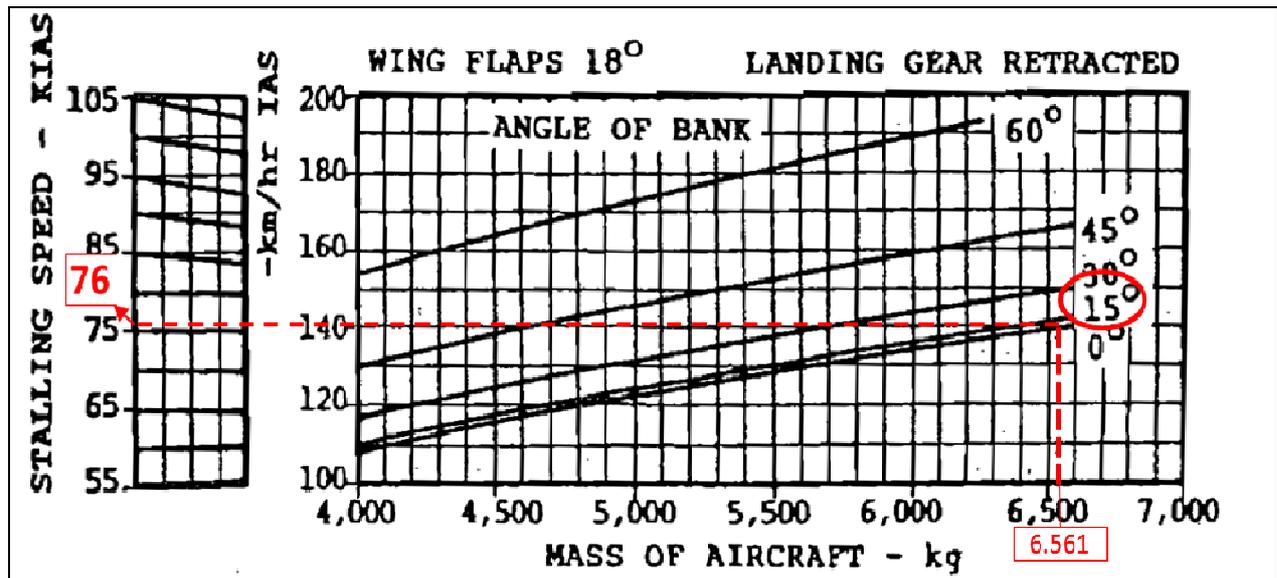
Figure 45 – Calculation of the stall speed (AFM, Section 5, page 7).

For the condition of weight, (approximately 6,561Kg), with flaps at 18° and an inclination of about 15°, the stall speed is around 76 KIAS (Figure 45). If the weight of 6,502,9kg (after deduction of anti-ice and catering service weights) is considered, the stall speed would be around 75 KIAS.

For that weight condition (approximately 6,561Kg), with flaps at 18°, and a banking of about 15°, the stall speed is approximately 76KIAS (Figure 45). If one considers the weight of 6,502.9Kg, after subtracting the anti-ice and catering service weight values, the stall speed would be around 75KIAS.
