# Aircraft Accident Report

**Crash Into The Sea After An In-Flight Fire**

**Boeing 747-400F, HL7604**

**28 July 2011**

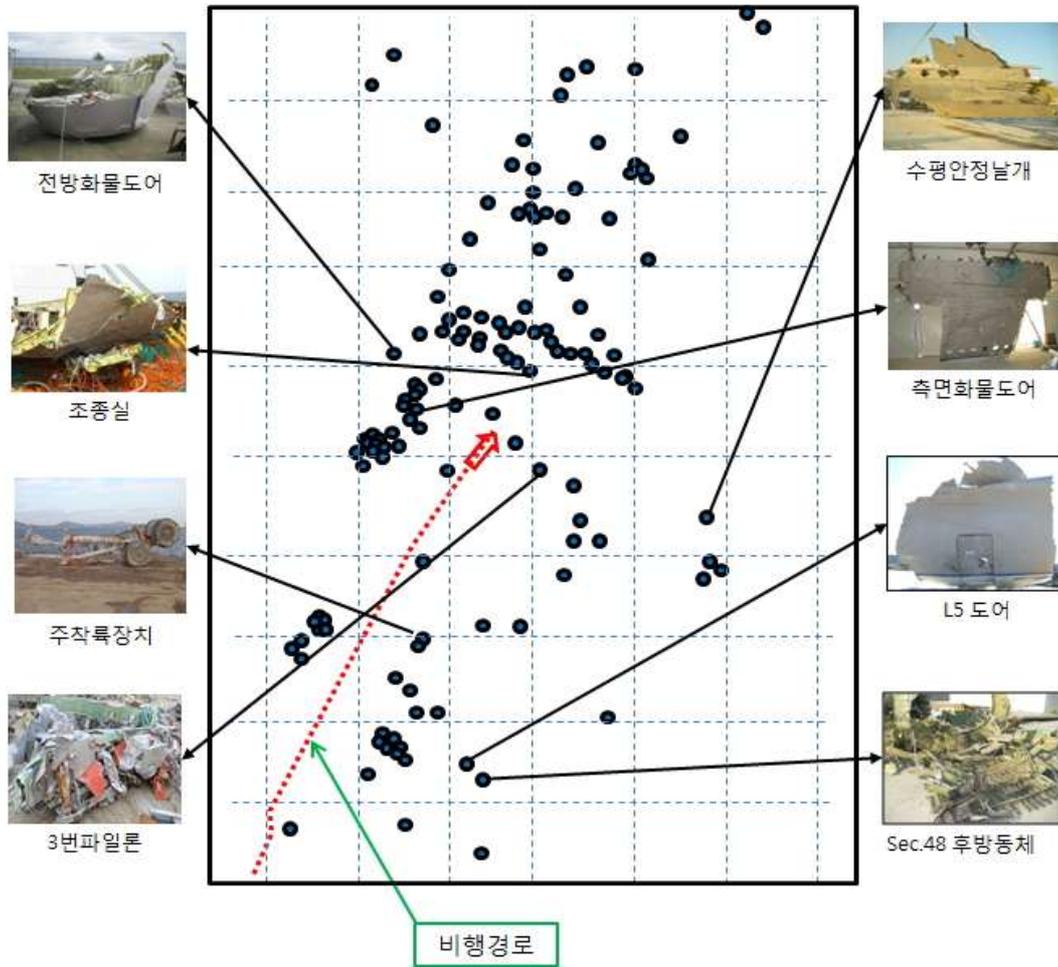
[Figure 14] Wreckage Distribution Map

As shown in [Figure 14], the wreckage of AAR991 was distributed in the underwater area 3 km by 4 km, 130 km west of Jeju Airport, in southwest-northeast direction. The black dots in [Figure 14] indicate recovery points of the main pieces of the wreckage.

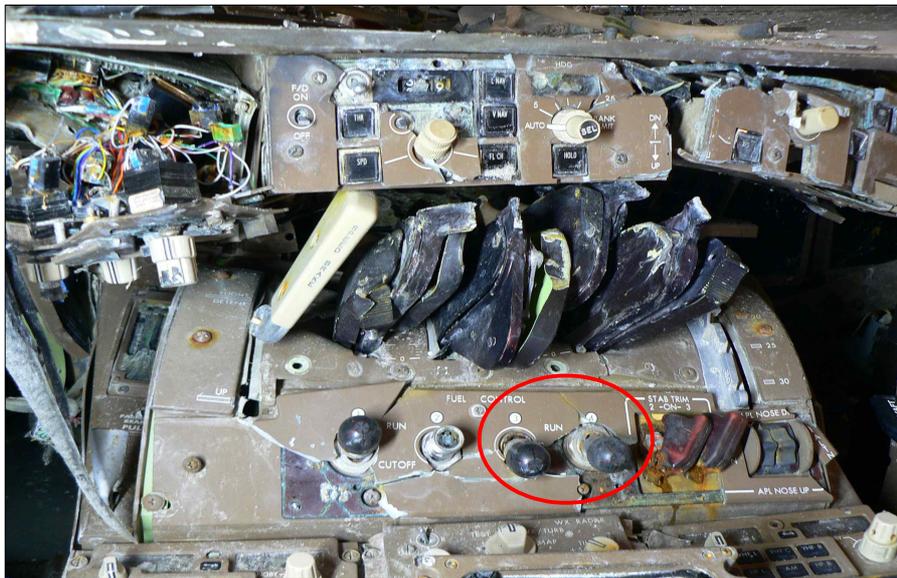
[Figure 18] Cockpit (Throttle Quadrant, Fuel Cutoff Switches, & Others)

The upper section of the cockpit was extensively pressure formed by direct impact of water, which caused the throttle quadrant, switches, and many levers to sustain mechanical damage.

As shown in [Figure 18], fuel cutoff switches No. 1 and 2 were in the ON position, whereas No. 3 and 4 in the OFF position, but under magnification, it was confirmed that No. 3 and 4 moved to the OFF position due to impact forces.

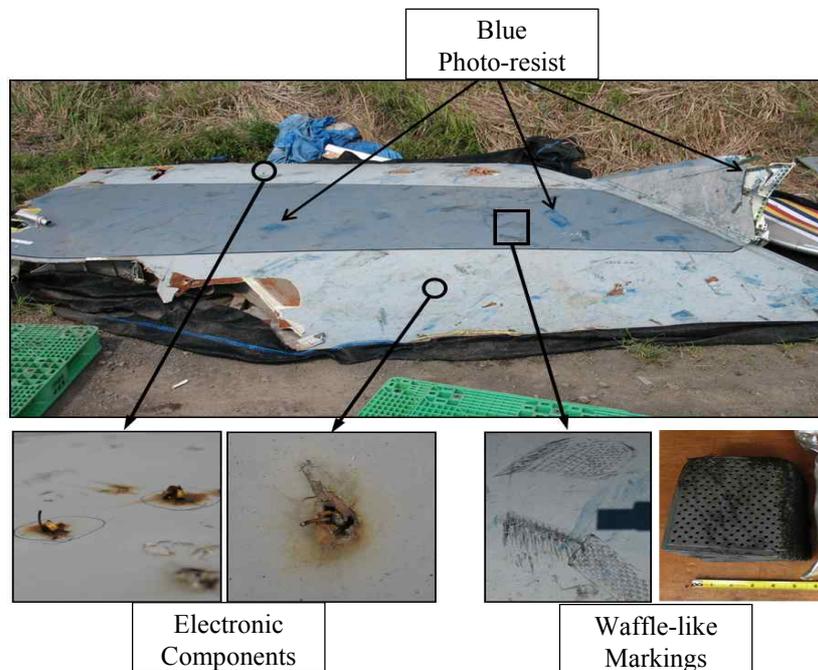
[Figure 20] Damaged Right Wing Tip

As shown in [Figure 20], blue photo-resist was found on the top surface of the right wing. The top surface of the wing contained multiple black waffle-like markings caused by collisions with electronic components containers<sup>48)</sup> loaded in position MR, and about 120 electronic components with a diameter of 5 mm, a thickness of 1.2 mm, and a weight of 0.3 g were imbedded in the composite wing upper surfaces.

The forward facing surface of the fuel jettison tube as well as the inside surface of a skin fragment in the right wing fracture at WS1516 also contained black waffle-like markings. No indications of hydro forming were found on the top and bottom surface of the wing.

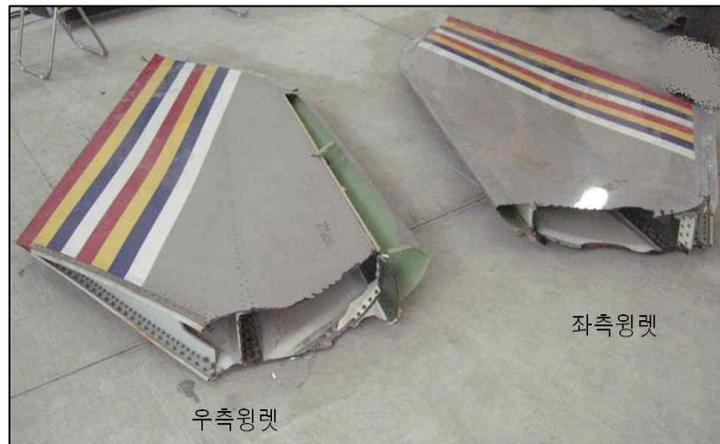
[Figure 21] Winglets

As shown in [Figure 21], the left and right winglets<sup>49)</sup> were separated from the wings, and their fracture areas sustained damage consistent with overspeed. Blue photo-resist was discovered inside the right winglet fracture area, but no black waffle-like markings or blue photo-resist stains were found on the right winglet, the surface of which was relatively in good condition, with no damage by electronic components.

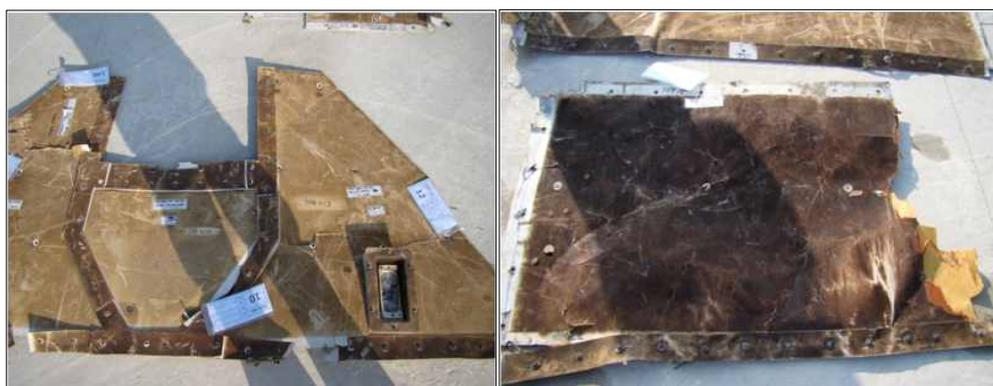
[Figure 36] Panels Near (Left) & Aft (Right) of FS360

As shown in [Figure 36], portions of the ceiling panels belonging to the area under the flight deck had a layer of soot adhering to the surface. Ceiling panels aft of FS360 were also sooted and had a darker appearance.

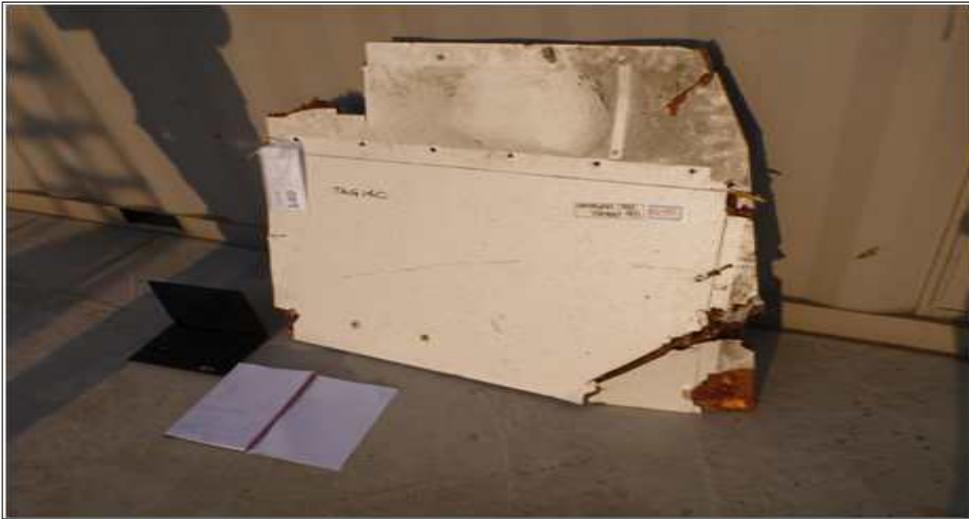
[Figure 37] Upper Deck Interior Panel with the Area of Sooting

As shown in [Figure 37], the upper deck interior panel, part of the lavatory module wall where emergency equipment is installed, exhibited soot accumulation.

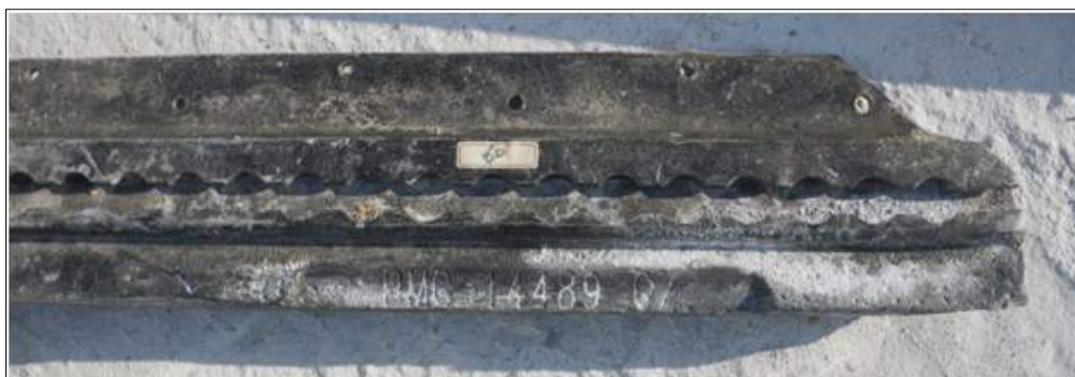
[Figure 39] Pallet Edge Rail

There was no fire damage or sooting in the container wreckage located at 44L and 43L of the lower cargo compartment. Edge rails of cargo pallets were found separated from the pallets, and their levels of fire damage are shown in [Table 8], and the serial number of a certain rail could be confirmed as shown in [Figure 39].

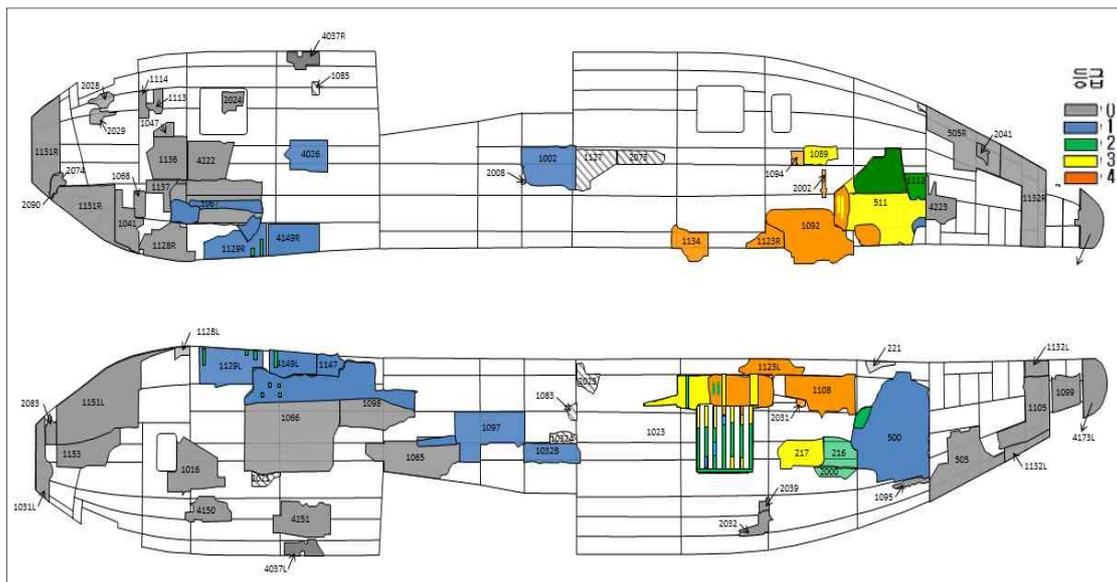
[Figure 40] Thermal Damage Map - Fuselage Frames

Apart from the thermal damage map of the wreckage between FS1700 and APB in [Figure 33], two thermal damage maps at the airplane level - one for the fuselage skin and the other for the fuselage frames - were generated as shown in [Figure 40] and [Figure 41].

Portions of the wreckage forward of FS1700 generally have fire damage consisting of sooting with areas of more severe damage along the upper areas of the aircraft's attic space and crown.

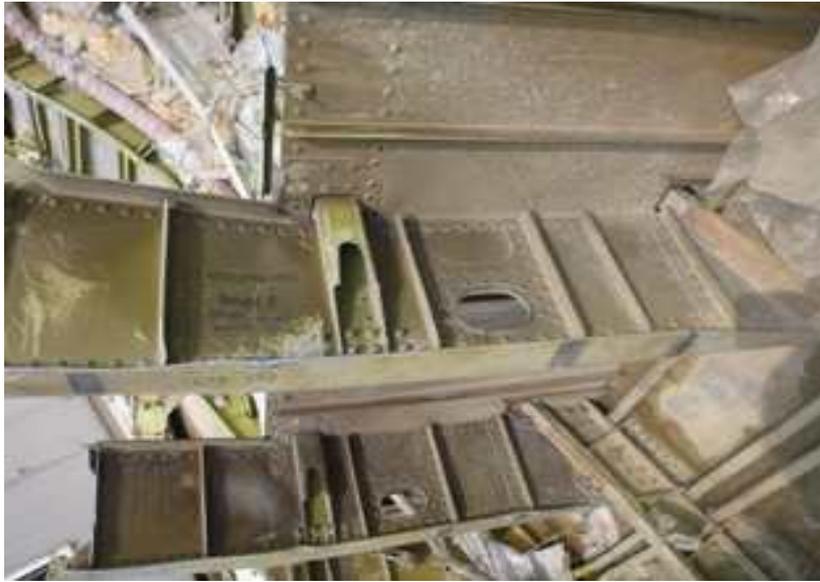
[Figure 43] Upper Deck Floor Beam at FS520

As shown in [Figure 42], among the farthest forward wreckage (FS480 - 700), sooting was found on the fuselage frame at FS500 on the LH side in the area of the main deck cargo compartment. As shown in [Figure 43], sooting was also found on the upper deck floor beams as far forward as FS520.

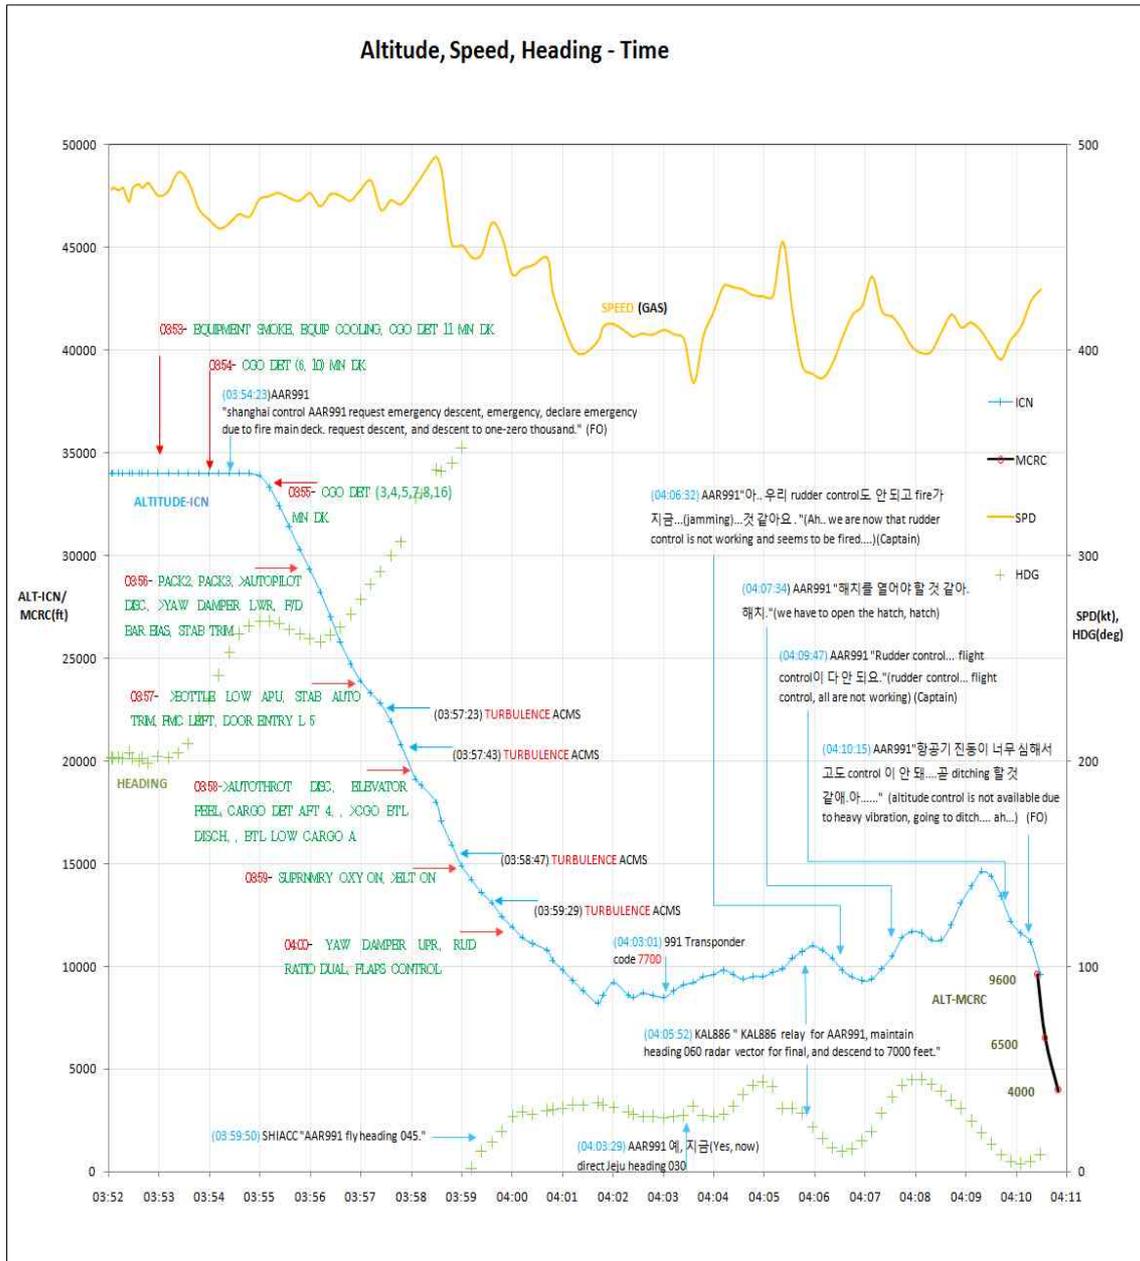
[Figure 62] Vertical Flight Track Including Altitude, Speed & Heading

[Figure 62] shows AAR991's vertical flight track, altitude, speed, heading, and major ATC/pilot communications. The FDE message CGO DET 11 MN DK, which indicates that smoke was detected in zone 11 of the main deck cargo compartment, is transmitted when it is correlated to the CMC fault message.

At 04:00:XX,<sup>111)</sup> AAR991 was descending from 11,900 ft to 9,800 ft. ACARS messages generated at this time indicate a fault with flaps control and rudder control such as upper yaw damper and rudder ratio dual. The messages were not transmitted any more after 04:00:XX.

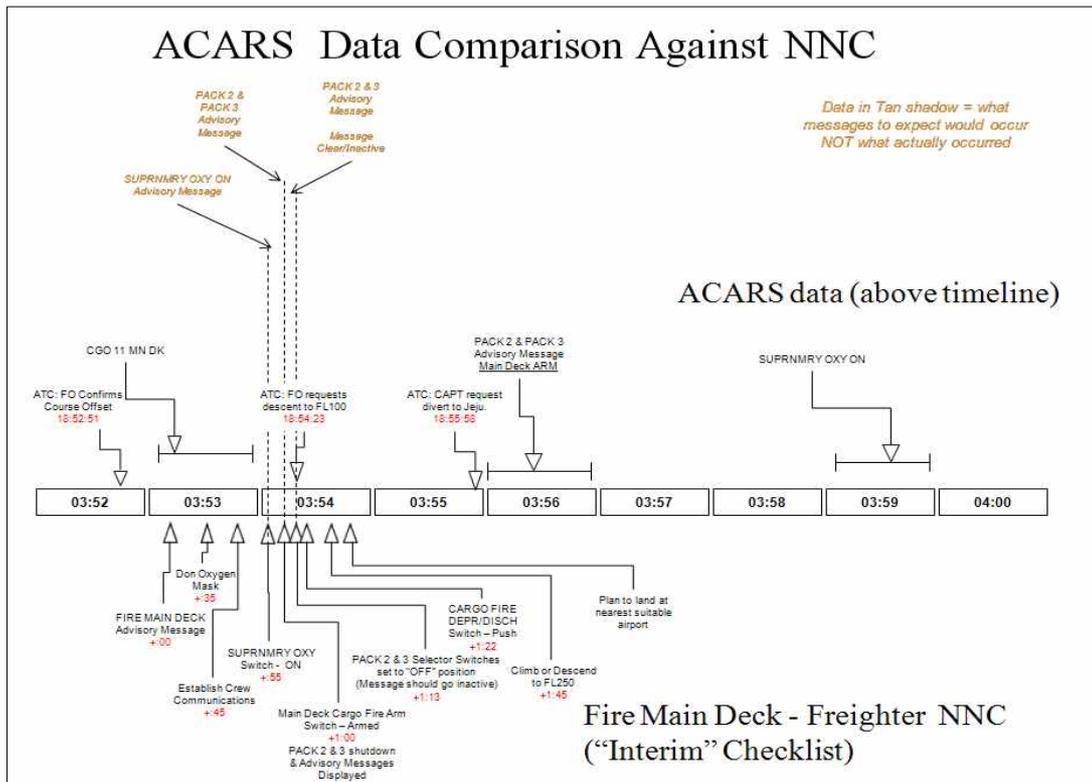
[Figure 65] ACARS Data Comparison Against NNC

Second, a freighter's Fire Main Deck depressurization procedure was delayed. When a main deck cargo fire arm switch is armed, PACK 2 and 3 ACARS messages are generated. At 03:53:XX, CGO DET 11 MN DK ACARS message was generated, followed by PACK 2 and 3 ACARS messages at 03:56:XX.<sup>122)</sup> [Figure 65]<sup>123)</sup> shows that AAR991's PACK 2 and 3 messages were generated

about 2 minutes<sup>124)</sup> later in comparison to Boeing pilots' implementation of the non-normal procedures, which indicates that AAR991's Fire Main Deck depressurization procedure was delayed for about 2 minutes. Step No. 1 of a combi plane's Fire Main Deck non-normal procedures is to "instruct the designated crewmember<sup>125)</sup> to verify the presence of smoke or fire." If the captain<sup>126)</sup> personally verified the presence of fire and continued to implement a combi plane's Fire Main Deck non-normal procedures, the generation of PACK 2 & 3 ACARS messages would be delayed for the time required for fire verification, which explains the time difference of PACK 2 & 3 messages between timeline above and below as shown in [Figure 65].

Meanwhile, AAR991's implementation of depressurization procedures for suppressing a main deck cargo fire was delayed for about 2 (1 - 3) minutes, judging from ACARS messages, PACK 2 & 3 at 03:56:XX and SUPRNMRV OXY ON at 03:59, as shown in [Figure 65].

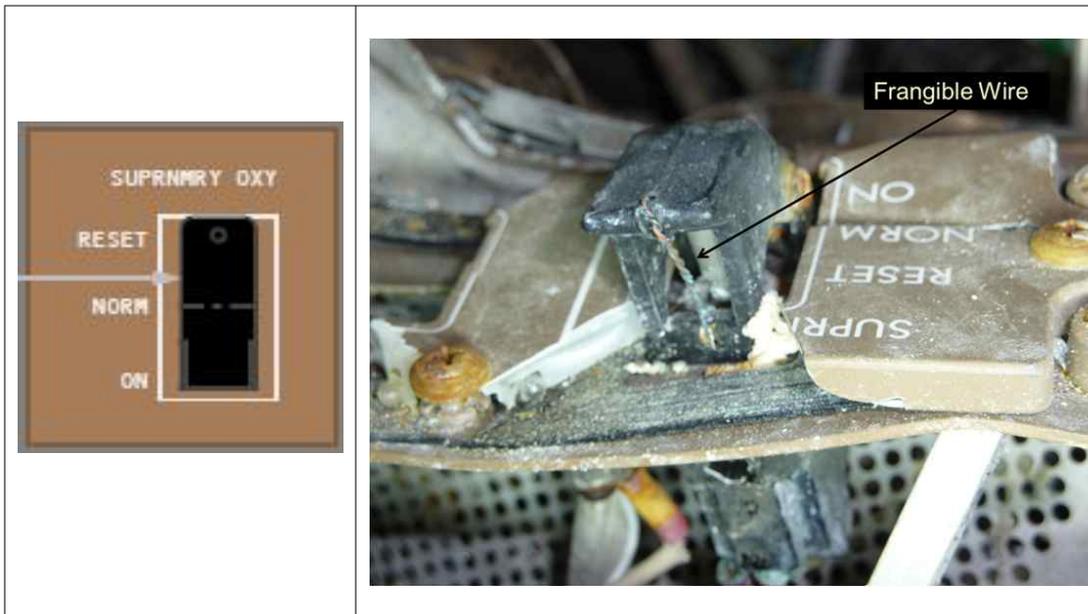
[Figure 66] Supernumerary Oxygen Switch & the Cockpit Wreckage (Right)

Third, as shown in [Figure 66], AAR991's flight crew failed to turn on the supernumerary oxygen switch,<sup>127)</sup> which is specified in non-normal procedures in a freighter's Fire Main Deck checklist, but not in a combi plane's.<sup>128)</sup> Detailed examination<sup>129)</sup> of AAR991's cockpit wreckage revealed that a frangible wire<sup>130)</sup> of the switch guard did not fracture as shown in [Figure 66], and that the supernumerary oxygen switch was in the NORM<sup>131)</sup> position.

130) The supernumerary oxygen switch in the NORM position was covered with the guard connected to a frangible wire that provides protection against careless movement. Therefore, the guard should be open to move the supernumerary oxygen switch to the ON position, which fractures a frangible wire.

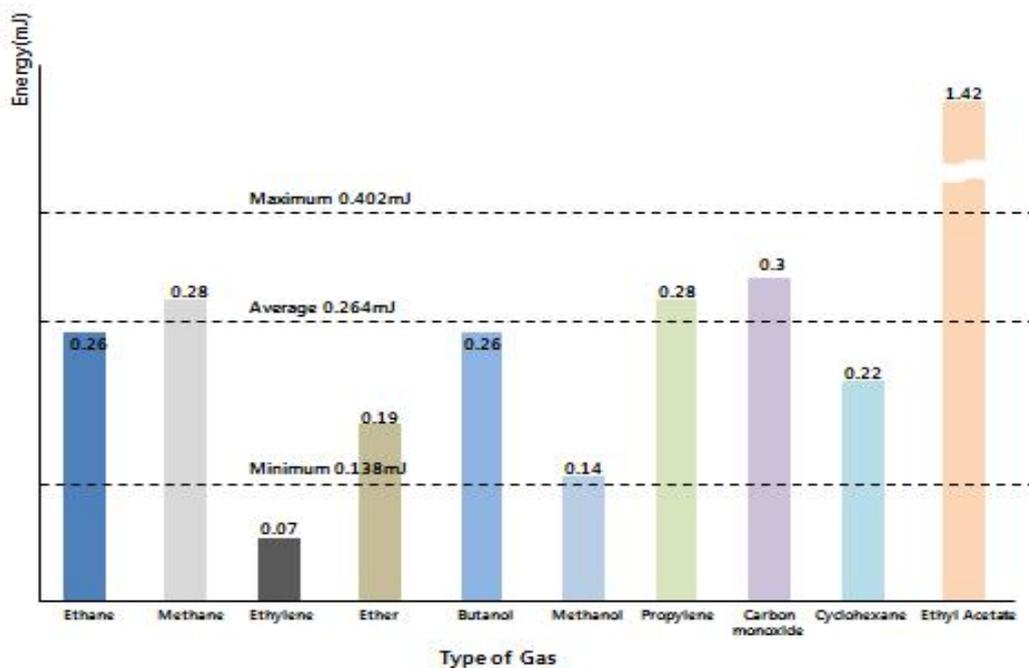
[Figure 69] Comparison of Electrostatic Energy & MIEs

The ARAIB measured the amount of electrostatic energy that could be accumulated in the plastic wrap used for bundling pallet-loads of products together prior to loading since the Board concludes that electrostatic energy could play a role as an ignition source. As shown in [Figure 69] comparing electrostatic energy with the MIEs, the amount of electrostatic energy varied from a minimum 0.138 mJ to a maximum 0.412 mJ, with the average of 0.264 mJ. The plastic wrap was used to fix or protect cargo from rain.

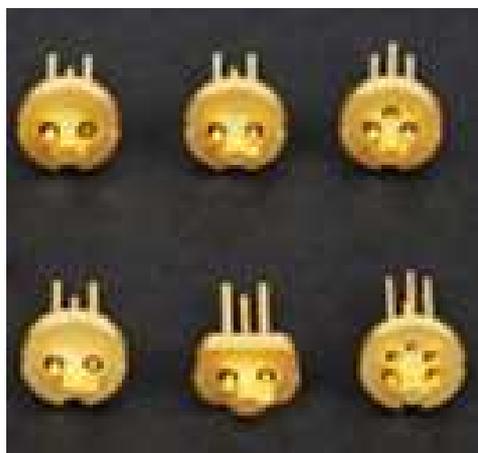
[Figure 70] Glass-to-Metal Seals

Blue photo-resist and paint were found on the top surface of the right wing. The top surface of the wing contained multiple black waffle-like markings caused by collisions with electronic components containers loaded at position MR forward of PR. As shown in [Figure 70], electronic components with a diameter of 5 mm in the containers were imbedded in the composite wing upper surfaces. They, made of metal, are glass-to-metal seals used for photoelectronic materials.

At position PR were loaded dangerous goods such as lithium-ion batteries, flammable liquids, Amines liquid corrosive N.O.S., paint, and blue photo-resist/LCD. At position MR forward of PR were loaded electronic components used as glass-to-metal seals in [Figure 70]. Dangerous goods at position PR were located across the main deck side cargo door, on the RH side of the fuselage.

The ARAIB concludes that powerful "fire energy" was produced to the extent that photo-resist/LCD and paint in position PR splattered on the top surface of the right wing, about 30 meters from PR, and that electronic components in position MR, shown in [Figure 70], were imbedded in the composite wing upper surfaces. The Board also concludes that this energy was generated by fire-induced explosion of flammable materials and lithium-ion batteries.

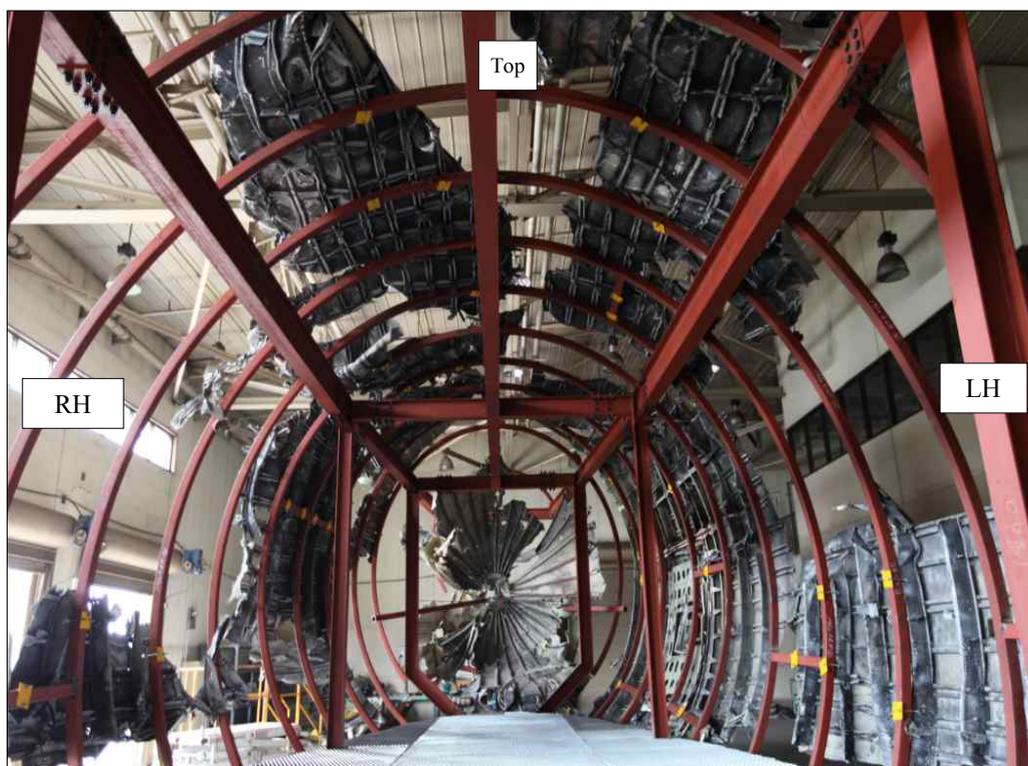
[Figure 71] 3D Wreckage Reconstruction

As shown in [Figure 71], the ARAIB carried out 3D wreckage reconstruction. The aircraft-shaped framework was made between FS1741 and FS2658, about 1/3 the length of the fuselage, and the selected pieces of the wreckage were attached to the framework.

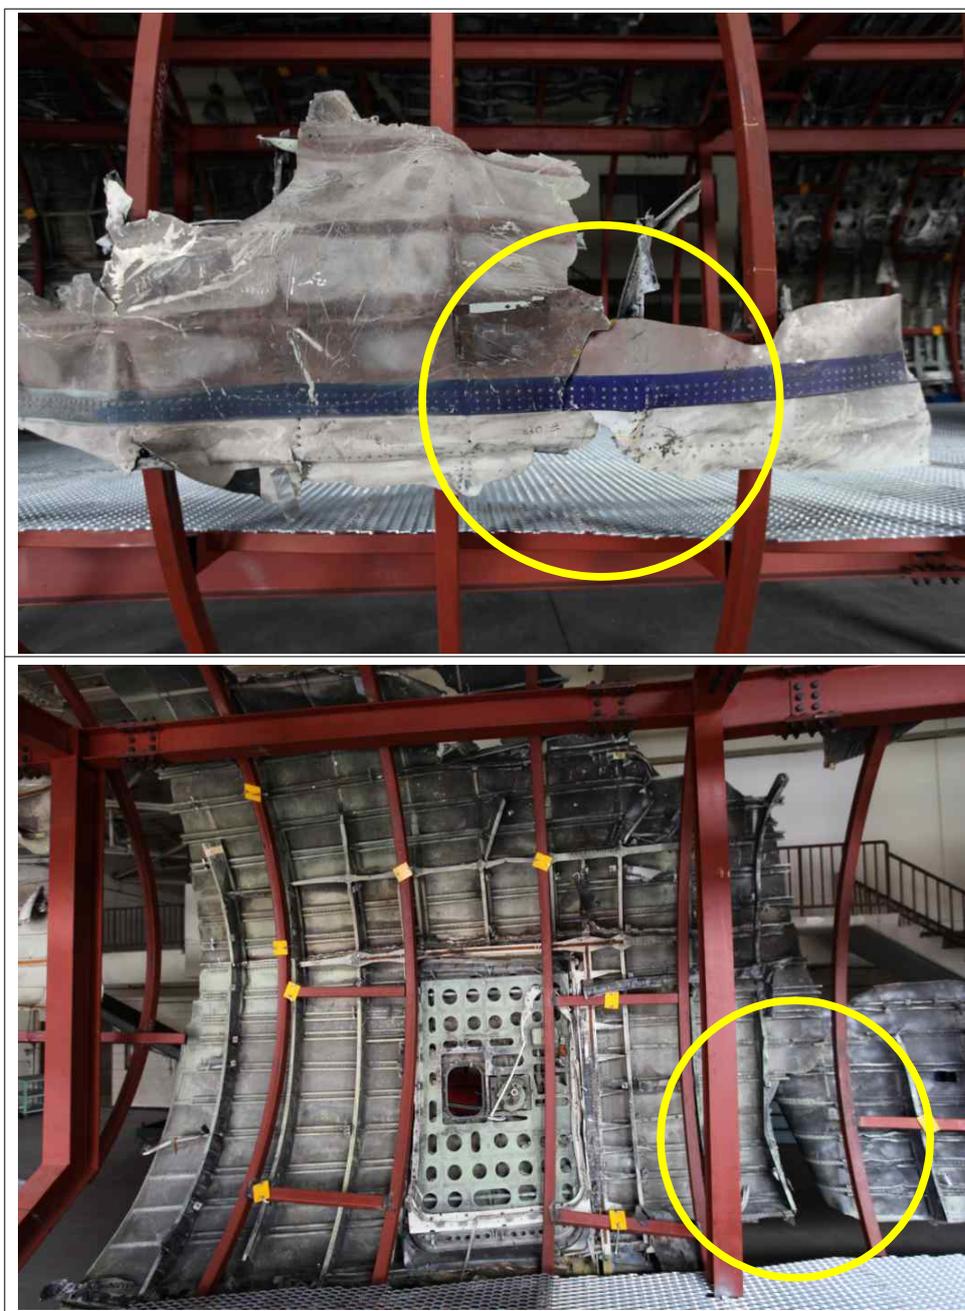
[Figure 72] In-flight Breakup Evidence

[Figure 72] shows certain portions of the reconstructed wreckage. The upper image in [Figure 72] contains a yellow circle in which there is a fracture line between two pieces of the wreckage. Color on both sides of the line that should have been the same is apparently different. The left piece of the wreckage is heavily sooted, whereas the right one does not exhibit sooting, which indicates that a fire lasted even after the separation of the wreckage. In other words, the left piece of the wreckage was attached to the fuselage while the fire progressed, whereas the right one separated from the fuselage.

The bottom image in [Figure 72] shows a yellow circle in which stress is observed along a fracture line between two pieces of the wreckage at FS2180. The left piece of the wreckage could stand outward force because it was attached to the fuselage frame, whereas the skin of the right piece was bent outward due to energy on the inside. In other words, the skin along the wreckage sheared off in midair due to energy on the inside of the airplane.

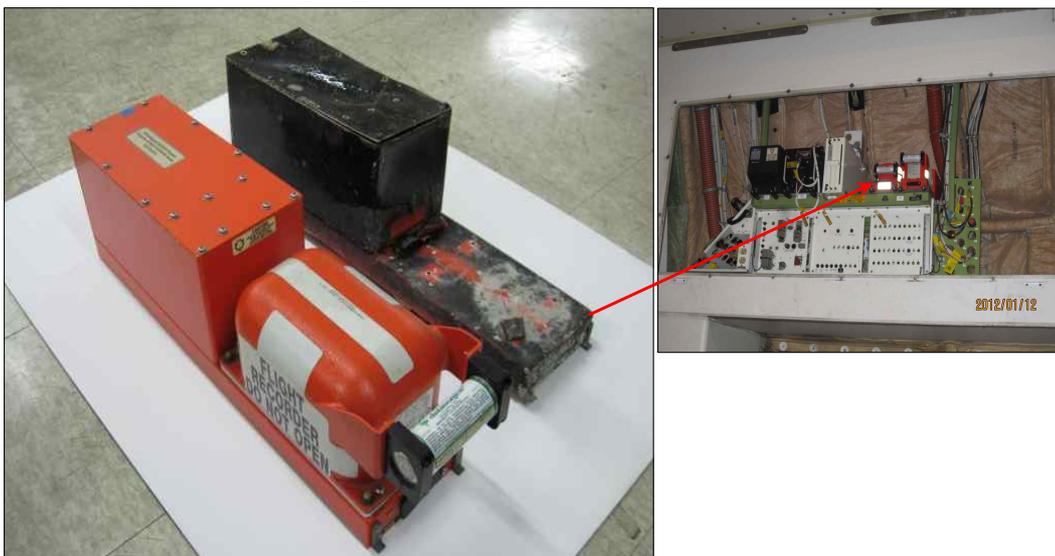
[Figure 73] FDR's Chassis

From 18 to 25 April 2012, the ARAIB in cooperation with the former Ministry of Land, Transport and Maritime Affairs and the Navy checked the movement of the underwater wreckage to pinpoint their exact locations at the accident site, and as a result, added new wreckage coordinates to search for the FDR and CVR. From 10 May until 10 June 2012, a private salvage company carried out a second-phase search operation using a pair trawling method, and on 16 May, recovered the chassis with a severe fire damage, as shown in [Figure 73].

According to the results of fire damage analysis, the location where the FDR and CVR were installed (FS2300, aft of L5 door) sustained a level 2 fire damage (minor charring and/or paint discoloration from heat).

The flight data recorder rack was separated from the frame aft of the upper portion of the L5 door. The upper portion of the frame was thermally damaged, and its interior surface was heavily sooted. Judging by this evidence and the chassis' fire damage including sooting, the ARAIB assumes that the ULB fitted to the CSMU must have exceeded its operable temperature between -2.2 and 37.8°C or must have been burned in a fire, thereby becoming inoperable.

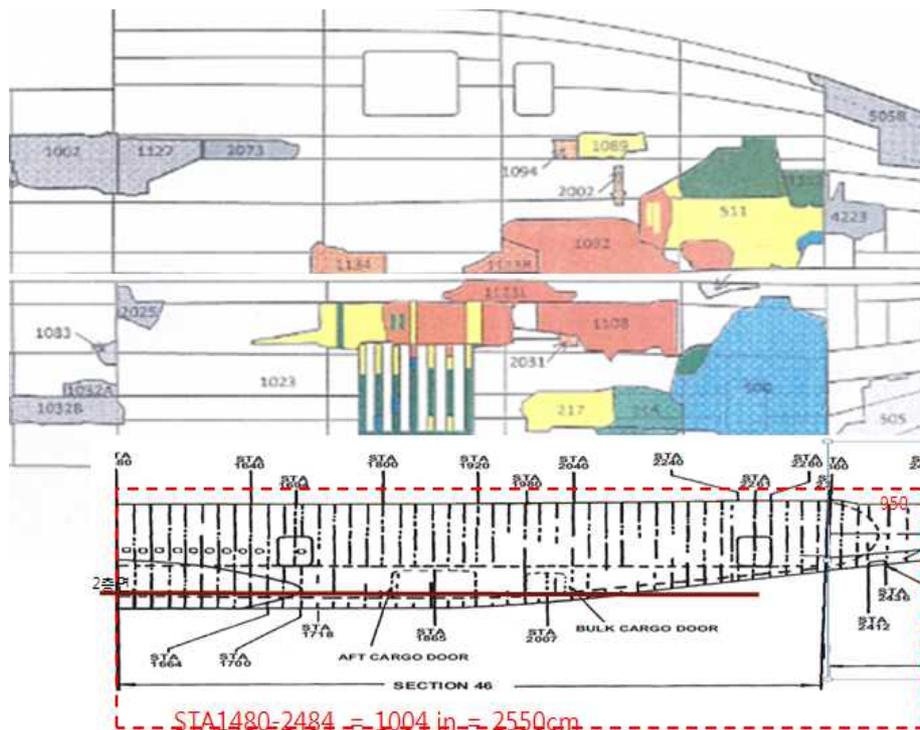
<Fig.162> 3D reconstruction section and the wreckages

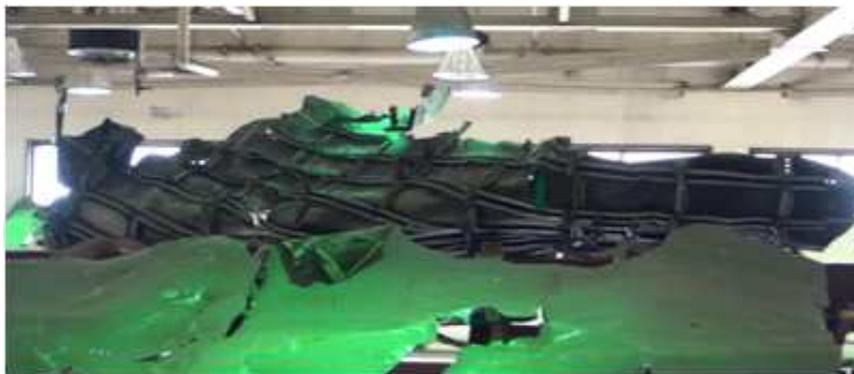
- 3D H/W reconstructed wreckages analysis : STA 1700 ~ 2000 in the vicinity of some tearing and appears to the outside of the spout form below to receive a column as shown by the pressure and heat damage of the explosion in wreckages #1134 and #1123. This location is the main cargo compartment of the aircraft ML/MR, PL/PR area. Aluminum alloy fuselage was damaged by the heat was some melted Refine torn up due to the shape of the crown form of explosive Dangerous Goods.

<Fig.164> Shape of the upper airplane

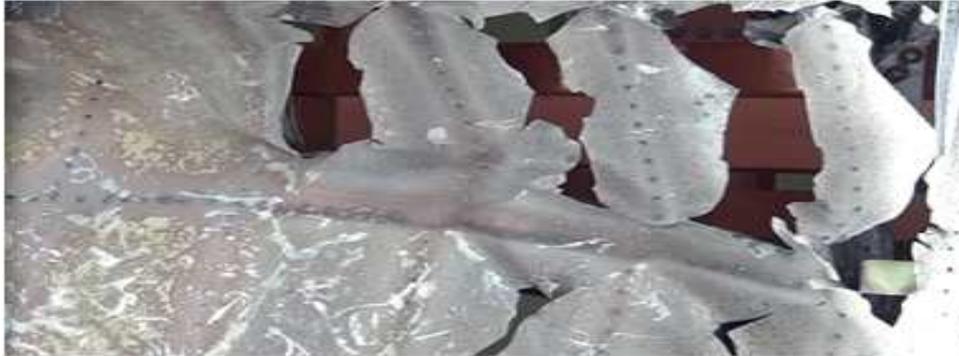
- 3D H/W reconstructed wreckages analysis : Some of the wreckage #511 of STA 2205 melt a hole in the vicinity of the melting of the heat received and appears to down a cup shape, corresponding to RR area that 250 inches rearward from the main cargo compartment appeared PR area .

<Fig.165> Melted by heat of fire plane right outside

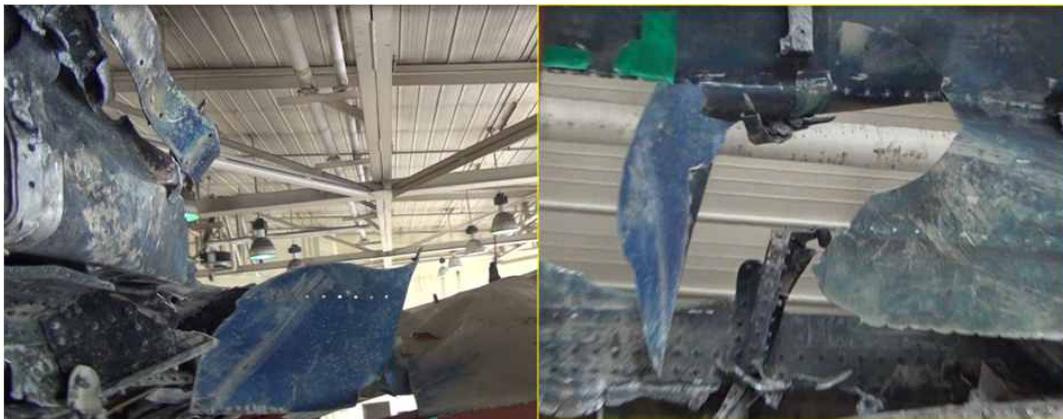
- 3D H/W reconstructed wreckage analysis : The state is heavily tanned inside of the top of the main cargo compartment with dangerous goods ML area wreckage #1134. Showed inside and outside that a colored state is loaded in the cargo hold PR area by Dangerous Goods of blue photoresist. This is thought to be the blue liquid flies in the plane ripped a hole in the state already has the upper body by the fire.

<Fig.166> Colored wreckage #1134, left)outside, right)inside

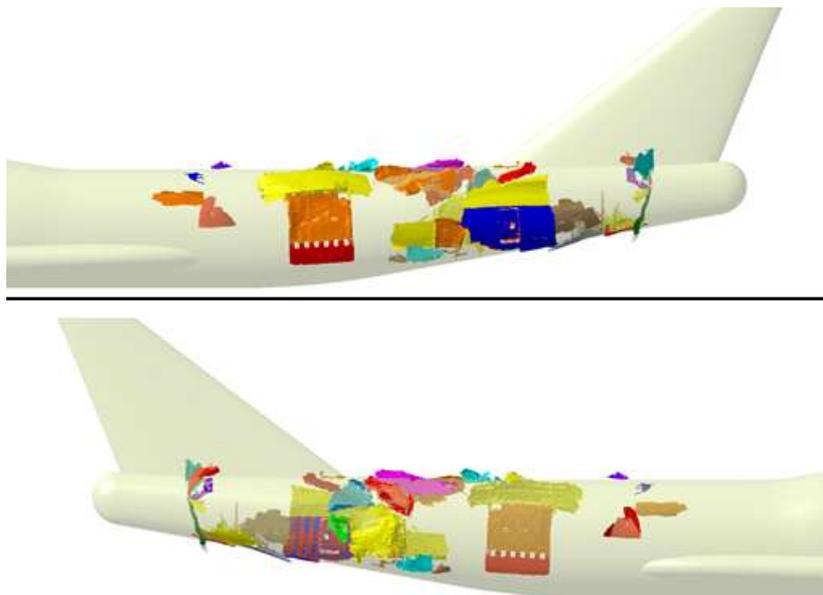
- Modeling and 3D Scan Data written : Guidelines for Reference Frame CAD Data written to the target, Use the "GSD Application" in the CATIA V5 model creation, Area division is divided into seven Area for the STA 1480 ~ STA 2436. Using 3D Scanning Camera TU-50, Scanning is complete, We make below Fig.

<Fig.167> S/W Reconstruction Result(1): Left View(Up), Right View(down)

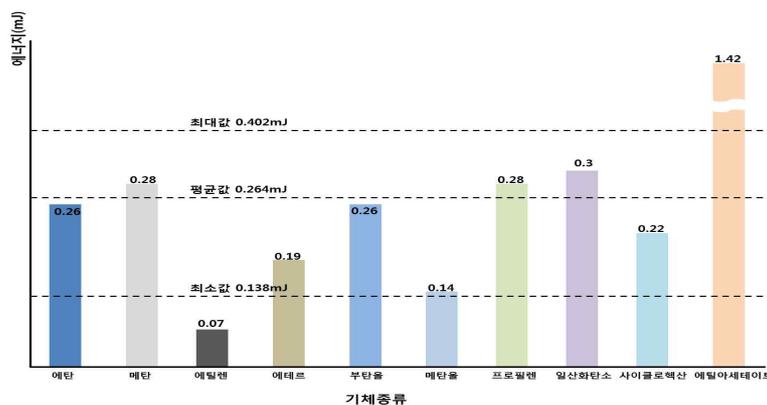
<Fig.170 > Type-A with MIE

- The minimum of the measured Type-A, which can be determined that the average, have at least one or more high electrostatic energy than the MIE of vaporized components from the maximum energy is dangerous goods.

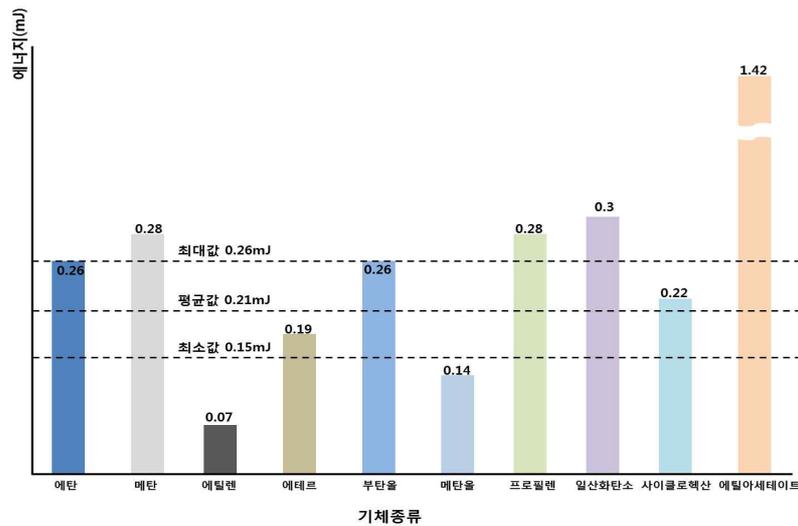
<Fig.171 > Type-B with MIE

● The minimum of the measured Type-B, which can be determined that the average, have at least 2 or more high electrostatic energy than the MIE of vaporized components from the maximum energy is dangerous goods.

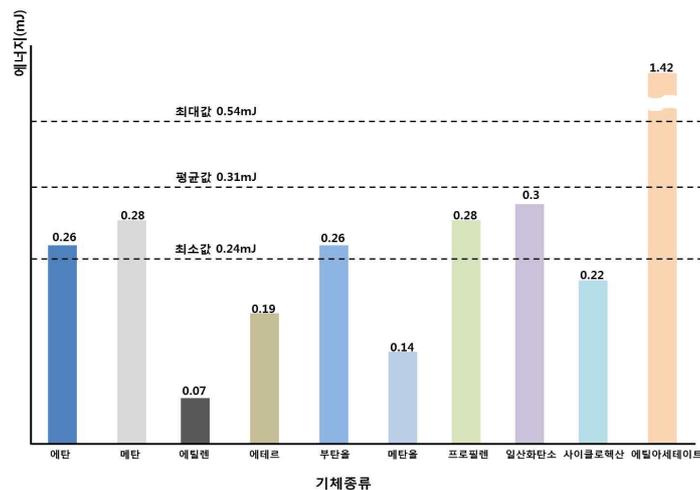
<Fig.172 > Type-C with MIE

● The minimum of the measured Type-C, which can be determined that the average, have at least 4 or more high electrostatic energy than the MIE of vaporized components from

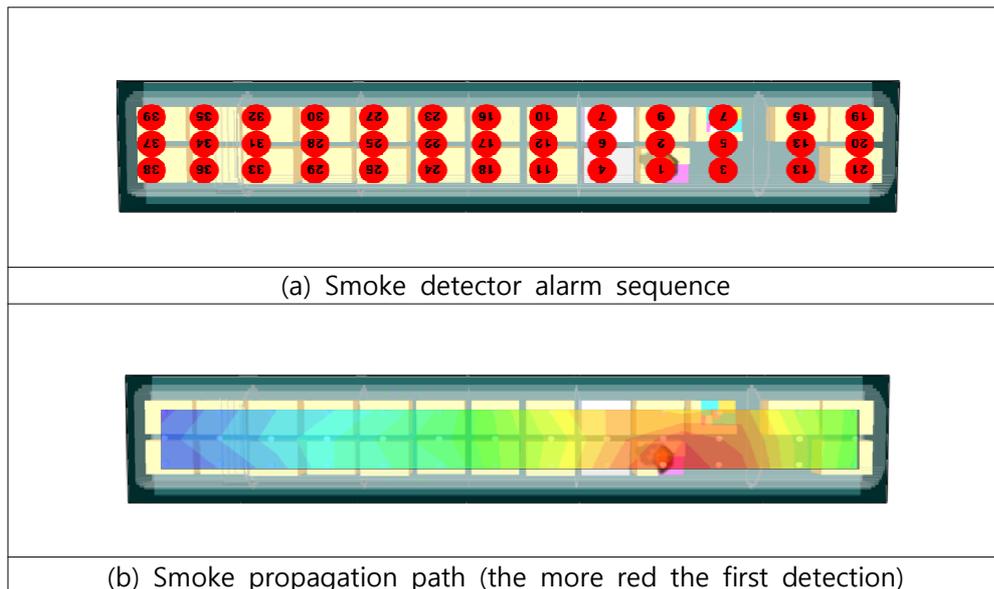
- Represents the trend leaning towards the front, but the direction of movement of the flame. Scenario 2 less than the heat release rate of the overall size.
- Propagation delay progression of peripheral sources of ignition are also different scenario 2 depending on the ignition source location. The farther away from the source of ignition is showing similar progress.

<Fig.177> After the fire, the smoke spread in the ML area

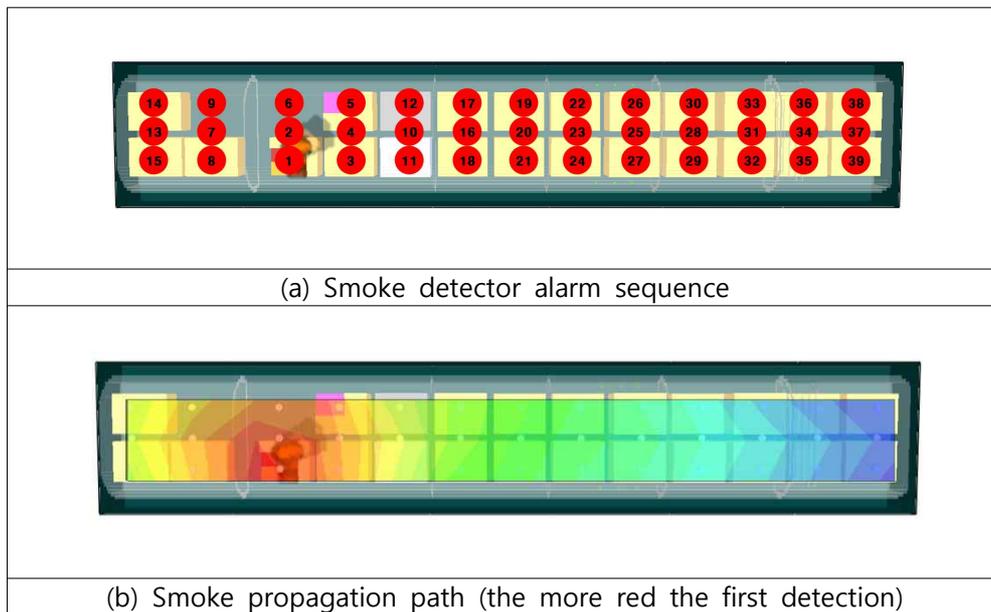
- Check that the first smoke and flames spread to the front than the rear.
- Refine the first detection of smoke in the front side MR, ML section area than the PL and PR in the STA position as an ignition source.

<Fig.178> After the fire, the smoke spread in the PR area

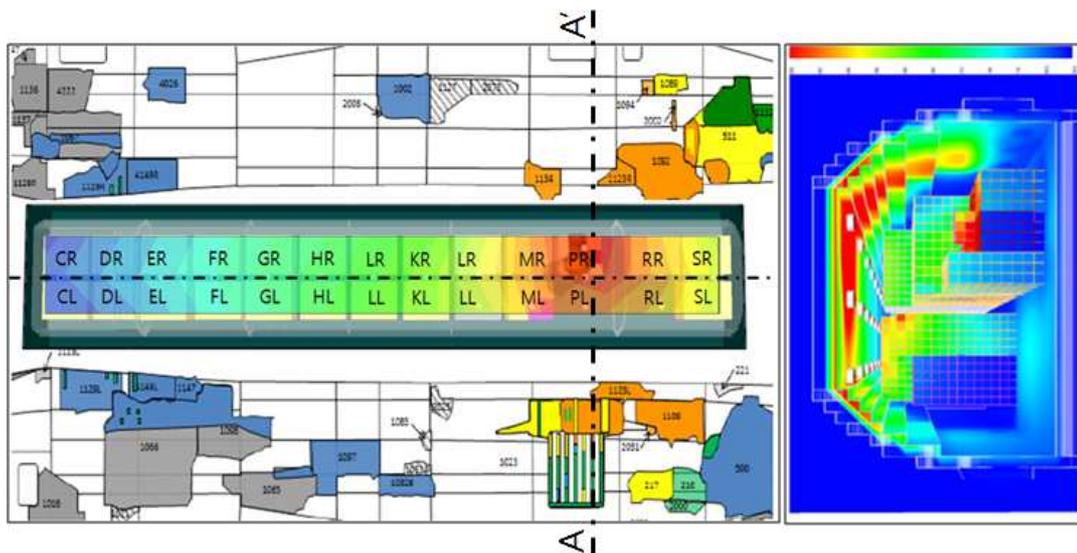
<Fig.179> Left), the thermal distribution of heat in the body even if the PR section also ignites and damages, Right) Heat distribution in the section A-A' for PR area of main cargo compartment

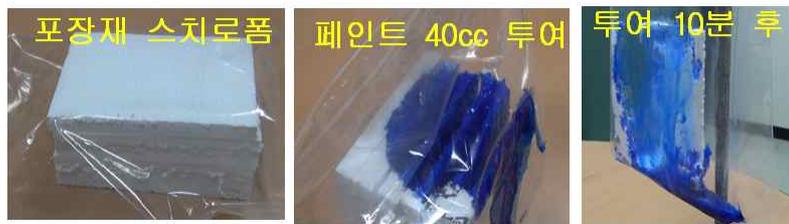
- Performing a test administered by the polystyrene form was used as packaging for liquid dangerous goods loaded on the airplane dangerous goods. Polystyrene form  $990\text{cm}^3$  ( $1.1\text{cm}\times 15\text{cm}\times 10\text{cm}\times 6\text{pieces}$ ), addition liquid Dangerous Goods 40cc. Test Result : Paint, Photo-resist/IC, Photo-resist/LCD are chemical respond rapidly.

<Fig.180> give paint to a Packaging Materials

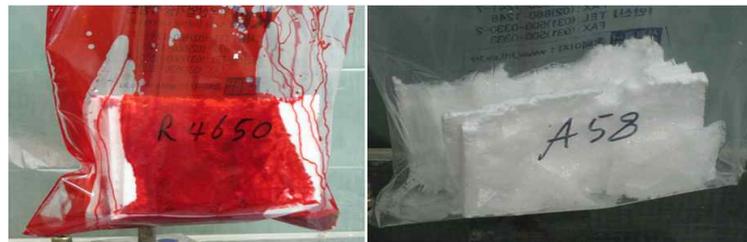
<Fig.181> give dangerous goods to a Packaging Materials Left) Photo-resist/LCD, Right) Photo-resist/IC

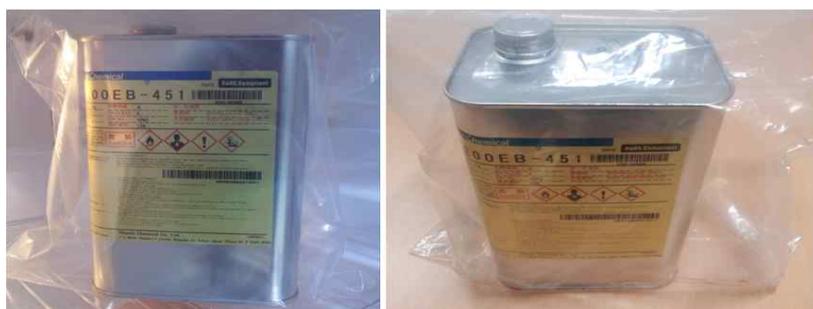
- Measured at the internal & external closure of the paint firmly locked state with the flammable gas leaks whether VOCs meter for the case was allowed to stand 2 hours, then kept at room temperature for 2 hours in a refrigerator, and if placed in a sealed plastic bag and the paint container.

<Fig.182> Ensure that you are ready to paint flammable gas leakage in closed closure, Left) In Refrigerator rest, 5°C, 2hrs, Right) At room temp. 18°C, after 2hrs, in Laboratory

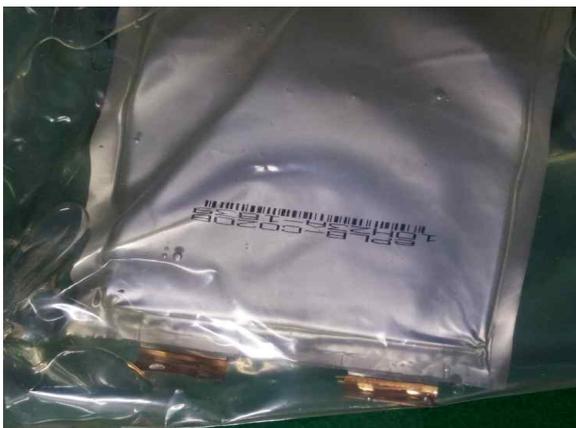
- A lithium-ion battery for car completely soaked in Amines Liquid Corrosive N.O.S 30 minutes after checking in ambient temperature 18 °C environment of the lithium-ion

battery damage result is not at all. Between the Amines Liquid Corrosive N.O.S with lithium-ion battery has not chemical and electrical reactions occur at all.

<Fig.183> A lithium-ion battery soaked in  
Amines Liquid Corrosive N.O.S
