Report

Accident on **13 July 2012**
at **Le Castellet aerodrome (83)**
to the **Gulfstream G-IV** aeroplane
registered **N823GA**
operated by **Universal Jet Aviation (UJT)**

BEA

Bureau d'Enquêtes et d'Analyses
pour la sécurité de l'aviation civile

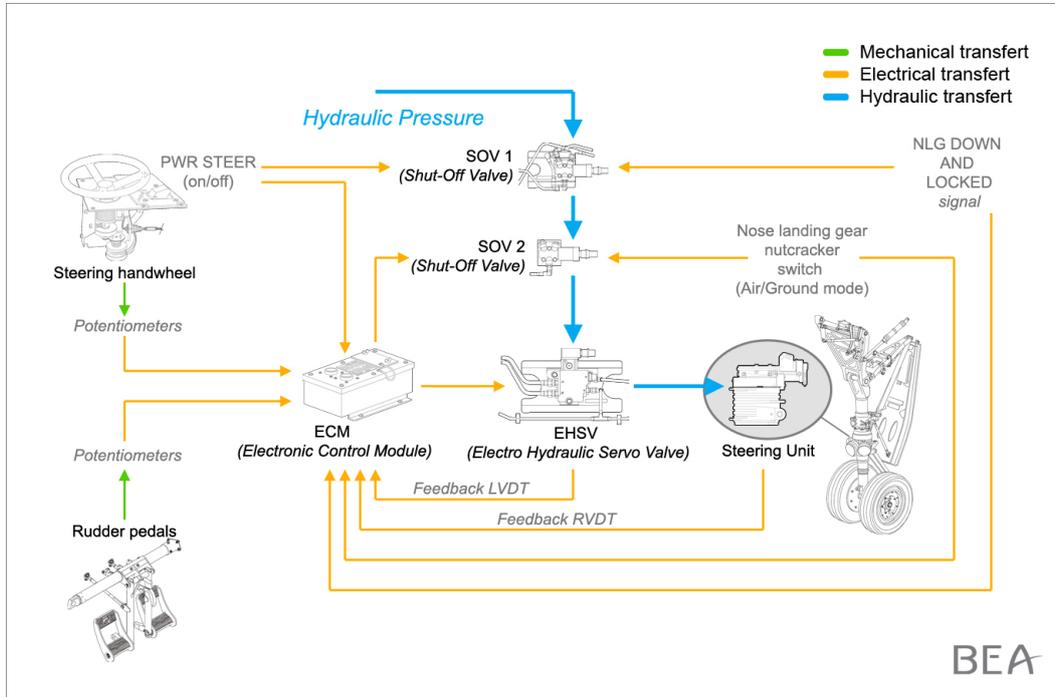
Figure 5: nose gear steering control system

Effect No. 5 can be caused by a failure of the EHSV (rupture of the EHSV feedback LVDT (see Figure 5), an abnormal position of the slide valves in the servo valve or loss of electrical connection with the EHSV). This effect cannot have been encountered in the case of the accident because it would have generated an audible and visual warning message, which was not the case when the aeroplane was on the runway.

- effect no. 3 could be caused by a blockage of a one-way restrictor of the hydraulic system;
- effect no. 4 could be caused by:
 - jam or seizure of the feedback of the steering unit (feedback RVDT see Figure 5)
 - blocking of the tiller or an internal disconnection of its potentiometers.

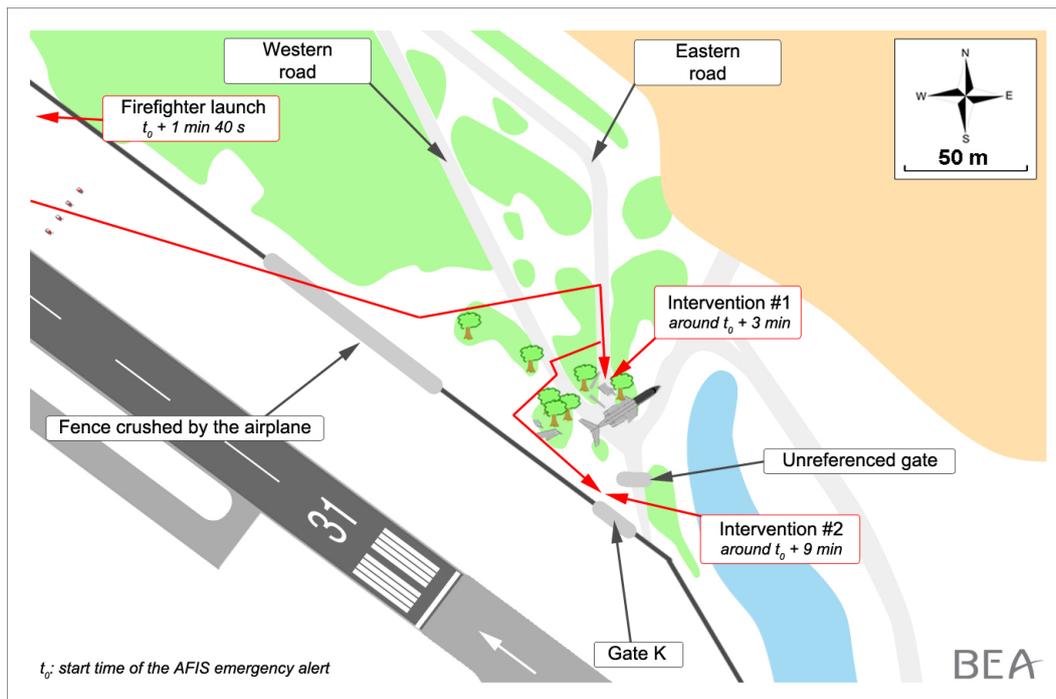
He was notified immediately after the runway excursion by the AFIS officer and intervened at the site about 3 minutes after the alert was given. He carried out the first intervention without moving about 30 metres from the wreckage using the cannon on the foam response vehicle (VIM), at full flow about 30 seconds. Hindered by trees located between him and the aeroplane, he changed strategy and decided to go around the wreckage to the south. The second intervention took place about 6 minutes after the first operation, also without moving at about 30 metres from the wreckage, first on the stretch of water on which the fuel was burning⁽²⁰⁾, then on the wreckage itself. The cannon was used at half-flow until all of the water was used up. A detailed chronology of the intervention can be found in **appendix 4**.

Figure 15: estimated fire-fighter routing and intervention positions, based on his interview

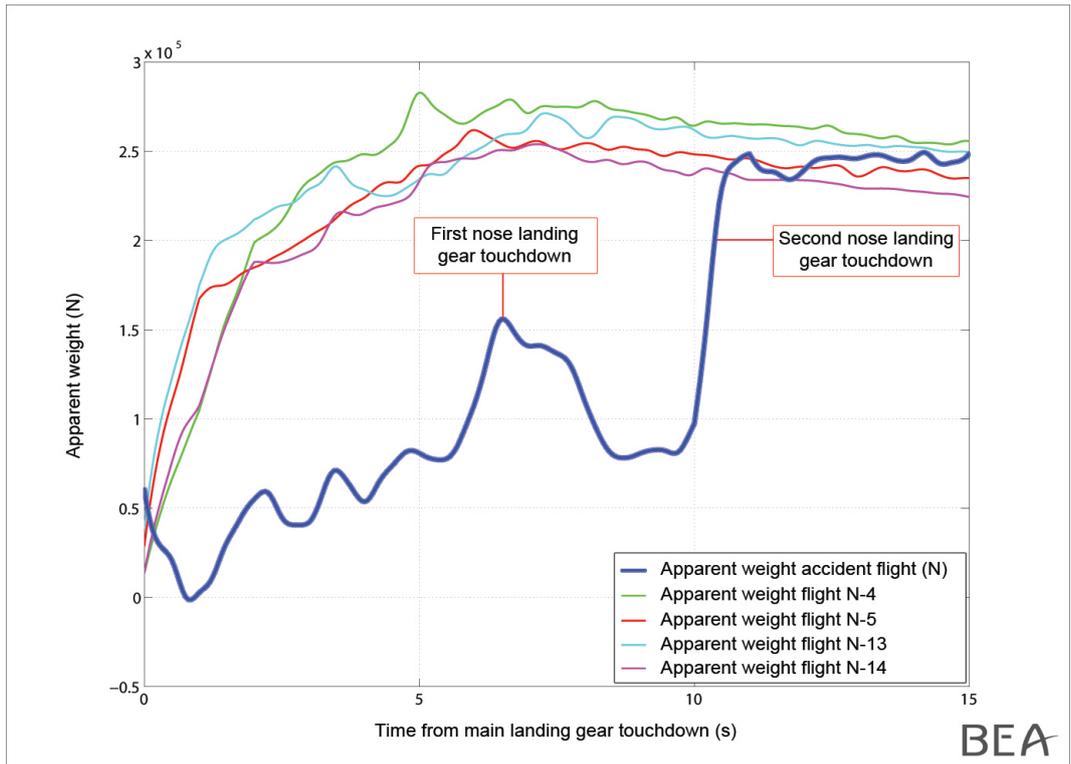
The speedbrakes were manually extended up to 26° and the thrust reversers were deployed and were used at MAX REVERSE thrust. The increase in drag and reverse thrust forces which resulted, and the increase in the apparent weight, associated with an increase in the hydraulic pressure applied to the brakes, had the effect of increasing the aeroplane's deceleration. The retarding force exerted on the aeroplane rapidly increased, reaching values 5 to 6 times higher than that of the other landings. This increase was partly explained by that of the braking intensity that could be seen through increased braking pressures, but also by the aeroplane starting to skid and a possible orientation of the nose gear that created additional friction forces on the tyres of all three components of the landing gear.

Figure 17: comparison of the apparent weight

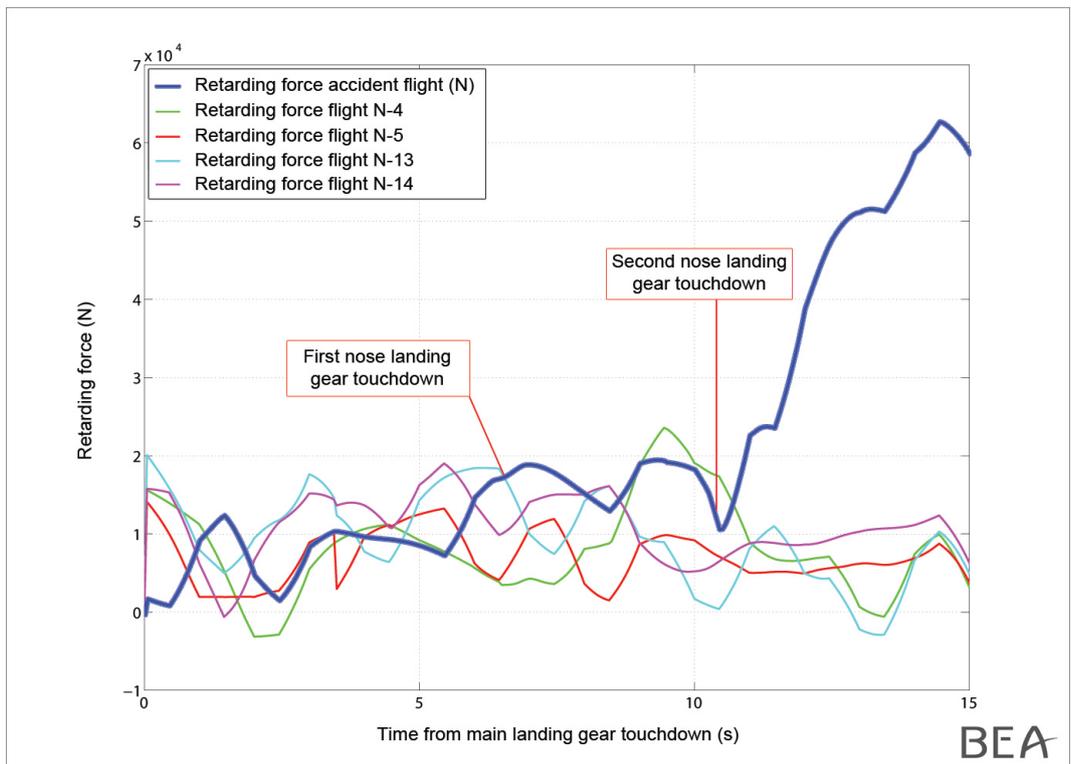
Figure 18: comparison of the retarding force⁽²⁴⁾

During this second, relatively short (270 m) phase, the ground speed of the aeroplane decreased by 31 kt.

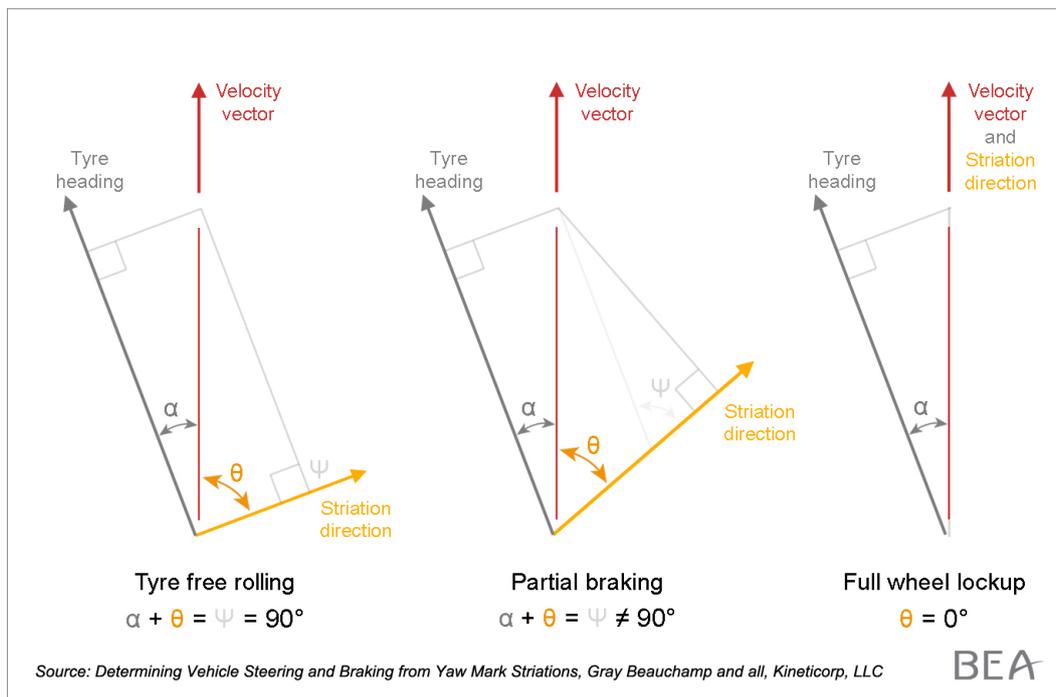
Figure 21: orientation of the striations for a braked wheel and an unbraked wheel, schematic diagram

The study includes tests that show that, for an unbraked wheel, the striations are substantially oriented at 90° in relation to the plane of the wheel (parallel to its rotation axis). Their orientation is close to the direction of movement of the wheel if it is partially braked.

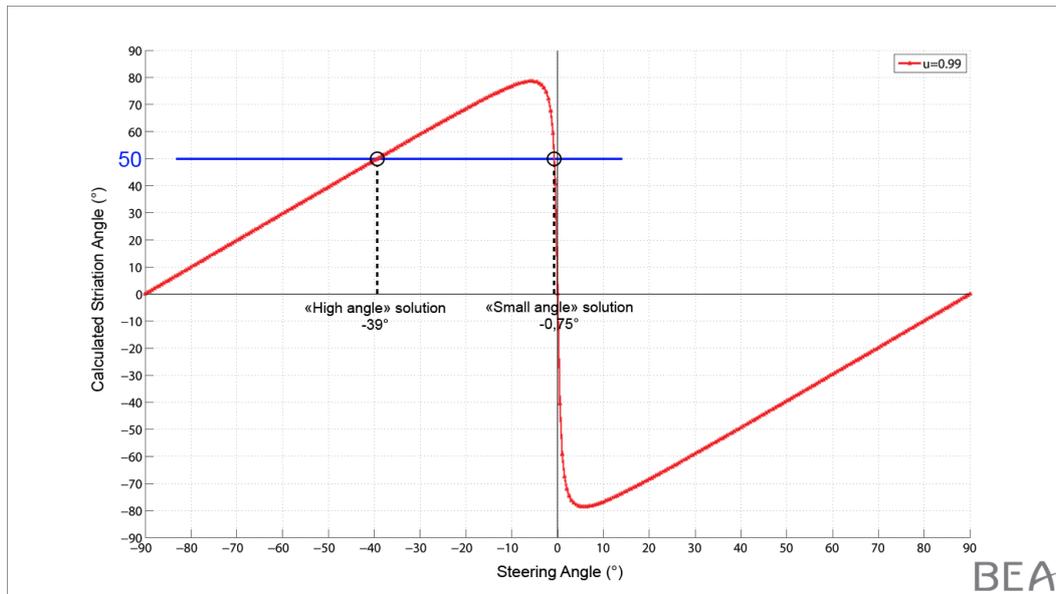
Figure 25: example of a striation angle value in relation to wheel orientation, for wheel rotation speeds close to their theoretical maximum value ($u = 0.99$)

The theoretical study of striations generation indicating, for the same striation angle, two possible orientations of the wheel (“strongly” and “slightly” oriented), the fact, in the case of the accident, that the aeroplane was skidding to the right leaves open the possibility that the landing gear was oriented to the right of the centre line of the aeroplane while being oriented to the left of the flight path (*small angle solution*, see figure 25). This solution was rejected because:

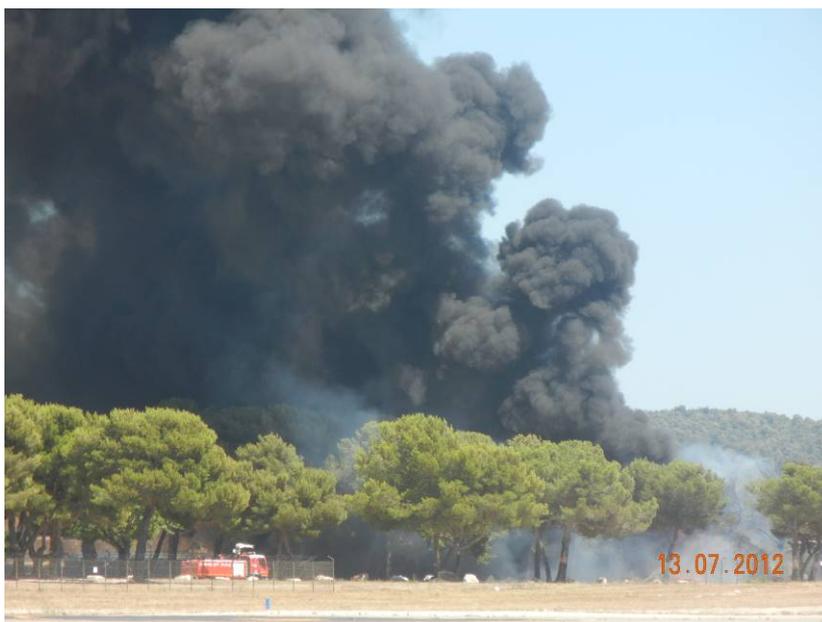
Photo 1

On photo 1, the foam response vehicle (VIM) has stopped (discussion with circuit staff). It is on its way to the site of the second intervention.

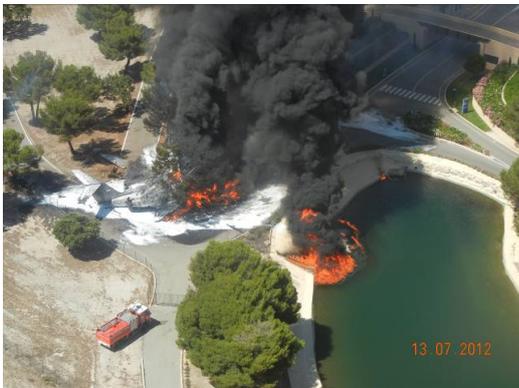
Photo 4

The second intervention probably took place at about 13 h 28 on the lake and then on the wreckage. About 6 minutes elapsed between the photo taken on the "west" access road and photos 4 (second intervention had not yet started) and 5 (second intervention under way).

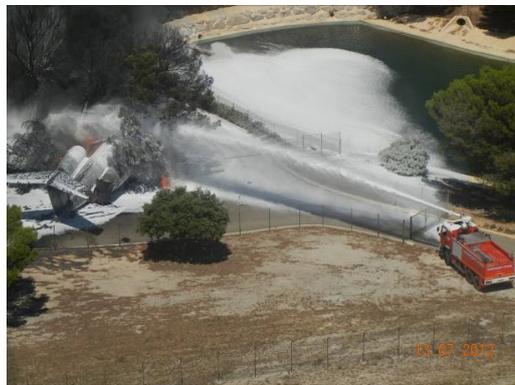
Photo 5

On photo 5, the vehicle is approximately 30 meters from the wreckage with the water cannon being used at half flow rate until it ran out of water.

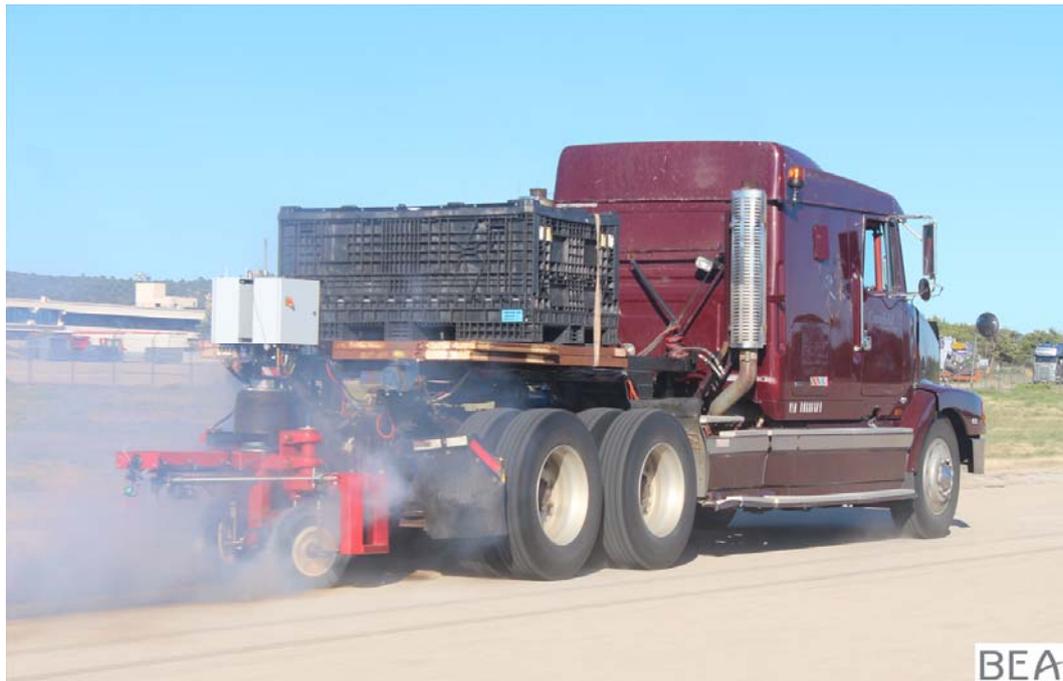
Figure 1 - tyre test platform

Cranfield University (UK) has a test platform capable of creating tyre marks on the ground, for different orientation angles of wheels, different loads and different speeds. The University built a truck to accommodate a metal frame on which is installed a system of two unbraked wheels that can be oriented symmetrically (see photograph below) and tilted sideways. The load on the wheels is controlled by an actuator.

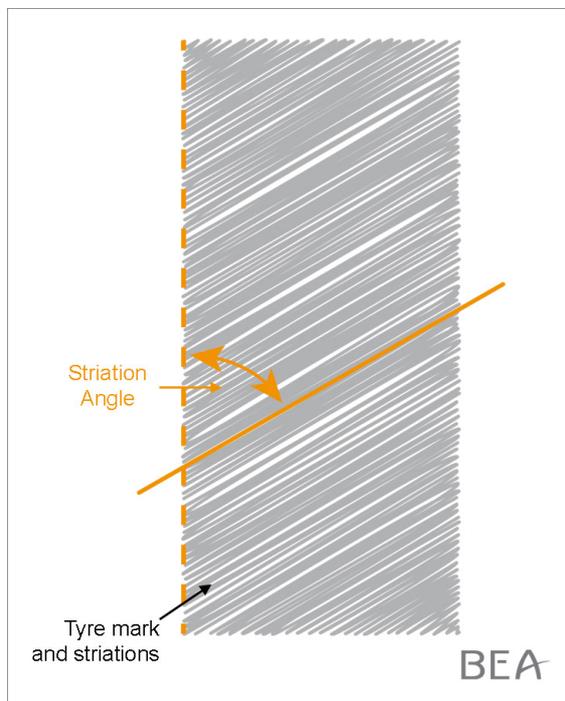
Figure 2: convention for measuring the striation angle

Following the passage of the truck, the marks were examined. Their width and the angle between the edge of the mark and the striation (when it was visible) were measured.

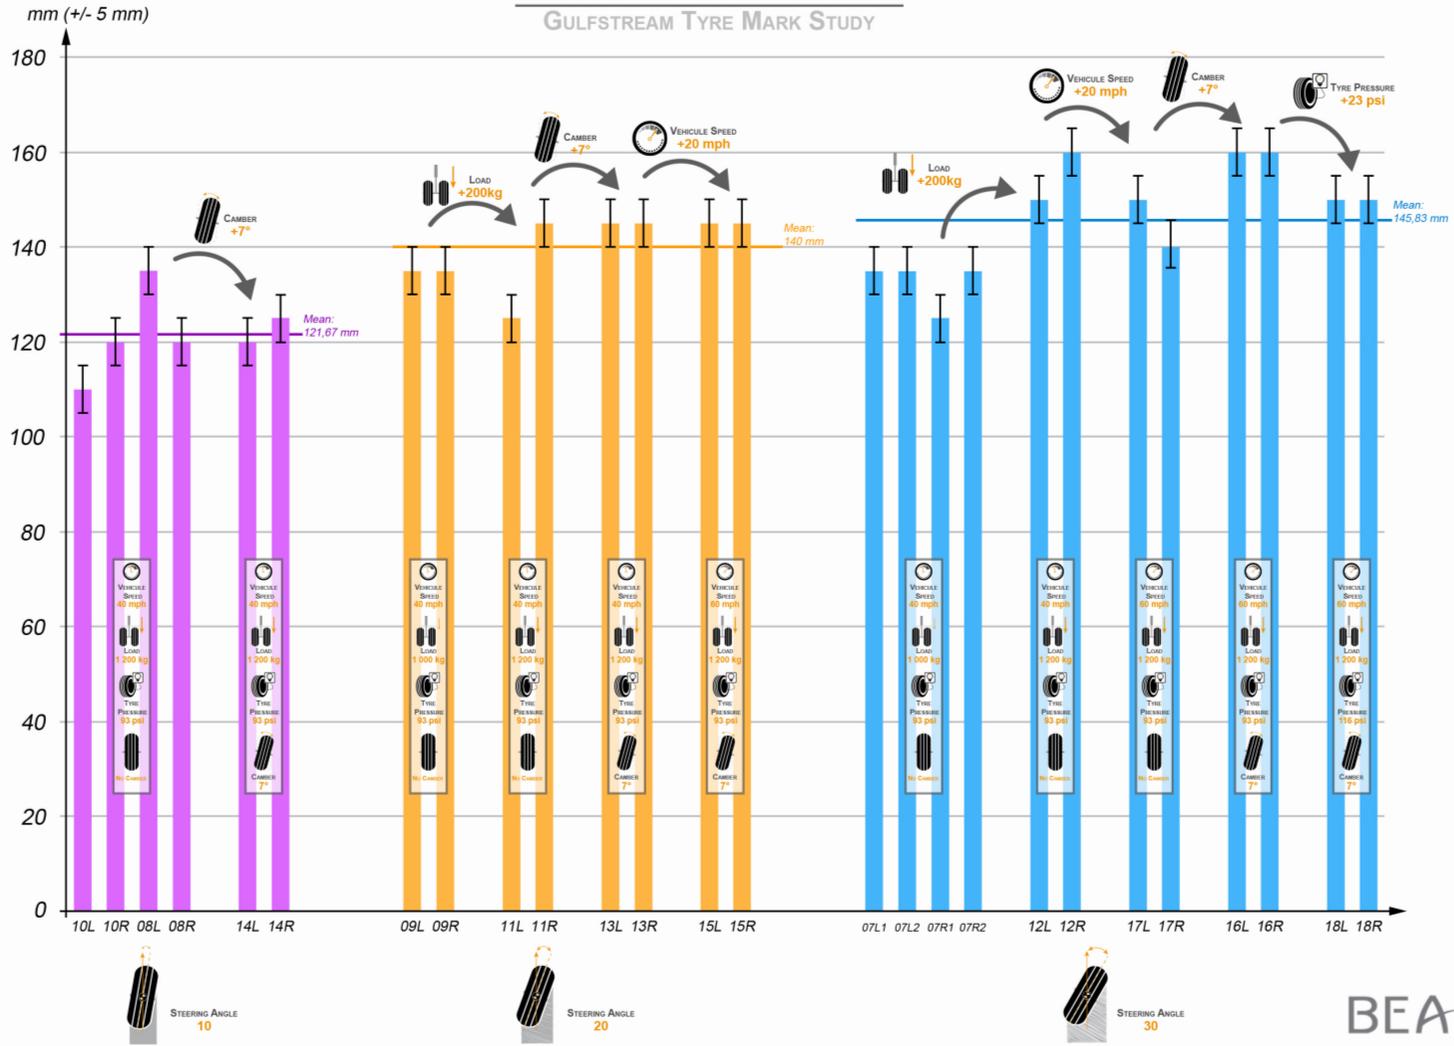
WIDTH OF TYRE MARKS

The tests resulted in the following findings:

- ❑ no striations were observed for wheel orientations of 10°;
- ❑ the angle of the striations (whatever their direction) appears to be primarily dependent on the orientation of the wheels. The other parameters (load, vehicle speed, camber, tyre pressure) do not appear to have a significant influence on the striation angle⁽⁶⁾;

- an increase in the camber does not have much influence on the width of the marks. However the latter seem darker.

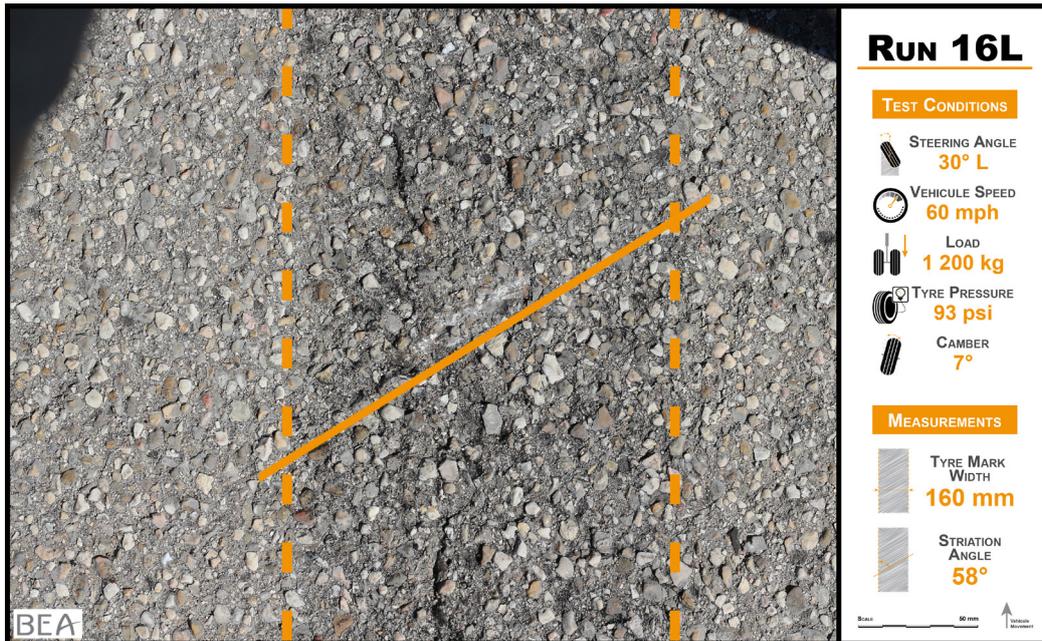
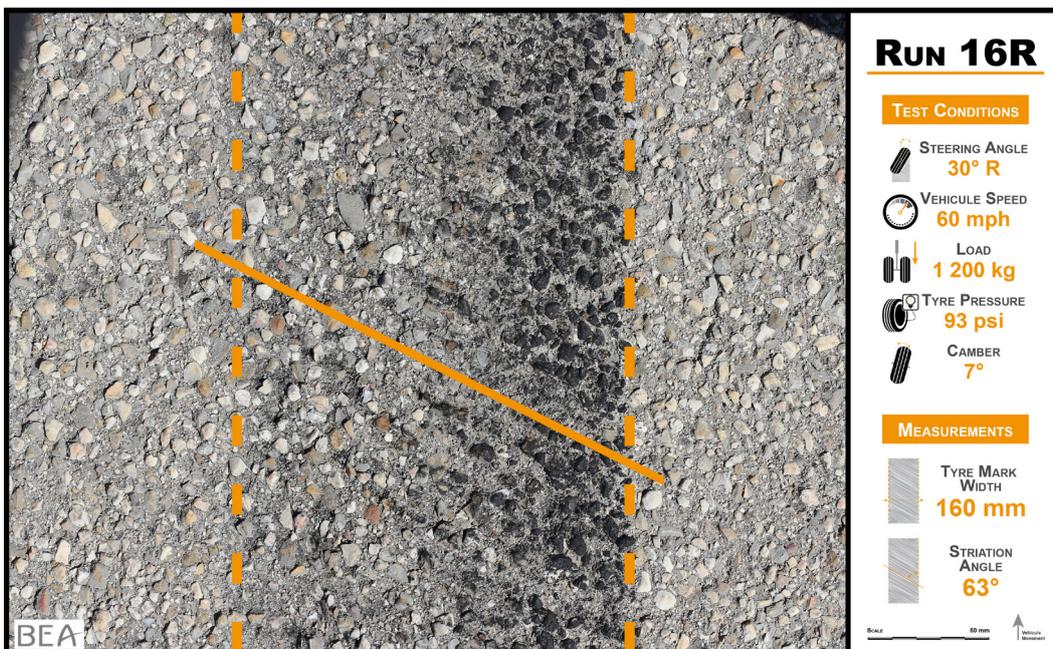
Figure 3: photograph taken at the end of a test

⁽⁶⁾This is particularly visible in the tests with a steering angle of 30°.
