REPUBLIC OF KENYA
MINISTRY OF TRANSPORT AND INFRASTRUCTURE
DEPARTMENT OF AIR ACCIDENT INVESTIGATION

ACCIDENT REPORT

5Y-UVP

PRELIMINARY REPORT

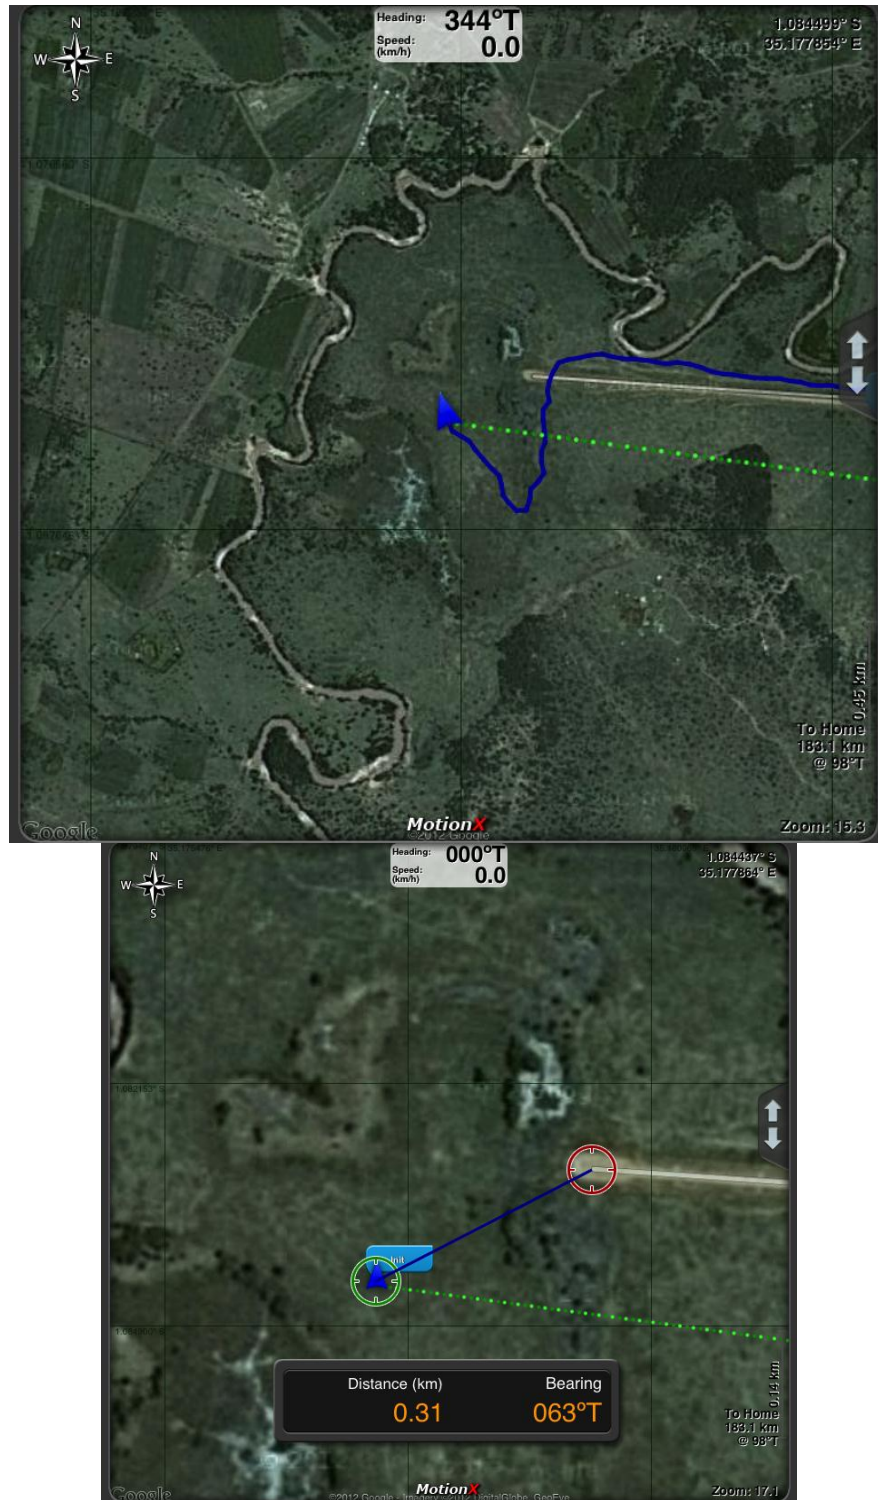
figure 1.2 : Accident site distance and location on google maps

GPS coordinates (figure 1.2) 01.084189° S, 35.1781127° E, Ngerende airstrip.
