AVIATION INVESTIGATION REPORT
A12Q0161

HARD LANDING AND AFT FUSELAGE STRIKE

**C-GUON DHC-8-301
OPERATED BY JAZZ AVIATION LP
GASPÉ AIRPORT, QUEBEC
10 SEPTEMBER 2012**

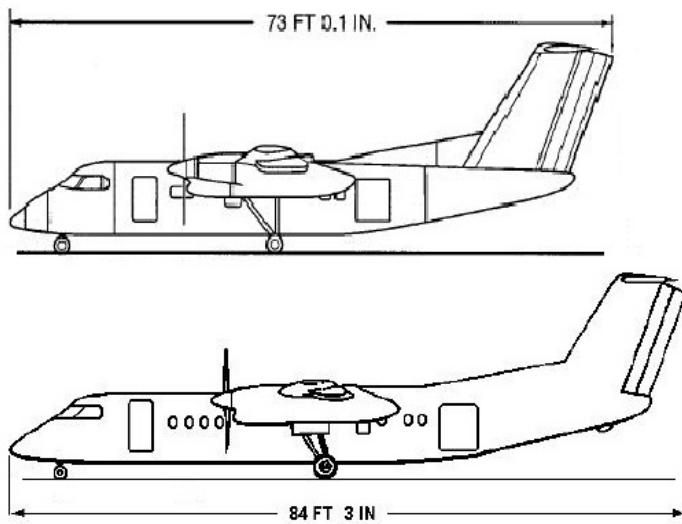
Figure 1. Length of the DH8A (top) versus the DH8C (bottom) (Source: *Air Canada Jazz DASH 8 AOM Volume 1: Aircraft Operating Manual* [31 January 2005], Figure 10-1, page 10.7-5, and Figure 10-18, page 10.25-23)

C-GUON is a DH8C, which is a stretch version of the DHC-8-100 (DH8A) with an additional 11.3 feet, increasing the maximum passenger capacity from 36 to 50 (Figure 1).

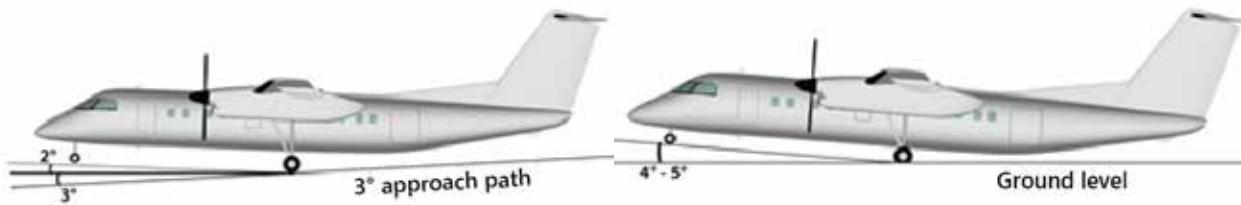
Figure 2. Attitude of the DH8C on approach

The attitude of the DH8C is between 2° and 3° nose-up on a 3° final approach path, in landing configuration with flaps at 15° and at $V_{REF} + 5$ knots (Figure 2). Normally, the attitude is increased approximately 2° during the flare for landing, and the aircraft sets down with a nose-up attitude of between 4° and 5° (Figure 3).

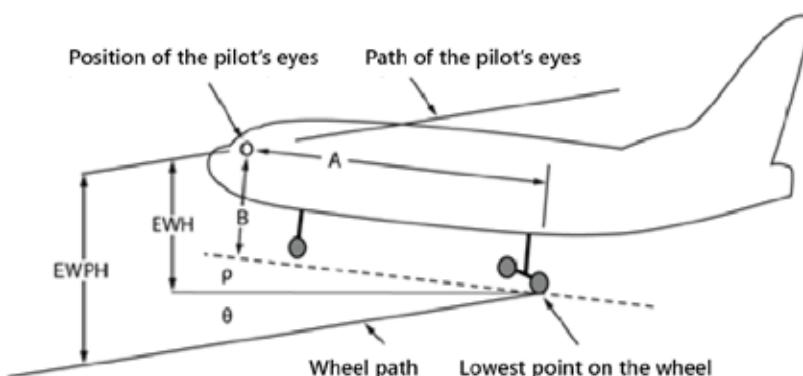
Figure 6. Eye-to-wheel height (EWH) and eye-to-wheel path height (EWPH)

The eye-to-wheel height (EWH) is the vertical distance between the pilot's eyes and the lowest part of the aircraft in landing position (Figure 6). This height varies from under 4 feet up to 45 feet for certain

horizontal and vertical distance that must be travelled by the wheels to reach the threshold. This vertical height between the pilot's eyes and the wheel path (eye-to-wheel path height, or EWPH) is 11.9 feet for the DH8C. The EWPH is used to determine the height of the wheels at the moment they cross the runway threshold. Some documents use the EWH and the EWPH interchangeably, and yet the difference is 1.5 feet for the DH8C. This report uses the EWPH, as it indicates more accurately the height of the wheels as they cross the threshold than the EWH, which is independent of path. EWH and EWPH data are not published by the manufacturer and do not appear in the DH8C's AOM.

The pilot must know the aircraft's EWPH to be aware of the distance of the wheels under its path (particularly during a visual approach) and thus to understand the impact of a deviation below the normal 3° approach path.

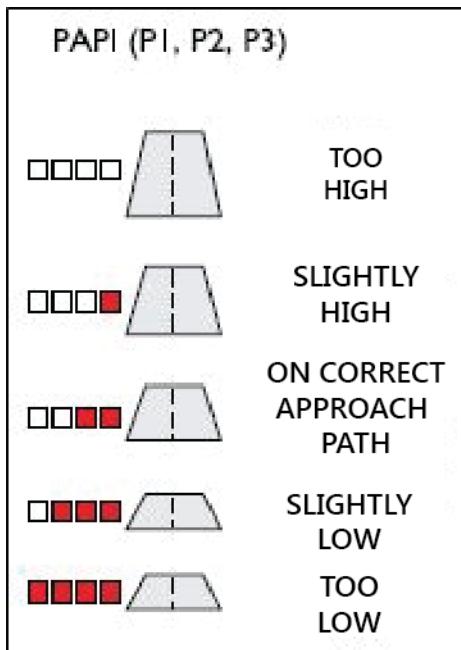
Figure 7. Precision approach path indicator (PAPI) (Source: *Transport Canada Aeronautical Information Manual [TC AIM]*, TP 14371 [18 October 2012], AGA – Aerodromes, section 7.6.2.3)

The PAPI consists of 4 lights located on the left-hand side of the runway in the form of a wing bar (Figure 7). Through adjustment of the distance of the lighting units from the threshold, adequate clearance is assured for aircraft with different EWHs. The threshold crossing height (TCH) increases proportionally with the distance of the PAPI from the threshold (Figure 8).

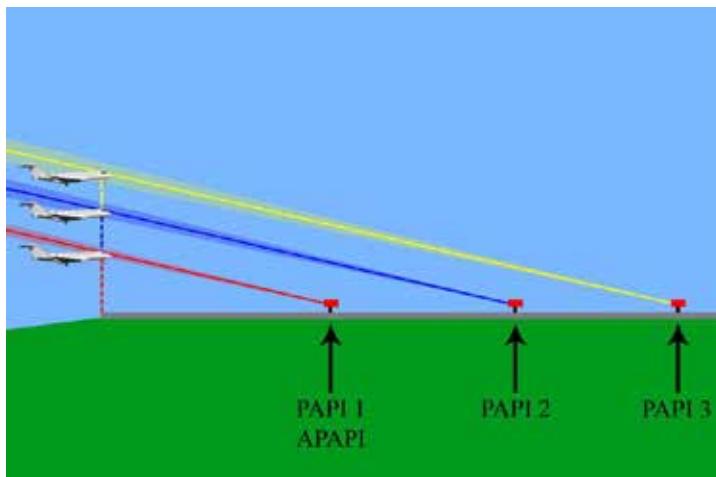
Figure 8. Threshold crossing height (TCH) as a function of PAPI type

According to these criteria, a PAPI (P2) is required to ensure adequate TCH for the DH8C.
