Aircraft Serious Incident Report

In-Flight Engine Shutdown

Eastar Jet Flight 223

B737-700, HL8207

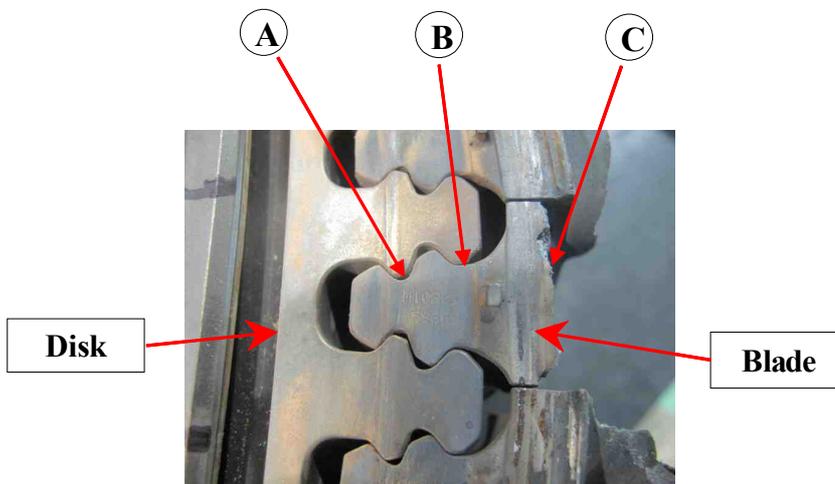
[Figure 18] Types of HPT Blade Root Cracks

Category	P/N	2002M52 P09/P11/P14	1957M10P01	1957M10P03
		Commencement of Blade Manufacture	2001, Q3	2002, Q2
A	Minimum Neck Crack	2	2	-
B	Edge of Contact Crack	4	6	-
C	Transition Zone Crack	15	-	1

[Table 4] Number of HPT Blade Root Cracks

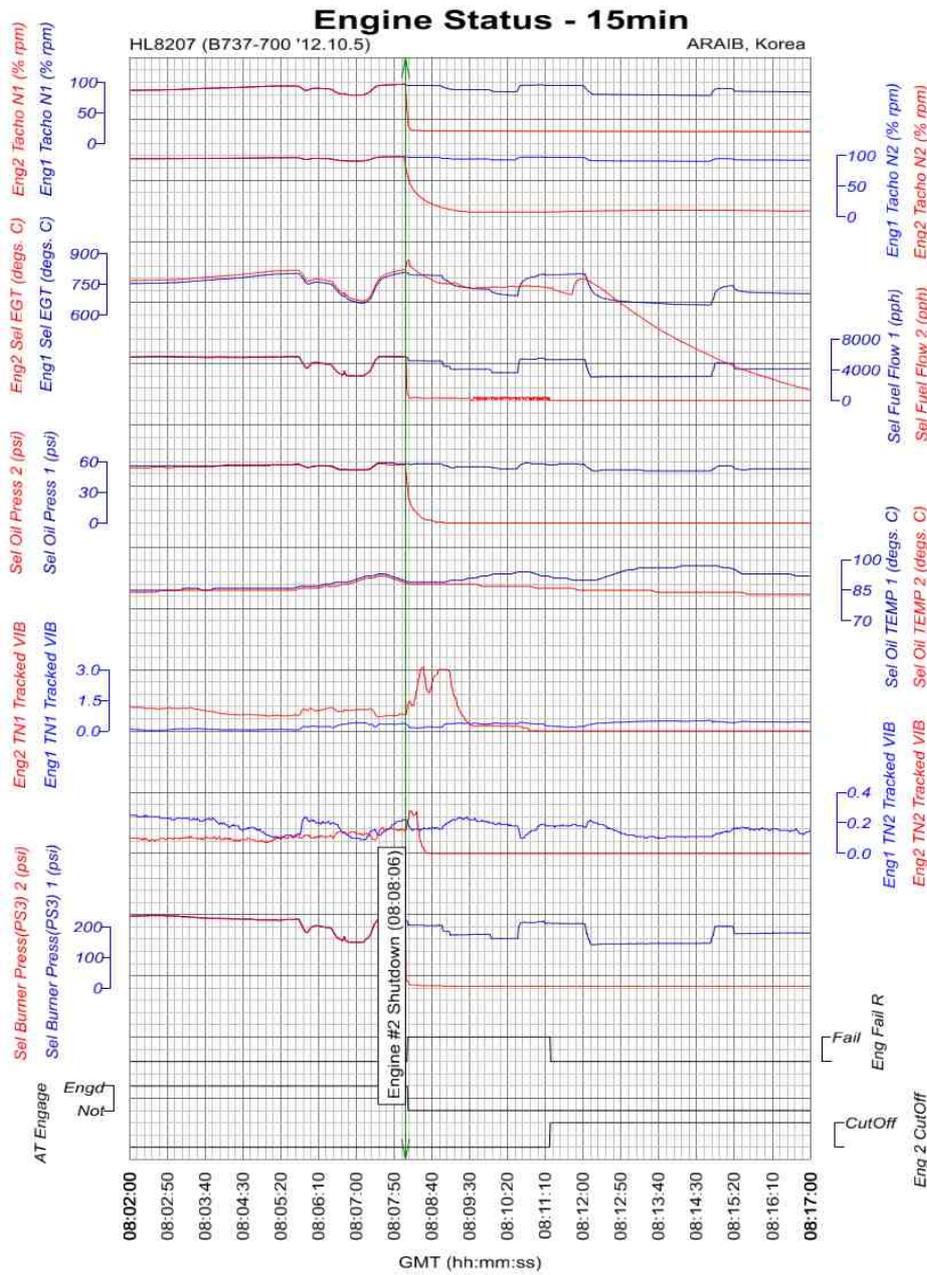
[Figure 19] Engine Parameters Analysis Graph

Among the data extracted from the FDR, major parameters relating to the engine failure, with the focus on Eastar Jet flight 223 on 5 October 2012, were selected and analyzed as shown in [Figure 19].

The FDR installed on HL8207 contained data for about 50 minutes from 07:49:41 UTC to 08:40:49 UTC. Major parameters of the right (#2) engine started to change drastically when the airplane was climbing through about 22,460 ft at 08:08:06 UTC.

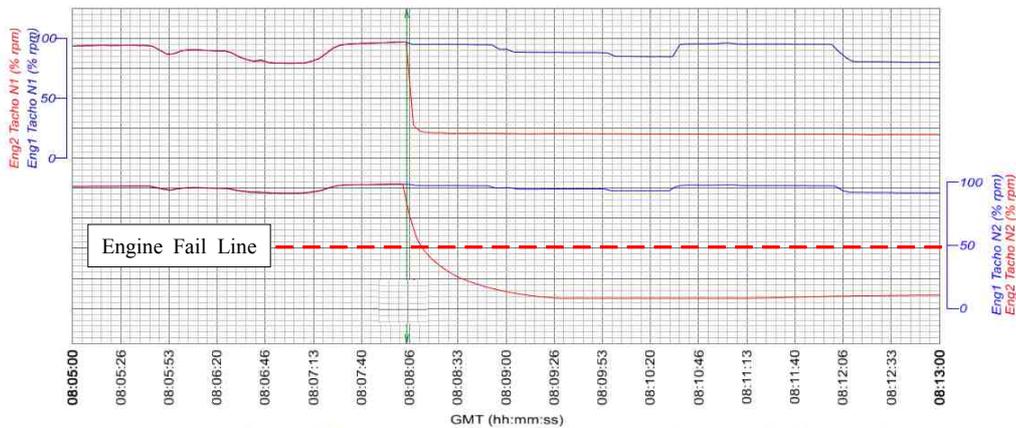
[Figure 20] N1 and N2 Speeds

As shown in [Figure 20], upon engine failure, the right engine's N1 speed sharply dropped from 96.9% to early 20% just within 3 to 4 seconds, and N2 speed also went down to less than 30% from 98.5%, which indicates that, although the flight crew put the thrust lever in the close position, the engine failed to maintain idle thrust.¹⁹⁾ If N2 speed decreases to less than 50%, the cockpit EGT indicator will display an "ENG FAIL" message.

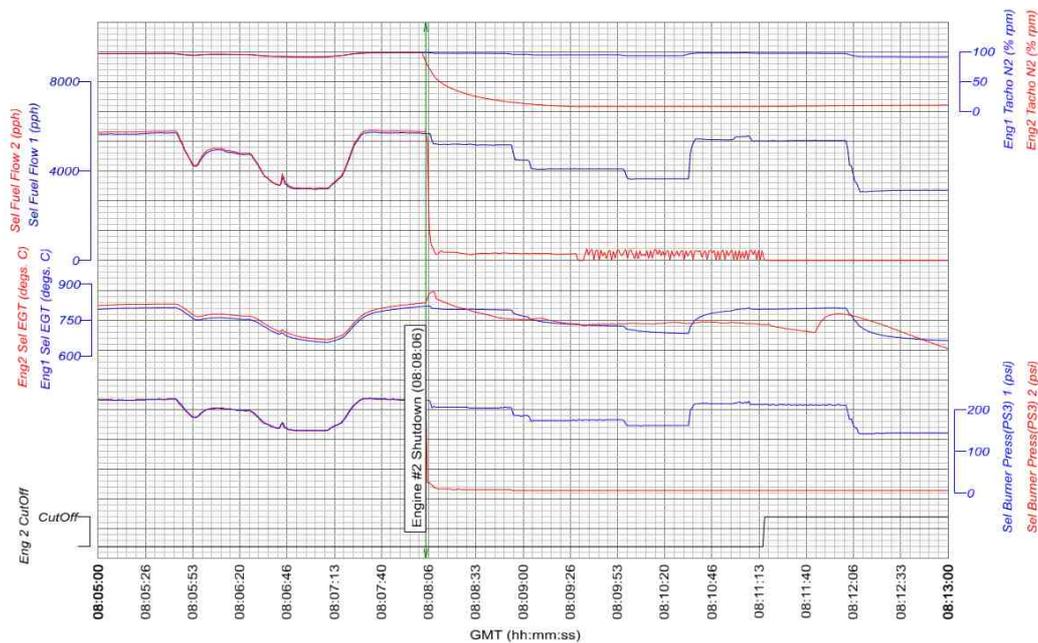
[Figure 21] N2, FF, EGT, and Ps3

As shown in [Figure 21], the right engine's fuel flow (FF) was about 5,760 pph before the event but, upon engine failure, drastically dropped. However, fuel did not completely stop flowing. Instead, it was flowing at 250 - 400 pph for about 3 minutes until the flight crew took action.

The flight crew disconnected the autothrottle 3 seconds after the event, when the "ENG FAIL" message was displayed. This message disappeared after the flight crew put the engine starter lever in the cutoff position.

A small amount of fuel which was supplied when the combustion chamber flamed out flew into the HPT and LPT and was burned at a high temperature, thereby increasing the temperature of the engine interior. Also, as the compressor shaft's low rpm weakened the cooling function of the engine, the LPT blades and vanes sustained secondary thermal damage.

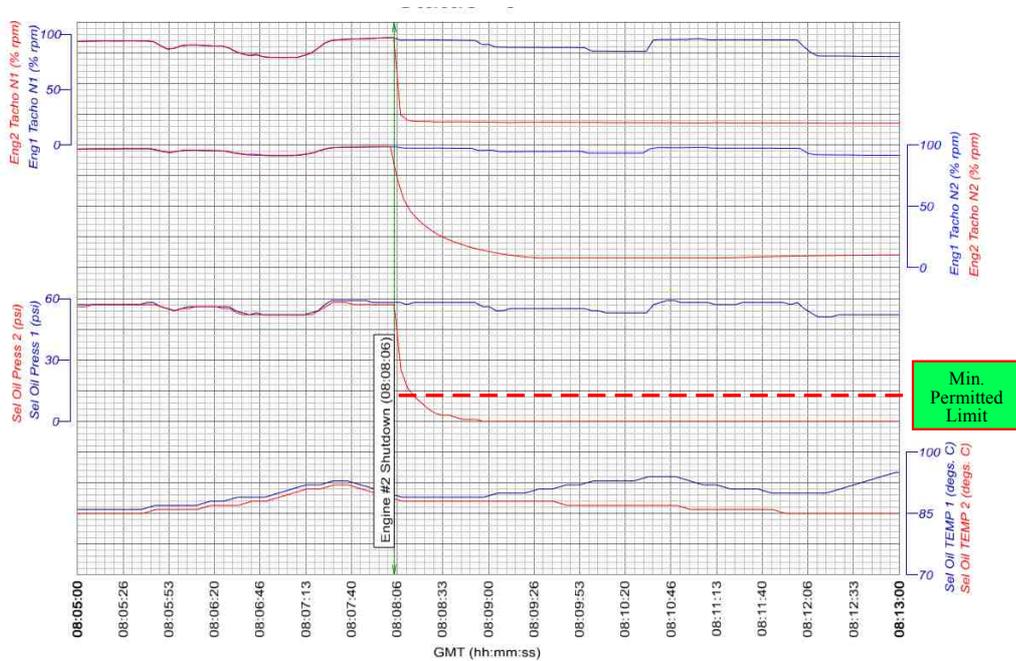
[Figure 22] N1, N2, Oil Pressure and Oil Temperature

As shown in [Figure 22], 10 seconds after the event, the right engine's oil pressure that had been 57 psid dropped to less than the minimum permitted limit, 13 psid, then 40 seconds after the event, further to 0. This was because the function of the oil pump was lost as N2 speed that was the driving force of the oil pump was too low. In the meantime, oil temperature²⁰⁾ started to decrease from 88°C very slowly without rising again since the system was not cooled due to the failure of oil to be circulated within the system.

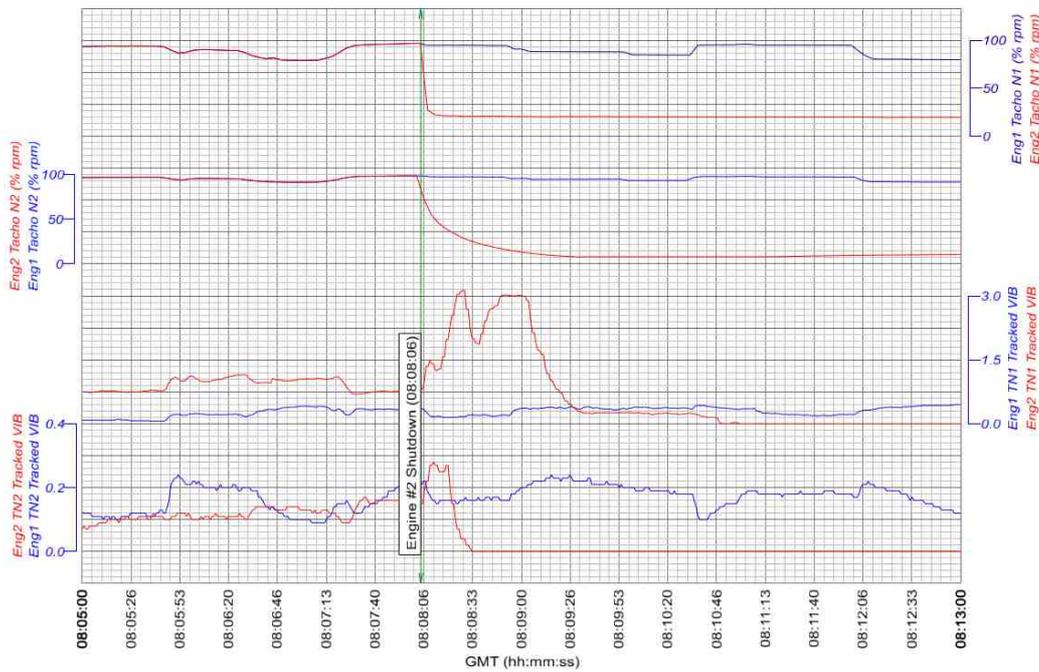
[Figure 23] Engine Vibration

As shown in [Figure 23], before the event, the engine vibration level was in good condition, much less than the maximum permitted limit, 4 units.²¹⁾ After the event, the N1 vibration level jumped to the maximum 3.1 units and after the engine shutdown, dropped back to less than 1.0 unit, which indicates that, after vibration levels temporarily increased due to the liberation of the LPT blades

and vanes, they gradually became stable due to a decrease of the shaft's rpm caused by the liberation of all the LPT stage 1 and 2 blades. The N2 vibration level did not exhibit a big change after the engine failure, which is because small loads applied to the HPT shaft (N2) as the HPC sustained a minor damage and all the HPT blades had airfoil liberation almost above the platform.
