# **FOKKER F-28 MK 0100, XY-AGC** **ACCIDENT NEAR HEHO AIRPORT (VYHH)** **ON 25 DECEMBER 2012**

## **Executive Summary**

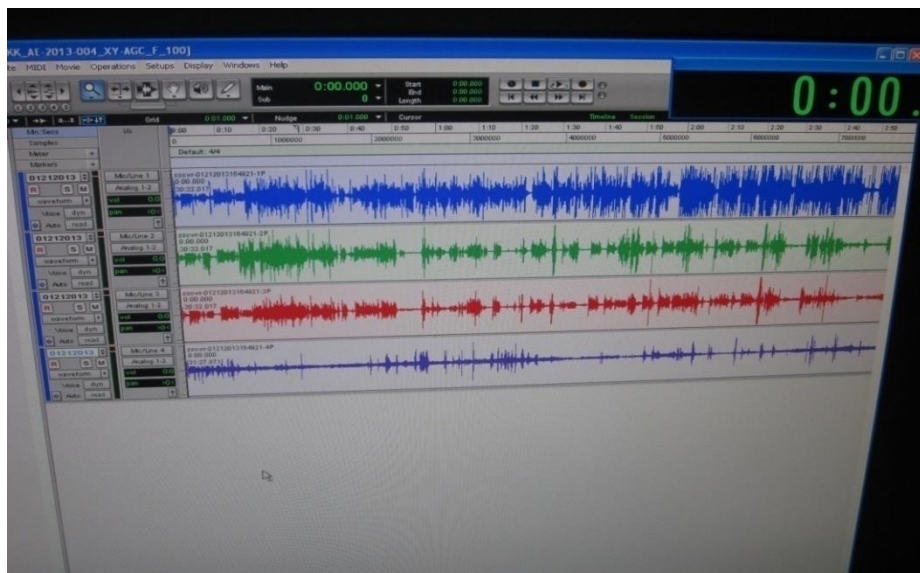
Figure 8: Cockpit Voice Recorder Downloaded

The SSCVR data was downloaded at ATSB and according with the downloaded data, FO was the designated handling pilot for this flight. While approach to MDA, the PIC reported to ATC about fog layer between the aircraft and runway. During the final approach, GPWS call out alert warning sound to crews with "500" "100" "50" "40" "30". PIC initiated to "Alt Hold" at about MDA 100 ft. The CVR transcript at ([Appendix-E](#)).
