FINAL REPORT

AIC 13-1007

AIRCRAFT ACCIDENT REPORT

Avions de Transport Régional ATR 42-320 freighter

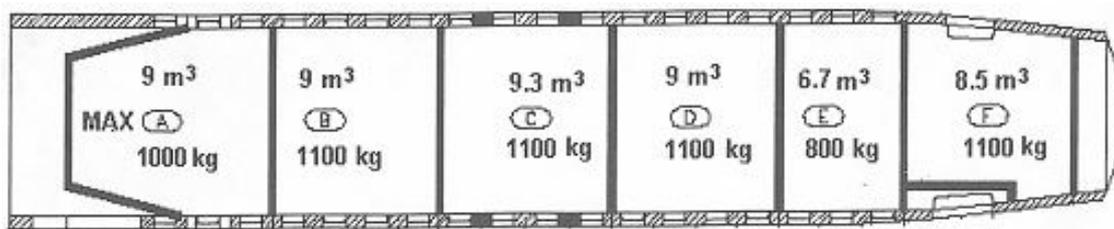
Figure 5: Diagram on PXY's load sheet showing compartments 'A' to 'F'

A diagram on the aircraft's load sheet showed the layout of the cargo compartments and the maximum permitted floor loading of each compartment (Figure 5).

The PIC determined that the maximum cargo weight³ to be loaded was 3,710 kg. During the AIC interview the Senior Cargo Officer stated that the PIC instructed 'Zone A to have 350 kg, 30 cartons'. The investigation determined that 30 cartons actually weighed 395 kg.
