# **FINAL REPORT**

## **AIRBUS A380, REGISTRATION 9V-SKE DIVERSION TO BAKU, AZERBAIJAN**

**5 JANUARY 2014**

AIB/AAI/CAS.101

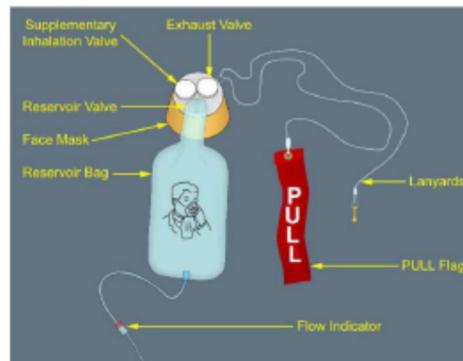
**Figure 11** – Oxygen mask arrangement

1.8.3.2 **Figure 11**, shows a typical arrangement for oxygen to flow to the oxygen mask<sup>11</sup>:

- (a) Oxygen will flow from the PSU through a tube to an oxygen bag and then to the oxygen mask.
- (b) The tube has a flow indicator that will indicate a green band when the oxygen flow is 0.5 litre per minute or more.
- (c) A lanyard is latched to the oxygen mask. Pulling on the oxygen mask will cause the lanyard to release a pin in the oxygen dispenser mechanism, thereby opening a valve to allow oxygen to flow into the tube.

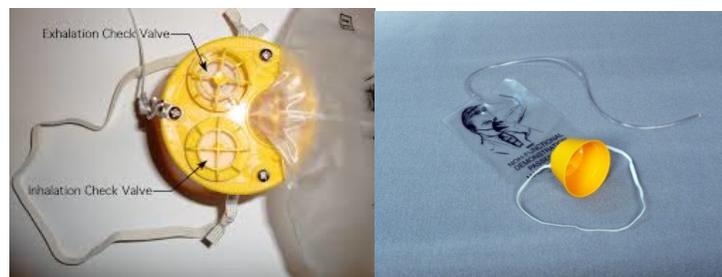
**Figure 12** – Oxygen mask construction

- (d) When a person inhales through the oxygen mask, air in the aircraft cabin will also be drawn into the mask through an inhalation check valve (**Figure 12**). Therefore, what a person is breathing in is actually a mixture of oxygen from the aircraft's oxygen supply system and air from the aircraft cabin. The resultant composition of the air mixture depends on the oxygen flow rate (which depends on the cabin altitude).
