**Havarikommisjonen**  
Accident Investigation Board Denmark

# **BULLETIN**

**OY-JAI**

File number: HCLJ510-2014-257  
UTC date: 22-1-2014  
UTC time: 07:50  
Occurrence class: Accident  
Location: Copenhagen Airport, Roskilde (EKRK)  
Injury level: None

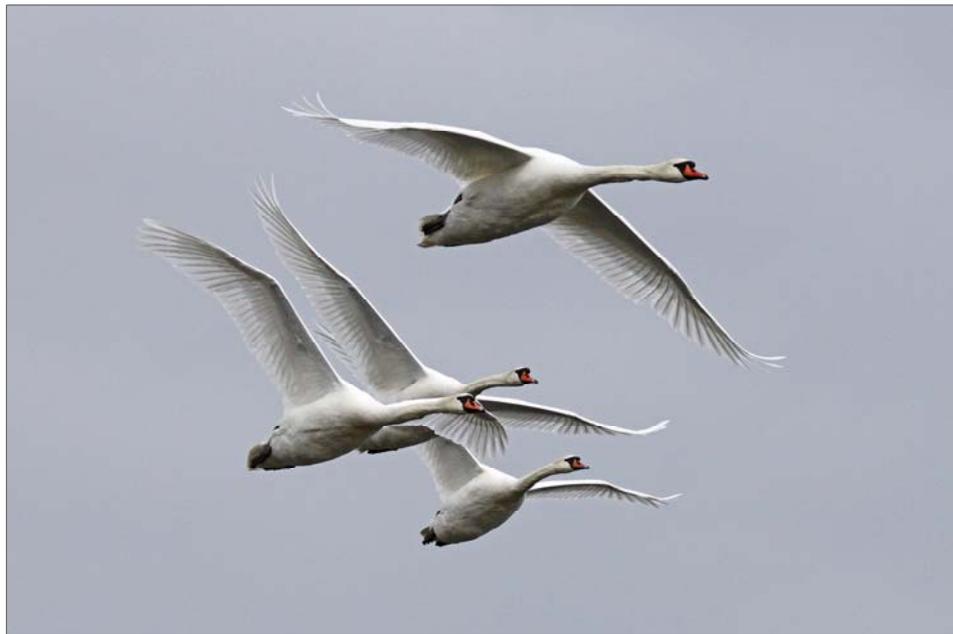
Immediately after the accident, four dead Mute Swans were found close to runway 11. The injuries indicated that the birds were struck by an aircraft.

Bird species:	Mute Swan ( <i>Cygnus olor</i> ) (In Danish: <i>Knopsvane</i> ).
Weight:	8 500 – 14 000 g.
Length:	150 cm.
Wing span:	205 - 235 cm.
