PRELIMINARY
KNKT.14.02.04.04

Aircraft Accident Investigation Report

**PT. Lion Mentari Air (Lion Air)
Boeing 737 – 900ER; PK-LFH
Juanda Airport, East Java
Republic of Indonesia
01 February 2014**

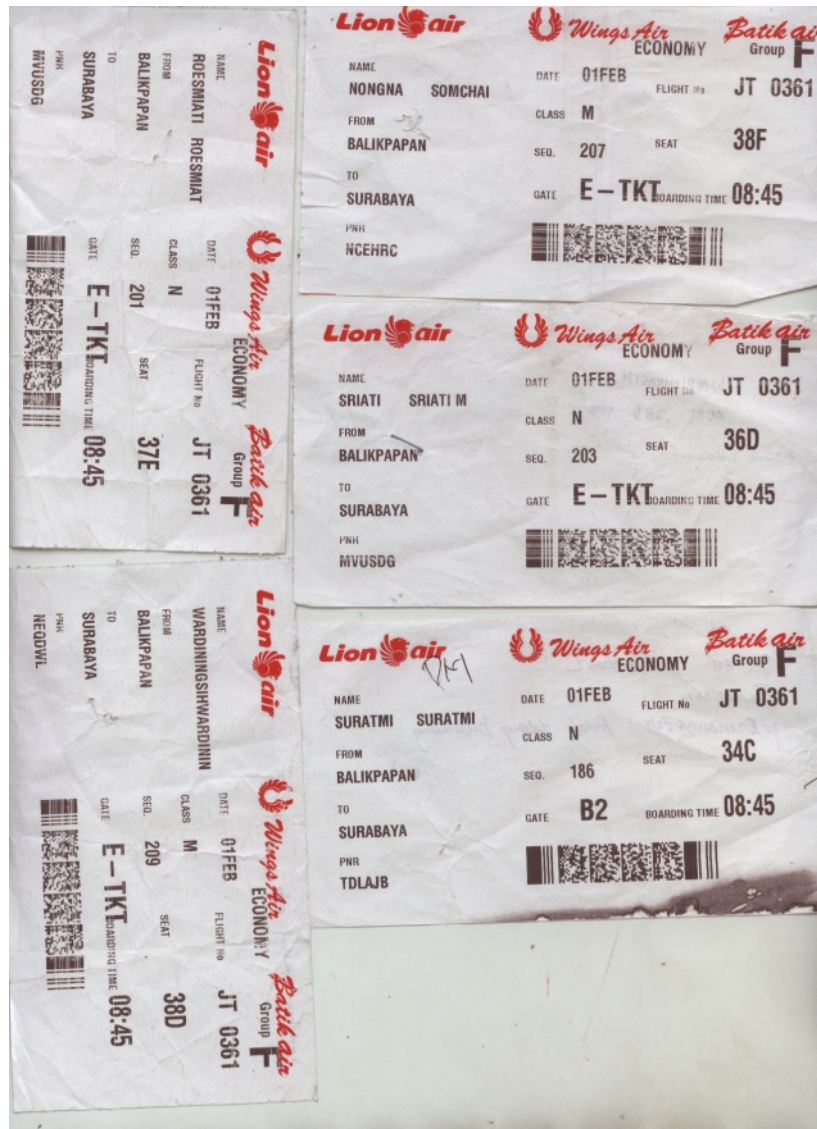
Figure 7. The injured passenger seating

The injured passengers seating

Seat no 38 F Nong Somchai, 2. 37 E Roesmiati , 3. 36 D Sriati M, 4. 38 D Wardining sih, 5. 34 C Suratmi.
