In-flight upset, inadvertent pitch disconnect, and continued operation with serious damage involving ATR 72 aircraft, VH-FVR

47 km WSW Sydney Airport, New South Wales | 20 February 2014

ATSB Transport Safety Report
Aviation Occurrence Investigation
AO-2014-032
Final – 24 May 2019

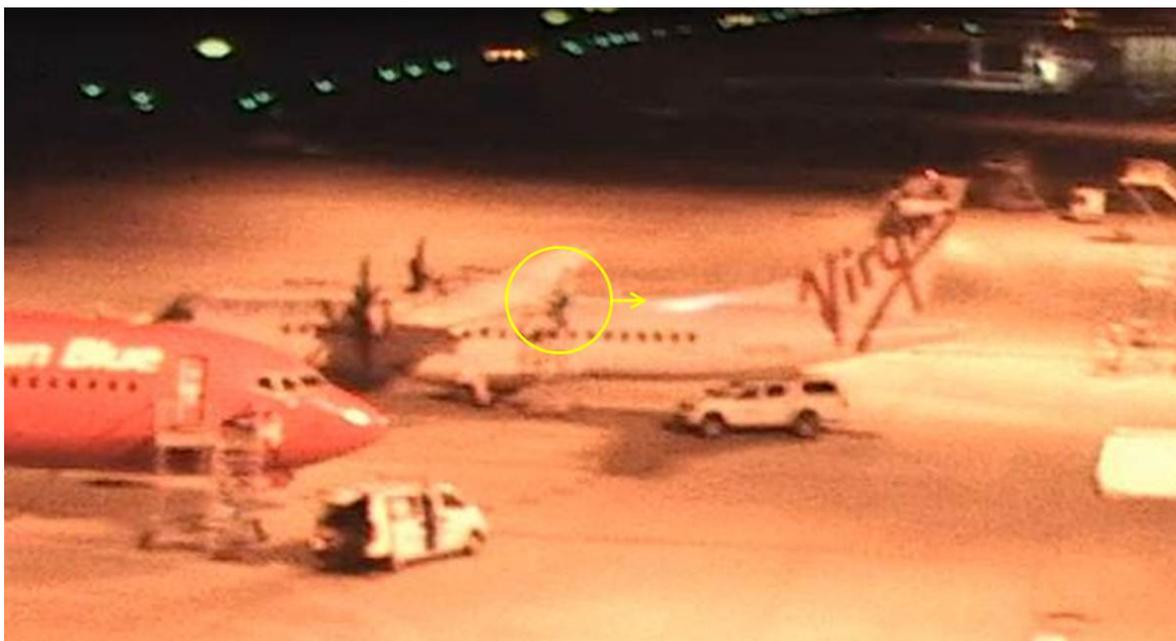
After attending to an arriving aircraft, LAME 2 returned to VH-FVR at about 2300. The engineer borrowed a nearby fixed-height stand to provide an elevated platform and positioned it to the rear of the left wing. That stand was described as the best he could get at that time and was of a height that provided a view of the top of the wing but not the top of the stabilisers. While on the stand, the engineer shone a torch over the upper surface of the wing, rear fuselage and tail (Figure 3). The engineer was on the stand for about a minute and the torchlight was directed to the rear fuselage and tail for a couple of seconds. No damage was identified.

Figure 3: Aircraft visual inspection underway at 2306:44 with LAME 2 on the stand at the rear of the left wing. The circle and arrow indicate the location of the LAME and the direction of torchlight (still image copied from closed circuit TV footage)

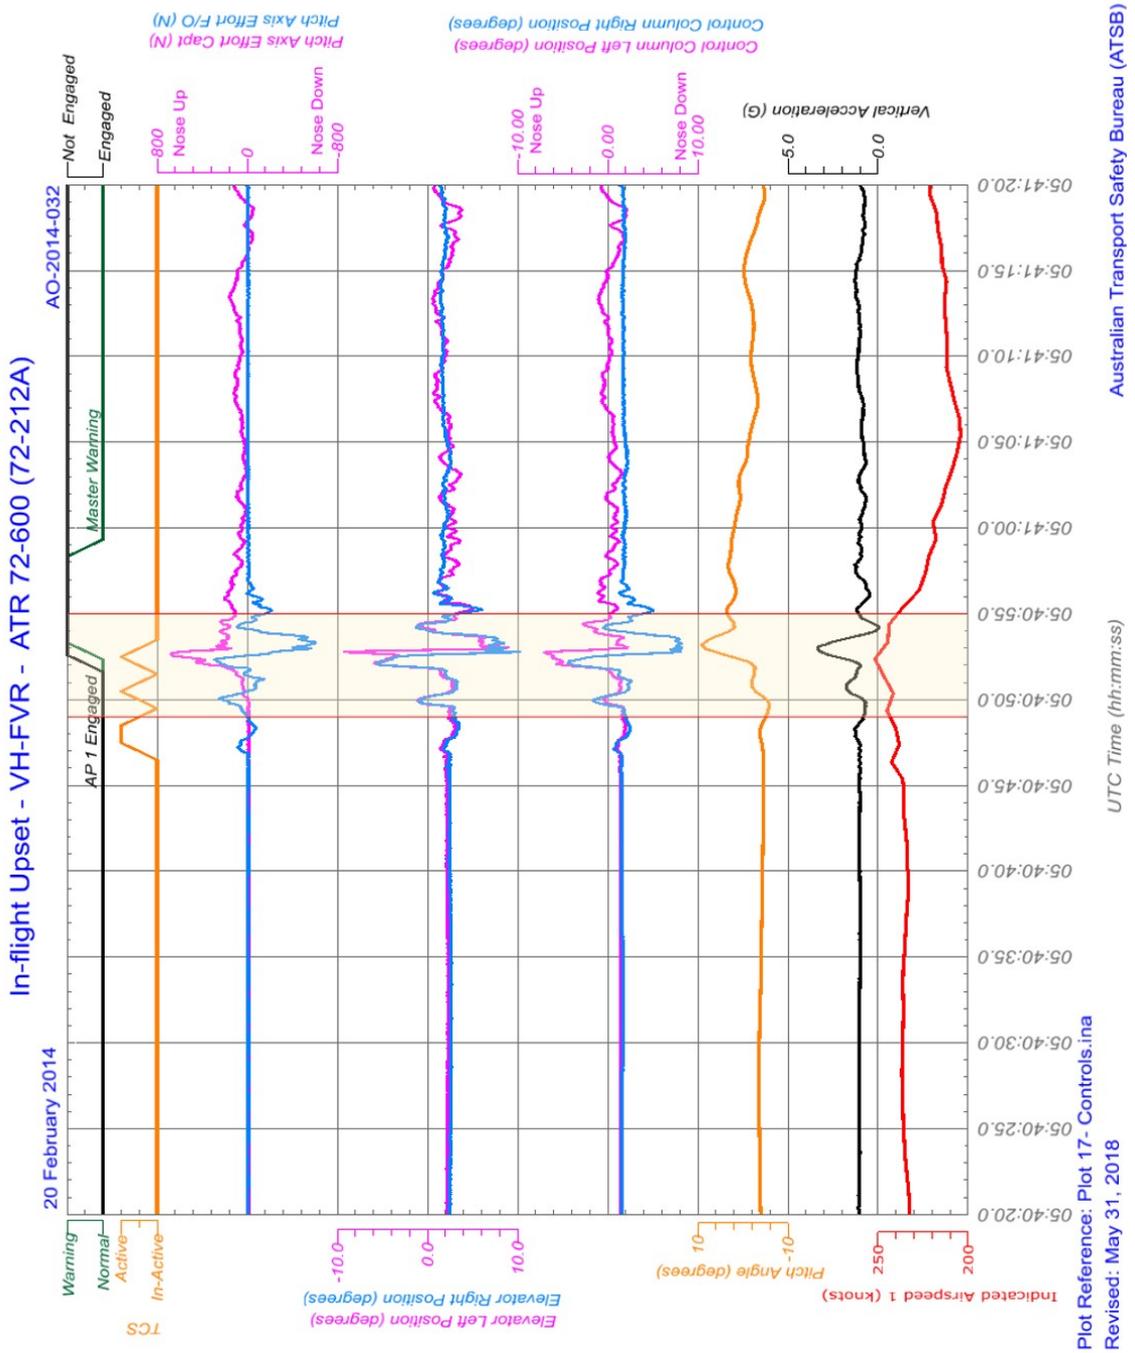
Figure 35: FDR information showing the relevant pitch parameters for a period spanning about 30 seconds before and after the pitch disconnect. The yellow shaded period is presented in Figure 36.

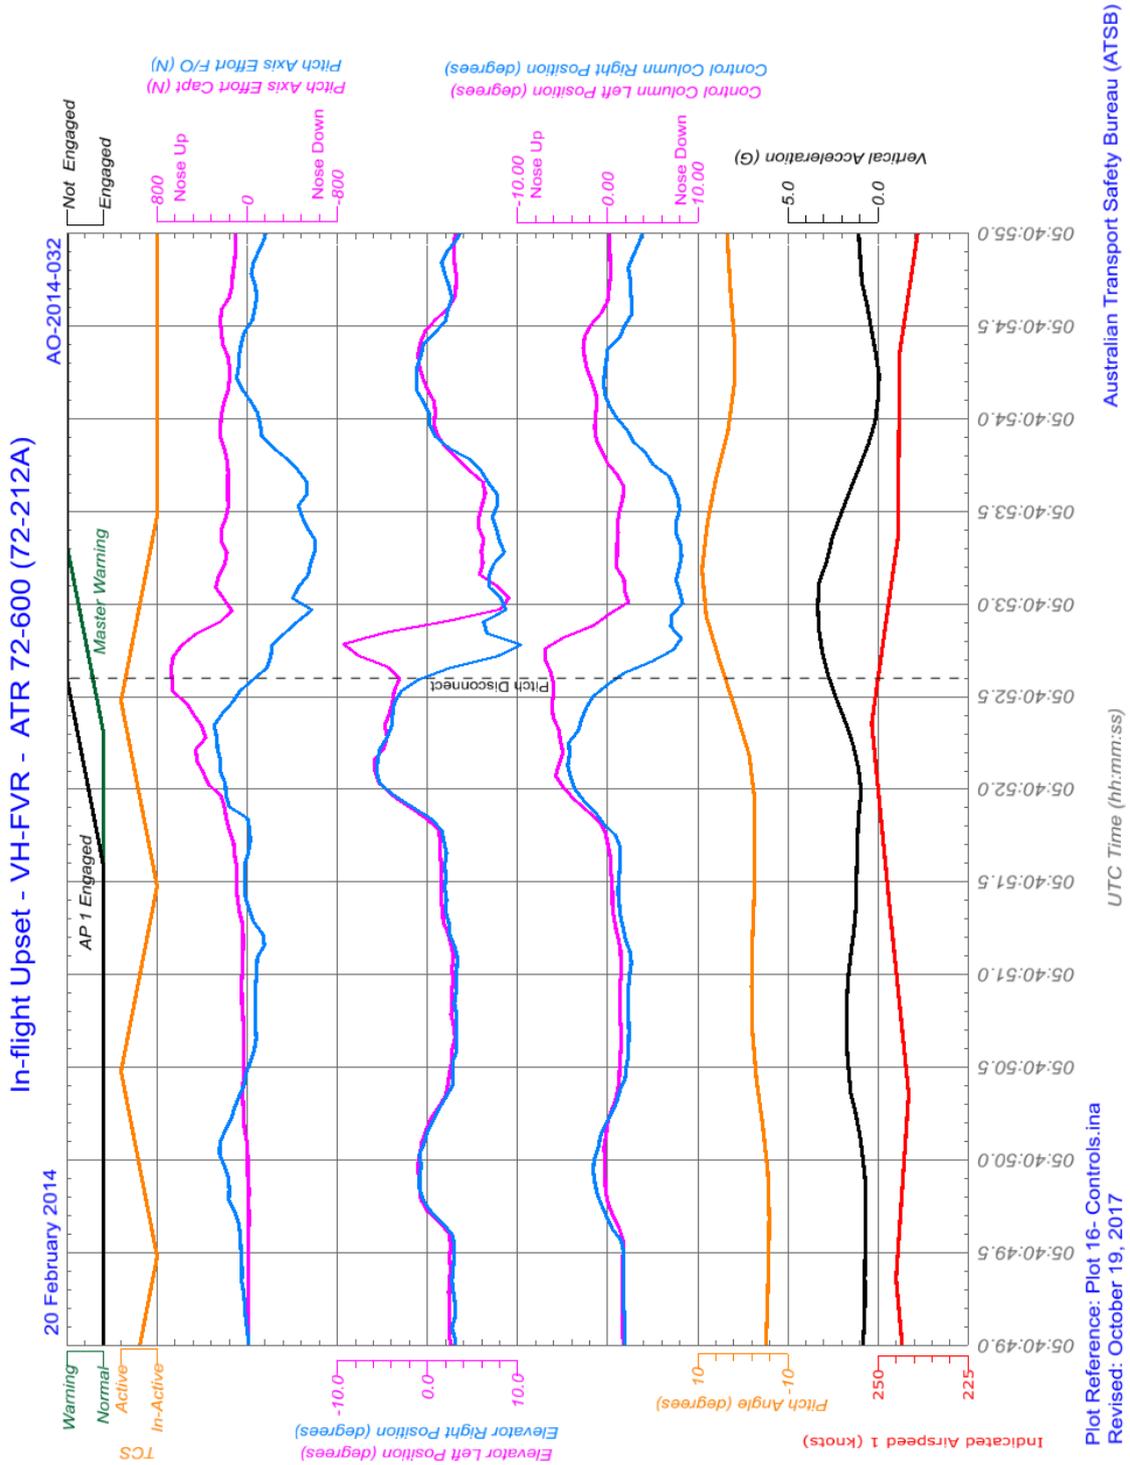
Figure 36: FDR information showing the relevant pitch parameters for the shaded 6-second period in Figure 35, during which the pitch disconnect took place. The estimated time of the pitch disconnect is shown with a black dashed line at time 05:40:52.6

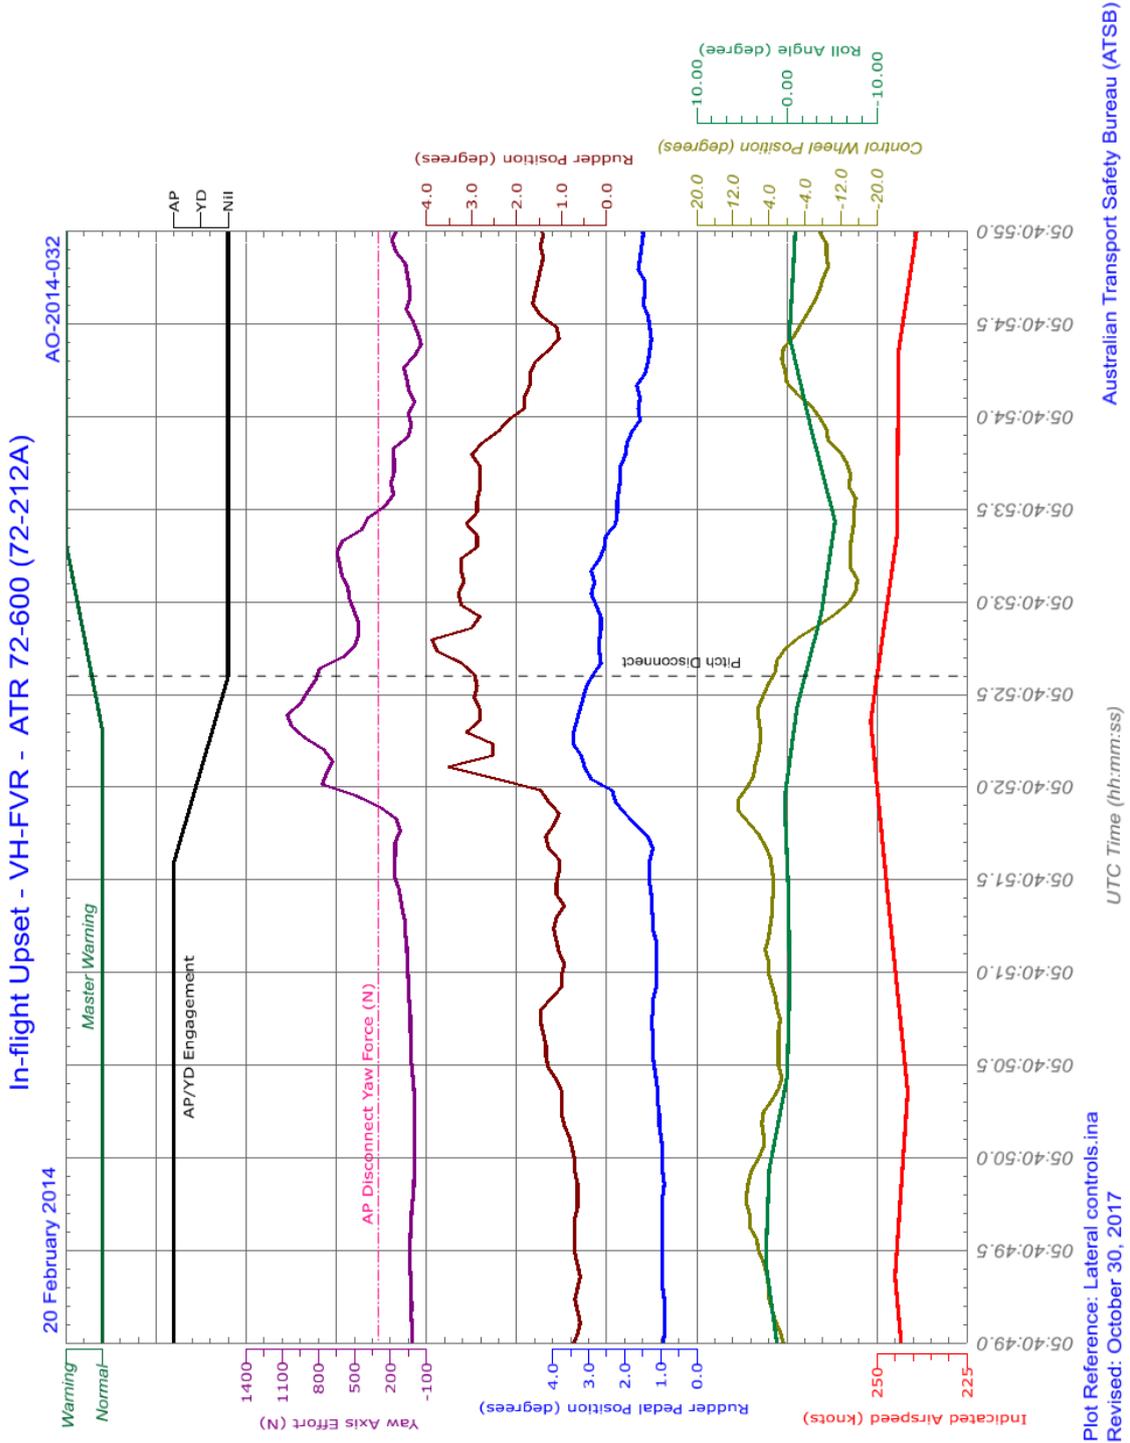
Figure 37: FDR information showing selected lateral-directional (yaw and roll) control parameters over the same 6 seconds as Figure 36. The yaw axis force required to disconnect the autopilot (AP) is identified as a pink dashed horizontal line on the yaw axis effort parameter.

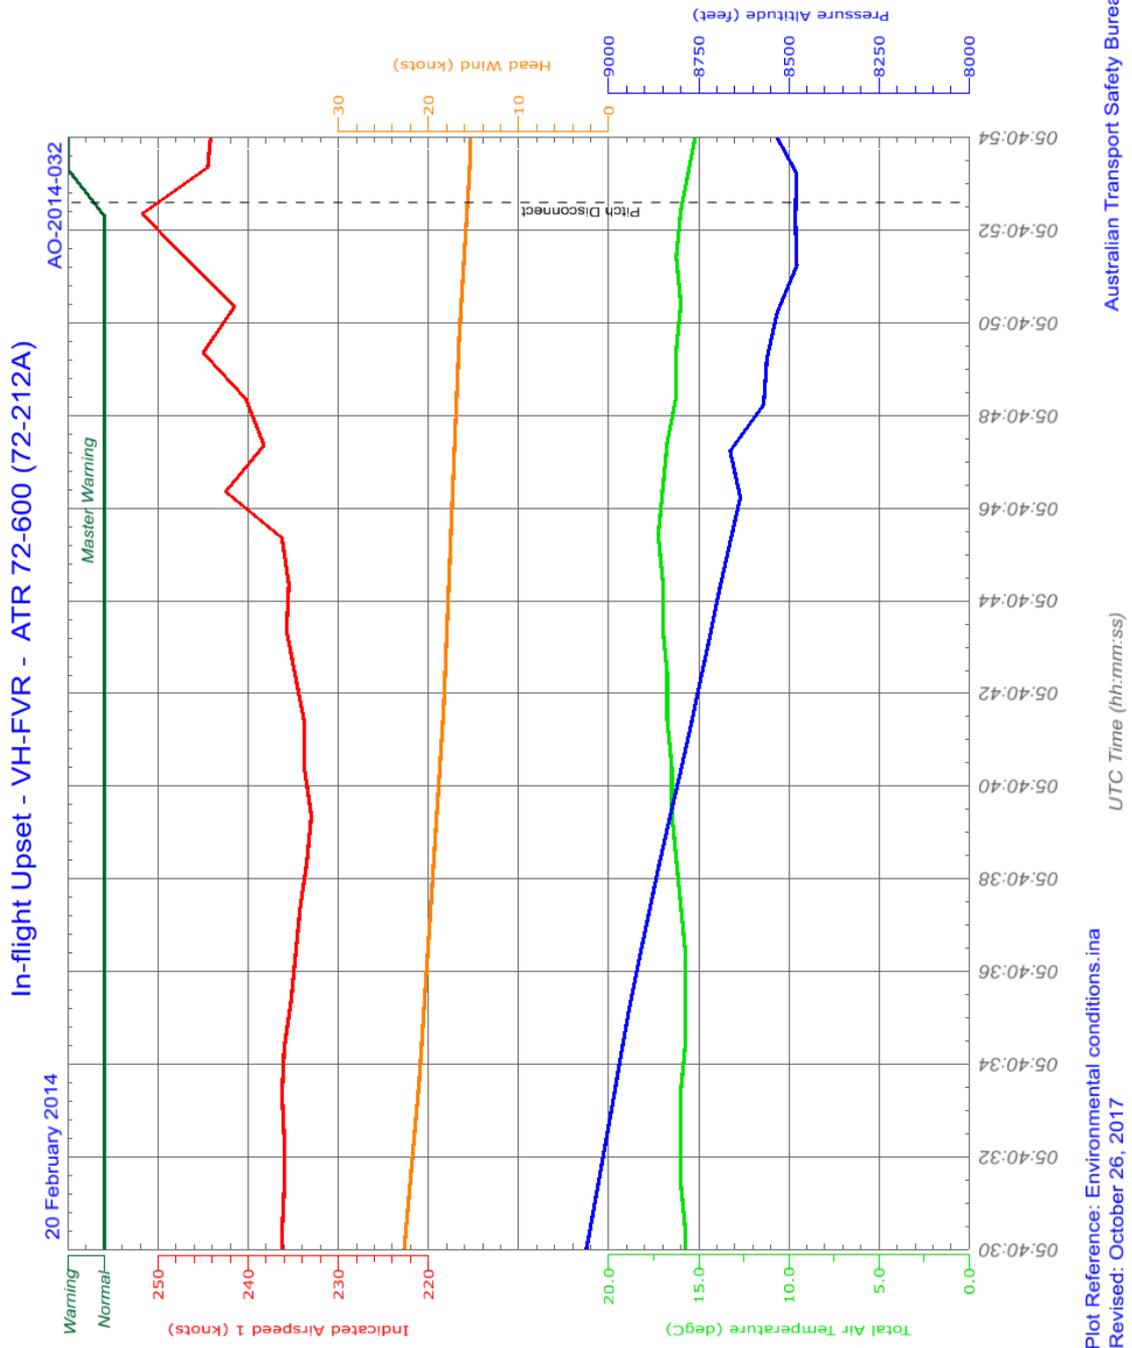
Figure 38: FDR information showing selected environmental data over a 24 second period, from 22 seconds before the pitch disconnect. The estimated time of the pitch disconnect is shown with a black dashed line at time 05:40:52.6

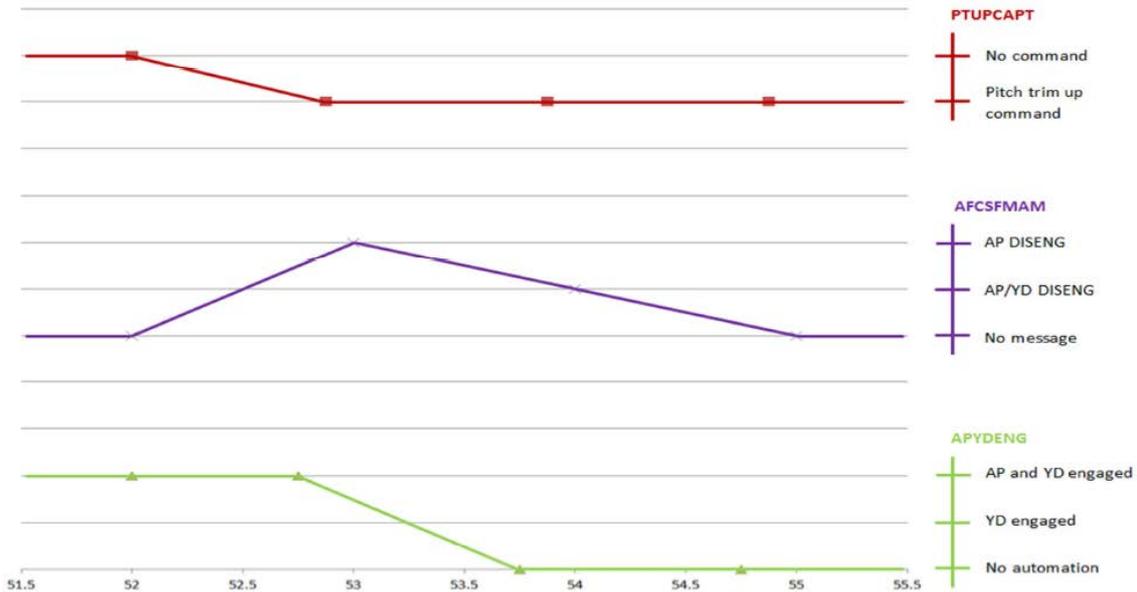
Figure 39: FDR information showing the captain’s pitch trim up command (PTUPCAPT), AFCS message (AFCSMAM) and autopilot/yaw damper engaged (APYDENG) parameters following the pitch disconnect event.

The data indicates that the recorded autopilot/yaw damper engaged parameter changed directly from both engaged to no automation. However, the automatic flight control system message changed from no message, to autopilot disengaged and then to autopilot/yaw damper disengaged, before returning to no message. It was also observed that the captain made a nose-up pitch trim command at about the same time.

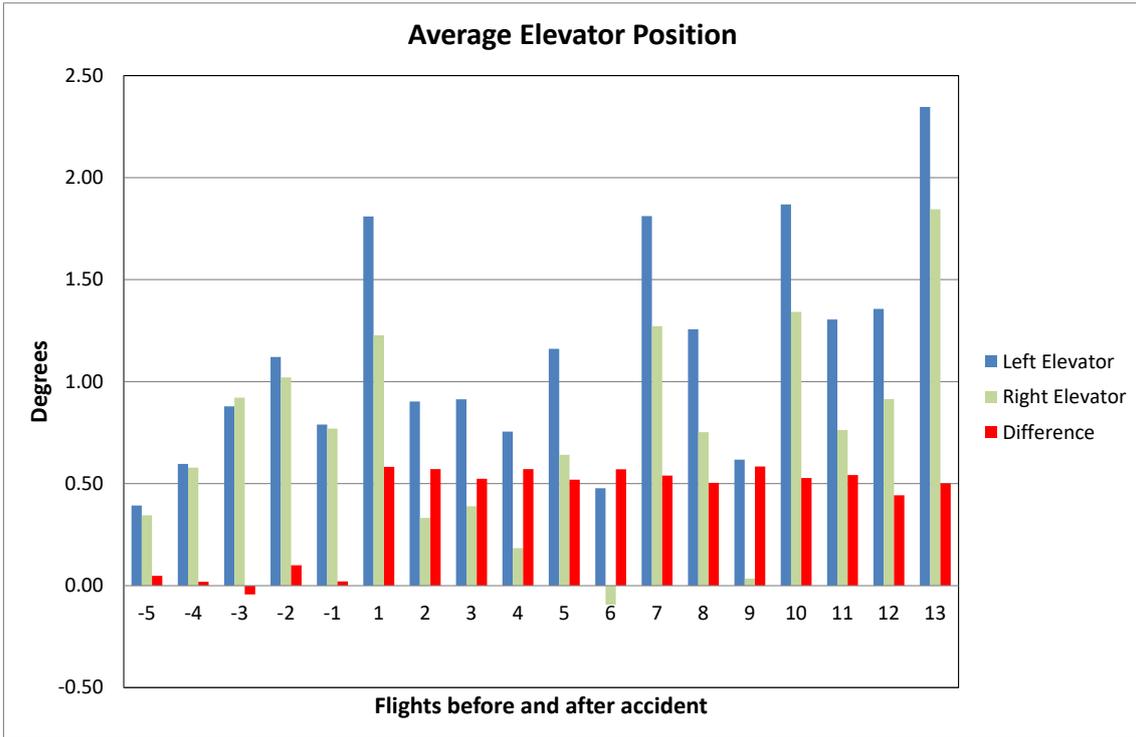
Figure 40: Comparison of the average position for the left and right elevators over a range of flights before and after the pitch disconnect.

Also included on the chart is the difference between the left and right elevator positions. Note: A negative flight number indicates that the flight was taken before the pitch disconnect.

The size and persistent nature of the difference between the elevator positions is an indication that the damage to the horizontal stabiliser was generated during the pitch disconnect event and that any further degradation of the structure was probably minimal.

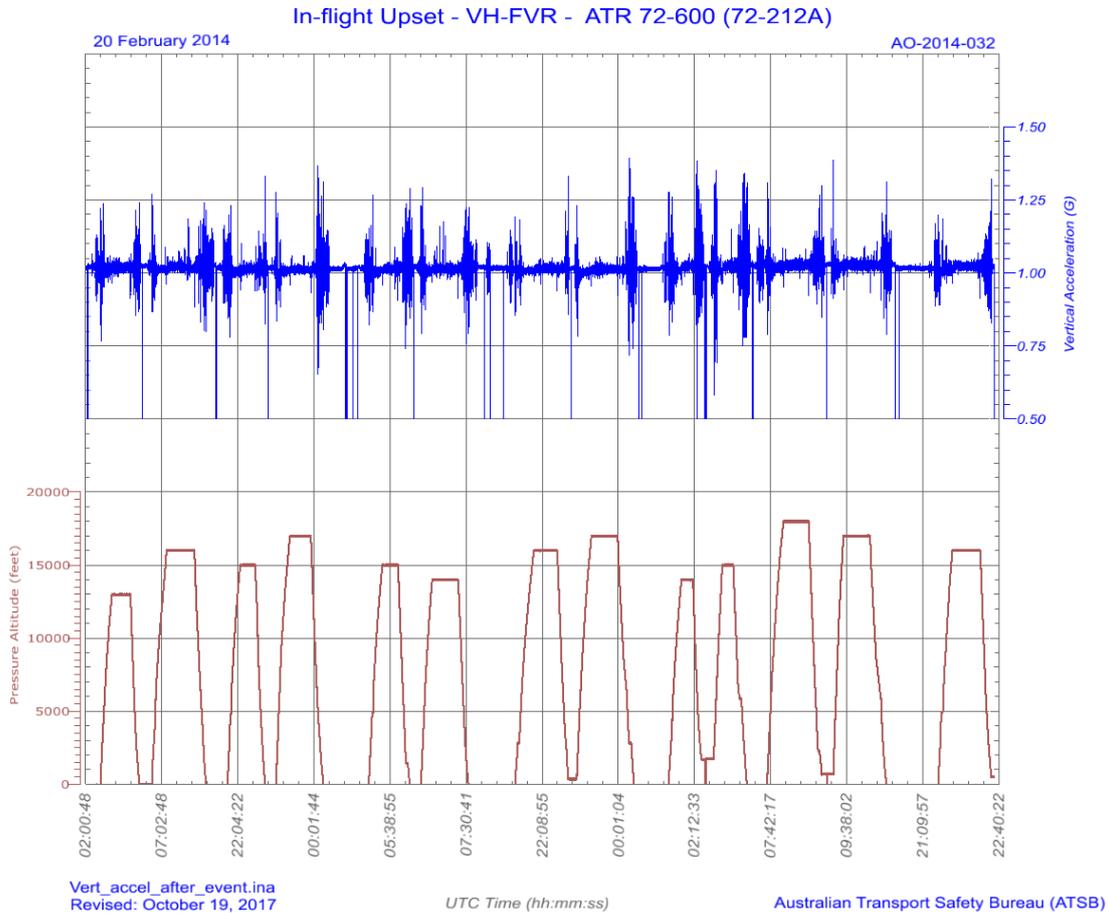
Examination of the vertical accelerations (flight load factors) during the 13 flights following the pitch disconnect (Figure 41), found that the largest vertical acceleration was 1.4 g.

Figure 41: Vertical acceleration recorded on flights between 20 February 2014 and 25 February 2014. The peak acceleration during the in-flight upset was 3.34 g. The maximum on the subsequent flights was 1.4 g.

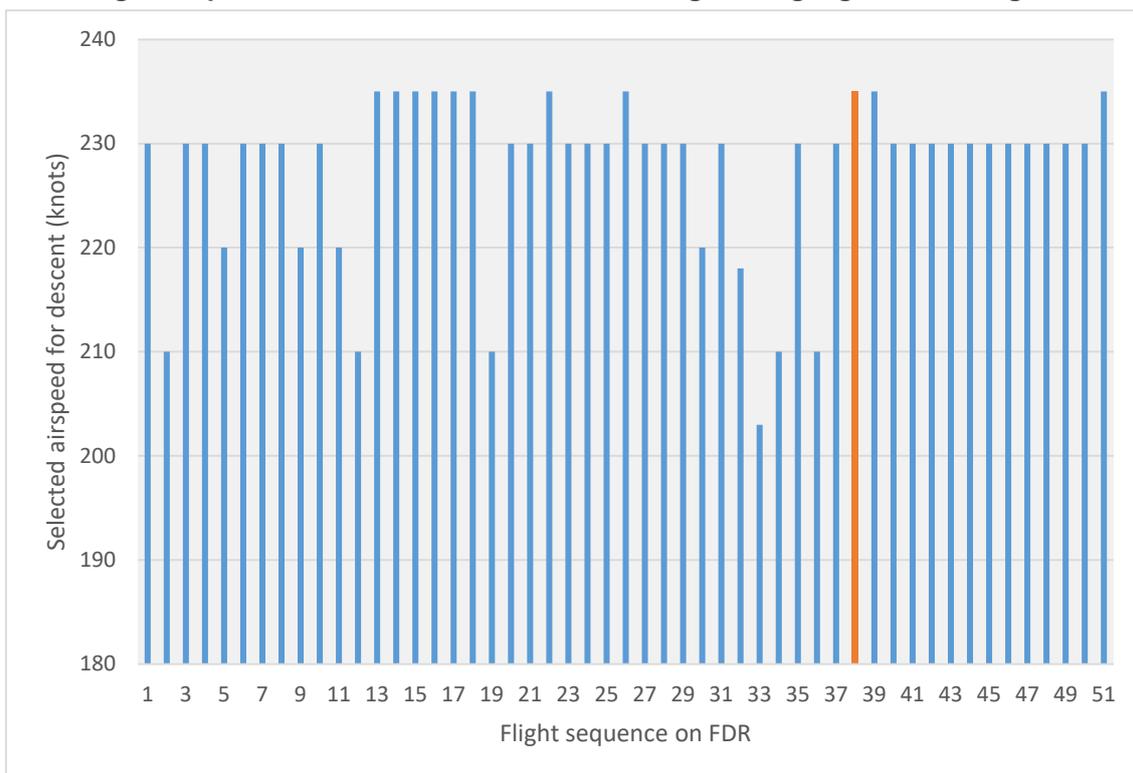
The airspeed that was initially selected for the descent for the 51 flights contained on the FDR were examined (Figure 42). For a number of the flights, the selected airspeed was lowered during the descent, for reasons that were not determined, but could be for factors such as turbulence and airspace restrictions. The initial selected airspeeds varied from 203 to 235 kt. The data indicates that 230 kt was the most commonly selected initial selected descent airspeed, with 29 of the 51 descents being at this speed. Eleven flights, including the occurrence flight (flight 38), had a selected airspeed of 235 kt, which was the second most commonly selected speed.

Figure 42: History of the initially selected descent airspeed for the descent for each of the 51 flights captured on the FDR. The occurrence flight is highlighted in orange.

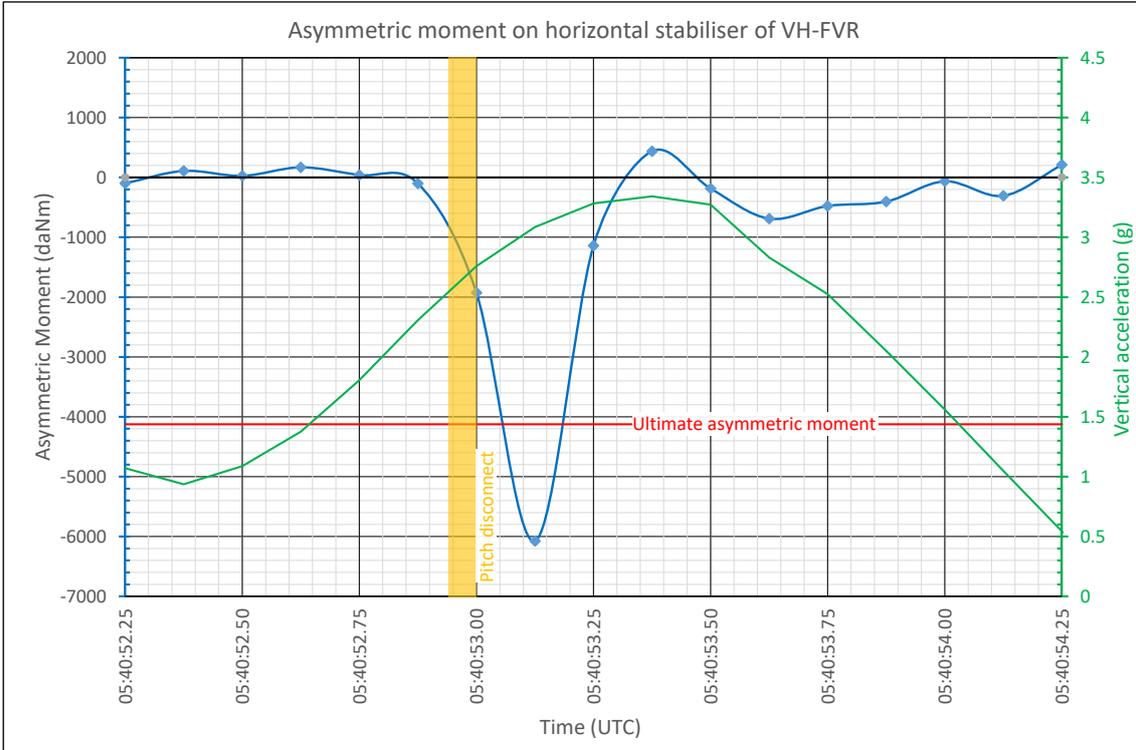
Due to the dynamic nature of the occurrence, the loads were not static, so the loads exceedances were only for short periods of time. For example, the variation in the asymmetric moment of the horizontal stabiliser is presented in Figure 43, clearly illustrating it exceeded the ultimate asymmetric moment for only about 0.125 seconds.

Figure 43: Variation in the calculated asymmetric moment in the horizontal stabiliser during the pitch disconnect event. The data calculated by ATR are represented by blue diamonds. A curve has been fitted to the data to represent the variation of the moment during the event.

The ultimate load (asymmetric moment) is shown by a red line and the time of the pitch disconnect identified by a vertical yellow line. Also included on the chart, in green, is the vertical acceleration recorded on the FDR.

The manufacturer's analysis showed that the asymmetric load was effectively zero while the elevators were connected through the PUM. Also, there was no distinguishable correlation between the flight load factor and the asymmetric loads on the horizontal stabiliser (Figure 43). This indicates that the asymmetric loads on the horizontal stabiliser during the pitch disconnect event were independent of the flight loads from the pitching manoeuvre. As such, the asymmetric loads developed during the pitch disconnect can be examined independently of the loads from the pitching manoeuvre. Similar asymmetric loads could potentially be developed during a pitch disconnect in straight and level flight with no associated pitching manoeuvre.

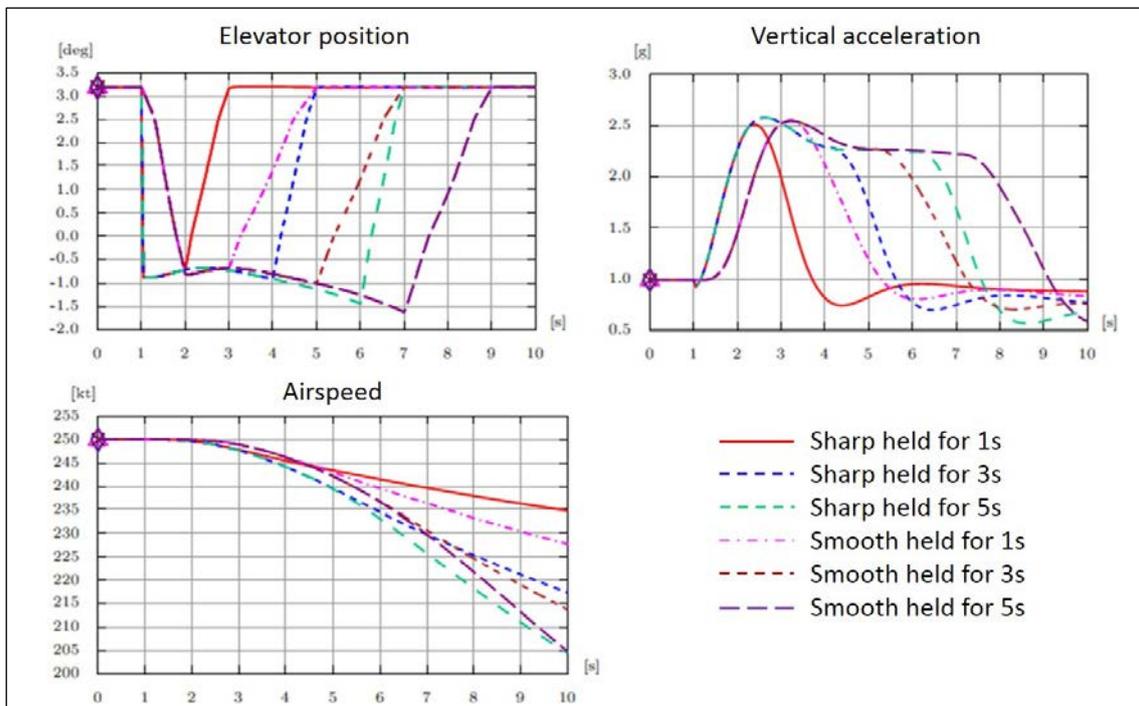
Figure 44: Results of the simulation of a single 45 daN input at 15,000 ft with a rate of descent of 3,300 ft/min. Note, the control input was made at time = 1s.

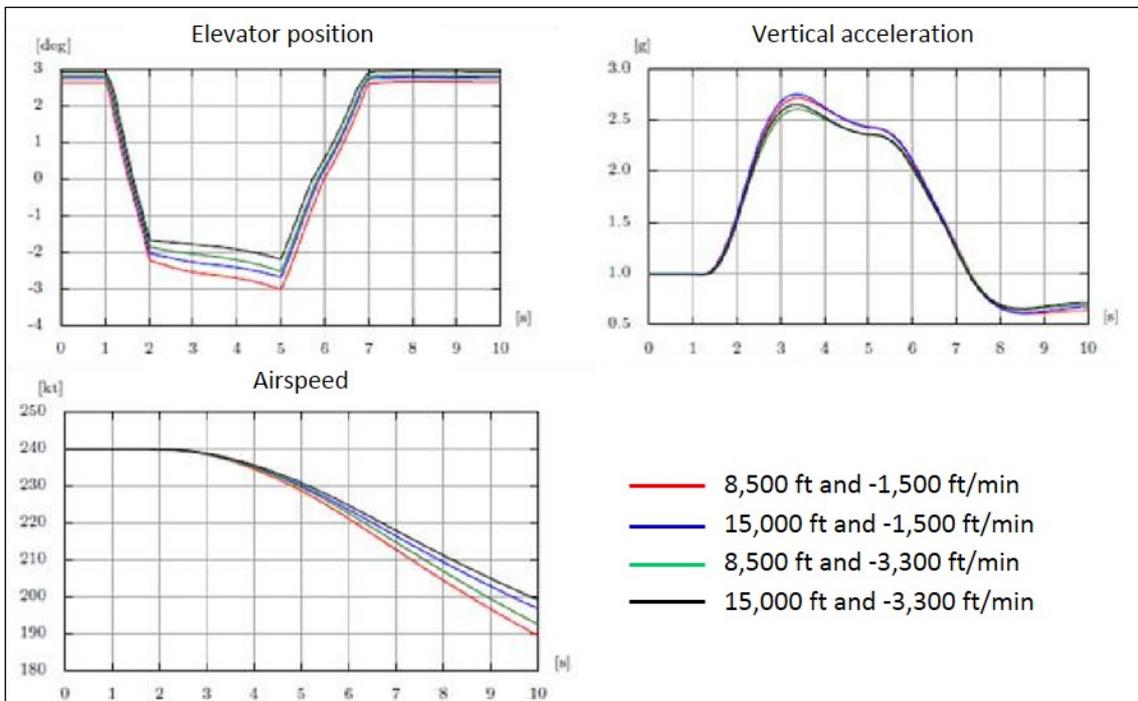
At the request of the ATSB, ATR also ran the simulation at 8,500 ft and with a rate of descent of 1,500 ft/min to compare the effect that those parameters would have on the results when these conditions were similar to the occurrence conditions. For comparative purposes, the smooth input held for 3 seconds case was used for all cases. The results of this comparative study are shown in Figure 45.

Figure 45: Results of the simulation of a single 45 daN input, with a comparison of the effects of rate of descent and altitude.

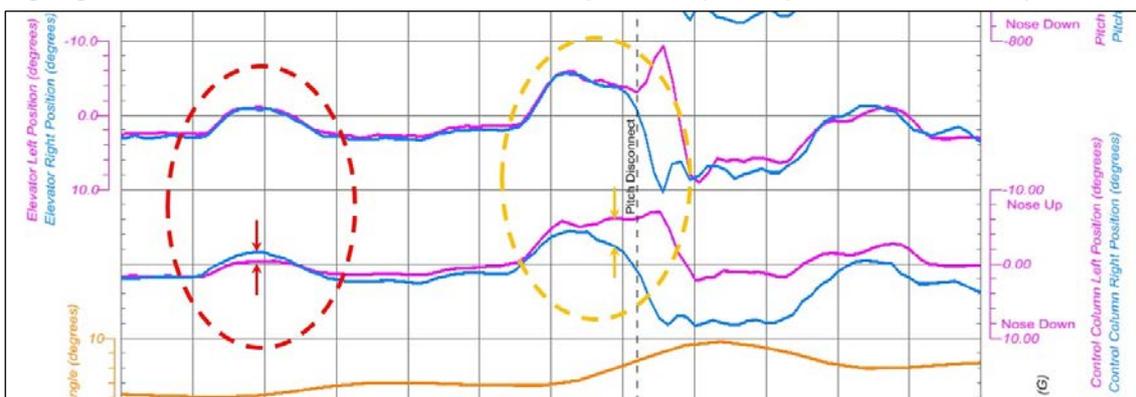
It was noted on the FDR data that when control inputs were made, prior to the pitch disconnect, the left and right elevator deflections were the same, but the left and right control column positions differed from each other (Figure 46). Given that the control column positions matched when there was no control input load, the differences in the recorded position was unlikely to have been a result of a recording or sensor error.

Figure 46: Excerpt from the flight data recorder information around the time of the pitch disconnect. The circled areas highlight regions where there was a notable difference in the left and right control column positions before the pitch disconnect. The arrows highlight the difference in the control column position (lower pink and blue lines).

Note, there is no corresponding difference between the position of the left and right elevators (upper pink and blue lines) until just before the pitch disconnect.

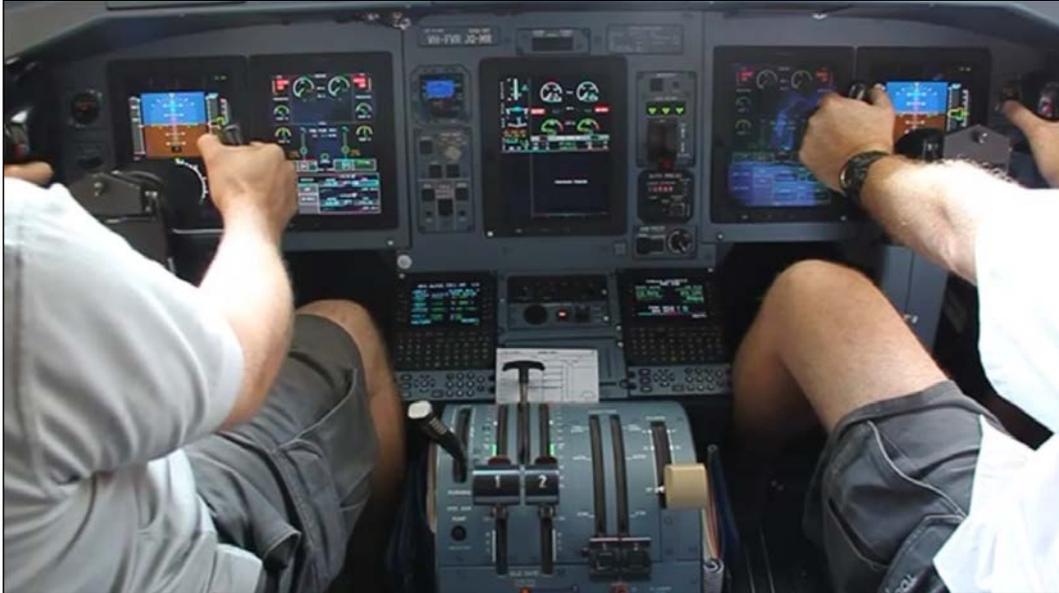
A difference in the control columns was also noted during the on-ground testing of the pitch disconnect system after the occurrence. When applying the control loads in order to intentionally activate the PUM, a significant difference in the control column positions was observed before the PUM activated (Figure 47).

Figure 47: Still image from video of on-ground pitch disconnect testing carried out on VH-FVR following the occurrence. The right control column was held fully forward while the left control was pulled back. The image is just before the pitch uncoupling mechanism activated. Note the difference between the left and right control column positions. The left control column is about halfway through its full travel, while the right control column is at the forward limit.

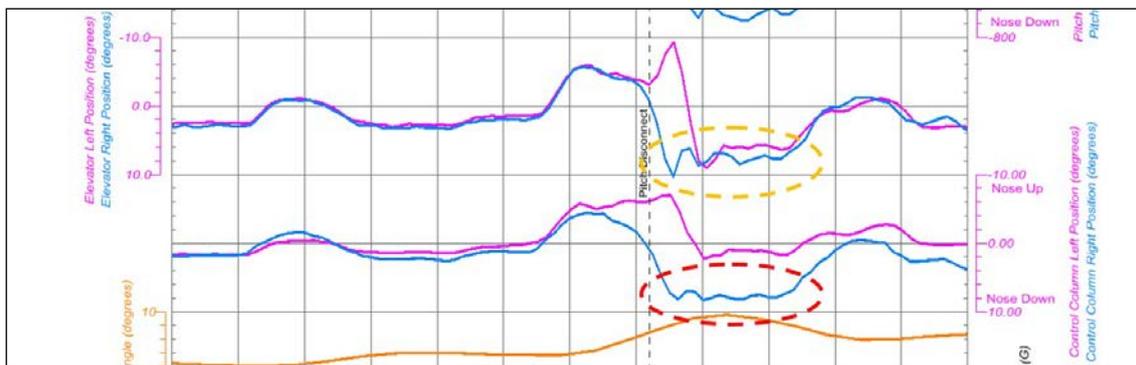
from the flight testing (Figure 48).⁶⁰ The captain’s side also exhibited a rapid increase in the elevator position immediately following the pitch disconnect that was not commensurate with the change in the control column position during the same time. The captain’s control column moved back by about 1°, but the elevator deflection increased by about 6°.

Figure 48: Excerpt from the FDR data from VH-FVR during the pitch disconnect event. The underdamped oscillatory characteristic response of the elevator movement following pitch disconnect is circled in yellow. The region circled in red indicates that there was also some oscillation in the control column, but the amplitude was not commensurate with the elevator deflections.

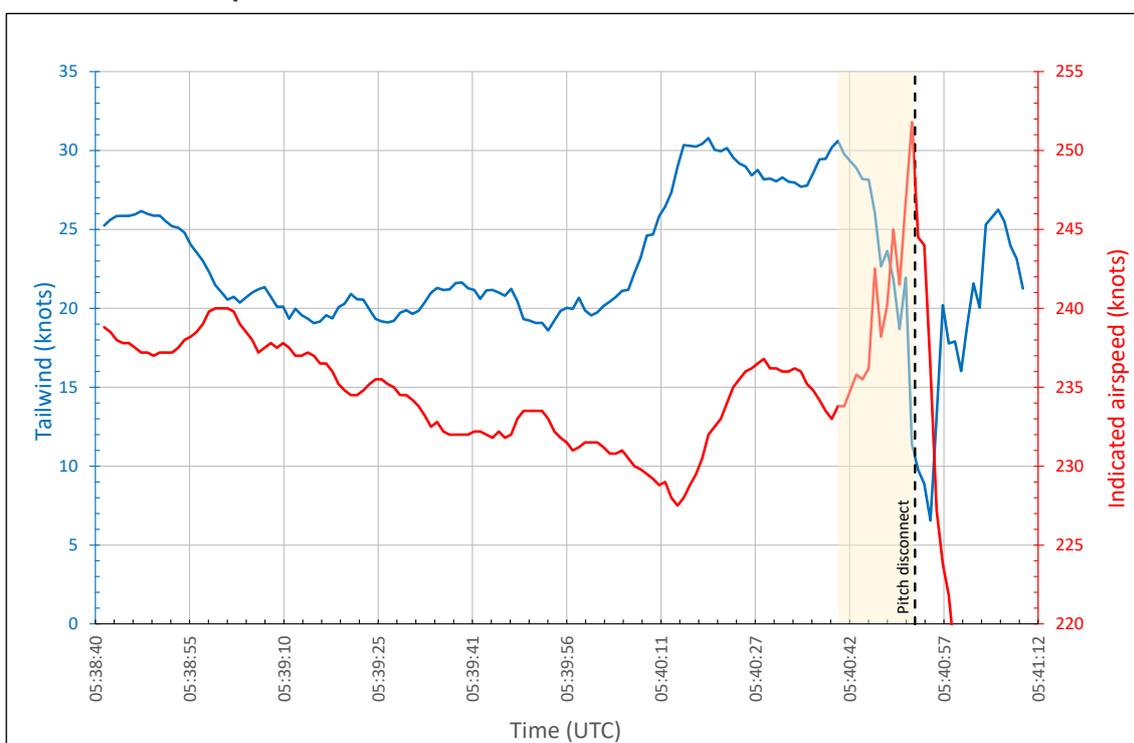
Similarly, in the seconds leading up to the pitch disconnect, there is a distinct correlation between the increasing airspeed and a corresponding rapid decrease in the calculated tailwind (shaded region in Figure 49). Thus, it is likely that there was a significant windshear that resulted in the indicated airspeed rapidly increasing toward VMO in 10 seconds before the pitch disconnect.

Figure 49: Comparison of the variation in the calculated tailwind component (blue) with the indicated airspeed (red) for a period of approximately 2 minutes before and 30 seconds after the pitch disconnect.

The shaded region shows a significant decrease in the tailwind component at the same time as the indicated airspeed increases.

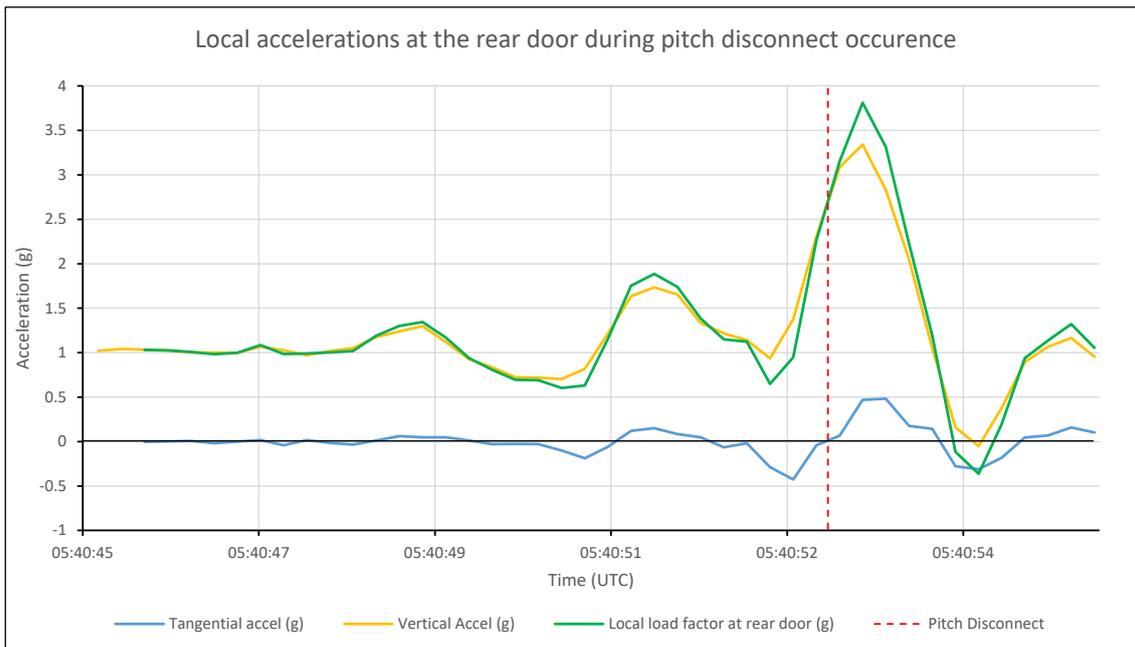
At the time, the first officer was the pilot flying, and his input alone should have resulted in a pitching manoeuvre that was only marginally greater than the previous two. It was also highly likely that the recovery from that pitch-up would have been similar. It was previously shown that the third, rapid, pitch-up was a result of the dual input. Thus, the recovery that resulted in the significant negative acceleration in the rear cabin was also a result of the dual control input and as such, the dual control input contributed to the SCCM's injury.

Figure 51: Local vertical acceleration (load factor) at the rear door during the pitch disconnect event.

The figure shows that an unrestrained occupant located at the rear door likely experienced a maximum load factor of about 3.8g followed by a dip to a minimum of about -0.4g, before returning to about 1g. The red dashed line indicates the time of the pitch disconnect.

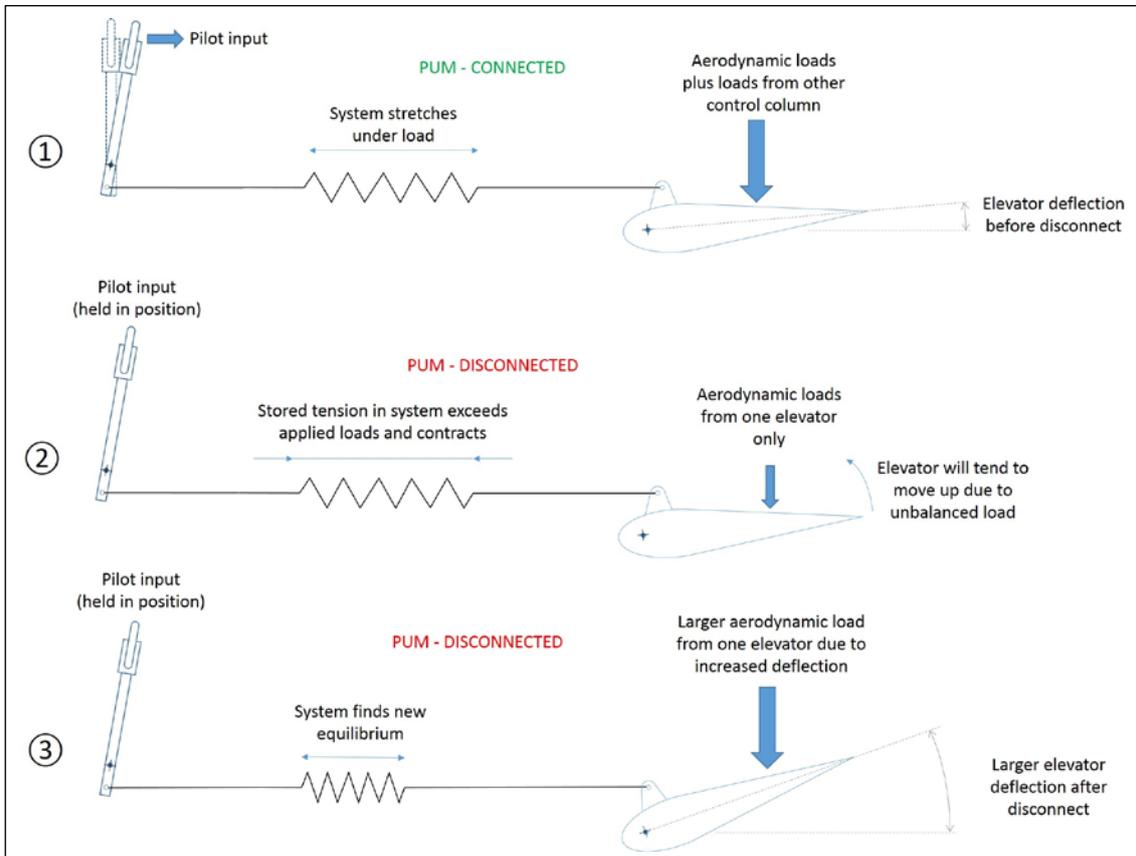
The instant before a pitch disconnect occurs (Figure 56 ①), the PUM has not been activated and the left and right elevators are connected. The control load input through one system is balanced by the aerodynamic load from both the left and right elevators and the tension generated in the other pitch channel (Figure 55). Because of the inherent flexibility, the system between the control column and elevator has been stretched.

At the instant that the PUM activates (Figure 56 ②), the left and right systems separate and each channel is only reacting the aerodynamic load from its corresponding elevator. The loads in the system are no longer balanced, so the tension in the control system will act to reduce the stretch in the system and the elevator will tend to move in a direction consistent with the control input; up for the example illustrated.

The contraction of the system will increase the deflection of the elevator until the aerodynamic load on the elevator balances the load on the control column (Figure 56 ③). The new deflection will be larger than the position just before the pitch disconnect.

Figure 56: Behaviour of the pitch control system during a pitch disconnect shown just before the pitch disconnect ①, the instant of the pitch disconnect ②, and at a time after the pitch disconnect when the loads have balanced ③. Note, this assumes that the control column is held in position following the pitch disconnect.

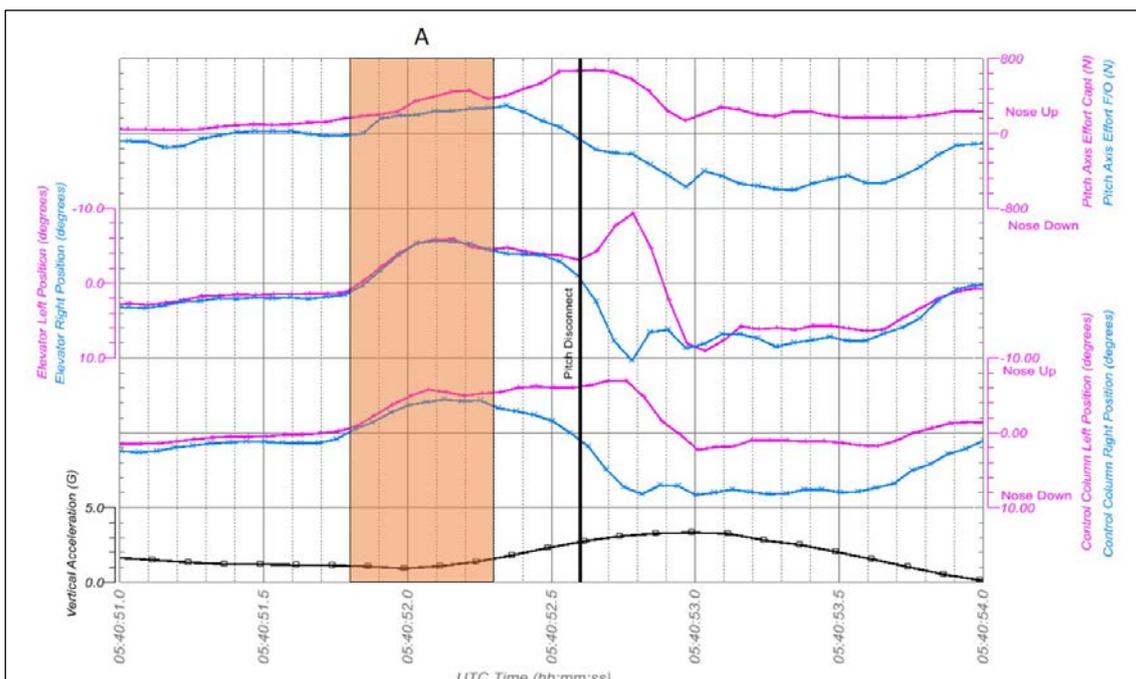
Figure B3: Period A – The graph shows that the recorded pitch axis effort on both the captain and the first officer sides was from nose-up control column inputs by both pilots.

The maximum effort on the captain’s side during this period was about 45 daN (450 N, or 46 kg of force) and the first officer’s side was about 27 daN. The respective nose-up control column movement indicates that the pitch axis effort was a result of both flight crew making inputs into the pitch system in order to raise the nose and slow the aircraft.

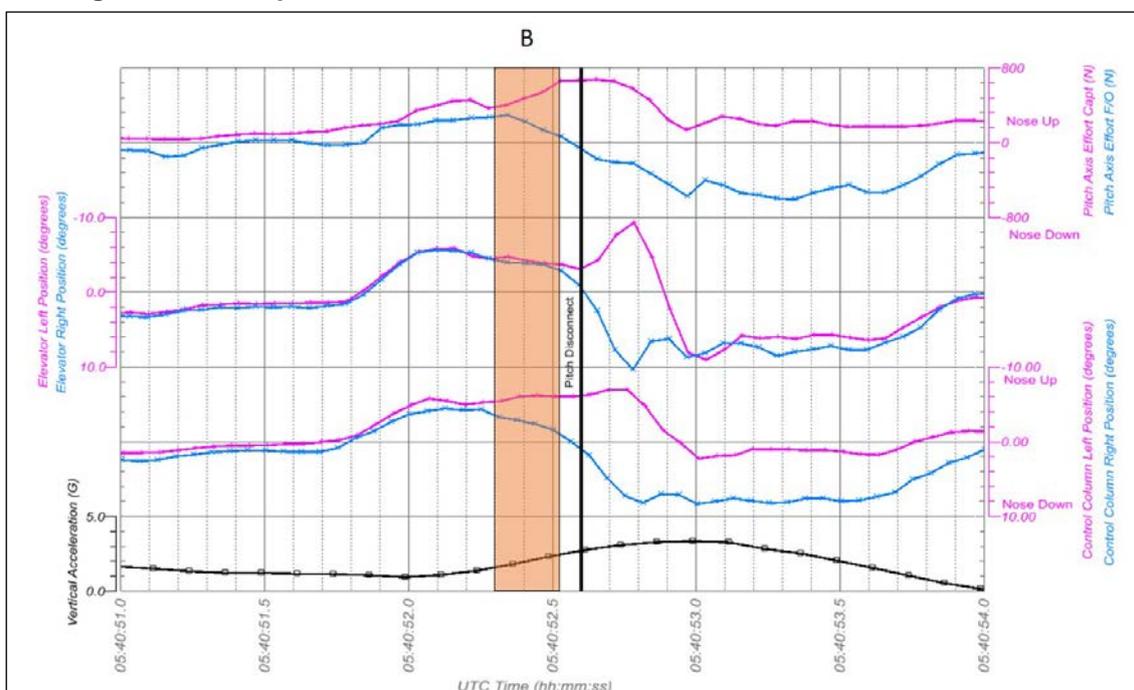
Figure B4: Period B – The captain’s side pitch axis effort increased while the first officer’s decreased. The captain’s control column movement was relatively small during this large increase in pitch axis effort.

The first officer reduced the nose-up input on their control column, while the captain control column moved slightly further back. The increased control position was only slightly more than the position that resulted in a peak pitch axis effort of about 45 daN; however, the pitch axis effort continued to rise, even after the control column position remained steady. This was likely because, as the first officer reduced their input, the elevators remained deflected and the first officer’s share of the aerodynamic loads was transferred to the captain’s side.
