In-flight upset, inadvertent pitch disconnect, and continued operation with serious damage involving ATR 72 aircraft, VH-FVR

47 km WSW Sydney Airport, New South Wales | 20 February 2014

ATSB Transport Safety Report
Aviation Occurrence Investigation
AO-2014-032
Final – 24 May 2019

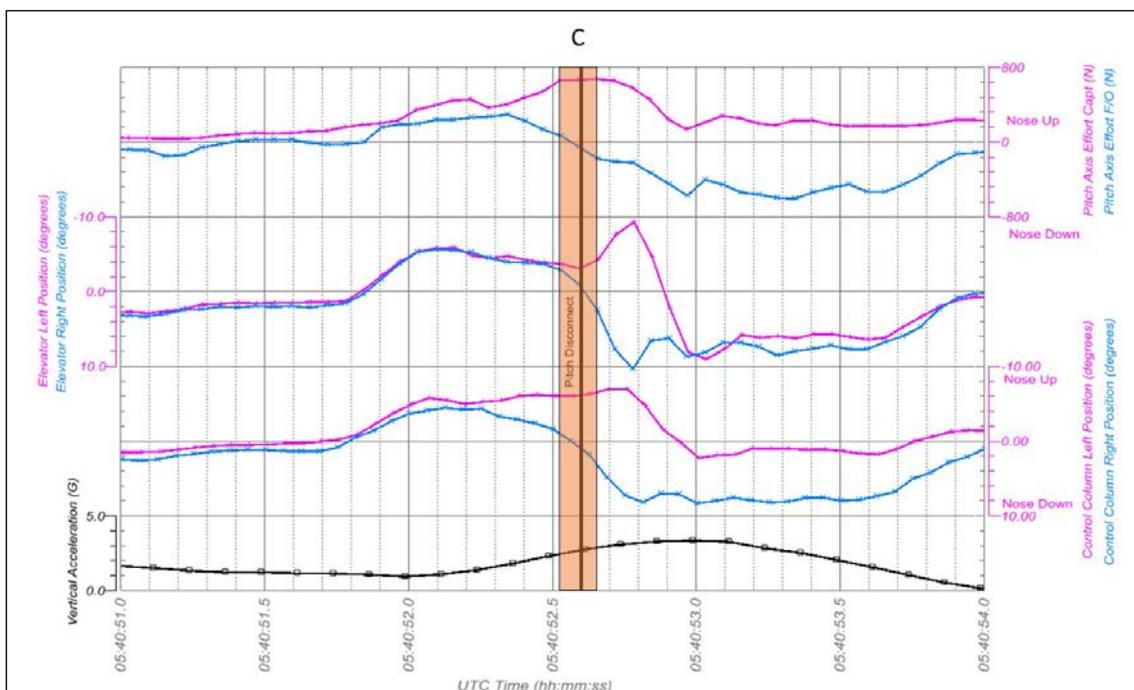
Figure B5: Period C – During activation of the PUM, the elevators start to diverge, while the captain’s input remained constant and the first officer’s input became nose-down .

The pitch axis effort recorded on the captain’s side plateaued at about 67 daN and the first officer’s changed from positive to negative, indicating that he had started to apply a nose-down load on the controls.

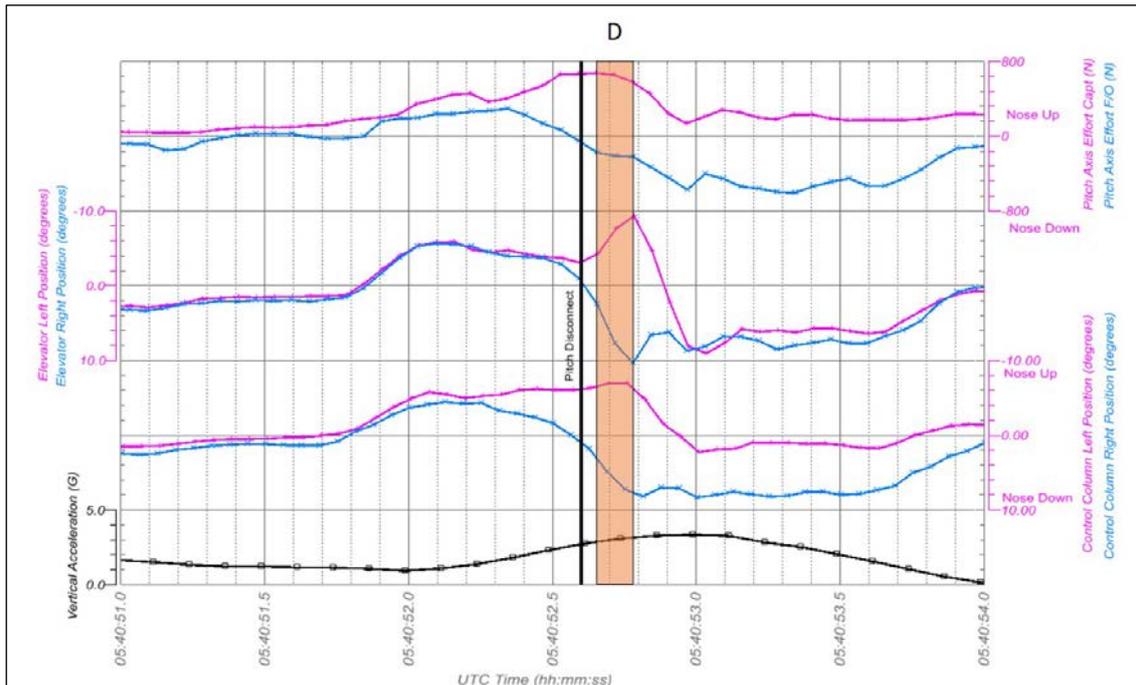
Figure B6: Period D – After activation of the PUM, the elevators moved in opposite directions. The captain’s and first officer’s controls also moved in response to the change in the loads resisting the flight crew’s input.

When the PUM activated, the aerodynamic load from the elevators acting through the left control channel would have been halved. Consequently, the pitch axis effort on the captain’s side decreased during this period, even though there was a small increase in the control column position.

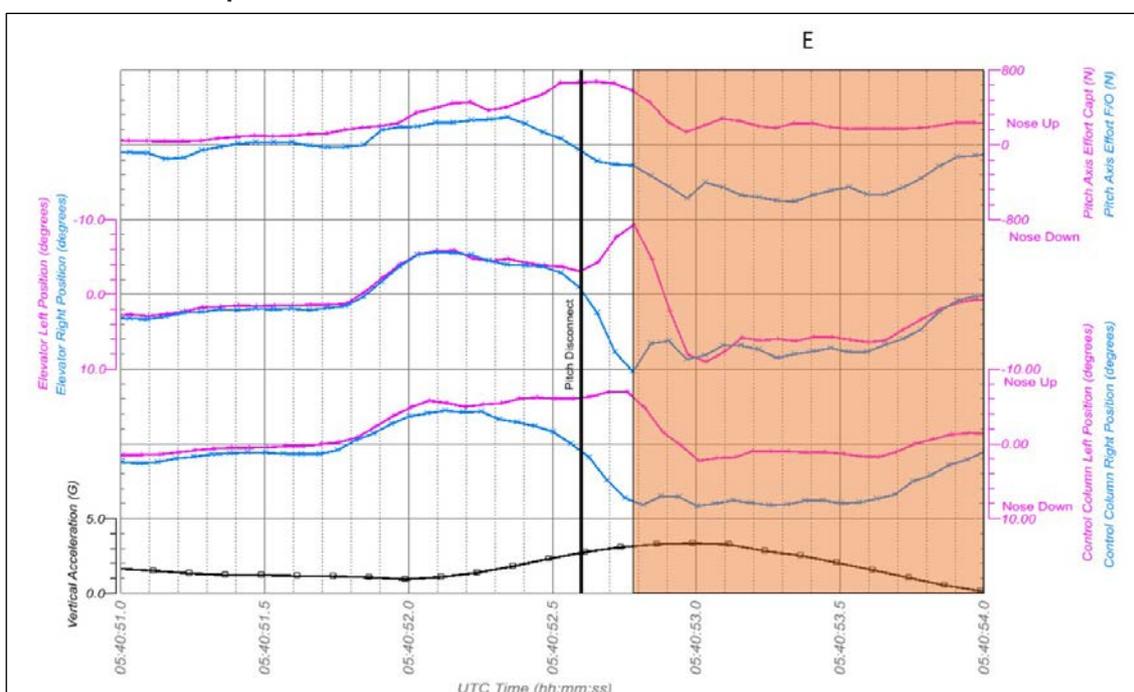
Figure B7: Period E – After the elevators reached their maximum deflections, the captain's control is returned to neutral and the first officer's was held at the position reached after the pitch disconnect.

Within about 0.2 seconds after the pitch disconnect, the captain's control column is moved forward, reducing the commanded input. Given how quickly this occurred in the context of human reaction time, it is unlikely to have been a conscious reaction to an unexpected pitch disconnect. It may have been an unconscious response to the change in the control feel, or an action that the captain was already in the process of performing, such as reducing the load factor, when the pitch disconnect occurred.
