**FINAL
AIRCRAFT ACCIDENT REPORT
19 APRIL 2016**

**AIRBUS 330 9M-MUC
HITS LAMP POST DURING TAXI AT ASTANA
ASTANA INTERNATIONAL AIRPORT
29 JUNE 2014**

ACCIDENT REPORT NO.: 07/2014

OPERATOR : MALAYSIA AIRLINES
AIRCRAFT TYPE : AIRBUS 330
NATIONALITY : MALAYSIAN
REGISTRATION : 9M-MUC
**PLACE OF ACCIDENT : ASTANA INTERNATIONAL AIRPORT
KAZAKHTAN**
DATE AND TIME : 29 JUNE 2014 AT 1046 HOURS LOCAL TIME

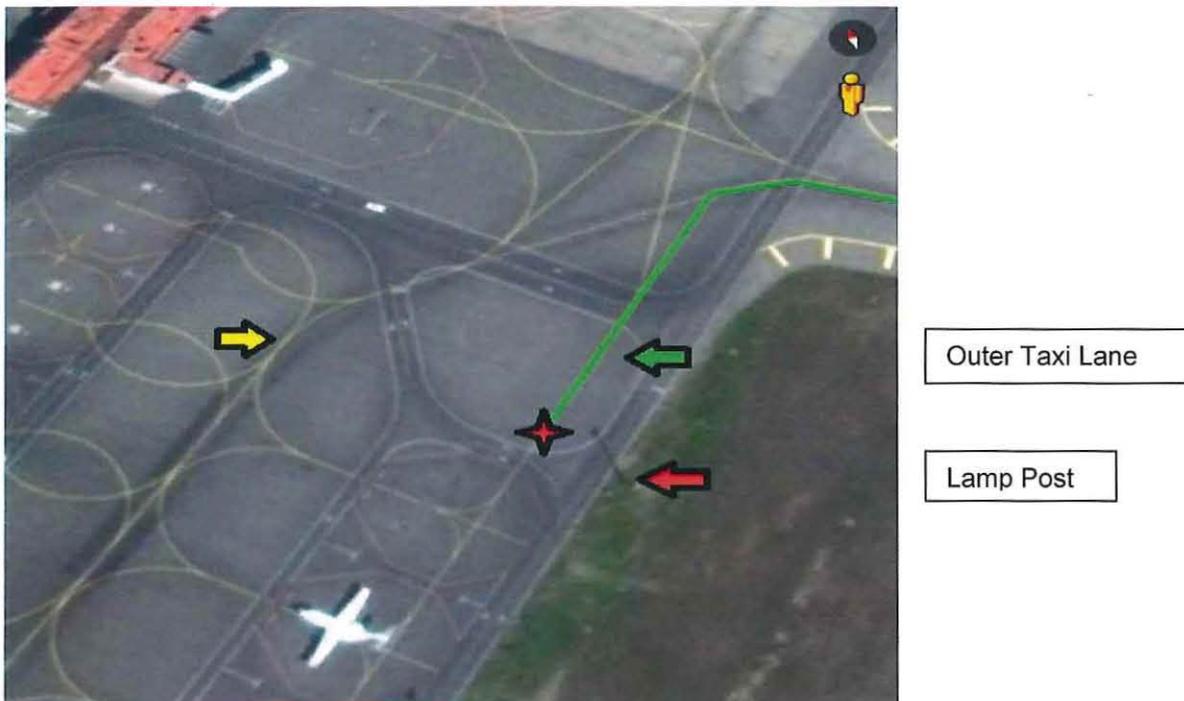
Figure 2: Map of Astana Airport's Apron sourced on 30 June 2014

- 1.1.4 Upon entering the Apron area, the crew observed that there were 2 separate taxi lanes adjoining Taxiway 'C'; one leading towards the main terminal and the other towards the opens bays across the terminal. These taxi lanes were not given any specific designation (name), either on the ground or on the airport charts that were provided. (see Figure 3).

- 1.1.8 During the interview, the crew mentioned that as they were turning into the outer lane, they saw the light pole on the left hand side of aircraft but were sure that there was sufficient clearance to clear the pole.

- 1.1.9 As the aircraft was taxiing on the centre line of the outer taxi lane, they felt a jolt and immediately stopped the aircraft.
- 1.1.10 The left wing of the aircraft had hit a lamp-post and caused it to topple. Apart from the light pole, the aircraft wing also came into contact with another smaller pole with a CCTV mounted. The CCTV was knocked off and the pole scratched the underside of the wing. The impact resulted in the number 6 slat leading edge being damaged. Refer Figure 2 below for view of the Apron area that was involved.
- 1.1.11 At this point, the crew were told by the Astana Ground Control to hold position and wait for a 'Follow-me' car to assist in the taxi. The crew then shutdown the engine and disembarked the plane and proceeded to the hotel after having their statement being taken.

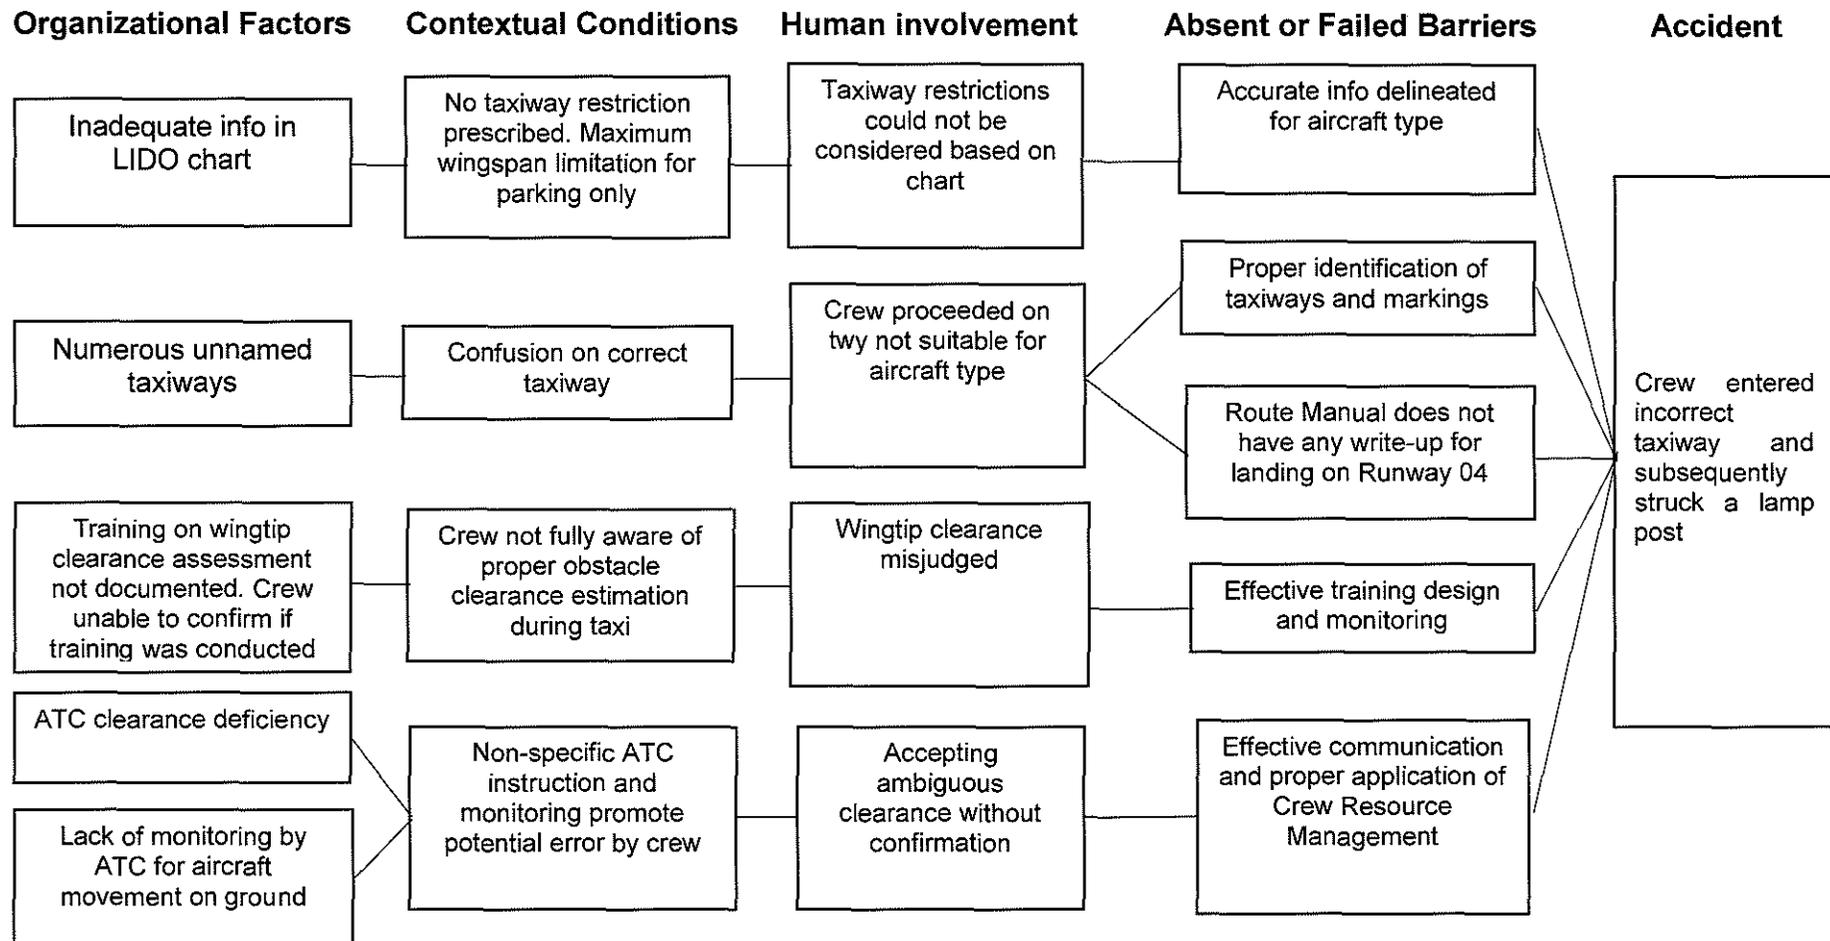
Appendix A – Root Cause Analysis Technique

Malaysia Airlines Root Cause Analysis Technique (MARCAT) was used as a Root Cause Analysis tool to determine the Root Cause of the accident. Refer appendix.
