Air Accident Investigation Unit Ireland

SYNOPTIC REPORT

ACCIDENT
Boeing, 737-8AS, EI-EMH/EI-EKK
LINK 2, Dublin Airport, Ireland

7 October 2014

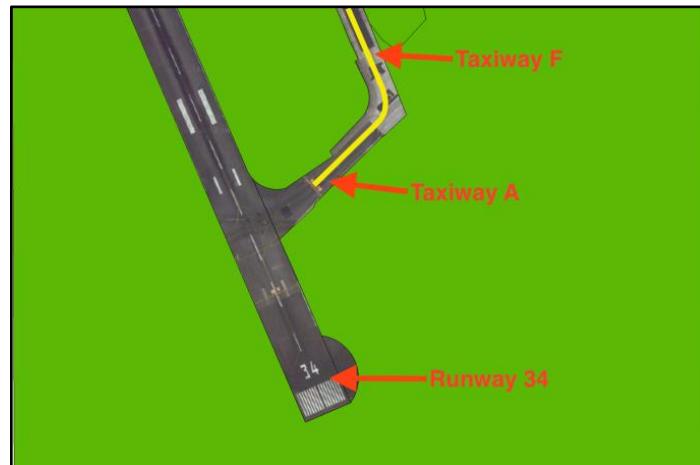
Graphic No. 4: RWY 34 with Taxiway A

Graphic No. 4 shows RWY 34 prior to the development of RWY 28 (pre-1989) and the new Pier 4. TWY F led directly to TWY A, which was the normal access onto RWY 34. Aircraft entered the runway approximately 200 m north of the threshold, and those requiring full length would backtrack to a turning circle at the RWY 34 threshold.

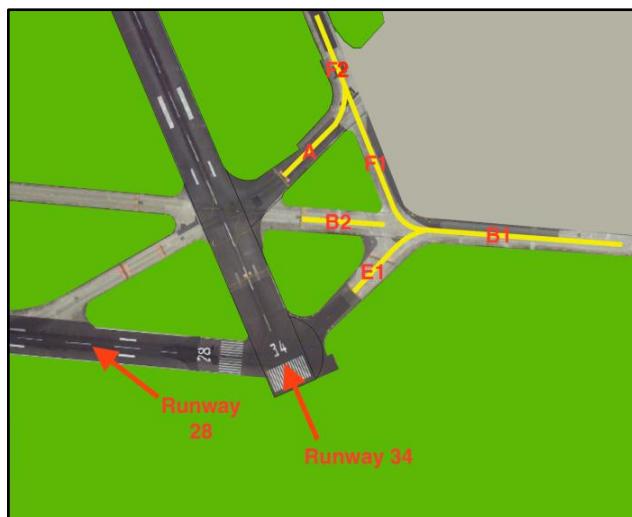
Graphic No. 5: New RWY 28 with TWY access through F2/F1/E1

RWY 28 was opened in 1989. It was built from the threshold of RWY 34 in a westerly direction. Additional taxiways were also constructed to service the new runway.

The threshold of RWYs 28 and 34 was accessed by TWY F1 and E1. TWY B, parallel to RWY 28, was constructed, crossing RWY 34 abeam TWY A and intersecting the vertex of F1 and E1 (**Graphic No. 5**).

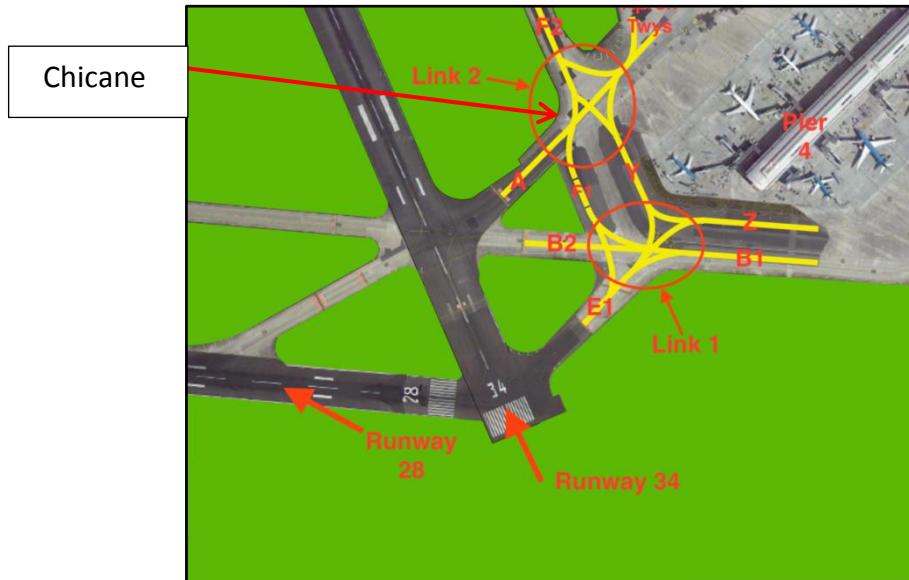
Graphic No. 6: Taxiway formation LINK 1/LINK 2

The construction of Pier 4 (November 2010) on the south apron resulted in the following changes between F2 and E1/B2: TWY F1 was repositioned southwest of its original line, on a new paved area. A new taxiway, TWY Y, was introduced, parallel and north east of F1. TWY Z was introduced parallel and north of B1. Two 'LINK' taxiways, LINK 1 and LINK 2, were introduced.

These changes resulted in the introduction of a chicane taxiway centreline formation from TWY F2 through LINK 2 to TWY F1 and the shortening of TWY F1 to 20 m (**Graphic No. 6 and No. 7:**). It should be noted that TWYs Y and Z had been withdrawn from service prior to the subject event.

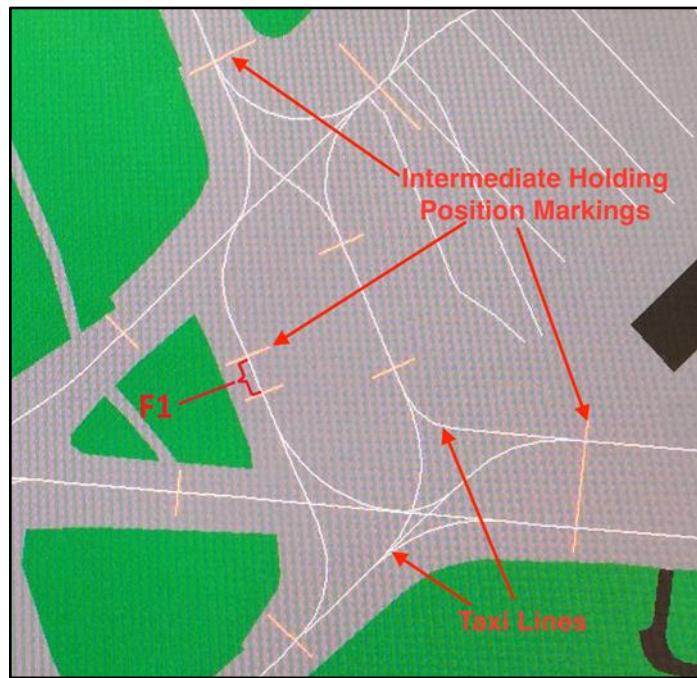
Graphic No 7: Intermediate Holding Position Markings LINK 1/LINK 2

Graphic No 7 represents a close-up of the LINK 1/LINK 2 area with the IHPMs, taxi lines, and TWY F1 shown.

TWY F1 is a short taxiway, connecting LINK 2 to LINK 1. It is bounded at either end by an IHPM, one between F1 and LINK 1 and the other between F1 and LINK 2. TWY F1 measures 20 m in length. When an aircraft taxis in a southerly direction on F1, and stops at the southern IHPM between F1 and LINK 1, there is sufficient clearance for aircraft up to Category E¹¹ to taxi from TWY B2 onto LINK 1.

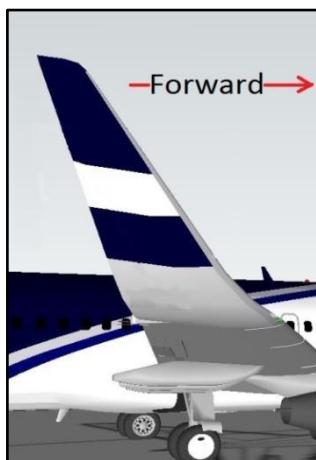
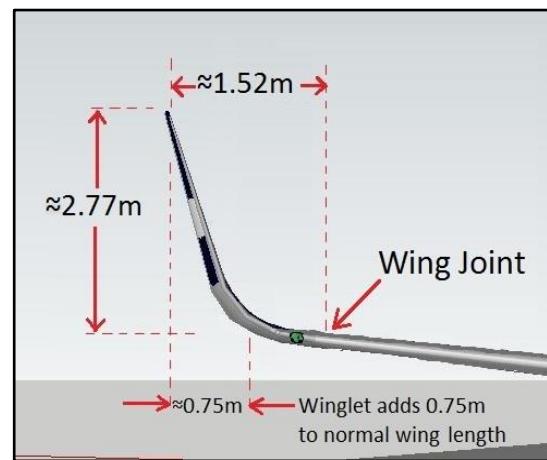
Figure No. 1: Side view of Winglet.

For aircraft such as the occurrence aircraft and aircraft of similar configuration, the addition of winglets does increase the wing dimensions of the aircraft. However, they do not extend upwards perpendicular to the horizontal plane, but rather extend upwards, backwards and outwards from the wing itself. Specific to the occurrence aircraft type, the winglet extends the wing by 1.52 m from the wing joint, adds 0.75 m to the normal wing length and rises to a height of 2.77 m above the wing (**Figures No. 1 and No. 2**).

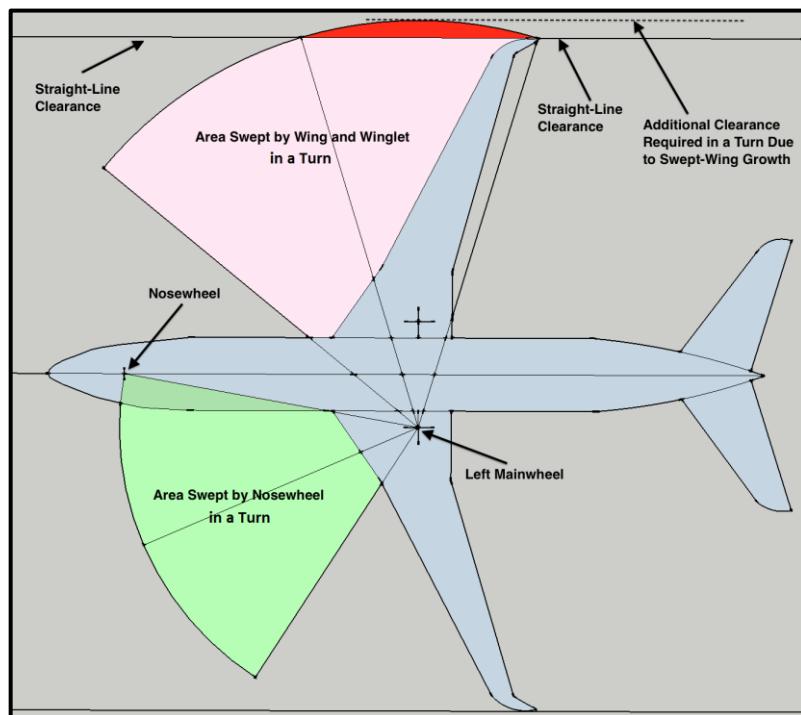
Graphic No. 10: Turning radius 'wing creep' depicted in red

Most modern transport aircraft have swept wings which are subject to a phenomenon known as 'swept wing growth' or 'wing creep'. This occurs during a turn when the wingtip describes an arc greater than the normal wingspan due to the geometry of the aircraft and the arrangement of the landing gear (**Graphic No. 10**).

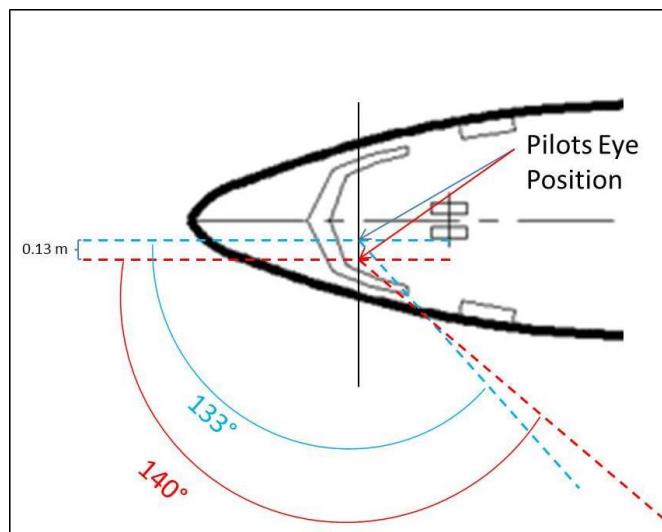
Graphic No. 11: Cockpit visual angles in the horizontal plane

Specific to the occurrence aircraft type and while seated in the left-hand seat, the visual angle in the horizontal plane through the pilot's normal eye position and looking towards the wingtip is 133°. If the pilot moves his head 0.13 m outboard of the normal pilot's eye position the visual angle in the horizontal plane increases to 140° (**Graphic No. 11**).
