**Final Investigation Report on Serious Incident to**  
**M/s Jet Airways (India) Ltd. B-737-800 Aircraft**  
**VT-JGE on 14-01-2015 at Kolkata Airport**

**COMMITTEE OF INQUIRY VT-JGE**

**FINAL INVESTIGATION REPORT ON SERIOUS INCIDENT TO  
M/s JET AIRWAYS (INDIA) LTD. BOEING B 737-800 AIRCRAFT  
VT-JGE AT KOLKATTA AIRPORT ON 14-01-2015**

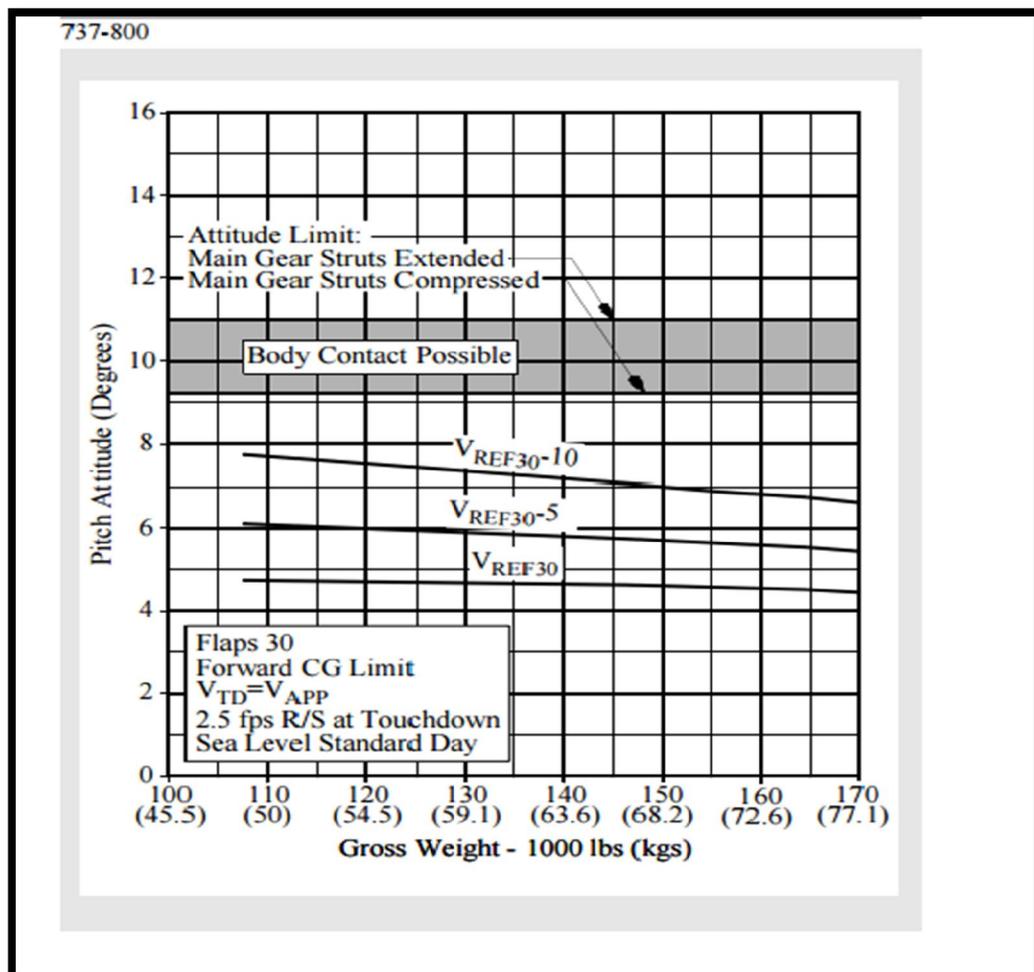
### 1.18.3 Normal Touchdown Attitude

The following figures illustrate the effect of airspeed on body attitude on touchdown. It shows normal touchdown attitude for flaps 30. If flare control and thrust are excessive near touchdown, the airplane tends to float in ground effect. With proper airspeed control and thrust management, touchdown occurs at no less than  $V_{ref} - 5$ . The illustration shows that touchdown at a speed significantly below  $V_{ref}$  seriously reduces aft fuselage-runway clearance.

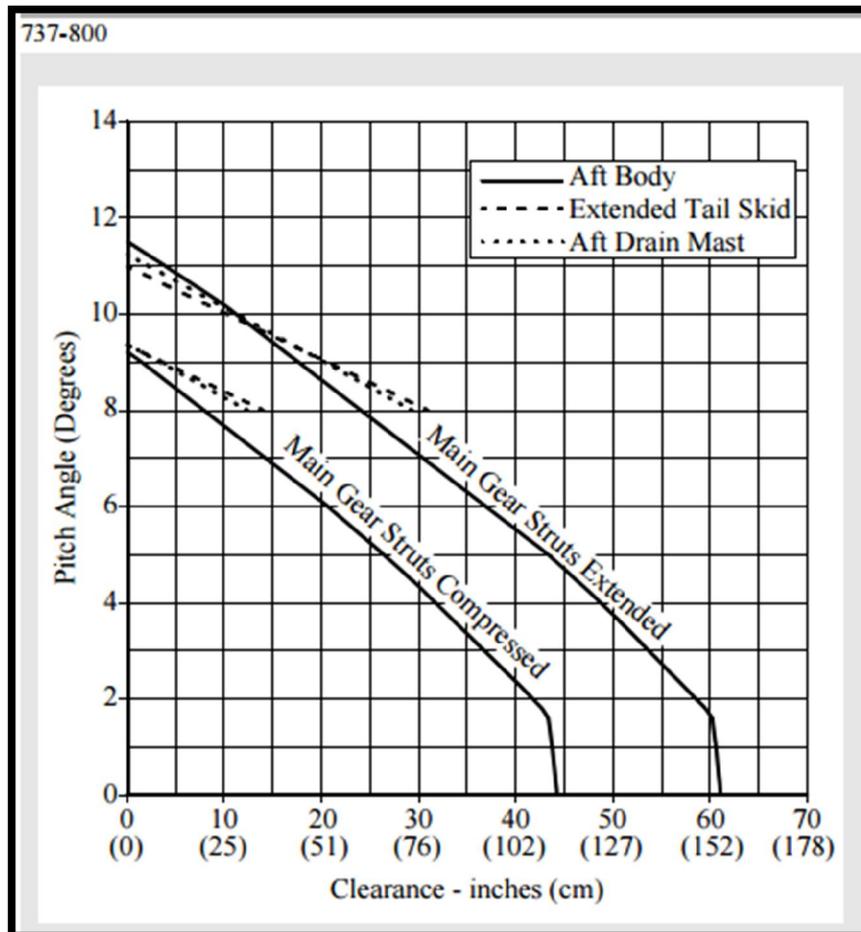
**Body Clearance above Ground**

The following figures show aft fuselage-runway clearance in relation to pitch angle with all main gear tires on the runway.

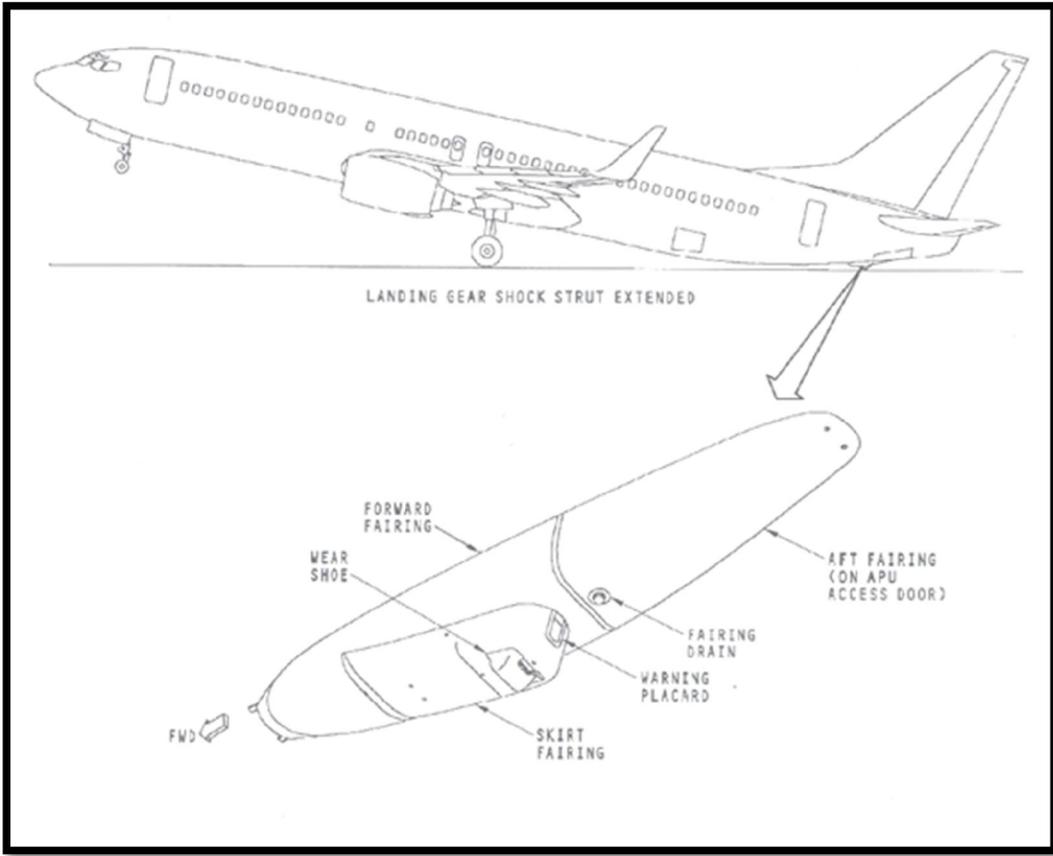
**Tail Skid**

To protect the aft lower fuselage from over rotation damage the Boeing 737-800/900 is equipped with tail skid. It consists of a sort-of-shock absorber cartridge, a skid fairing and a skid shoe, where the last two parts are outside the fuselage.

A light touch of aircraft tail to runway causes the shoe to wear off, indicating the amount of wear and is an indication when the shoe needs to be replaced.

A firm touch crushes skid disappears indicated by colored decals. If the green decal is still visible the skid is still “serviceable” but if the green decal disappears inside the fuselage, the red decal indicates that the skid must be replaced.
