INVESTIGATION OF RUNWAY EXCURSION ACCIDENT OF TURKISH AIRLINES TC-JOC, A330-303, AT TIA, KATHMANDU, NEPAL ON 4th MARCH 2015

**Accident investigation commission (TC-JOC, A330-303)
2015**

Date: 2015/10/06 (2072/6/19)

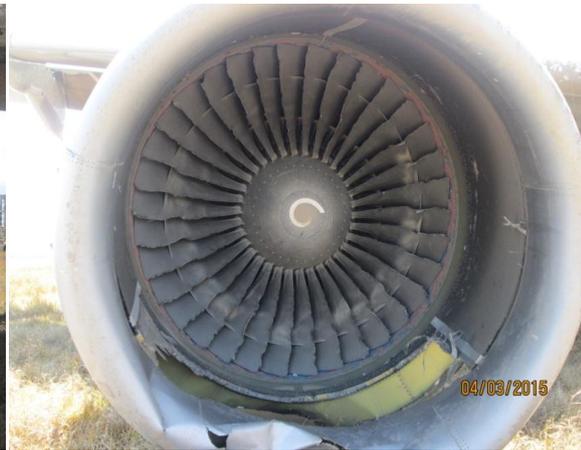
Front View

- Belly fairings on both sides of fuselage were damaged.
- Multiple foreign objects damage was seen on the right hand inboard slat.
- Left & right engines had sustained major damage and pylon bended. Thrust reversers were fully deployed, left and right fan cowl were out from engine, inlet cowls were severe damaged, and severe damages were found on fan blades.
- On the left main landing gear all the wheels were broken and out from its hubs, hydraulic fluid leakage observed.
- On the right main landing gear, three wheels were severely damaged and flat, strut door had substantial damage.
- Aircraft was completely out from runway and lying on grass field.
- Significant holes were found on the top of the inboard wing

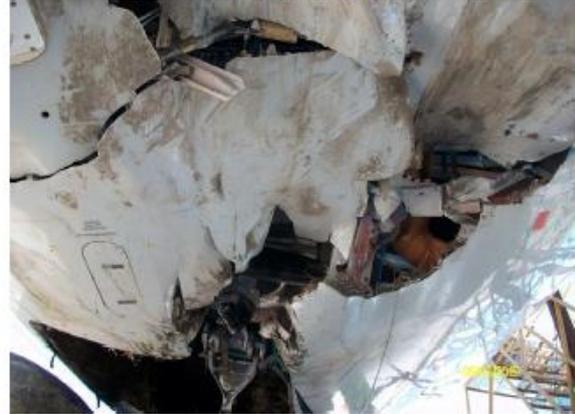
behind of the NLG bay

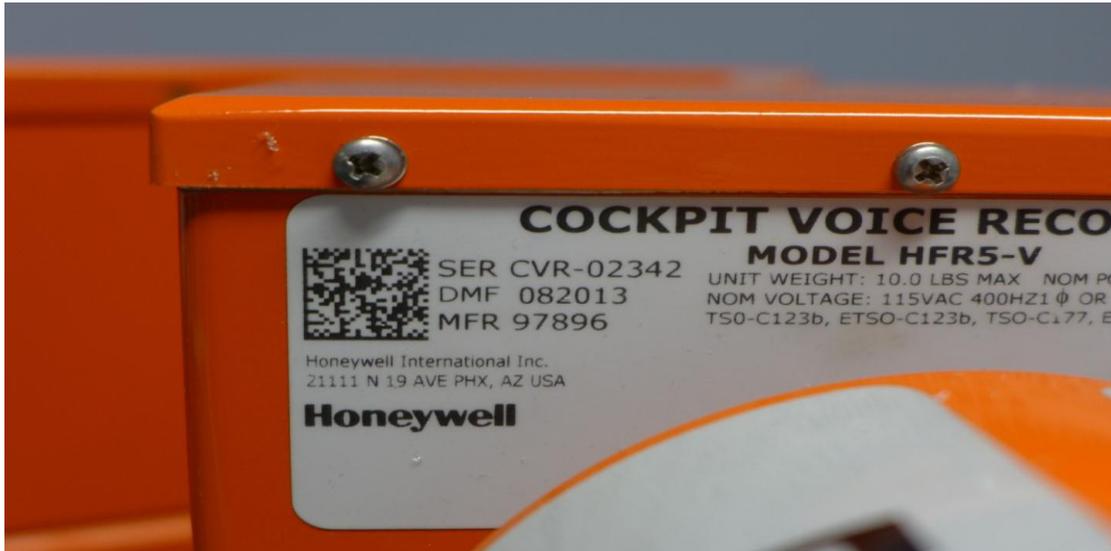
Photo of CVR installed on TC-JOC aircraft

The CVR along with under water locator beacon (ULB) was installed on the aft section of the fuselage. CVR was in normal condition and there was not any sign of damage. The details of installed CVR on TC-JOC (A330-303) aircraft is as follows:

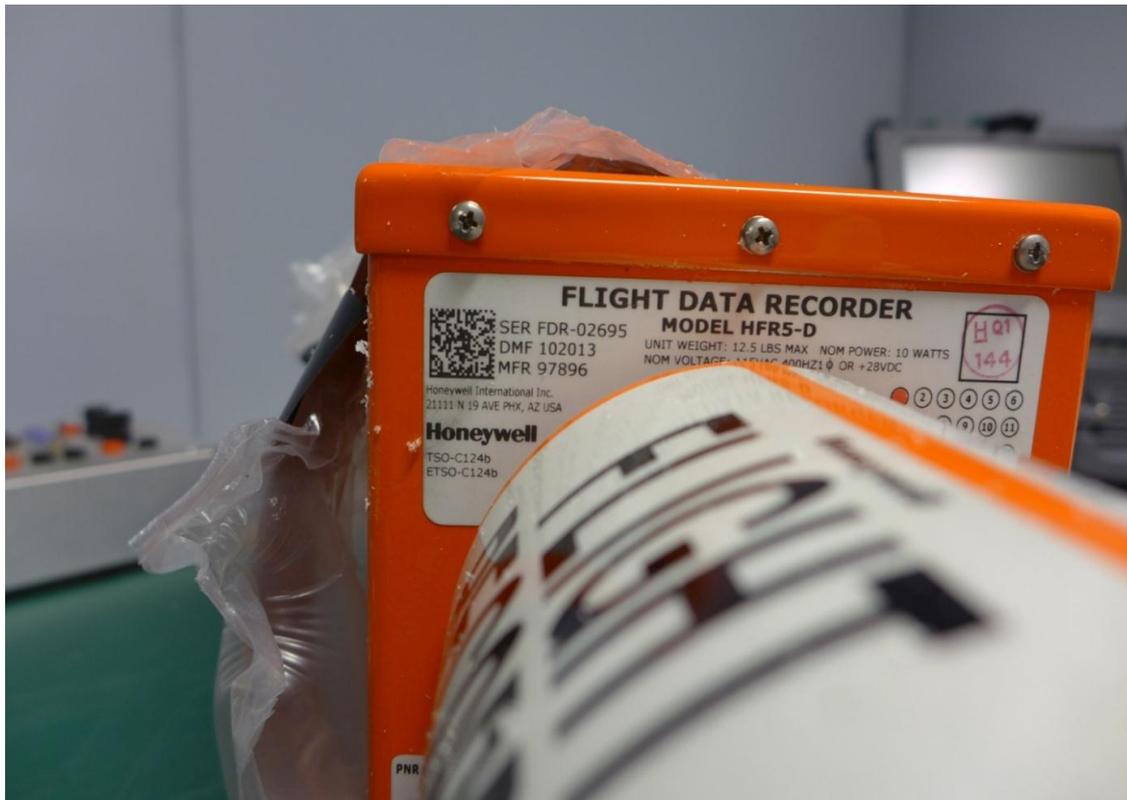
Photo of FDR in stalled on TC-JOC aircraft

- 1.13.2.2 The FDR was installed on the aft section of the fuselage. The ULB was also attached to the FDR. The last 25 hours data was stored in the FDR. When the FDR was removed, it was in good condition and there was no any sign of damage and fire.

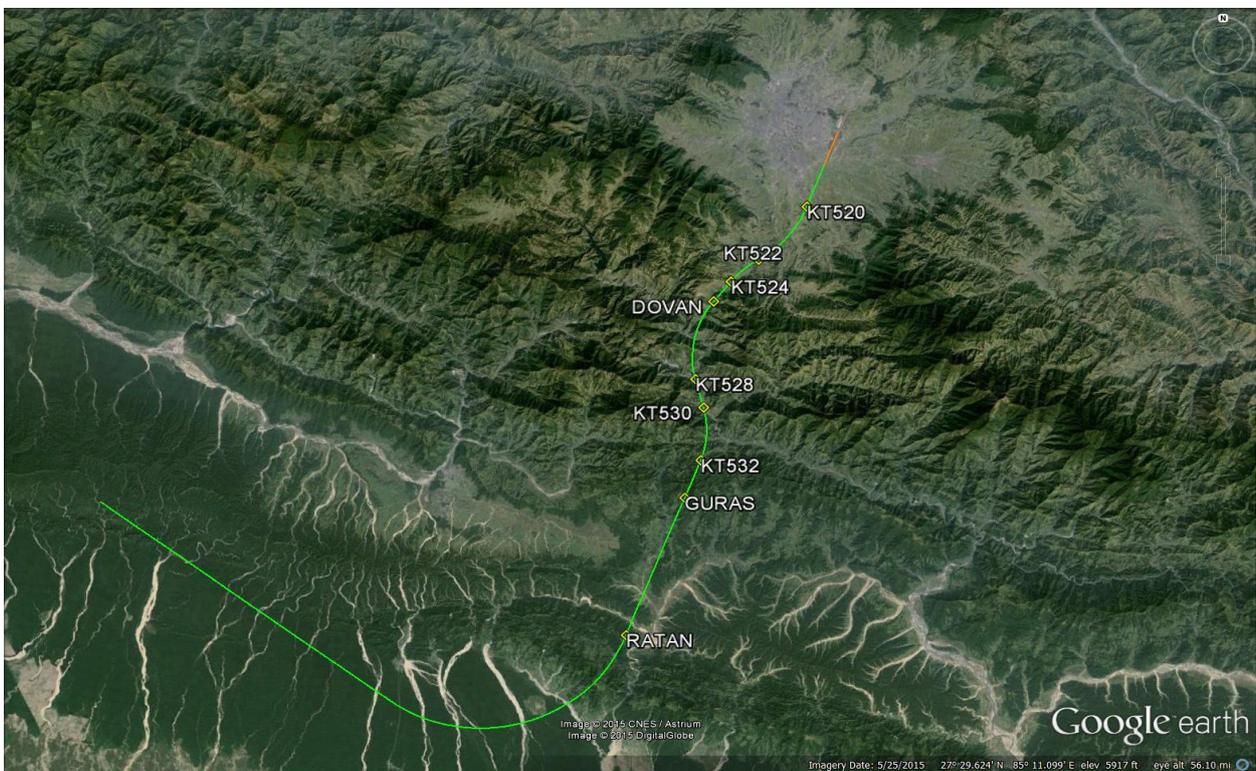
Picture showing the accuracy of the navigation based on FDR data

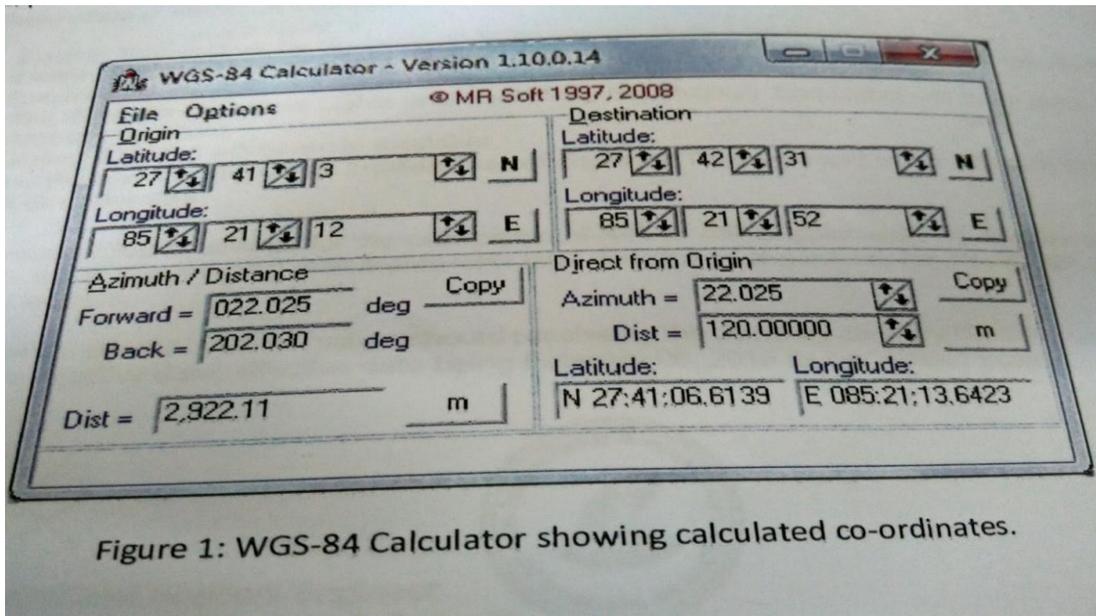
A report on calculation of threshold co-ordinate for AIRAC AIP Supplement was received from CAAN, which stated that software WGS-84 calculator downloaded from <http://www.mrsoft.ft/ohj02en.htm> was used in calculation, for which origin and destination

co-ordinates from ANNEX 1 of AIP Nepal were used. The screen print of software is shown as below:

As per the version of airline the runway coordinates for Kathmandu Airport as published by the CAAN in AIP SUP 01/2015 were given with a lower resolution compared to the runway coordinates published to 1/1000th of an arc second, whereas the coordinates in the supplement were in degrees, minutes and seconds. Bearing/Distance calculations showed that these published coordinates were not exactly lined up, but the published RW02 coordinates were slightly off to the left.
