**AIRCRAFT ACCIDENT
INVESTIGATION REPORT**

**ASIANA AIRLINES, INC.
HL 7762**

**ASIANA AIRLINES, INC.
AIRBUS A320-200, HL7762
COLLISION WITH
THE AERONAUTICAL RADIO NAVIGATION AIDS
CAUSED BY UNDERSHOOTING
HIROSHIMA AIRPORT
AT 20:05 JST, APRIL 14, 2015**

November 18, 2016

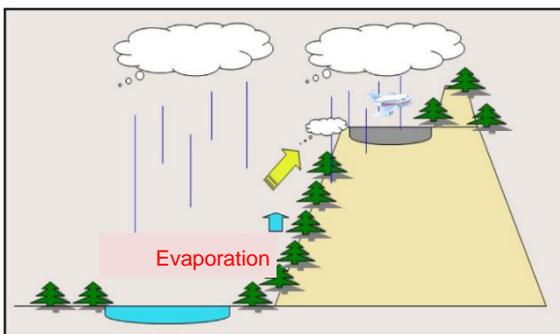
Figure 1: Image of Fog Generation

When it rains, the air of the southern slope of the runway would be cooled and humidity level would go up adding the effect in part because of ponds being there. The humid air would be blown up along the slope by the southerly wind and be cooled to generate the fog, which flows into the Airport (Figure 1).

Because the elevation of the north is high, when the northern wind prevails, the air goes down along the slope and fog is less likely to appear. Much the same is true when windy, the fog is blown away. For those reasons, the light southerly wind is requisite for occurrence of the fog. (omitted)

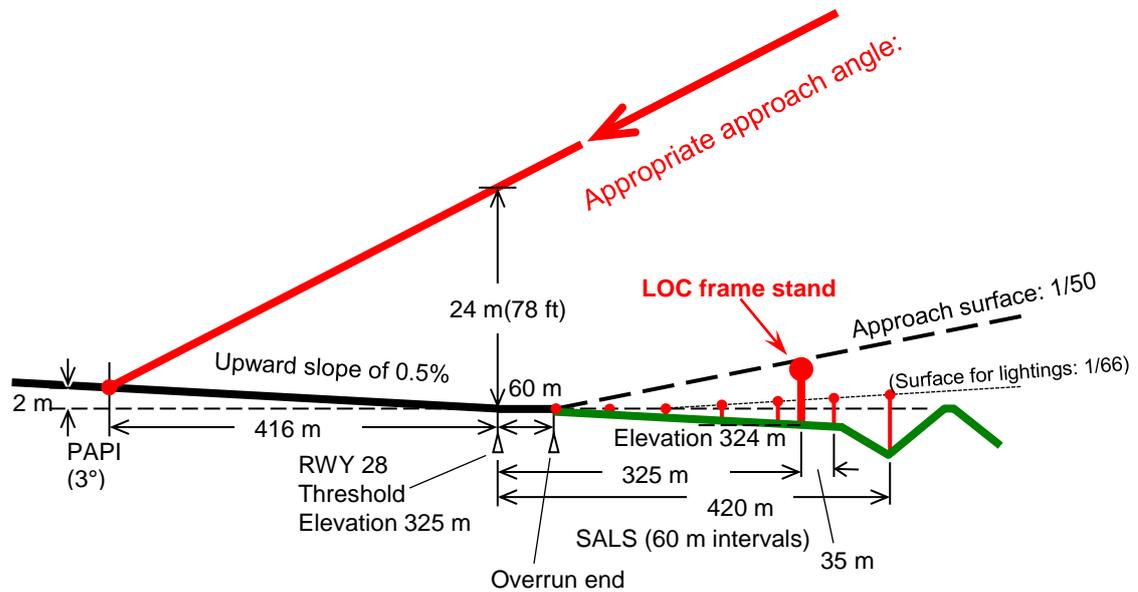
Figure 4: Cross-section of Vicinity of RWY 28 Threshold

There was a record that the operation of ILS was forced to be automatically suspended because failure warnings of localizer signals for Category III ILS RWY 10, which is emitted from the aids installed in the east side of RWY 28 threshold, had issued.

As described in 2.1.1 and 2.8.2, it is certain that the Aircraft first hit a part of approach lights of 4 m high, located 360 m east from RWY 28 threshold, with the wheels of the left main landing gear at 20:05:14; subsequently, it collided with the central parts of the LOC frame stand 6 m high, located 325 m east from RWY 28 threshold, with the both engines, the both main landing gears, the flaps, the lower surface of fuselage and the horizontal stabilizers. According to FDR records, the attitude of the Aircraft at the moment of the collision was a roll angle of slightly right approximately + 1°, a pitch angle of upward approximately + 11° as illustrated in Appended Figure 4; however, the Aircraft was on nearly level flight of the descent rate of about 30-50 fpm with the airspeed of 137 kt.

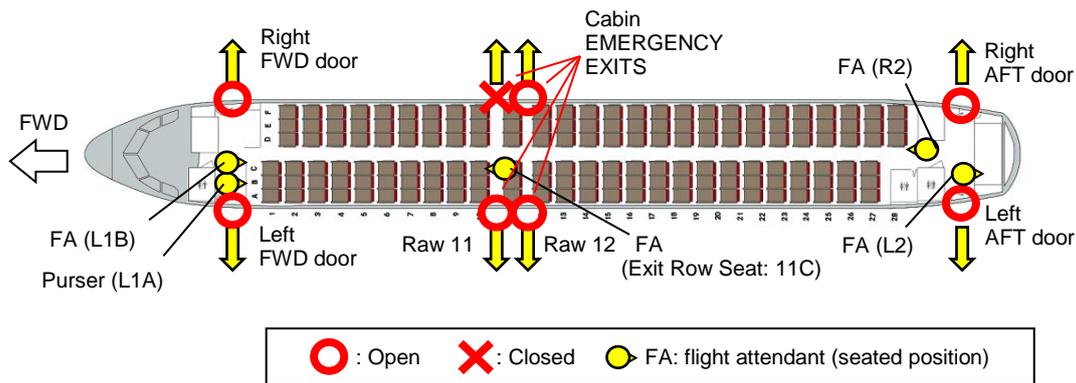
Figure 7: Location of Doorways, Emergency Exits and Seating Arrangements of FAs

As shown in Figure 7, main doorways: LEFT FWD DOOR (left forward door), RIGHT FWD DOOR (right forward door), LEFT AFT DOOR (left rearward door), and RIGHT AFT DOOR (right rearward door), and emergency exits doors in both sides of the middle cabin were all let open except for a right emergency exit of the 11th row and evacuation slides, which are installed in each doorway and emergency exit, were normally extended.
