National Transportation Safety Board Aviation Accident Final Report

Location:	San Diego, CA	Accident Number:	WPR15MA243B
Date & Time:	08/16/2015, 1103 PDT	Registration:	N442RM
Aircraft:	NORTH AMERICAN ROCKWELL NA265-60SC	Aircraft Damage:	Substantial
Defining Event:	Midair collision	Injuries:	4 Fatal
Flight Conducted Under:	Part 91: General Aviation - Other Work Use

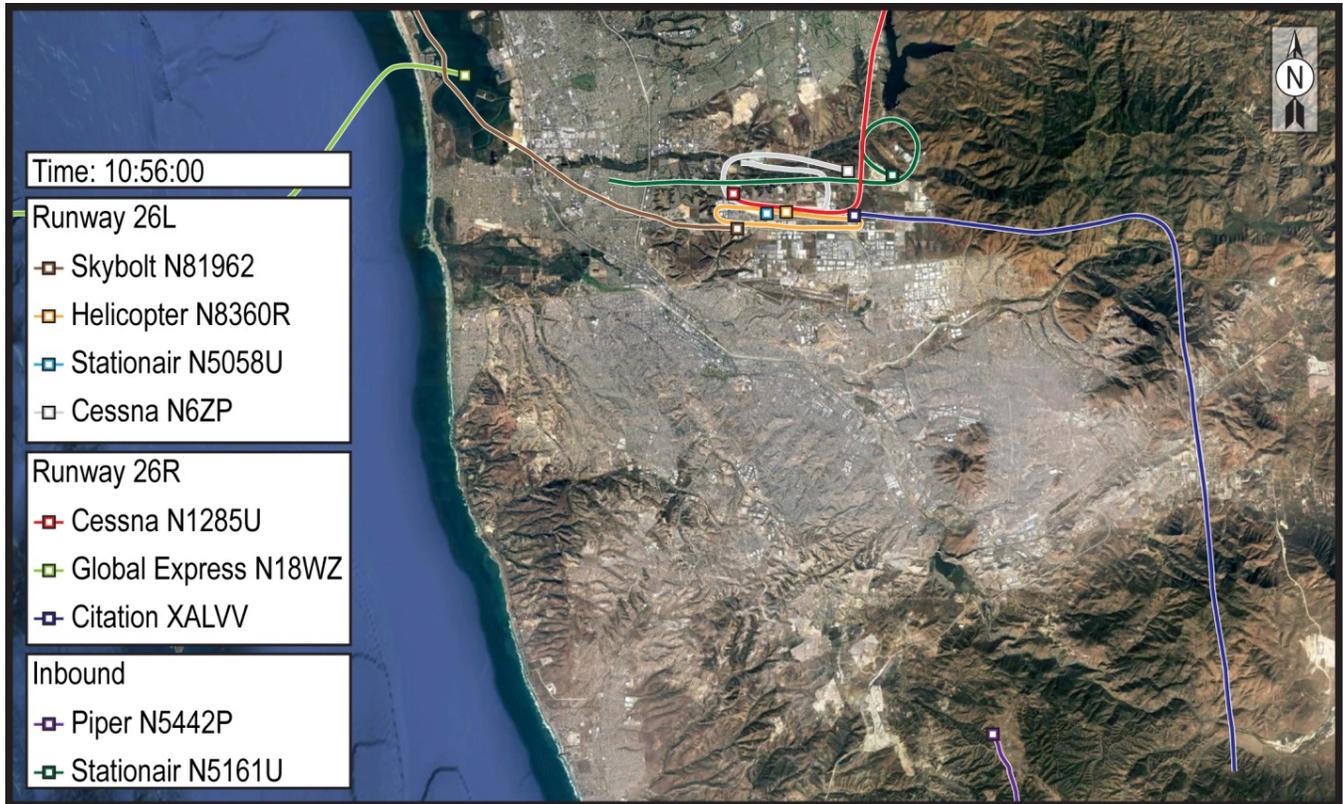
At 1056:31, the LC trainee advised the pilot of N1285U to expect runway 26L on the next approach, which the pilot acknowledged. At that time, three aircraft were using runway 26R (Global Express [N18WZ] was inbound for landing, N6ZP was on a right base for a touch-and-go, and XALVV was on short final) and three aircraft were using runway 26L (N1285U was turning right downwind for the touch-and-go, N81962 was on a left downwind for landing, and N8360R was conducting a touch-and-go operation). Figure 1 shows the aircraft in the SDM traffic pattern about 8 minutes before the accident.

Figure 1. Aircraft in the SDM traffic pattern about 8 minutes before the accident.

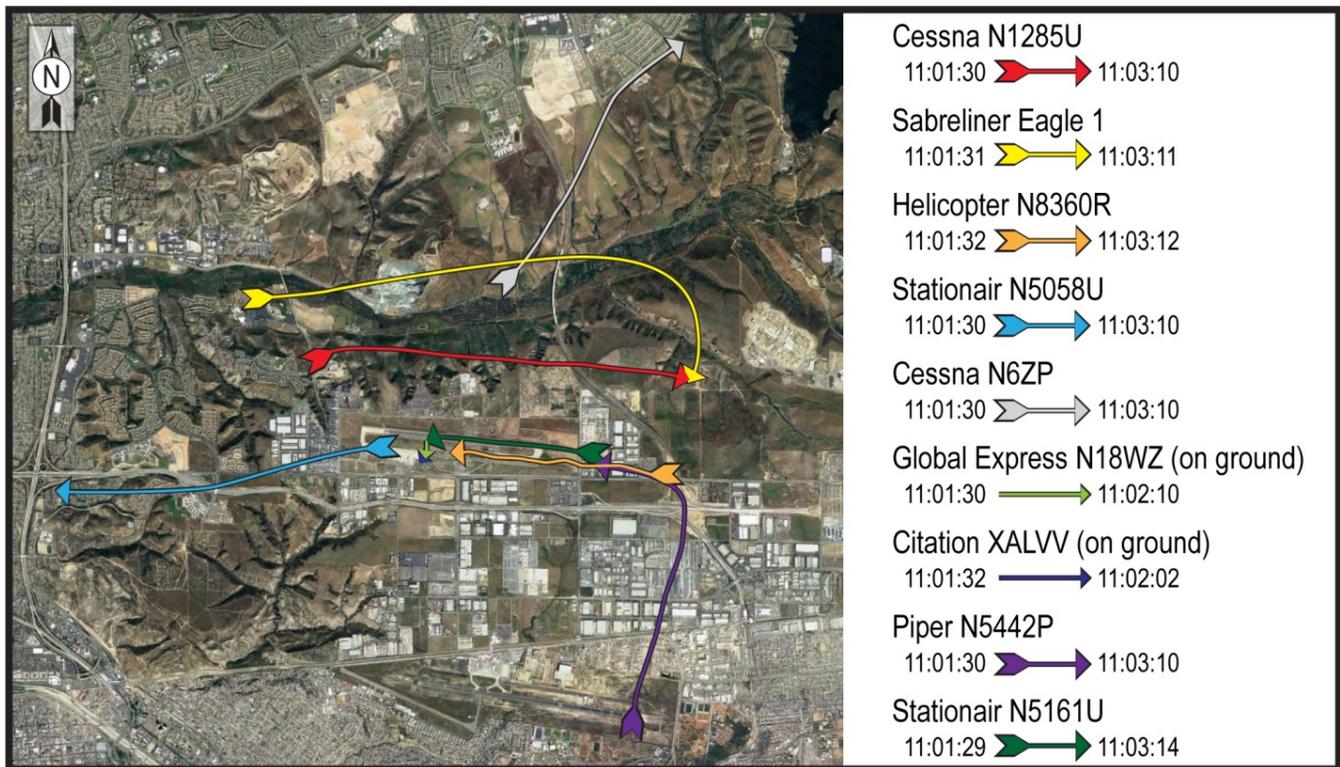
During the next 2 minutes, the LC made several errors that were either corrected by him or by the pilots under his control. At 1059:44, after the pilot of N6ZP completed a touch-and-go on runway 26R, he requested a right downwind departure from the area. The LC did not respond. At 1100:23, the LC instructed, "stationair five eight uniform two six right cleared for I'm sorry two six left cleared for takeoff." At 1100:29, the pilot of N5058U stated, "uh I'm sorry was that for five eight uniform?" The LC then cleared the pilot of N5058U for takeoff from runway 26L. At 1100:36, the LC transmitted, "helicopter six zero romeo there is a ces ah cen ah correction stationair just ahead they are going to the right runway base leg for two six left." At 1100:46, the pilot of N6ZP repeated his request for departure; the LC then approved N6ZP's departure request, and N6ZP departed the traffic pattern in a northeasterly direction. At 1100:53, the LC instructed the helicopter pilot, "helicopter six zero romeo listen up turn crosswind" before correcting the instruction 4 seconds later to "turn base." At 1101:15, the Eagle1 CVR recorded the copilot state, "got one on the runway," and at 1101:19, the Eagle1 CVR recorded the pilot comment, "wowwww. he's like panicking" (with an emphasis on panicking). Figure 2 shows the aircraft in the SDM traffic pattern from about 1101 until the time of the accident.

Figure 2. Aircraft in the SDM traffic pattern from about 1101 until the time of the accident.

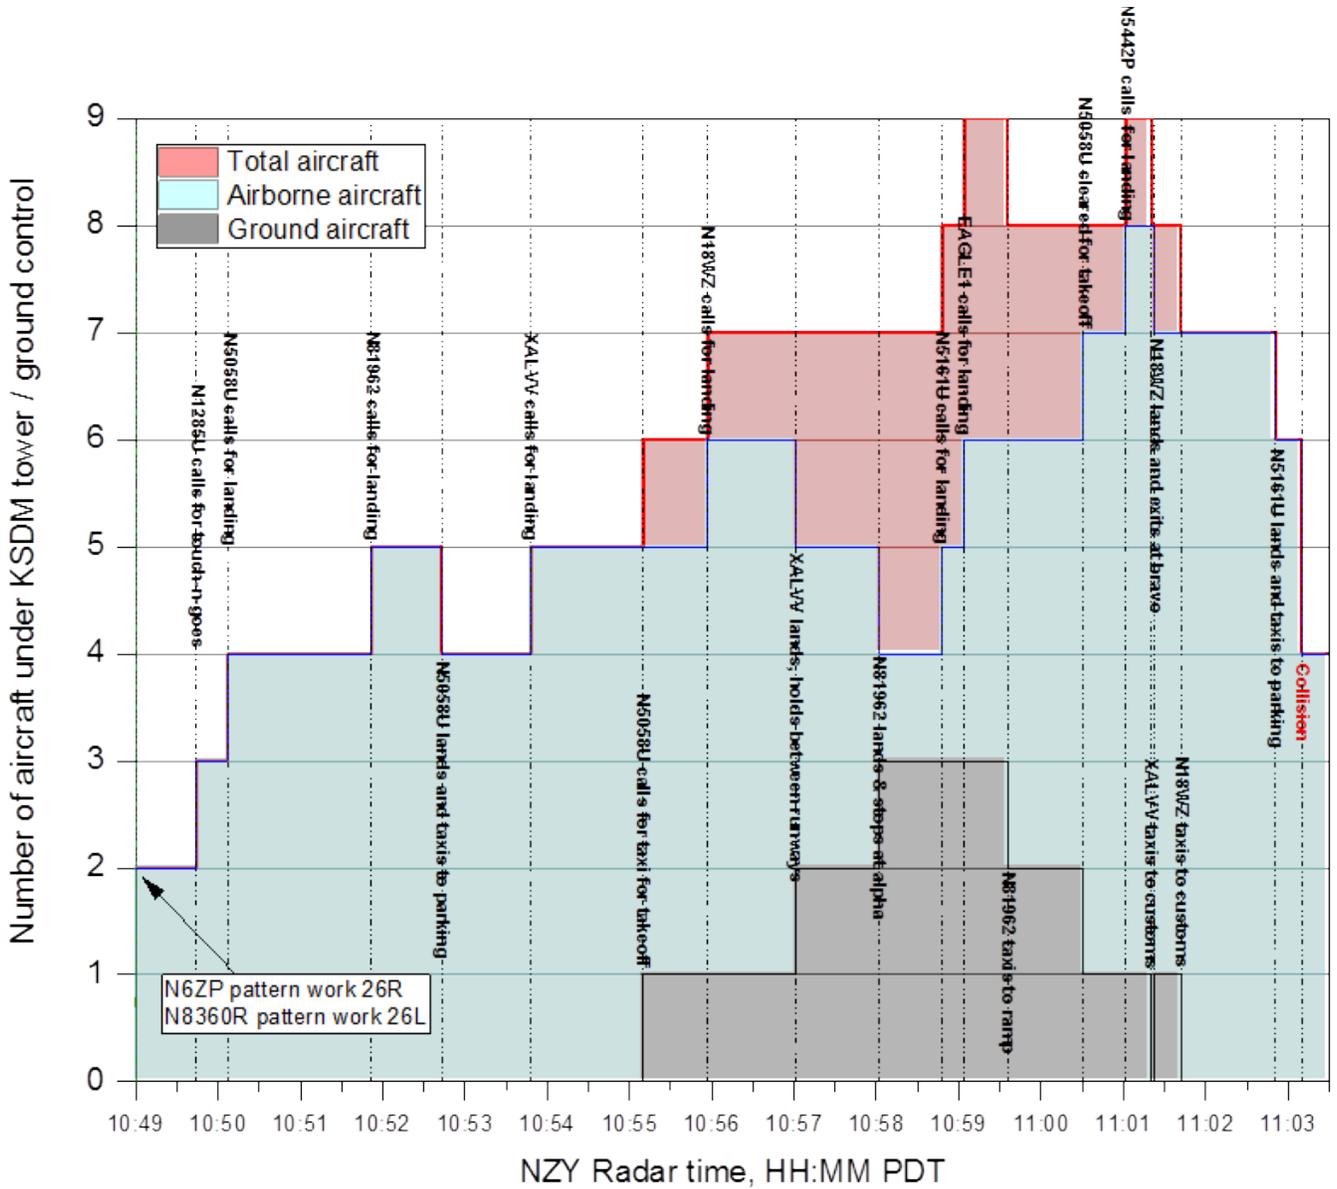
realized that Eagle1 was turning into N1285U, it was too late to help. Figure 3 shows the calculated flight tracks of Eagle1 and N1285U. Figure 4 shows the aircraft under SDM ATCT control from 1049 until the time of the collision.

Figure 4. Total aircraft under SDM ATCT control from 1049 until the time of the collision.

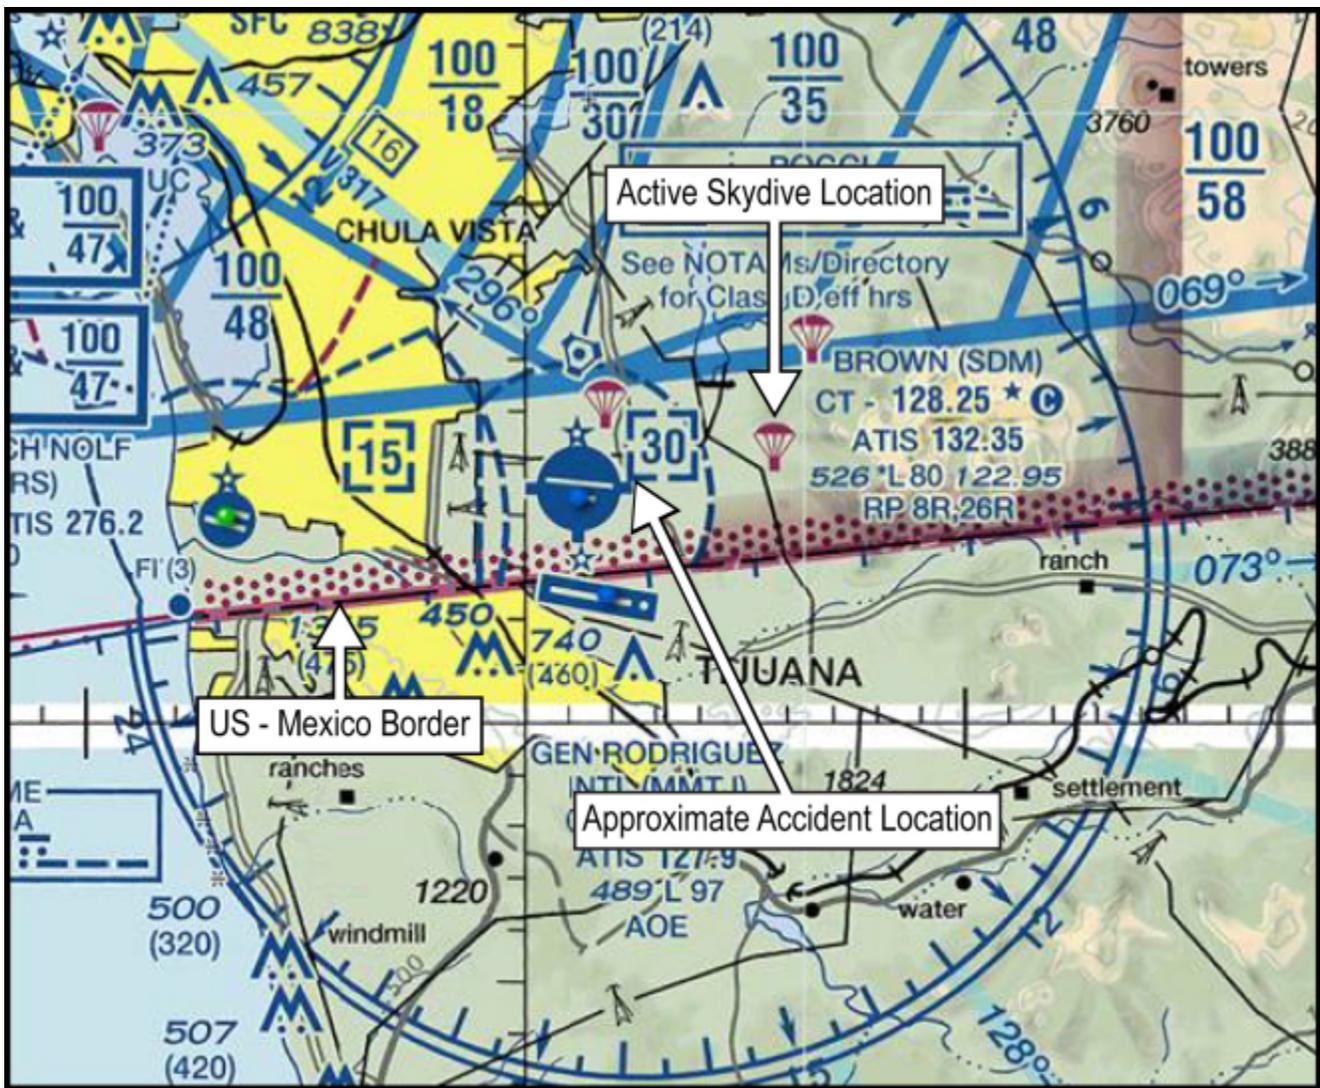
SDM is located about 14 nm southeast of San Diego on the Otay Mesa at an elevation of 526 ft msl. The rising terrain associated with the Otay Mountain peaks begins about 2 miles east-northeast of SDM, and the highest terrain, at an elevation of 3,566 ft msl, is located about 8 miles east of SDM. Designated skydiving areas are located at SDM and at a second location about 3 miles east of SDM (see figure 5).

Figure 5. FAA sectional aeronautical chart view depicting SDM and the approximate accident location. (Not for navigational use.)

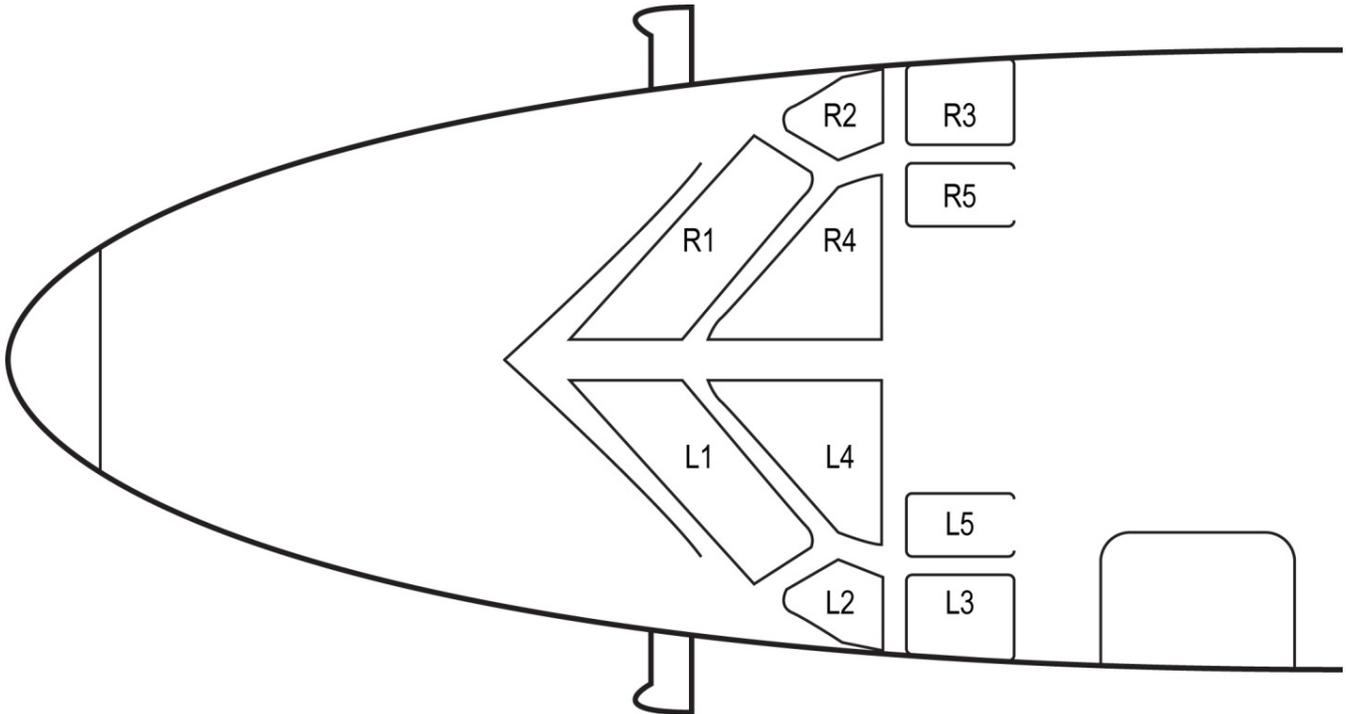
Eagle1's 10 cockpit windows (5 on each side of the airplane) are labeled L1 through L5 for the left windows and R1 through R5 for the right windows, as shown in figure 6. The Cessna windows are the windshield, left window, and right window.

Figure 6. Top-down view of Eagle1 forward fuselage, showing labels used to identify cockpit windows.
