Investigation Report

Type of Occurrence:	Accident
Date:	30 September 2015
Location:	Saarbrücken
Aircraft:	Airplane
Manufacturer / Model:	Bombardier Inc./DHC-8-402
Injuries to Persons:	None
Damage:	Aircraft severely damaged
Other Damage:	None
State File Number:	BFU 15-1354-AX

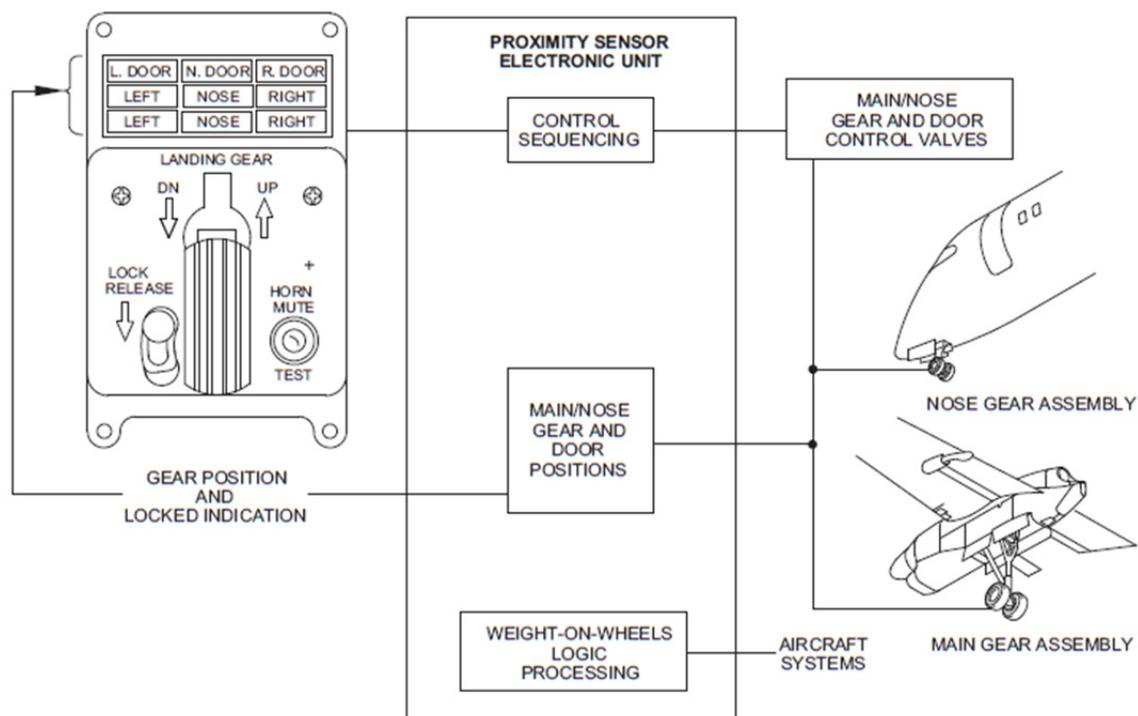
When the landing gear selector lever is selected to the UP position, hydraulic pressure from No. 2 system is applied to the retract side of the system (Figure 12.13-19). This opens the nose gear forward doors and retracts the nose gear, it also opens the main gear aft doors and retracts the main gear. The aft nose gear doors are mechanically linked and close with the retracting nose gear. After nose gear retraction, the forward nose gear doors close hydraulically. The forward main gear doors are mechanically linked and close with the retracting main gear. After main gear retraction, the aft main gear doors close hydraulically.

The advisory light sequence during retraction starts with the LEFT, NOSE and RIGHT red unsafe lights and the amber selector handle light coming on. At the same time, the green LEFT, NOSE and RIGHT lights go off to show the gear is not locked down. The amber door advisory lights come on to show the hydraulically operated gear doors are open. When the landing gear is retracted and locked in the up position, the amber selector handle light and red advisory lights go out. Finally, the amber gear door advisory lights go out to show all the hydraulic gear doors have closed. No advisory lights should be on if the gear is up correctly. The main and nose gear are held in the up position mechanically with uplocks, and hydraulic pressure is removed from the system.
