FINAL REPORT

ACCIDENT OF M/S SHAHEEN AIR INTERNATIONAL FLIGHT NL-142 B-737-400 AIRCRAFT REG # AP-BJO AT AIIAP, LAHORE ON 03RD NOVEMBER, 2015

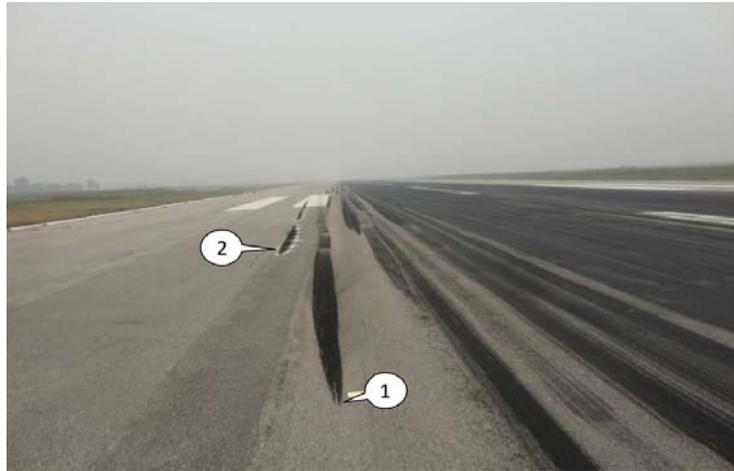
1. Right outer (No. 4) tyre mark starts 1394 ft after Runway Threshold (RWT), 28 ft left of Runway Centre line (CL). After about 25 ft tyre marks pattern, gradually becomes lighter and repeats after small gaps till white line.

2. Right inner (No. 3) tyre dark mark start 24 ft from point 1 and is 31 ft left of CL. Mark is 24 ft long, then there is 5 ft gap and then dark mark continues for 75 ft. Its end point is 34 ft left of CL.

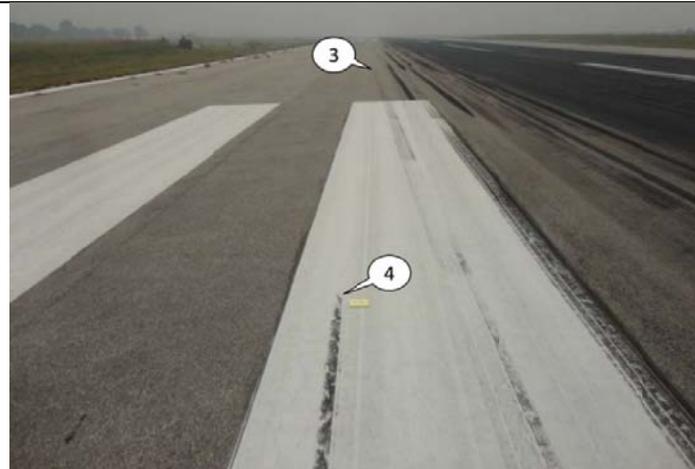
3. End point of right outer (No. 4) tyre mark (1656 ft from RWT).

4. End point of right inner (No. 3) tyre mark (1578 ft from RWT and 34 ft left of CL).

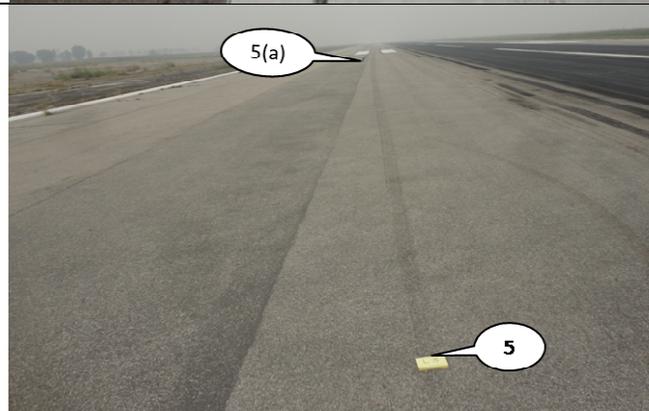
5. Very light right outer (No. 4) mark started again after 82 ft from point 3 (1738 ft from RWT), 33 ft left of CL. Right inner (No. 3) and left tyre marks not visible around here.

5(a). Right inner (No. 3) dark tyre mark is visible at distance, before left white line.

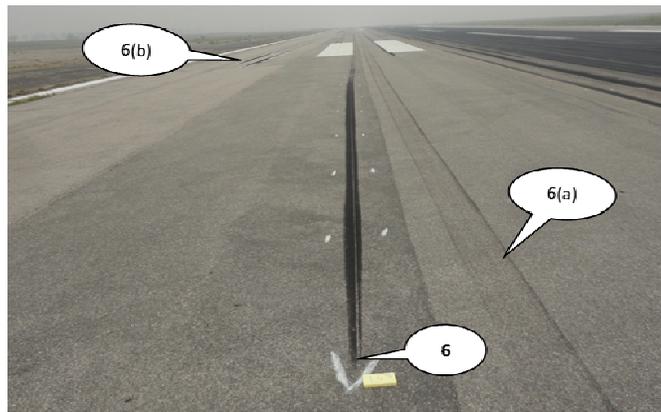
6. Right inner (No. 3) dark tyre mark started again, 4443 ft from 1 (1837 ft from RWT) and 39 ft left of CL.

6(a). Right outer (No. 4) tyre mark is continuing very light from point 5.

6(b). Left wheel mark is visible at distance.

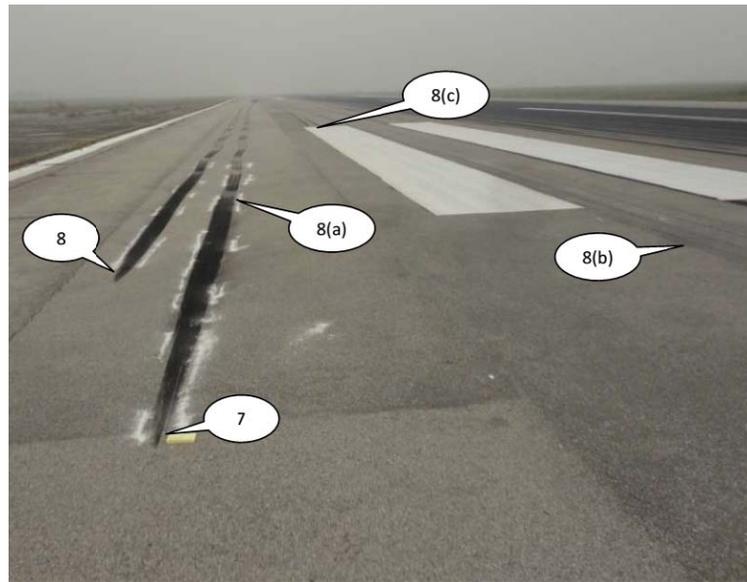
7. Left main inner (No. 2) tyre mark started 184 ft from point 6 (2020 ft from RWT, 56 ft left of CL).

8. Left main outer (No. 1) tyre mark started about 10 ft after point 7.

8(b). Right wheel marks are very light.

8(c). Nose wheel dark mark started near end of left thick line.

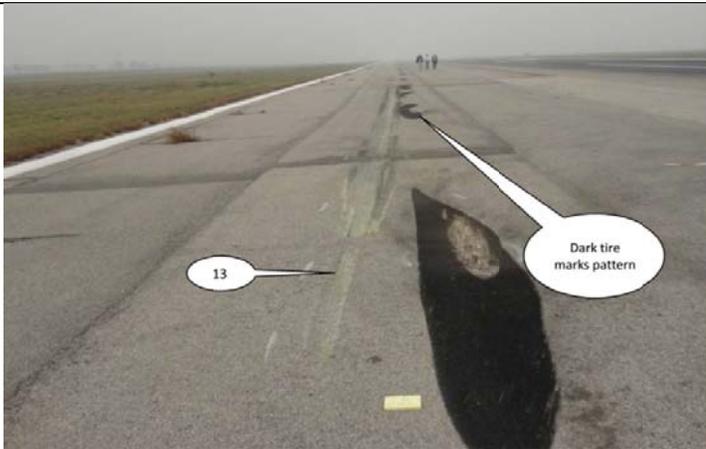
13. Left engine (No. 1) touched runway (2650 ft from RWT, 56 ft left of CL).

- 2.2.6 The left engine cowling mark on the runway surface was located at 2650 ft from RWT, 56 ft left of CL (Para 1.12.3, Picture #13). This distance corresponds to FDR time of approximately 5334 seconds. The identification of the LMLG collapse time interval (5331 to 5335 seconds) was corroborated by increase in left roll and increasing of pitch angle.

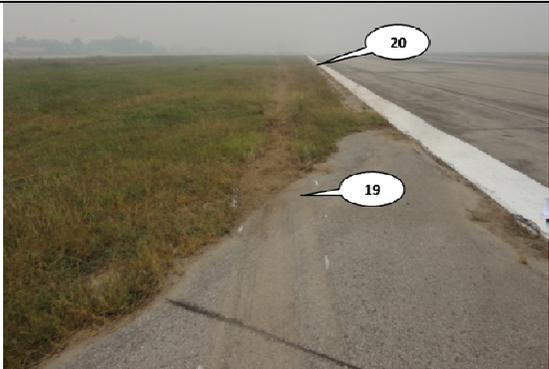
<p>19. Left engine (No. 1) rub mark entered unprepared surface on left of runway (6468 ft from RWT, 115 ft left of CL).</p> <p>20. Nose wheel entered unprepared surface on left of runway (6711 ft from RWT)</p>

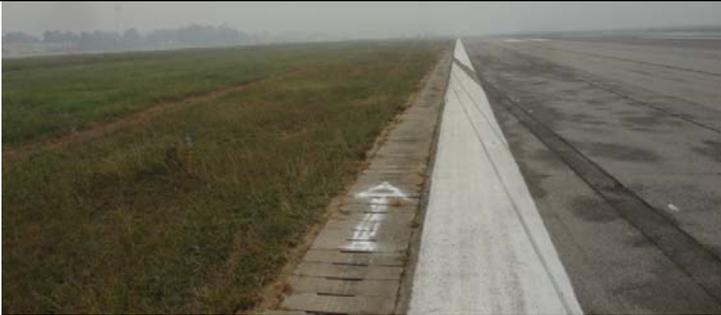
<p>21. Right wheel entered unprepared surface on left of runway (6878 ft from RWT).</p>

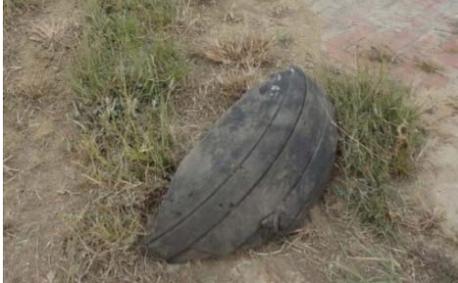
<p>22. Right wheel tyre piece (6996 ft from RWT, 85 ft left of CL)</p>

- 2.2.9 One piece of RMLG tyre (Para 1.12.3, Picture #14) was located on the path of the aircraft after it left the runway and was moving forward on unprepared surface. It appeared that tyre piece separated after it encountered a brick lining on the soft ground along the runway edge. The distance was 6996 ft from RWT and 10 ft away from runway left edge. Most probably the RMLG tyres failed due to cumulative effect of braking and encountering uneven load off the unprepared surface.

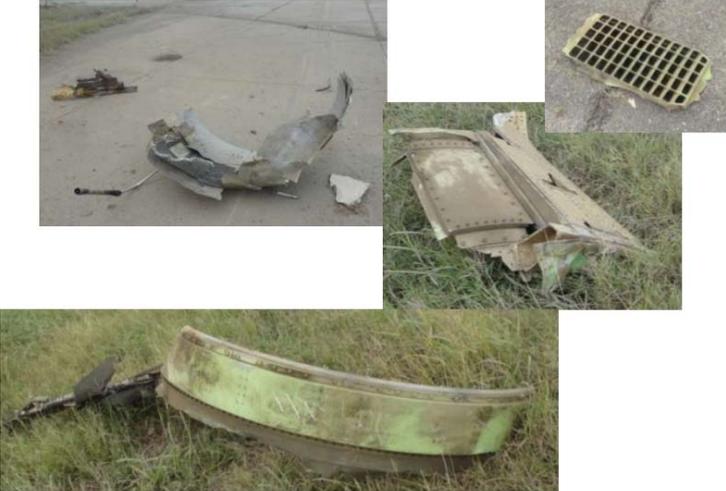
<p>23. Engine cowling , thrust reverser and miscellaneous hardware debris scattered around (7390 ft from RWT)</p>

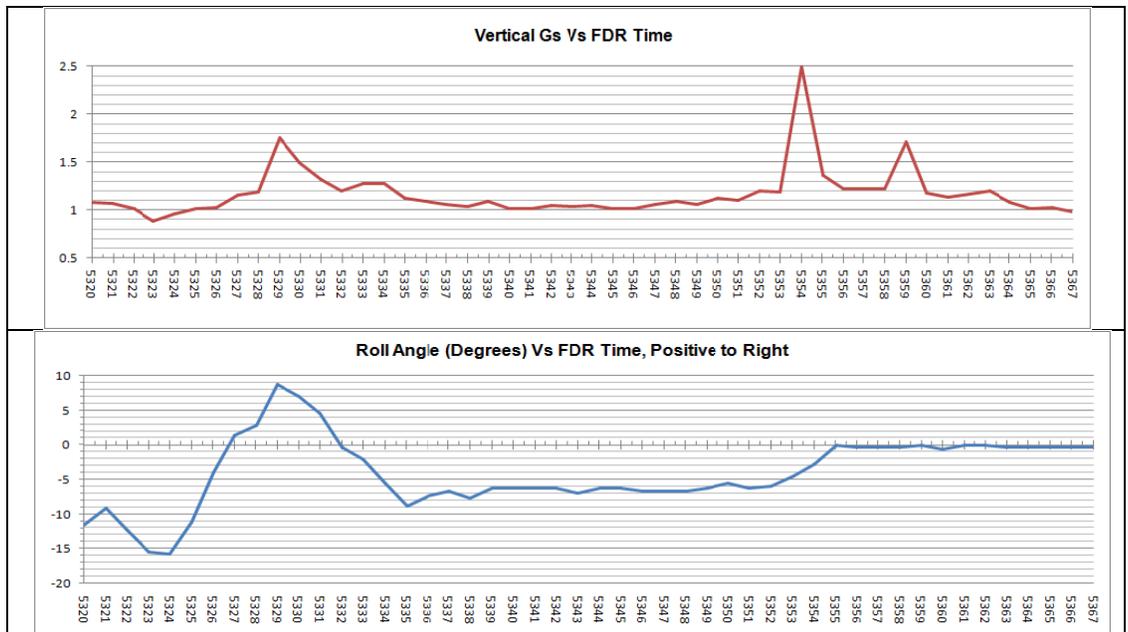
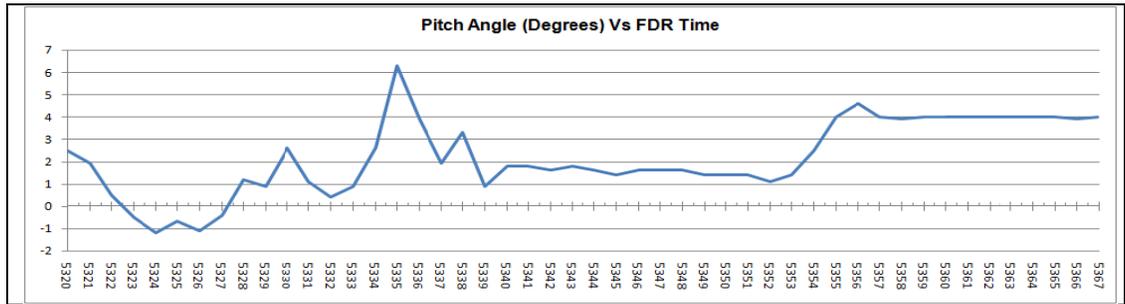
2.2.1 The initial landing contact of the aircraft with runway was indicated by the recorded local spike of 1.75 Gs in vertical acceleration at 5329.6 seconds FDR time. The FDR Ground speed, True airspeed were 174 kts and 166 kts respectively against reference speed of 134 kts at the time of touchdown. The roll angle at this time was about 8° to right side and pitch attitude was approximately 1.5° nose up. The RMLG outer tyre (No.4) marks started 1394 ft after the Runway Threshold and 28 ft towards the left of Runway Centerline (CL). The presence of No.4 tyre mark and FDR parameters of right roll and local spike in vertical acceleration suggested that this tyre mark was of the initial landing contact of the aircraft and corresponded with FDR time of 5329.6 seconds.

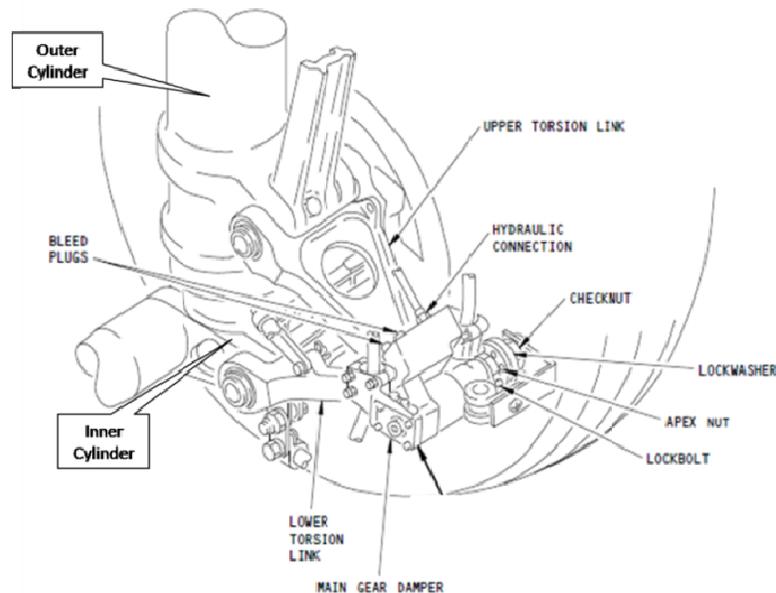
Torsion Links and Shimmy Damper Assembly

- 2.2.13 The following pictures shows schematic of torsion links and shimmy damper assembly. The axel of the wheels is mounted on the inner cylinder. The torsion links and shimmy damper assembly prevents pivot of the inner cylinder inside the outer cylinder (torsional movement). The torsional vibrations are prevented by the shimmy damper. It is pertinent to mention that clearance/play at the attachment points of shimmy damper and torsion links are detrimental in effectiveness and efficiency of the whole mechanism to prevent torsional vibrations of the wheel assembly.

- 2.2.14 Ineffective shimmy damper mechanisms due to low sink rate, trapped air/internal leaks/failures of damper, and more than specified play of the associated linkages results in torsional vibrations, which is termed a shimmy event. If the vibrations approach the natural frequency of assembly then resonance phenomenon is excited which results into very large amplitude vibrations. The large amplitude vibrations exert excessive load on associated linkages, resulting into failure of the torsion links/shimmy damper piston rod.

- 2.2.17 The Boeing maintenance instructions in applicable Maintenance Planning Document (MPD) and Aircraft Maintenance Manual (AMM) specify inspection and adjustment of Shimmy Damper Linkages mostly in C-check. In order to address the problem of shimmy the Service Letter (SL 737-SL-32-057-D) dated 16th September, 2014 (applicable at the time of the incident) recommends more frequent checks, summarized as follows:

- 2.2.17.2 After performing the above adjustment, measure across the faces of the thrust washers. If dimension is more than 2.7 inches, disassemble the joint and replace worn parts.

- 2.2.17.3 Disassemble the Apex Joint and inspect spherical cup washers, the damper piston, and the spherical bushings in the torsion link for wear annually escalating to every C-check as service experience with the damper is attained. Worn parts are to be replaced if measurable wear is detected.

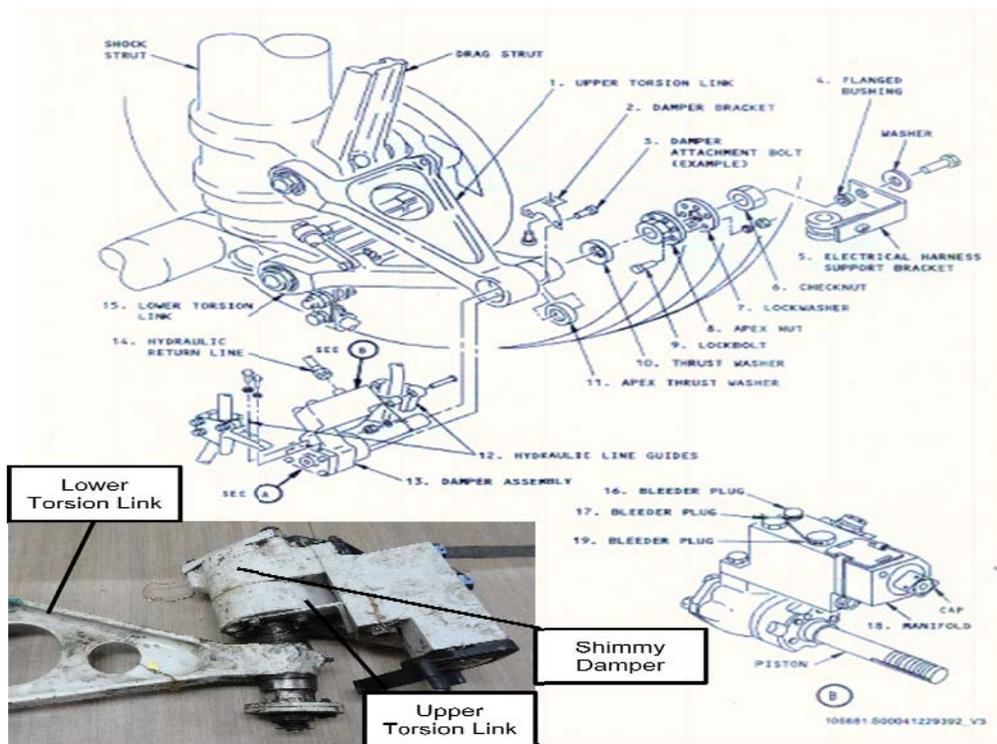
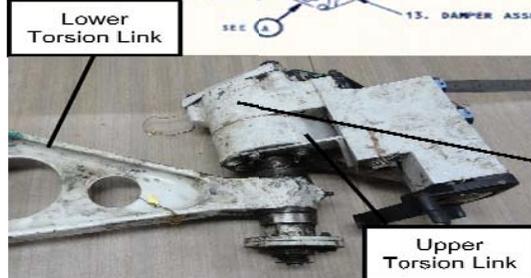
2.2.25 As discussed earlier, the forward piece of upper torsion link, outer piece of shimmy damper piston rod and shimmy damper were located at 3556 ft, 3818 ft and 4474 ft from RWT respectively. The forward link of the upper torsion link is attached to the shimmy damper body with the help of bolts. The shimmy damper piston rod passes through opening of the upper torsion link and is attached to the lower torsion link. The assembly sequence of the parts is shown in following schematic. The forward portion of the torsion link can dislodge only after breakage of its attaching bolts with shimmy damper body and breakage of the shimmy damper piston rod end. The evidence therefore, suggested that shimmy damper piston rod broke before separation of the forward portion of the upper torsion link from its assembly.

2.2.26 The tensile overload failure of the shimmy damper piston rod end suggested that it encountered overload due to large amplitude torsional vibrations during the shimmy event. The fact that there was no reported LMLG shimmy event prior to the incident and there was no evidence of fatigue failure of shimmy damper linkages suggests that the 15.5% reduction in strength of the shimmy damper rod was not responsible for failure under the normal circumstances. However, the occurrence of shimmy event introduced extra

ordinary load condition and the shimmy damper piston rod could not sustain it. After failure of the shimmy damper piston rod the inner cylinder was no more restrained against torsional movement inside the outer cylinder.
