**KOMITE NASIONAL KESELAMATAN TRANSPORTASI  
REPUBLIC OF INDONESIA**

**Aircraft Serious Incident Investigation Report**

**PT. Batik Air Indonesia**

**Boeing 737-900 ER; PK-LBO**

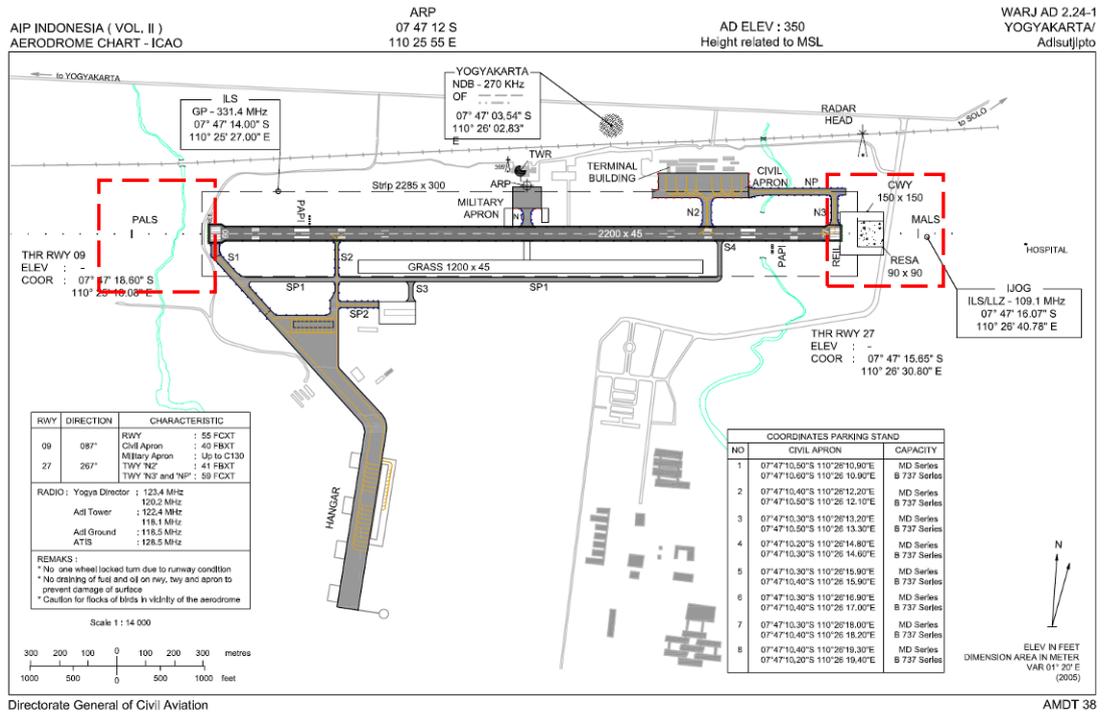
**Figure 7: The airport layout published on Aeronautical Information Publication**

There was different information related to stopway, clearway and RESA between Aerodrome Information Publication (AIP) and Jeppesen publication.

3.	11	<b>Figure 7: The airport layout published on Aeronautical Information Publication</b> The airport layout is using aerodrome chart amendment 38(20 February 2014), meanwhile the current chart is amendment 41 (2 April 2015)	KNKT has not received the amendment 41 of the airport layout.

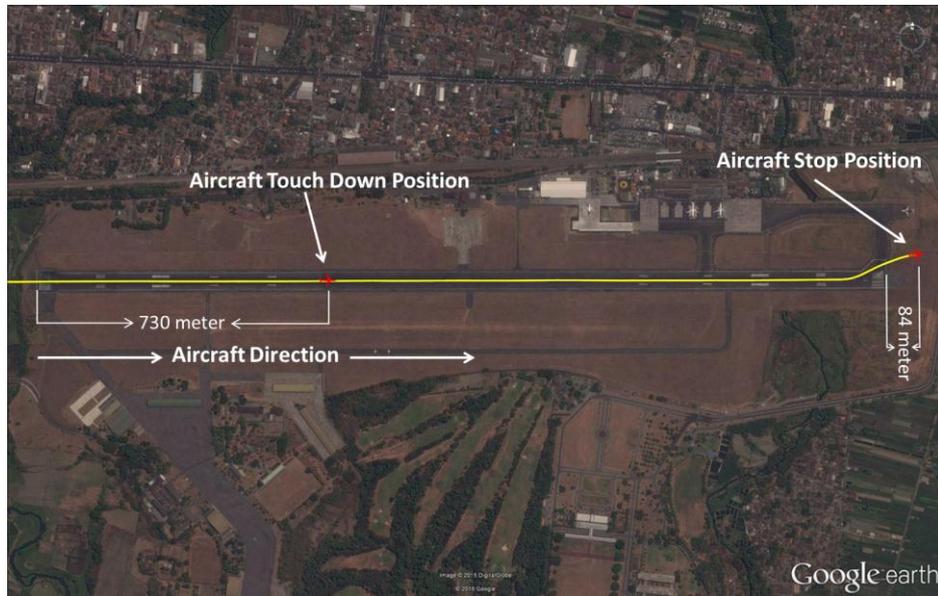
**Figure 10: The aircraft movement based on FDR data**

After the aircraft leaving the pavement, there were no sign of nose wheel mark on the gravel instead of an indentation the gravel with the dimension approximately 50 cm in width and 150 cm in length. Subsequently, after the indentation, there was a long single scratch mark on the gravel until the aircraft final position.

The aircraft stopped at about 80 meters on the left of runway 09 centerline extension and about 84 meters from end of runway 09 with the nose landing gear collapsed.

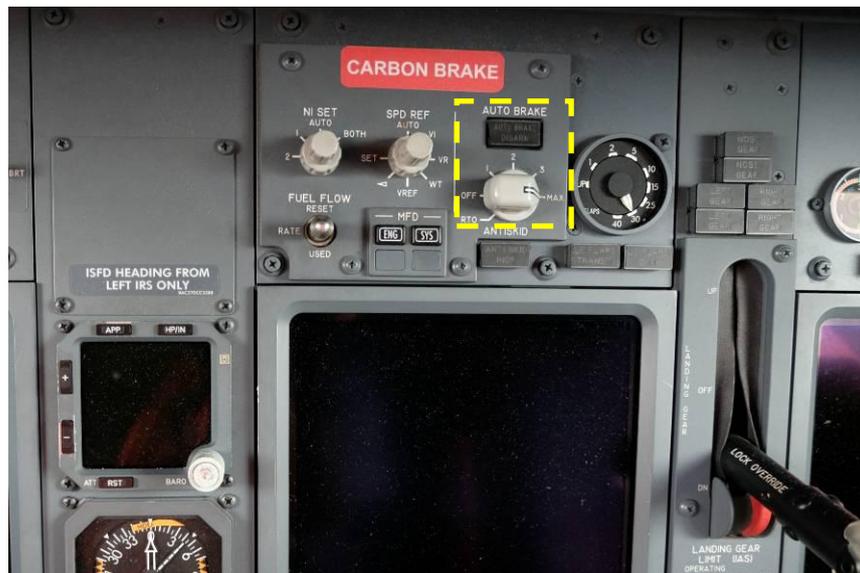
**Figure 13: Auto brake selection at “MAX”**

At 0756 UTC, the pilot asked the Adi Tower whether the runway was wet and it was affirmed by Adi Tower. Referring to the runway condition, the pilots decided to change the selection of the auto-brake to maximum.
