Report IN-033/2015

Incident involving an Airbus A-330-300, registration EC-LZX, operated by Iberia, and a Boeing B-777-200, registration N758AN, operated by American Airlines, at the Adolfo Suárez Madrid-Barajas Airport (Spain) on 6 December 2015

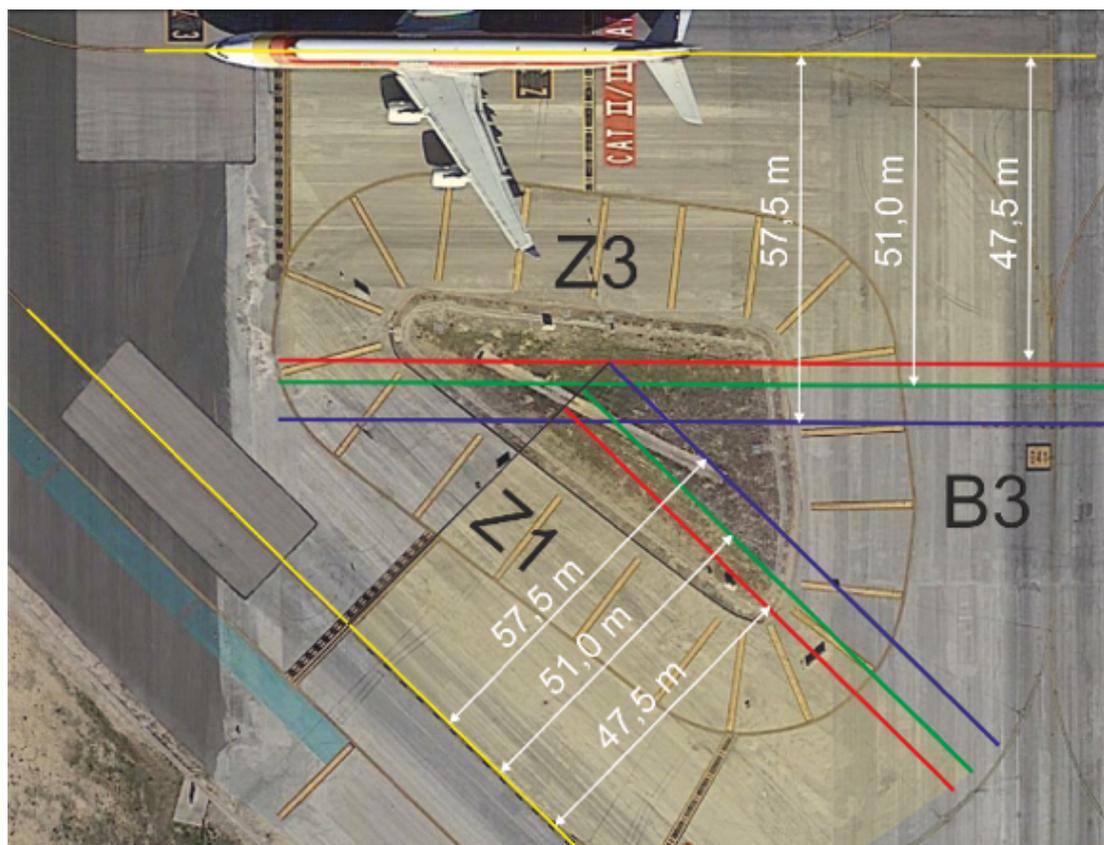
Figure 4. Photograph of taxiways Z1 and Z3, showing the distance from the edge to the centerline associated with codes E (as per RD 862/2009) and F (as per RD 862/2009 and CS-ADR-DSN)

Figure 4 contains an aerial photograph of the 36L threshold area, which shows the length between the edge and the middle of the strip for taxiways Z1 and Z3 for the purpose of seeing if there is any interference or overlap.

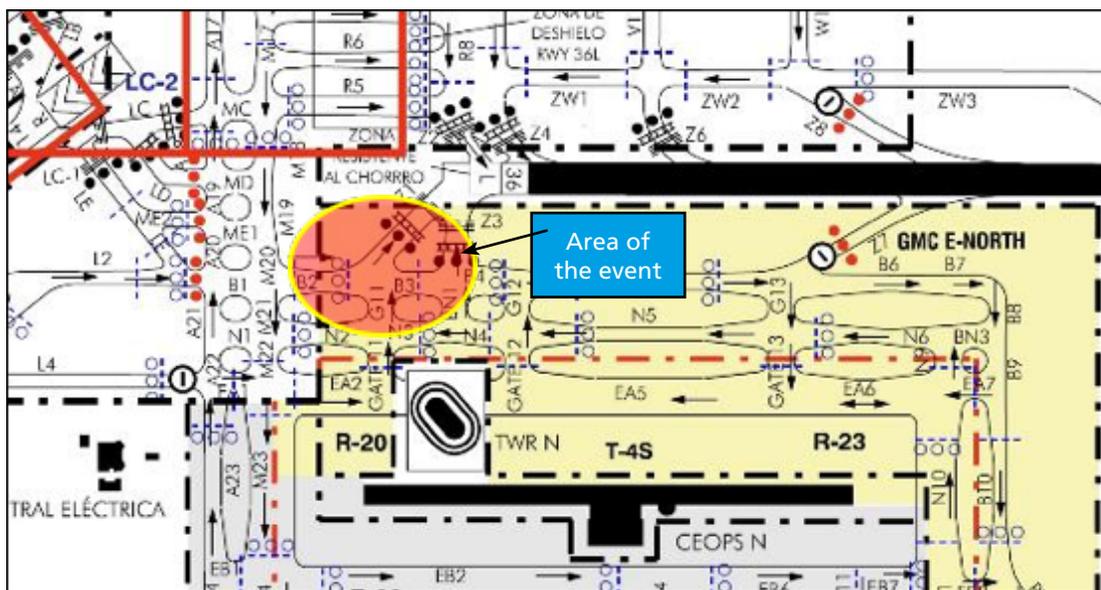
Figure 7. Segment from the aerodrome chart for ground movements, north configuration, AD.2-LEMD GMC 1.1, which was published in the AIP Spain for the airport, indicating the area where the incident occurred

Figure 7 contains a segment of the aerodrome chart for ground movements published in the AIP Spain (AD 2-LEMD GMC 1.1), showing the area where the incident took place. This chart also shows that taxiway Z-1 has two holding point markings for runway 36L. The chart even differentiates between the different configurations used for the two markings.

The one furthest from the runway, which would be encountered first by an airplane taxiing to the runway, corresponds to configuration B, described in point 5.2.10 of Royal Decree 862/2009 and in the point with the same number in ICAO Annex 14.

As Figure 7 shows, the control tower is located between the T-4S satellite terminal building and runway 18R-36L, very close to the site of the incident.

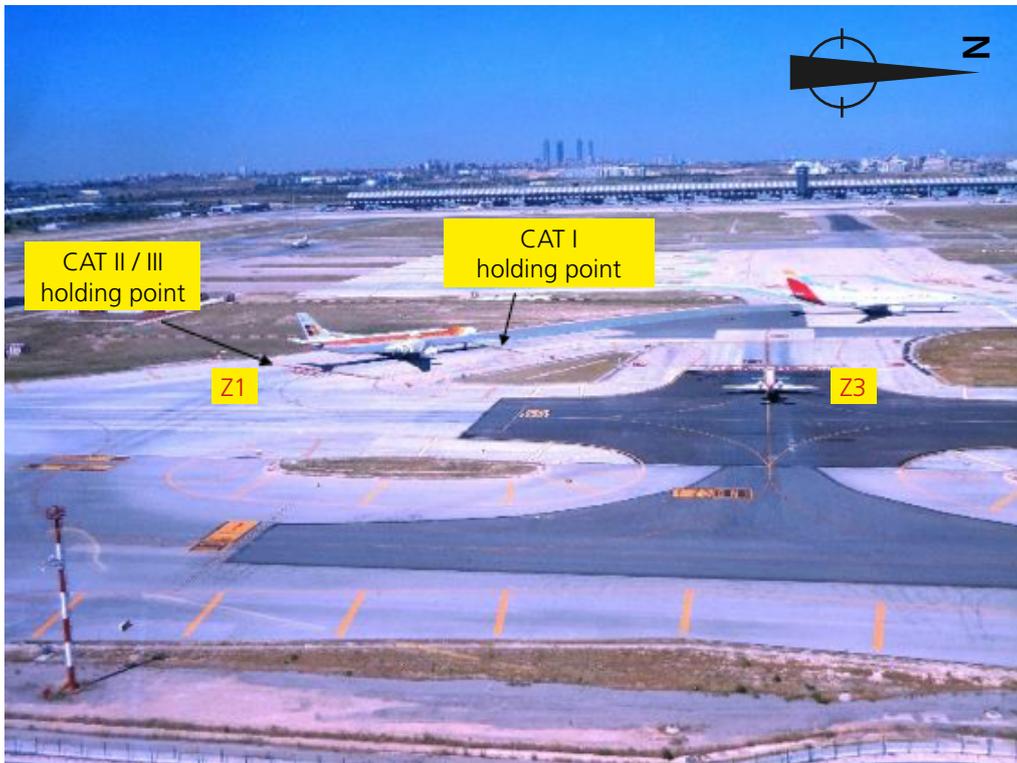
Figure 9. Photograph of taxiways Z1 and Z3, taken from the GMC-EN post in the control tower

Figure 9 shows a photograph of the incident site, taken from the GMC-EN post in the control tower. Labeled on the figure are taxiways Z1 and Z3, as well as the CAT I and CAT II/III holding points on taxiway Z1.

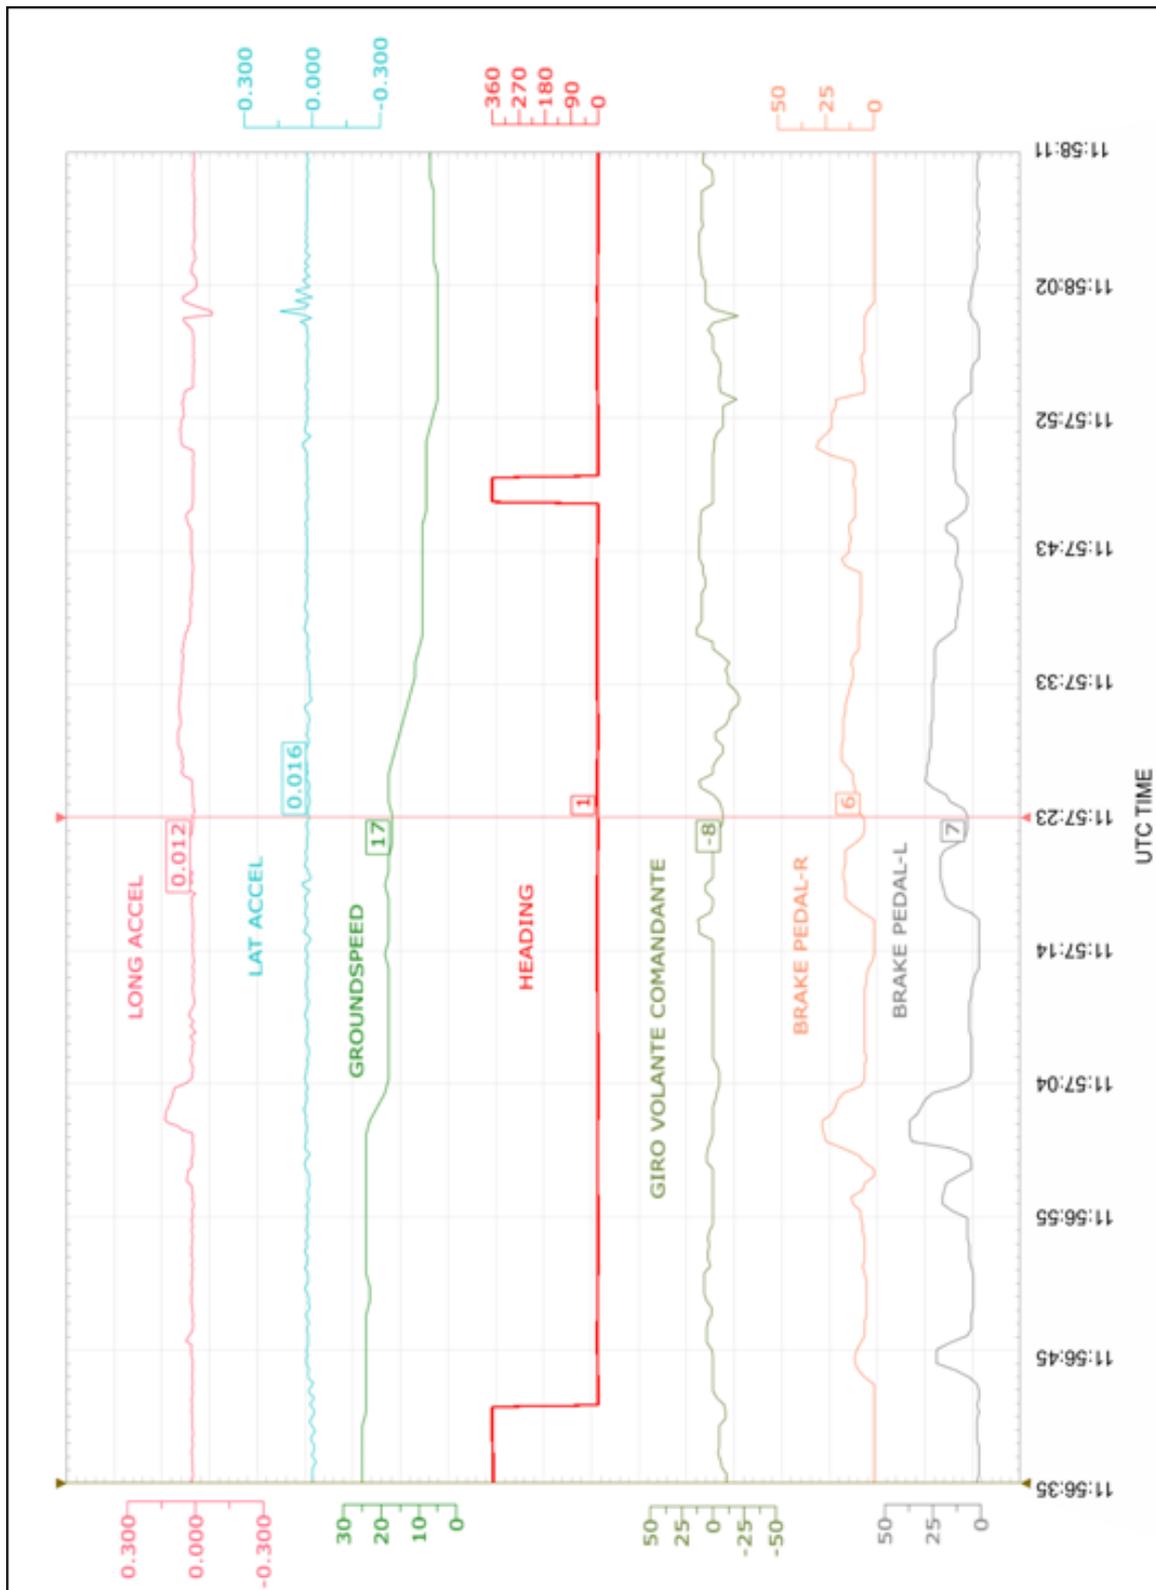
Figure 11. Graph with several parameters from aircraft EC-LZX

The graph in Figure 11 shows the captain's inputs to the brake pedal, as well as the trend in the aircraft's speed, from 11:56:39 until 11:58:11, which was 12 seconds after the collision.

At 11:57:59, another increase in lateral acceleration was recorded, peaking at 0.145 g.

The brake pedals were not activated at any time during the period from 11:57:54 and 11:58:31.

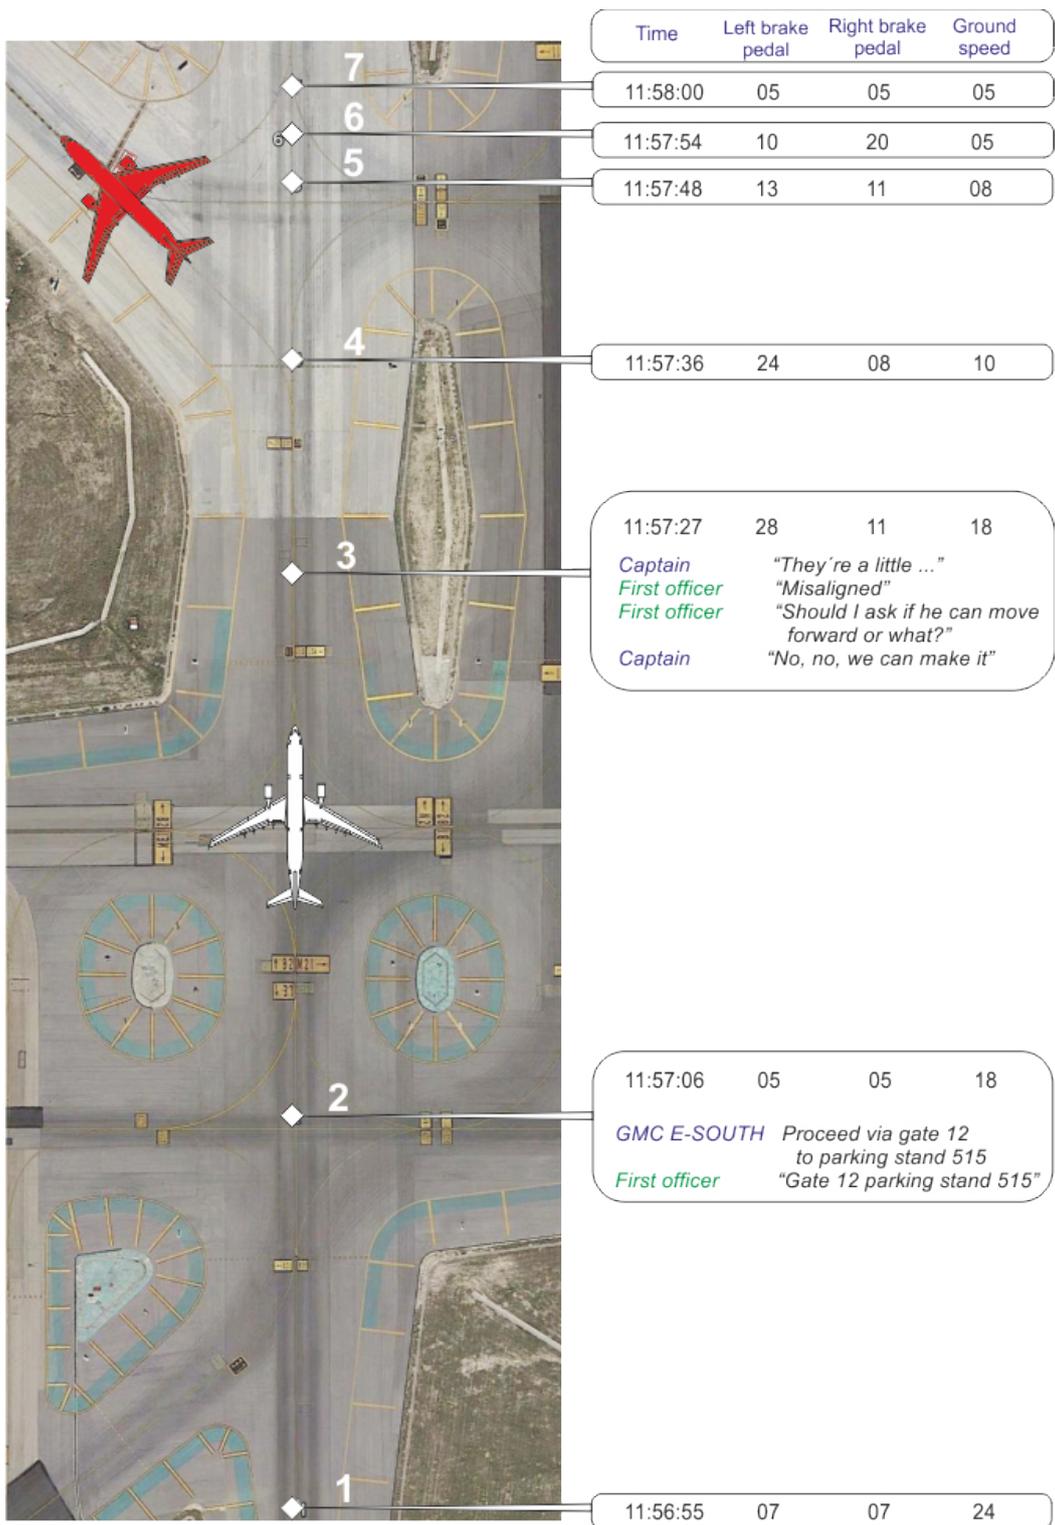
Figure 12. Detail from taxi phase of aircraft EC-LZX on taxiway B

Figure 12 shows the position of the aircraft at different times as it was taxiing on runway B. For each time, the table shows the degree of deflection for each brake pedal, the aircraft's speed and the conversations in the cockpit.

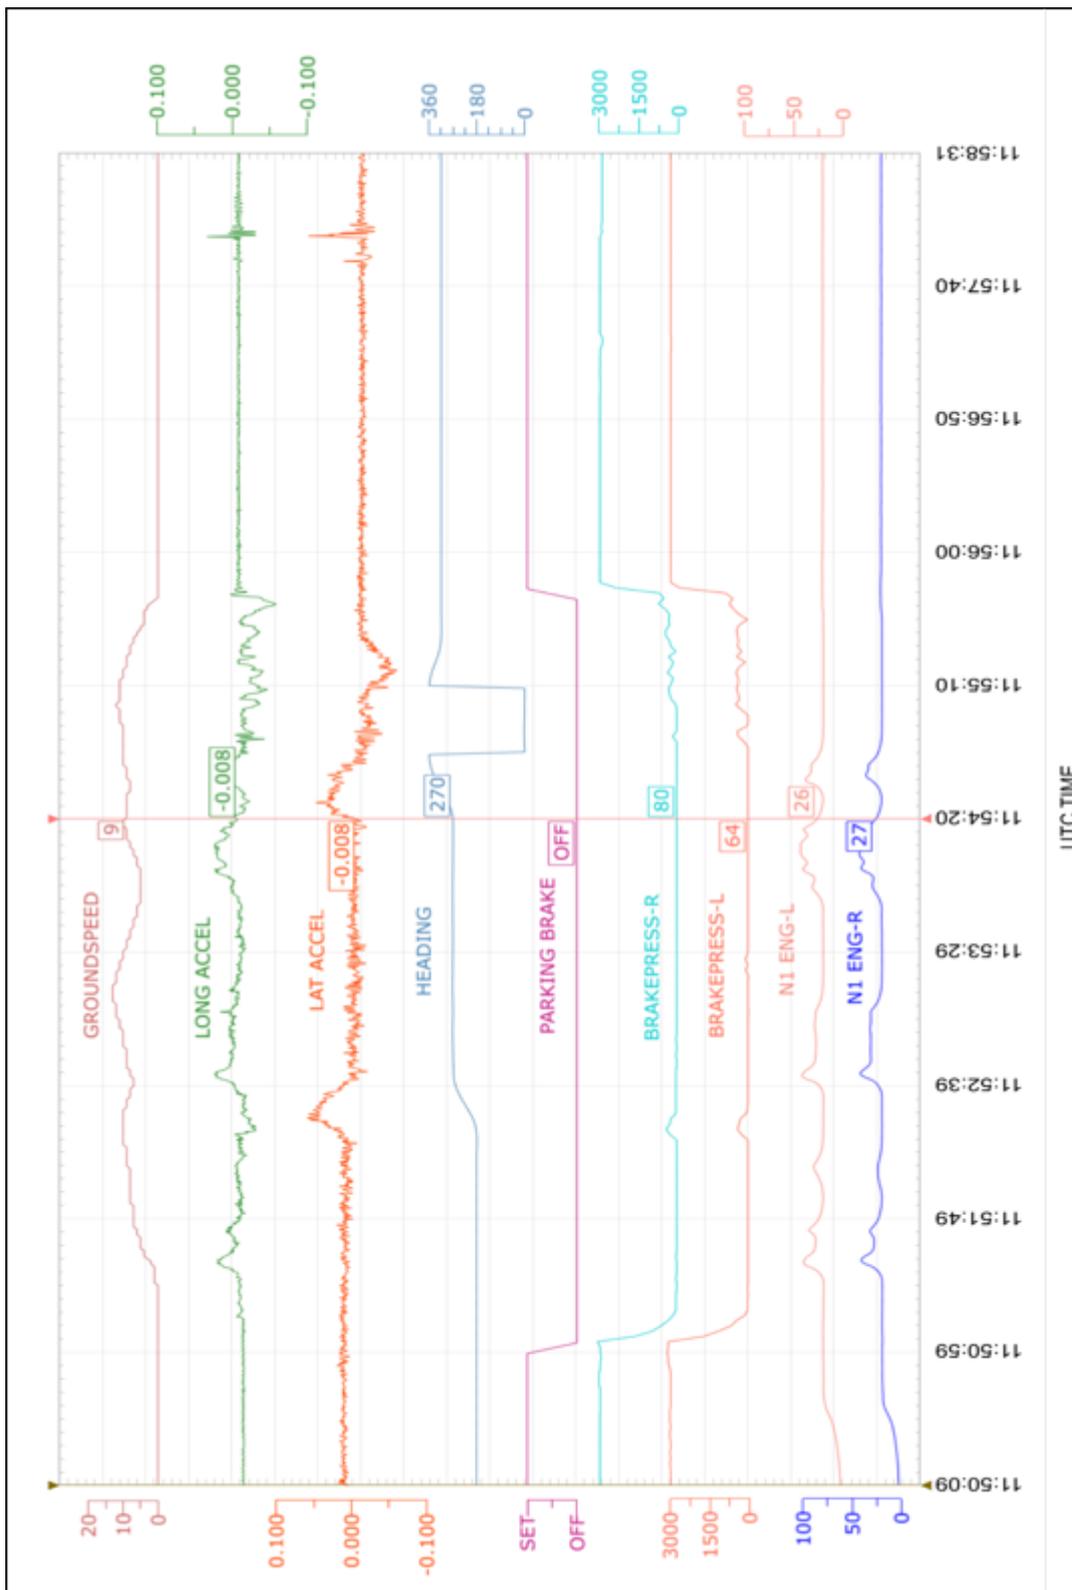
Figure 13. Graph of several parameters for aircraft N758AN, from 11:50:09 to 11:58:31 UTC

Figure 13 shows a graph with the trend for several parameters: ground speed, longitudinal and lateral accelerations, heading, parking brake, brake pressure (left and right) and engine speed (N1), spanning from 11:50:59 until 11:58:31 UTC.

At 11:57:51, a slight increase in the longitudinal acceleration was recorded, as was a larger increase in the lateral acceleration, which peaked at 0.025 g (see Figure 13).

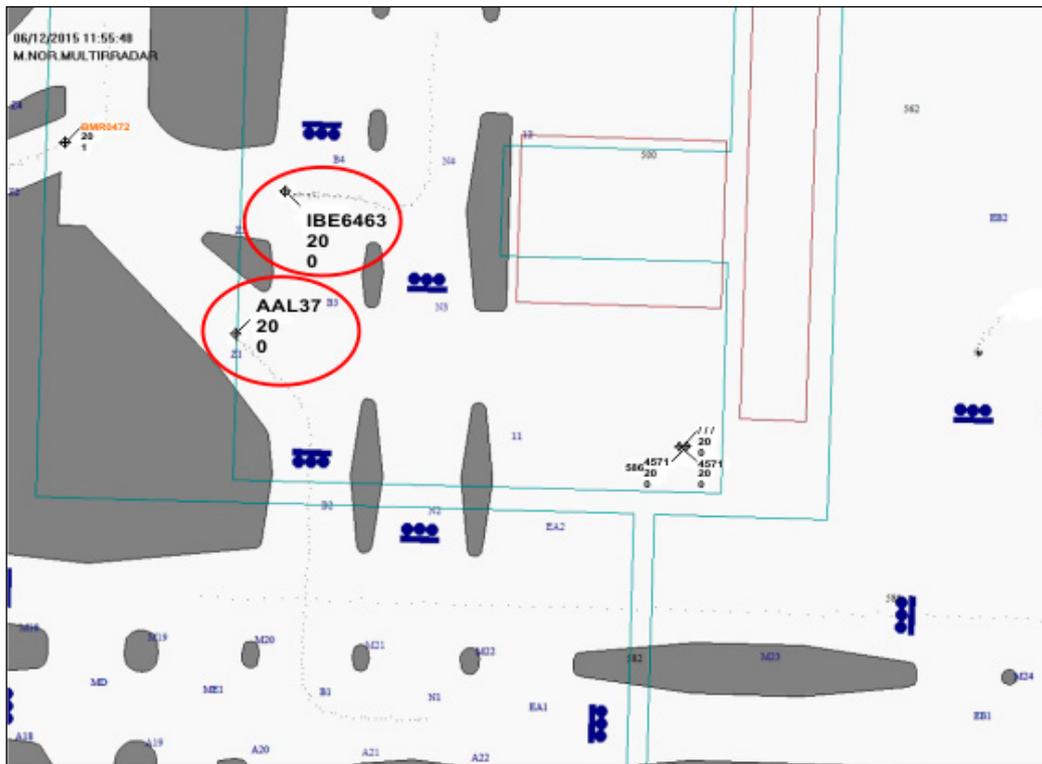
Figure 17. Multilateration radar image from 11:55:48

At 11:55:48, aircraft AAL37 stopped inside taxiway Z1. It did not move until after the incident. Aircraft IBE6463 was still stopped at the entrance to taxiway Z3.

Figure 18 shows a reproduction of the multilateration radar image from that instant, with the labels for the two aircraft circled in red.

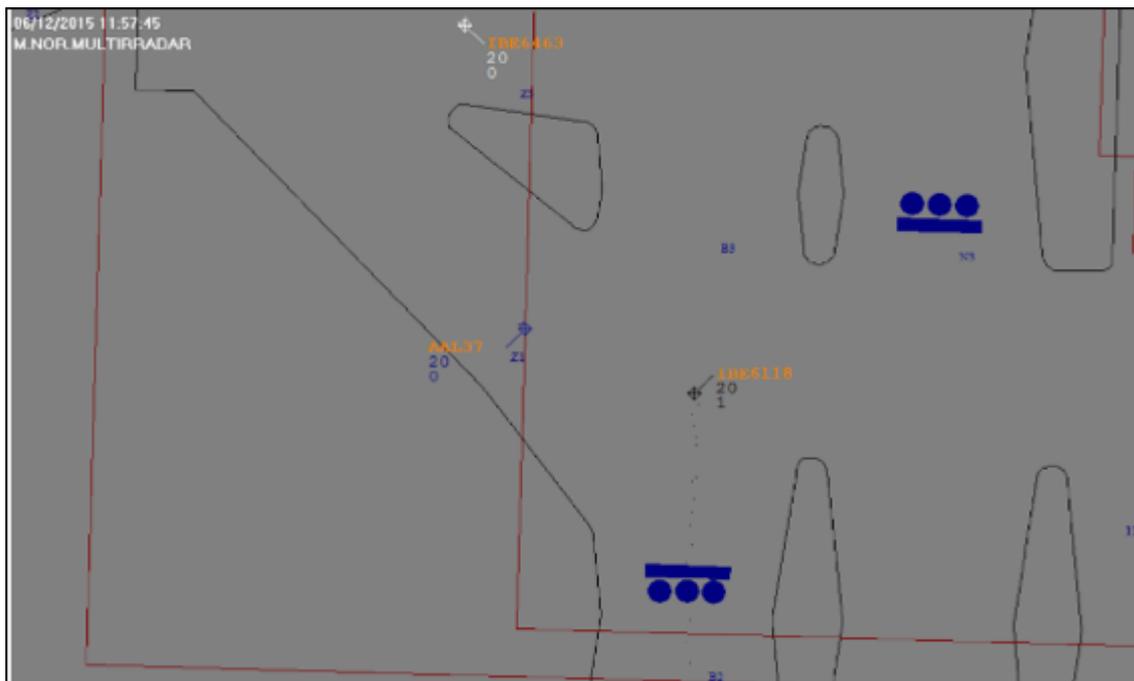
Figure 18. Multilateration radar image from 11:57:45

The image in Figure 19 shows a section of the radar screen from 11:57:45 UTC, which is practically the same time when the event occurred. This image shows that aircraft IBE6463 was closer to runway 18R-36L than aircraft AAL37 was.

In his statement, the captain indicated that he stopped the aircraft at that position in Z1 far enough away to ensure safe separation with another aircraft that was at Z3, and which preceded them in the takeoff order. The crew are not heard making any comments in this regard in the cockpit voice recorder. In addition, the multilateration display (Figure 18) shows that AAL037 reached point Z1 before IBE6463 reached holding point Z3.
