AIRCRAFT ACCIDENT REPORT AND EXECUTIVE SUMMARY

Reference:	CA18/2/3/9505	
Aircraft registration	ZS-DKS	Date of accident	7 December 2015		Time of accident	0857Z
Type of aircraft	Eclipse EA500 (Aeroplane)		Type of operation	Private (Part 91)		
Pilot-in-command licence type		Private	Age	57	Licence valid	Yes
Pilot-in-command flying experience		Total hours	2 977.0		Hours on type	506.15
Last point of departure		Lanseria International Airport (FALA), Gauteng				
Next point of intended landing		Cape Town International Airport (FACT), Western Cape				
Location of the accident site with reference to easily defined geographical points (GPS readings if possible)						
On the farm Spioenkop, Overberg district, (GPS position: 34°10.31' South 020°08.15' East)						
Meteorological information		Surface wind: 160°/5kt, Temperature: 24°C, CAVOK				
Number of people on board	1 + 0	No. of people injured	0	No. of people killed	1	
Synopsis						
<p>The aircraft had taken off on a private flight with the pilot being the sole occupant on board. The pilot had filed an IFR flight plan and had informed air traffic control (ATC) at FALA that the aircraft had a fuel endurance of 4 hours and his estimated flying

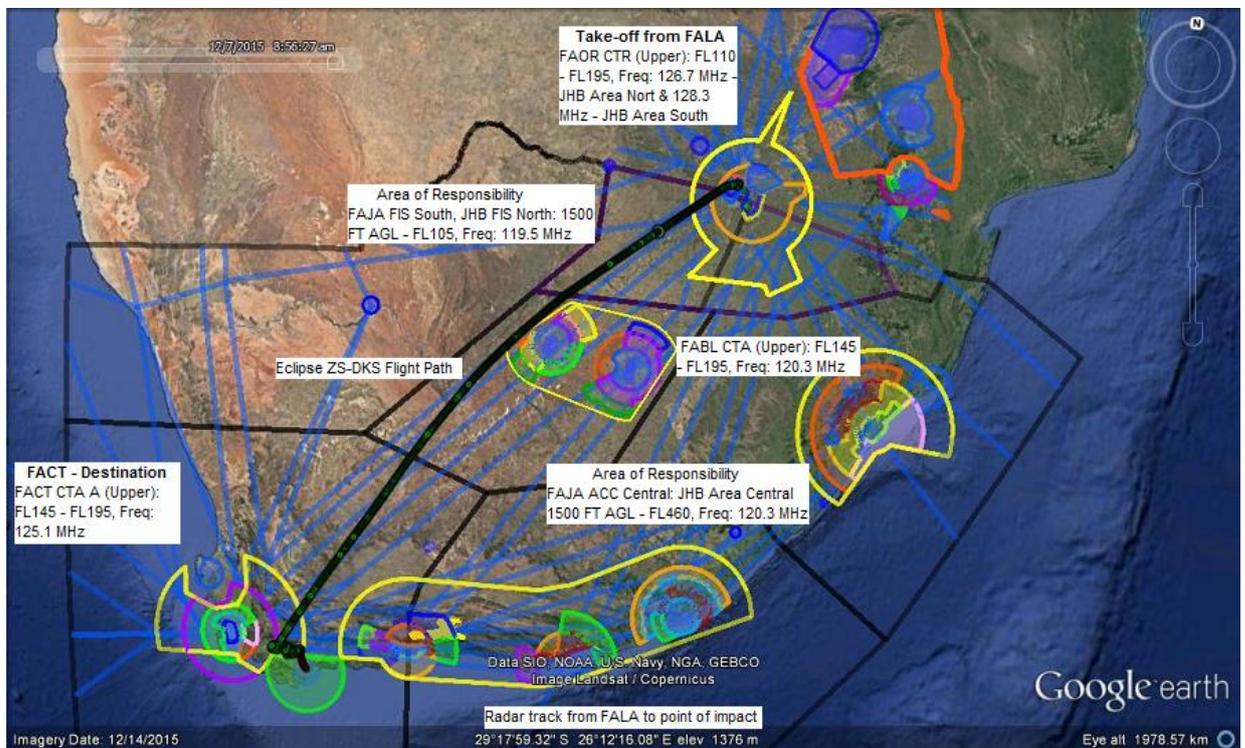
Figure 1: The flight path (visible in black) of the aircraft from FALA to the point of impact

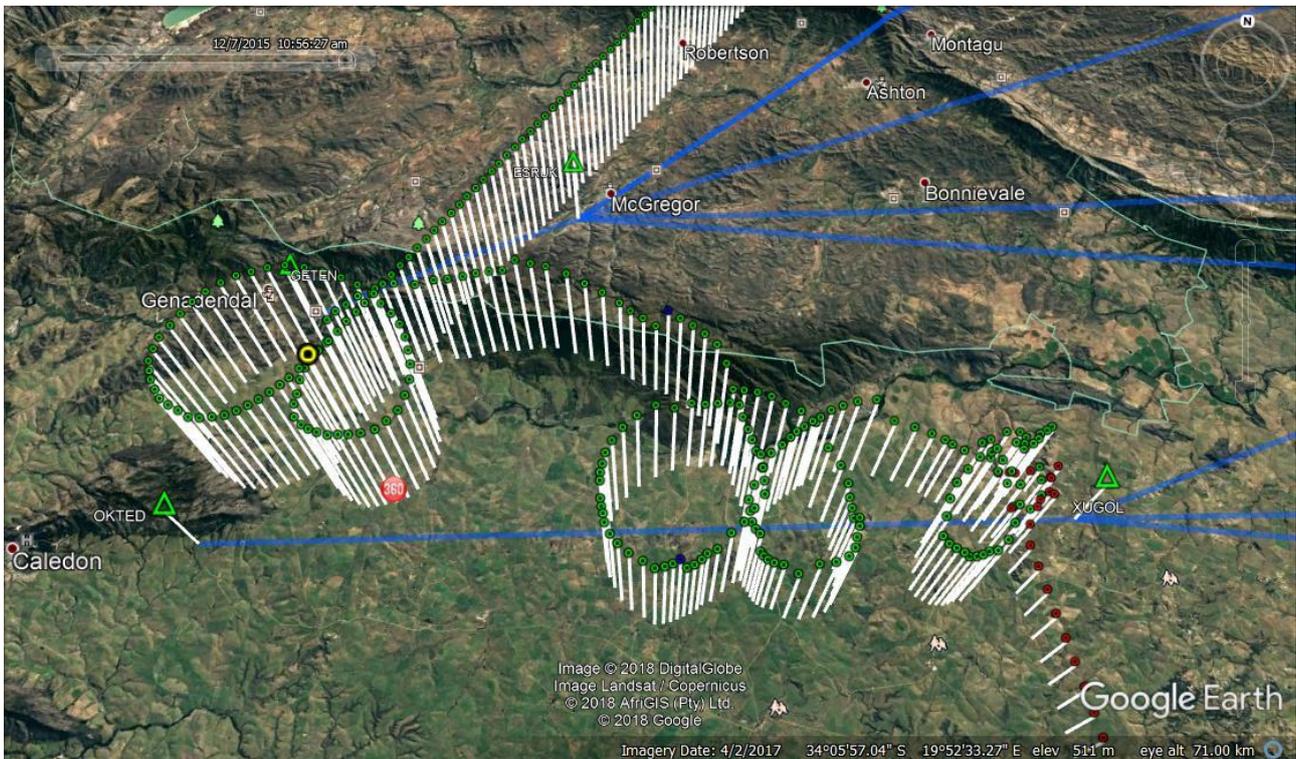
Figure 16: The radar data showing the five orbits the aircraft made before ground impact

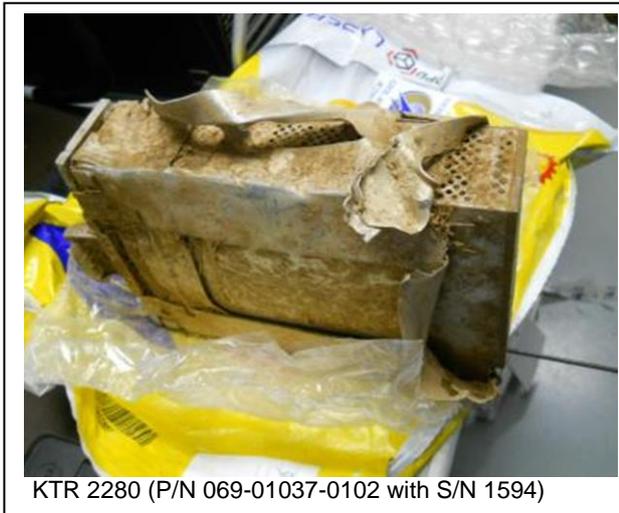
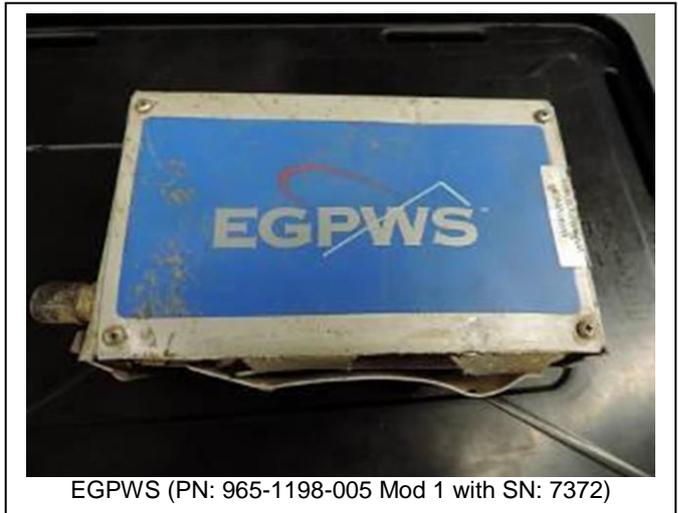
Figure 18 and 19: The KTR 2280 and EGPWS units that were sent to the USA for downloading

- (iv) Functional testing found that the VHF and ADF receivers were both functional and capable of receiving a very weak signal. The VHF transmitter did not function.

- (v) Analysis found that the transmitter fault (i.e. fault log downloaded at 09:44:01 central daylight time) was in an area on the transmitter circuit board where impact damage had occurred (cover dented inward). No determination was made as to whether the fault was the result of a damaged circuit board or a component.

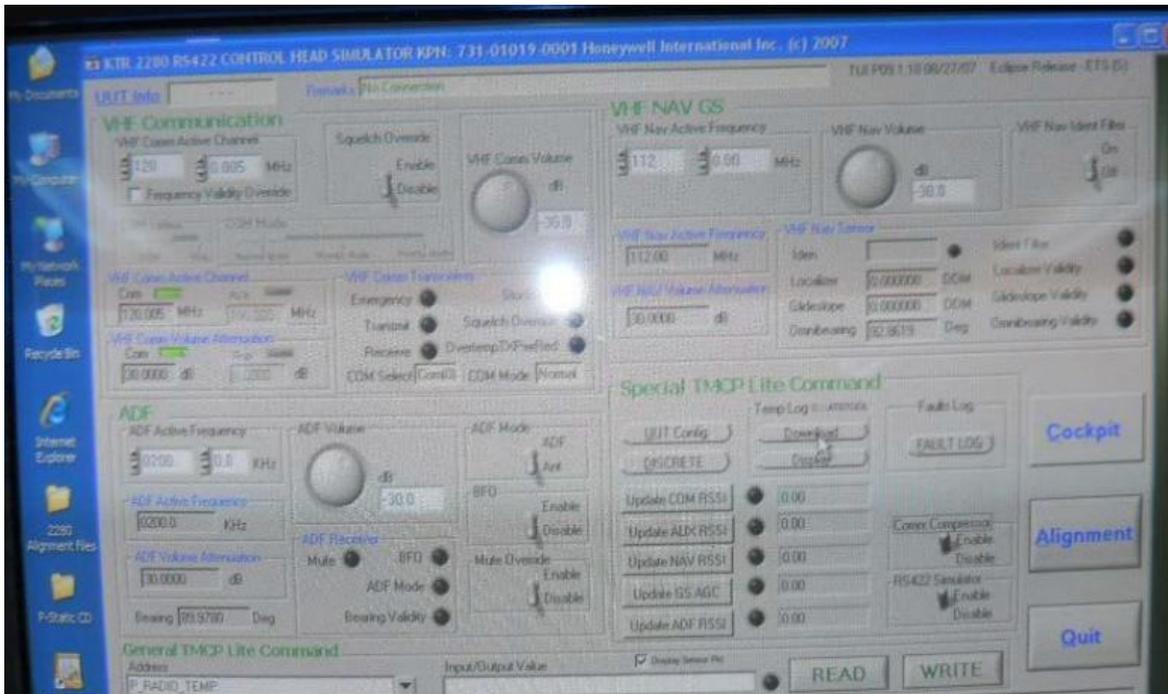
- (vi) The active/in-use frequencies were as follows: VHF communication frequency 120,005 MHz; VHF Nav/GS 112,00 MHz; ADF frequency 200 KHz.

Figure 20: A computer screenshot of the frequencies that were retrieved from the unit

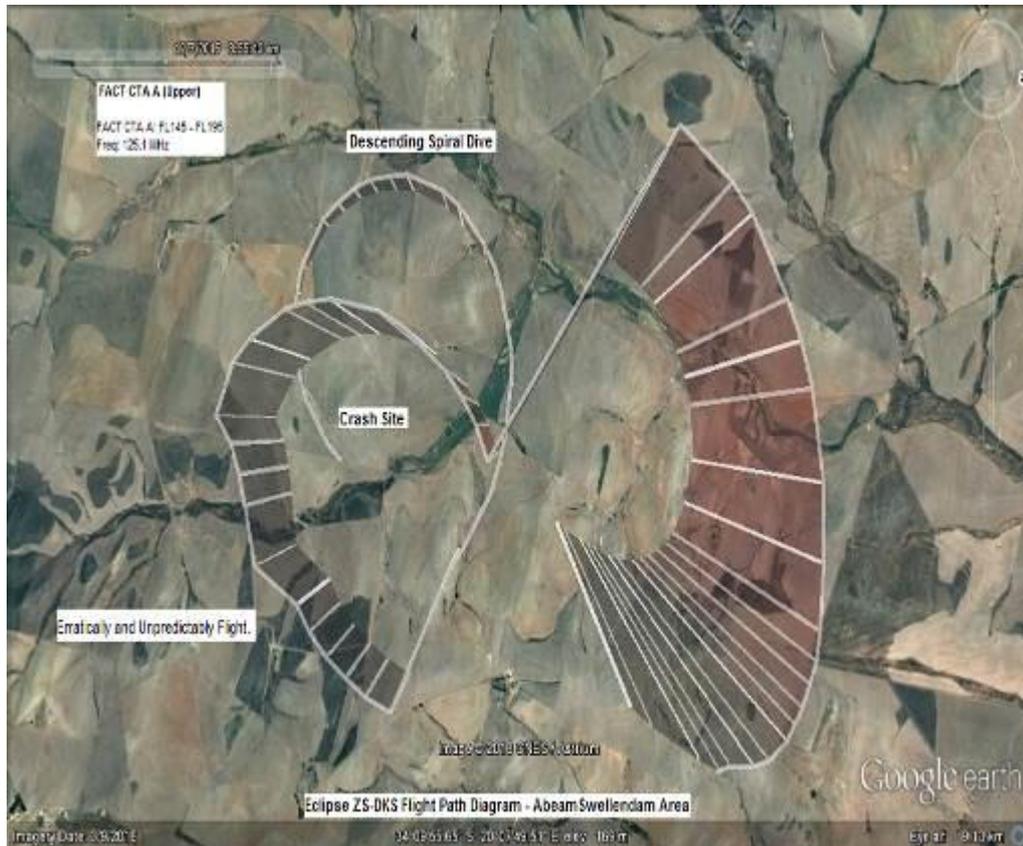
1.16.7.1 Flight path diagram: The flight data track properties (latitude and longitude, TACAIt, magnetic track & true track, true heading & roll etc. were downloaded from the EGPWS. The flight data was then used to plot the flight path on Google Earth as can be seen in Figure 21 below.

Figure 21: A plan view of the final flight path

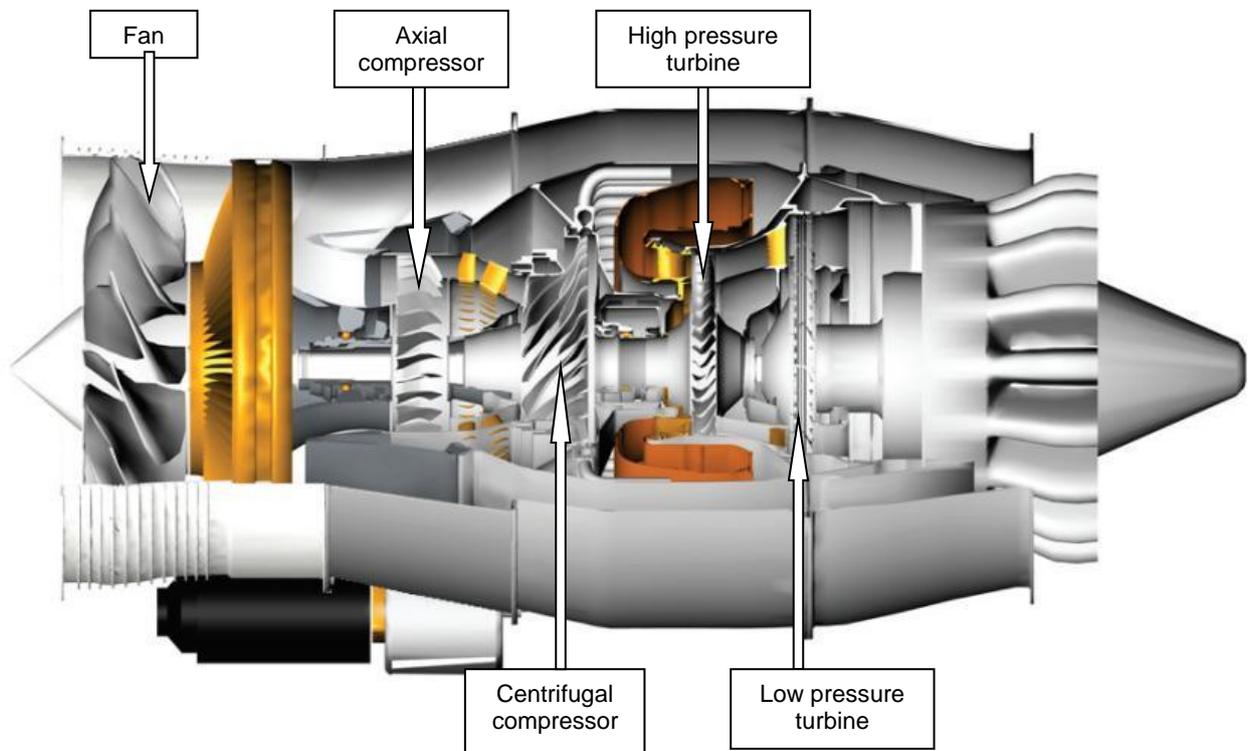
1.16.10 Both engines displayed evidence of foreign object ingestion, which consisted mainly of soil, small stones and vegetation, which were located downstream as far as the hot section of the engines. The aircraft impacted the ground in a left wing low attitude; as a result, much more destruction was observed on engine No. 1 (serial number PCE-LA0284) than on engine No. 2 (serial number PCE-LA0290). However, both engines displayed evidence marks (at more than one location within the engine) associated with the engines delivering power on impact. The figures below illustrate the internal rotational signature marks that were observed during the teardown inspection of both engines.

1.16.11 For illustration purposes, a cross-section of the PW 610F-A engine has been included in Figure 22. The photographs that follow the cross-section diagram show the hardware found on the No. 1 and 2 engines. All the engine components illustrated below displayed evidence associated with rotation during impact.

Figure 22: A cross-section of the engine

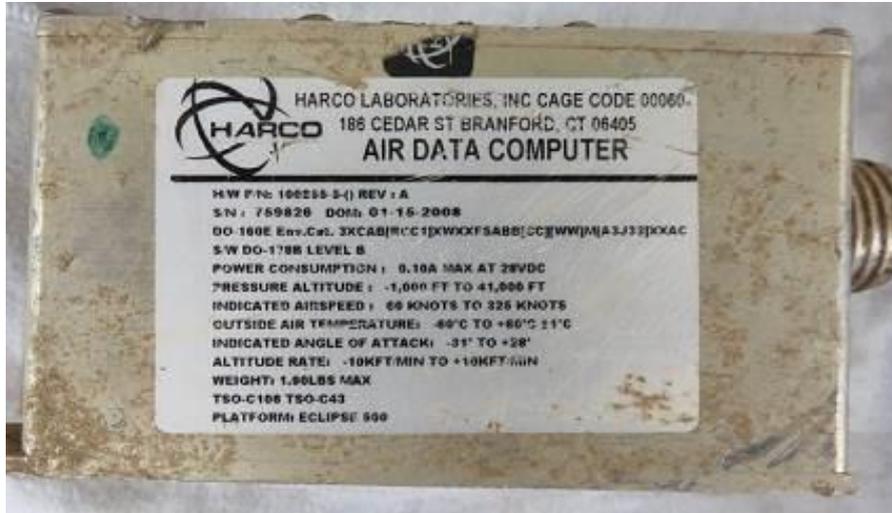
1.16.14 The investigation team recovered the air data computer (ADC) unit from the accident site and forwarded it to the NTSB engineering division, where the unit was assessed. It was determined that the ADC did contain non-volatile memory, but no flight data was recorded that could be downloaded.

Figure 38 The air data computer that was recovered
