AVIATION INVESTIGATION REPORT A15C0163

Icing encounter, loss of control, and collision with terrain

Wasaya Airways Limited Partnership
Cessna 208B, C-FKDL
Pickle Lake, Ontario, 10 nm N
11 December 2015

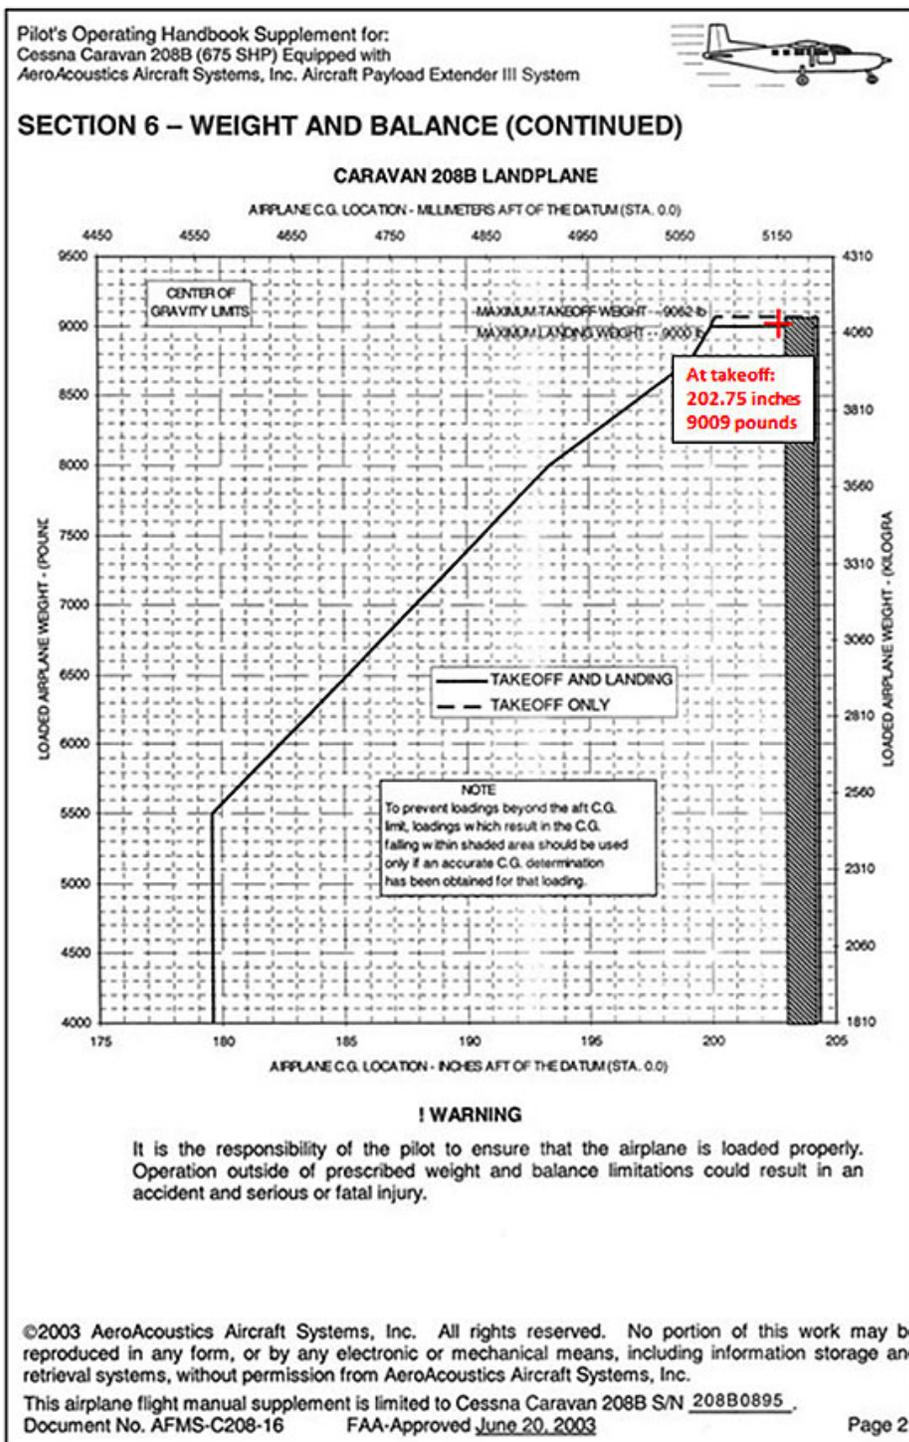
Appendix A – Weight and balance for flight WSG127

2. The high take-off weight of WSG127 increased the severity of degraded performance when the flight encountered icing conditions.
3. The pilot of WSG127 continued the flight in icing conditions for about 6 minutes, resulting in progressively degraded performance.

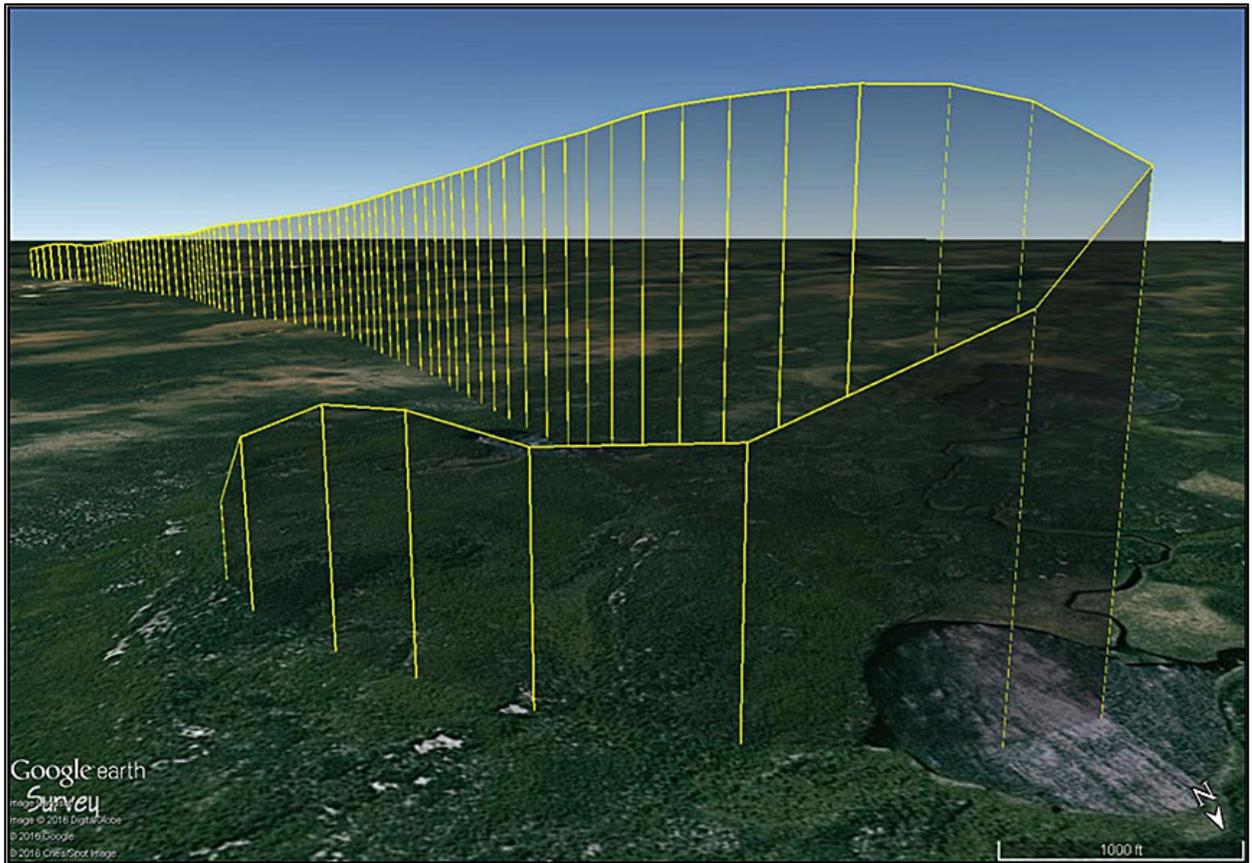
Appendix I – End of recorded flight path for flight WSG127

4. WSG127 experienced substantially degraded aircraft performance as a result of ice accumulation, resulting in aerodynamic stall, loss of control, and collision with terrain.
