FINAL
KNKT.15.12.28.04

Aircraft Accident Investigation Report

**PT. Kalstar Aviation
Embraer 190-200LR; PK-KDC
El Tari International Airport
Kupang, Nusa Tenggara Timur
Republic of Indonesia
21 December 2015**

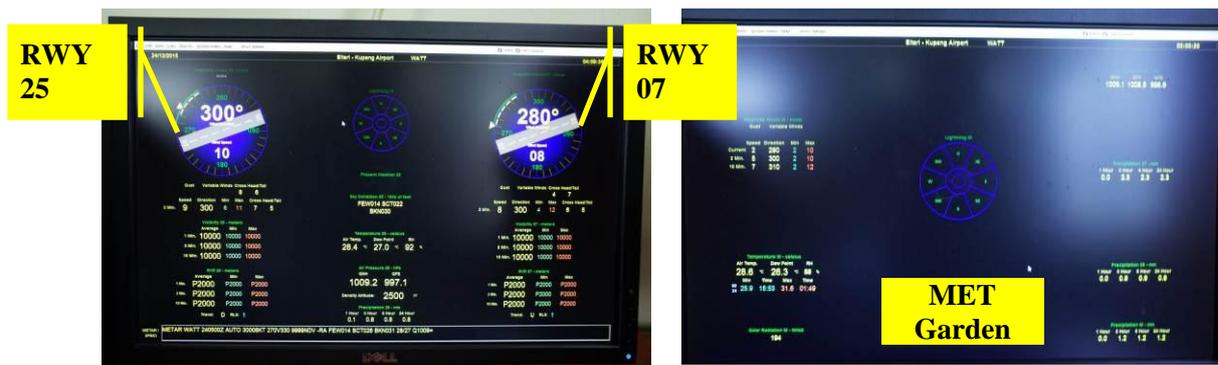
Figure 4: The display of AWOS

The AWOS information displayed in Meteorology Station office and also in El Tari Tower station. The display showed information according to its sensor location, which were labeled 07, 25 and M (Figure 4).

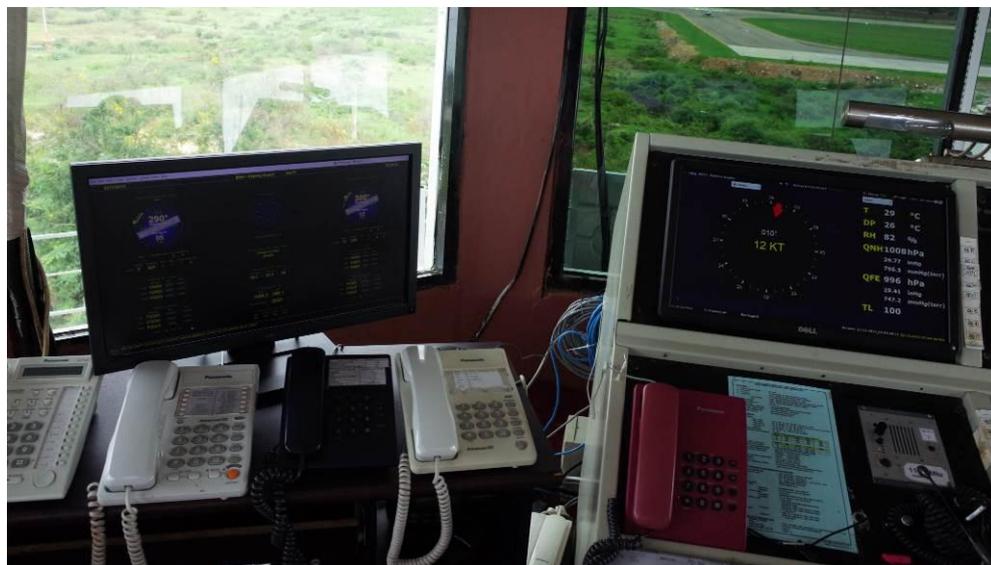
Figure 5: AWOS display (left) and Tower Set display (right).

On 1 December 2015, the AirNav Indonesia District Office Kupang as a unit providing Air Traffic Services at Kupang installed a new tower set display to provide meteorological information. The display provides information of wind, temperature, dew point, QNH and QFE (Figure 5).

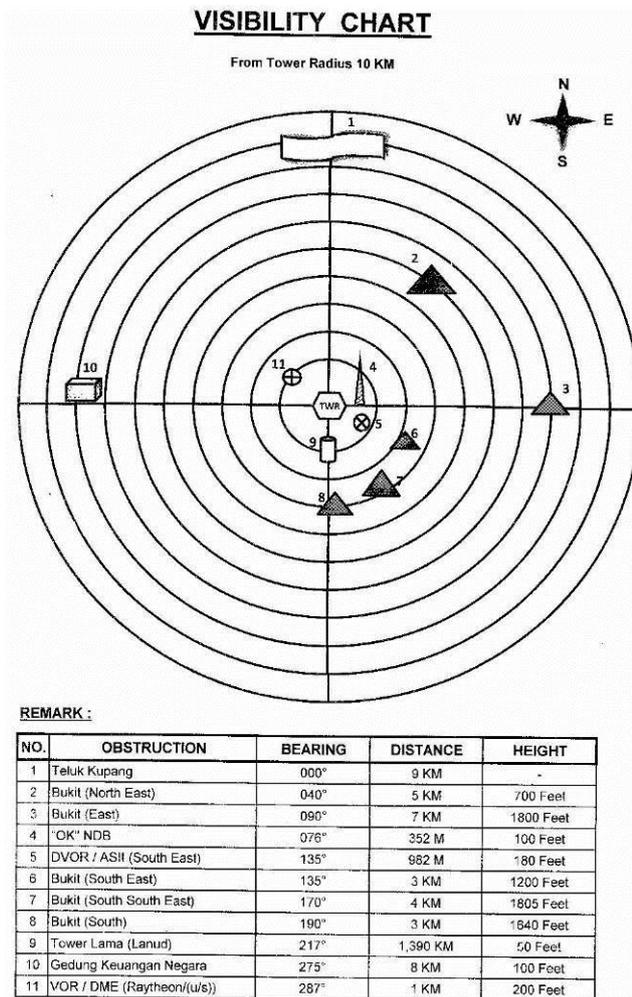
Figure 6: El Tari visibility chart

The air traffic controller was provided with visibility information by the AWOS display and visibility chart that was provided in tower (Figure 6).

Based on the interview of the air traffic controller on duty, the visibility chart is used to compare the information on the AWOS display with the actual conditions based on the air traffic controller observation from tower.

There were several landmarks that were used as reference points to determine the visibility. The landmarks were selected to provide visibility information. The investigation could not find the standard operating procedure that describes the usage of the visibility chart.

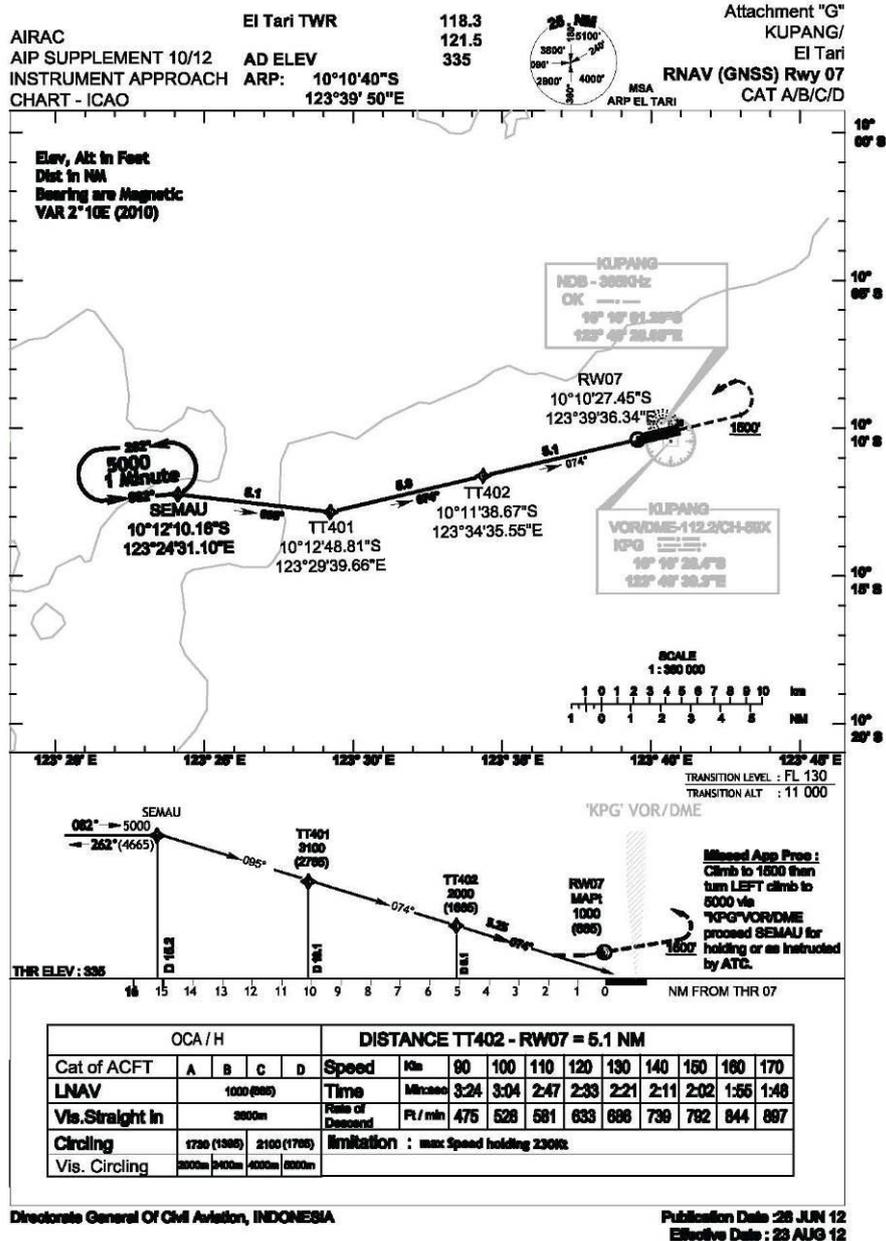
Figure 8: RNAV approach Runway 07 chart published on AIP supplement

Runway 07 Kupang was equipped with a Global Navigation Satellite System (GNSS) that can be used for RNAV Approach since 23 August 2012. The detail of RNAV Approach can be seen figure 7.

Approach guidance facilities such as Precision Approach Path Indicator (PAPI) lights and runway lights were all serviceable.

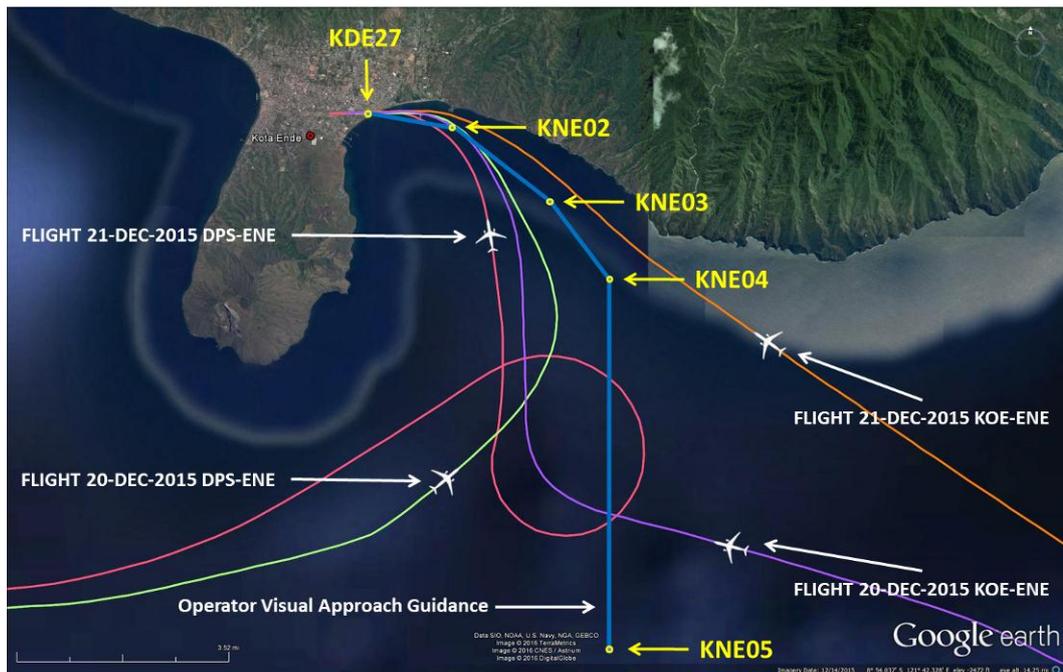
Figure 13: Flight paths of approach to Ende on 20 and 21 December 2015

The DVDR recorded four approach flights to Ende including the flight on 20 and 21 December 2015 prior to the accident flight. The recorded approach flight paths were as follows:

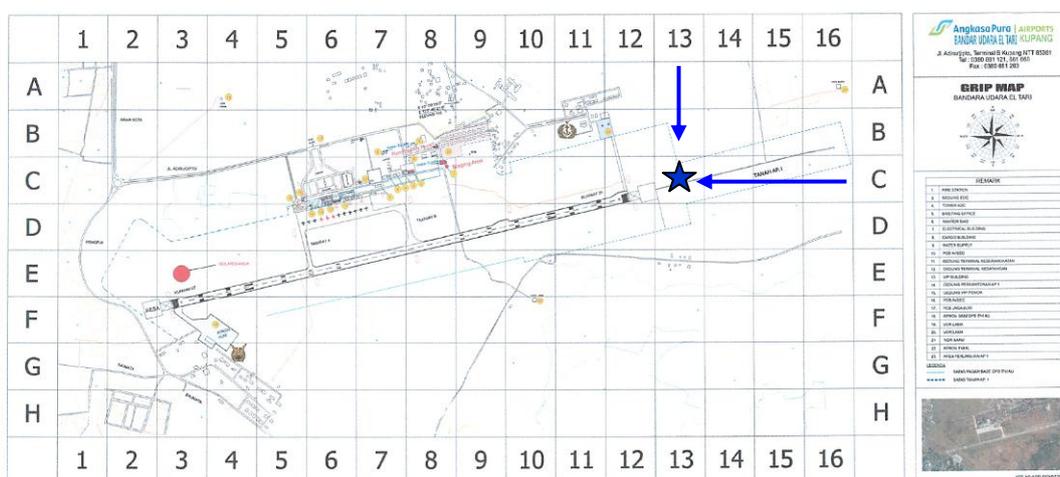
Figure 19: The aircraft location on grid map

At 0946 UTC, the El Tari Tower controller noticed that the aircraft overran the runway and pushed the crash bell to inform the Aircraft Rescue and Fire Fighting (ARFF) personnel. The controller then called the ARFF personnel and informed that there was aircraft overrun from runway 07 on sector C13 of the grid map (Figure 19). The ARFF team then deployed three vehicles.
