Havarikommisjonen
Accident Investigation Board Denmark

FINAL REPORT

Serious incident

OY-LHA

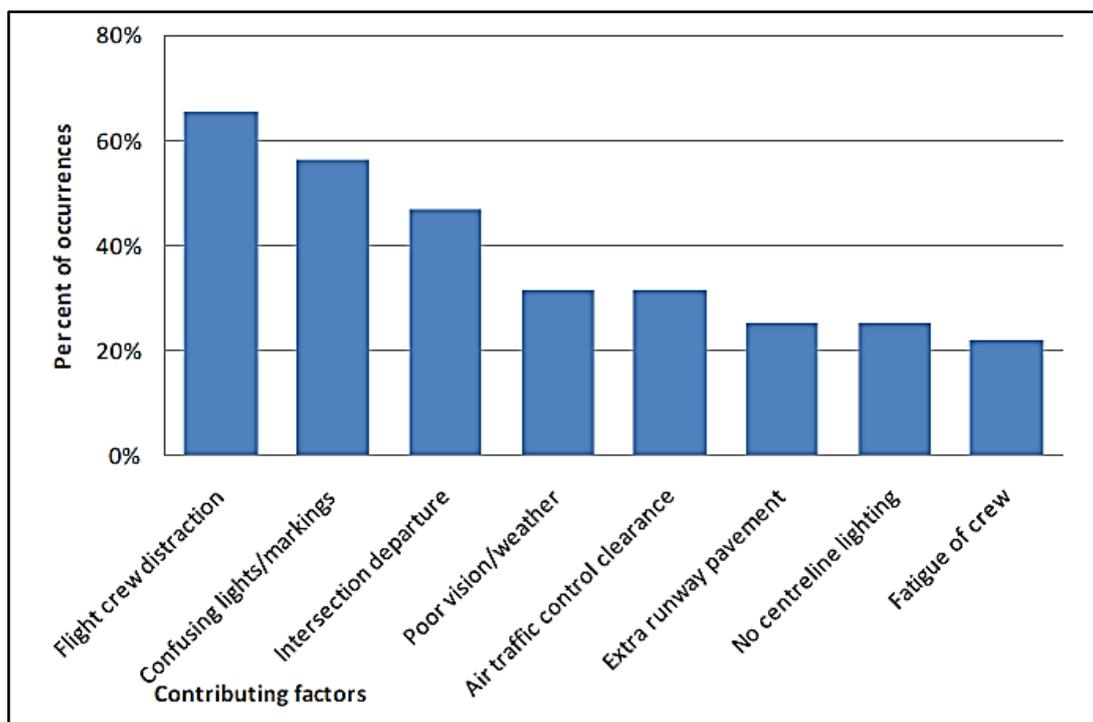
Factors contributing to misaligned take-off occurrences.

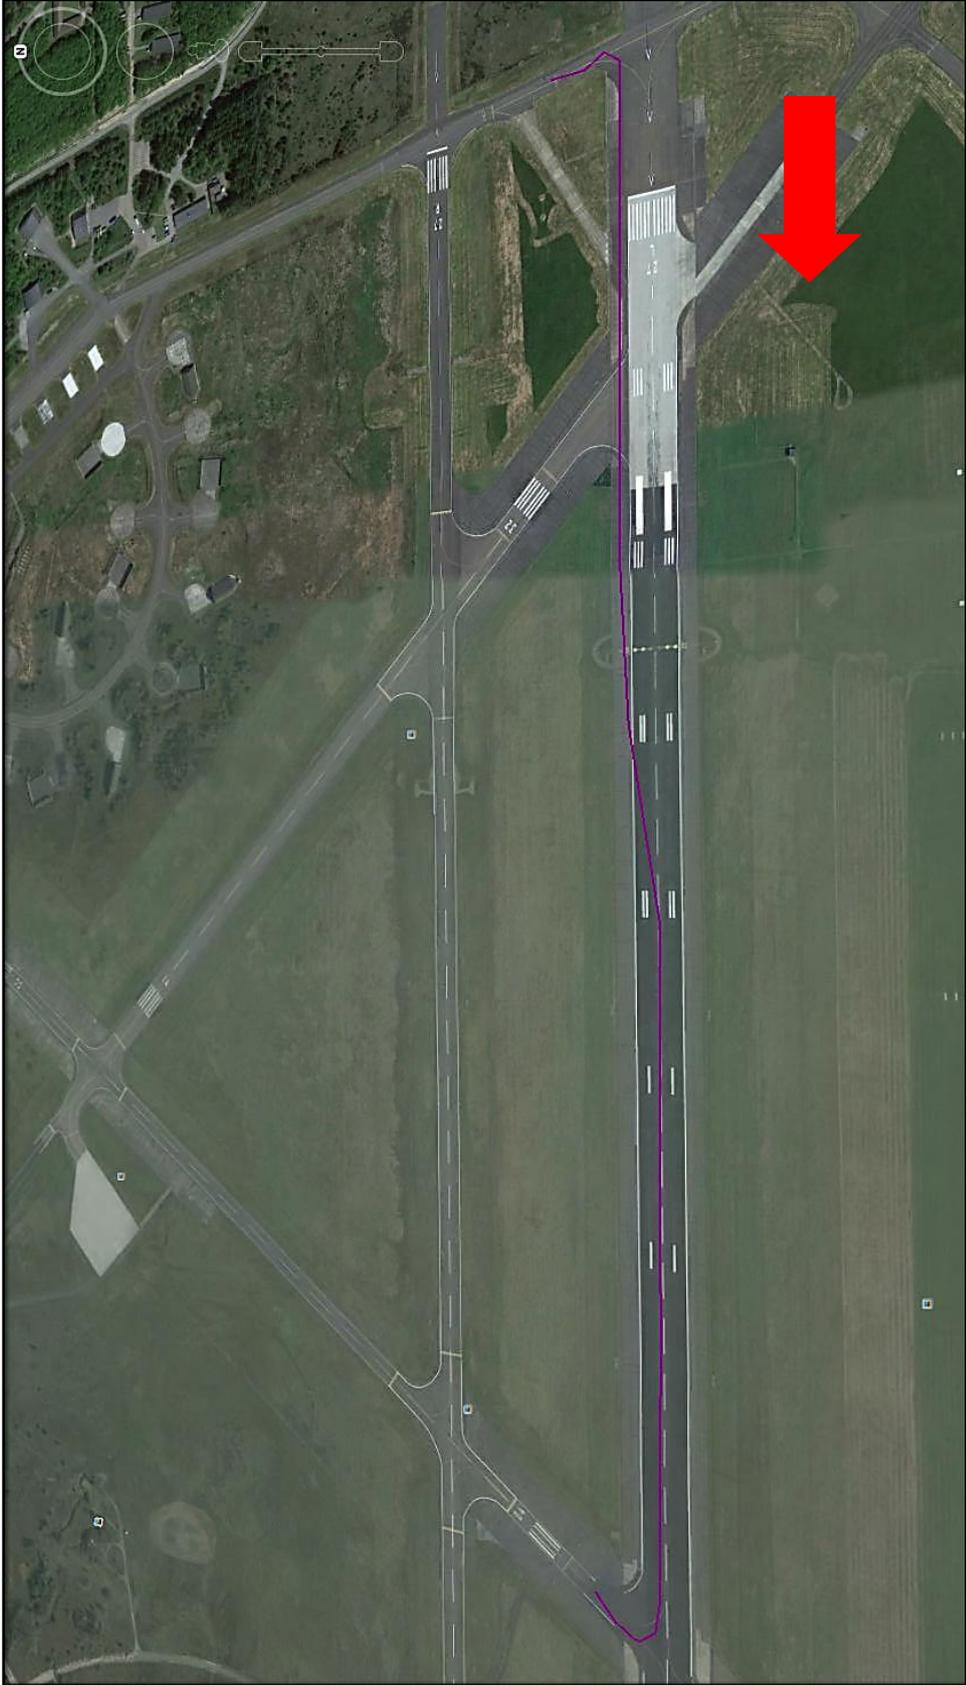
5.6 The take-off roll sequence - FDR plot

This resulted in a misaligned take-off roll over the elevated runway edge lights along the right-hand side of runway 27L leading to damages to the runway edge lights and the aircraft itself.

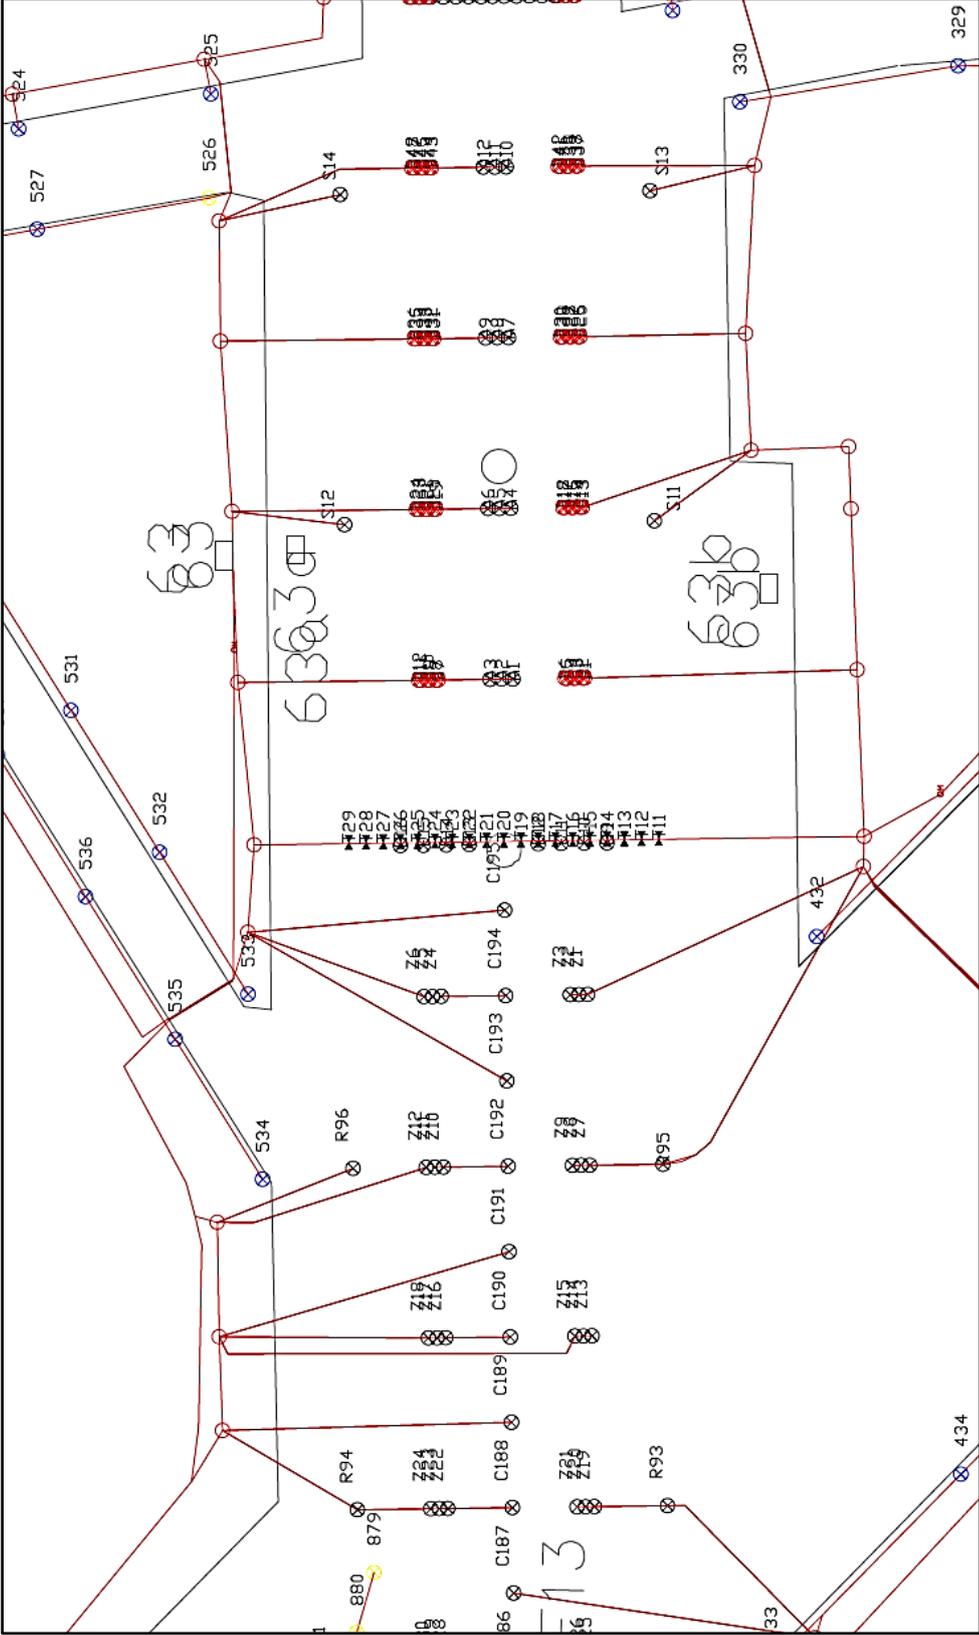
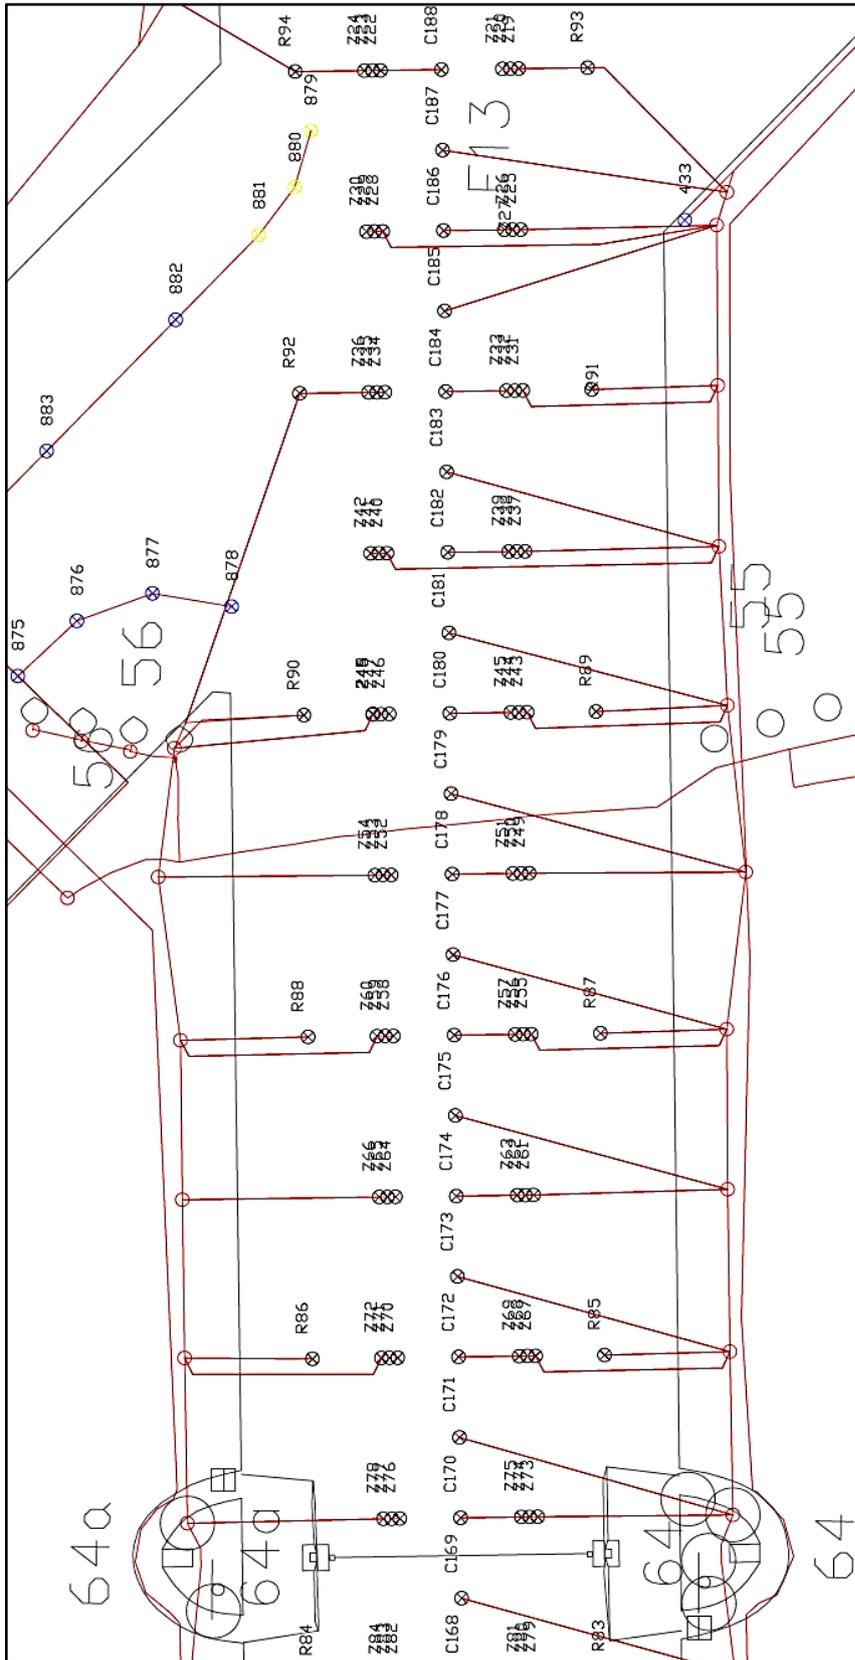
5.14 Schematic overview of the positioning of the runway lighting system

In darkness and hazy weather conditions, the flight crew lined up the aircraft on the runway edge lights along the right-hand side of runway 27L instead of the runway centreline lights of runway 27L.
