AIRCRAFT ACCIDENT INVESTIGATION REPORT

**ENGINE FIRE DURING TAKE-OFF ROLL
KOREAN AIR LINES CO., LTD.
BOEING 777-300, HL7534**

**ON RUNWAY 34R
AT TOKYO INTERNATIONAL AIRPORT
AT AROUND 12:38 JST, MAY 27, 2016**

July 6, 2018

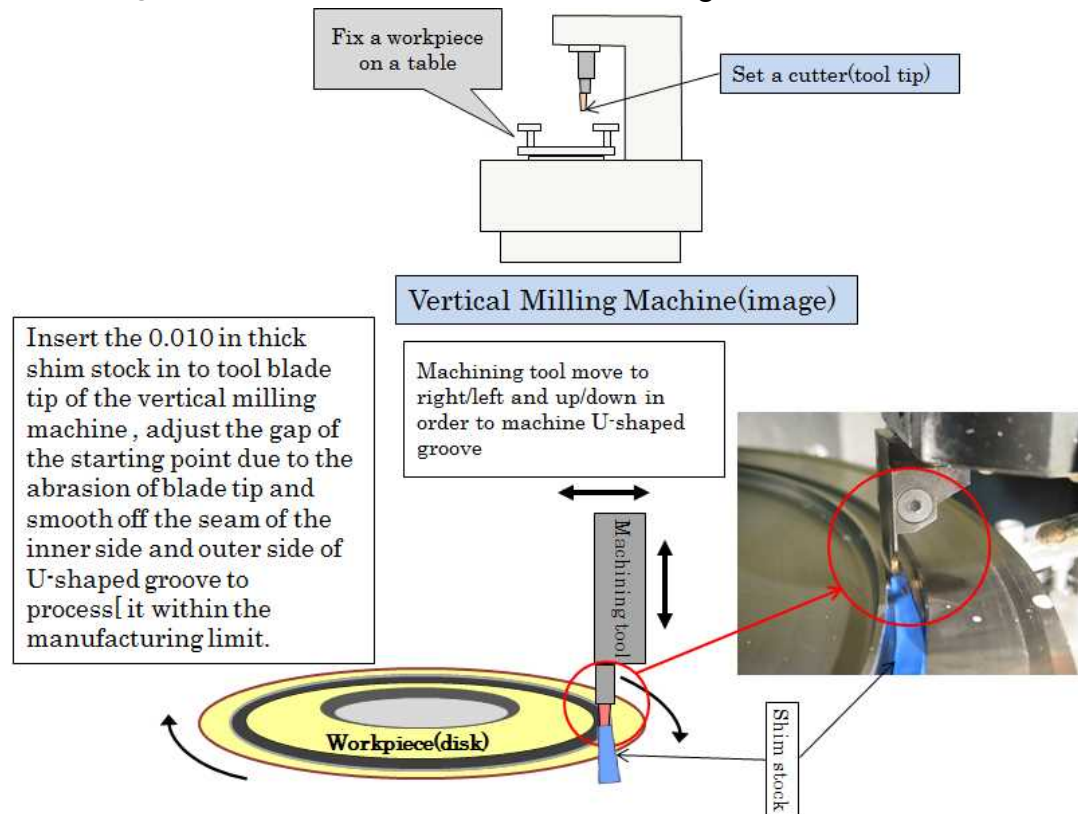
Figure 3. Processing the HPT Disk with use of a vertical milling machine

According to the investigation by recreating the processing as the final processing position without using the 0.010 inches thick shim stock and investigating by recreating the machining by setting the condition without no gap at the bottom of U-shaped groove initiated by the tip of the machining tool had resulted in 0.010 inches deep step at the bottom of U-shaped groove. (See Figure 3. Processing the HPT Disk with use of a vertical milling machine.)

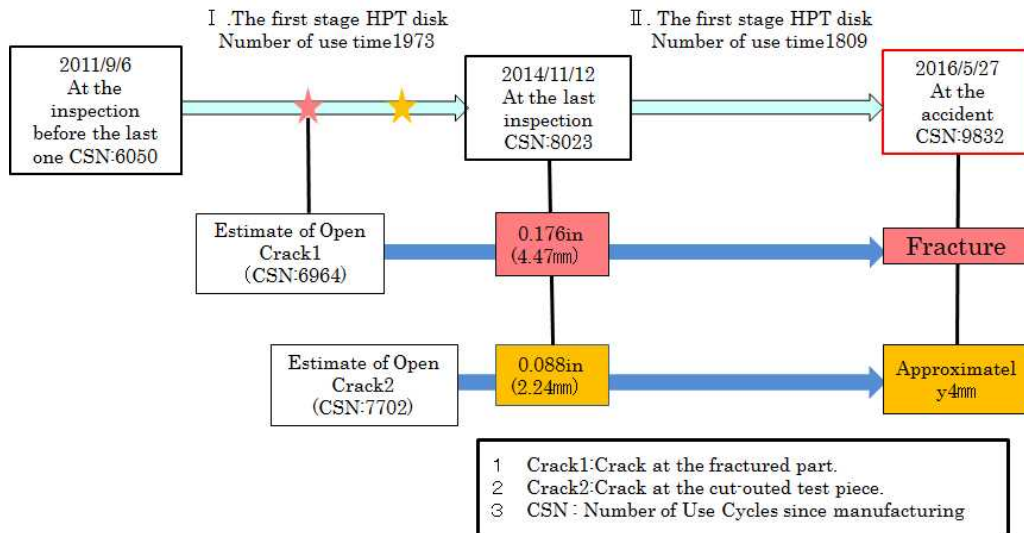
Figure 6. Number of Cycles of the Disk estimated from the analysis of the fracture surface of rejected fragment

The striation count analysis completed on the fracture surface and crack surface estimated 2,130 cycles and 2,868 cycles of repeated stress respectively. Why these two numbers differed from each other were because the time period to initiate cracks were differed and cracks initiated at the initial crack propagation stage was damaged by corrosion, heat and others. As shown in Figure 5, at the time of accident, the disk had 9,832 cycles as the total number of cycles since the manufacturing the disk, subtracting 2,130 cycles from these number became 7,702 cycles and subtracting 2,868 cycles from these became 6,964 cycles. Besides, the total number of use cycles of the disk at the time of the previous inspection was 8,023 cycles. Based on these numbers, it is possible that the 1st stage HPT disk had cracks when it delivered to the engine shop of the Company to have the previous inspection (November 12, 2014). (See Figure 6. Number of Cycles of the

Furthermore, from the numerical analysis based on the counting at the crack surface, values of 0.088 to 0.176 inches (2.24 mm to 4.47 mm) along the surface were obtained on the cracks at the latest inspection at the engine repair shop of the Company.

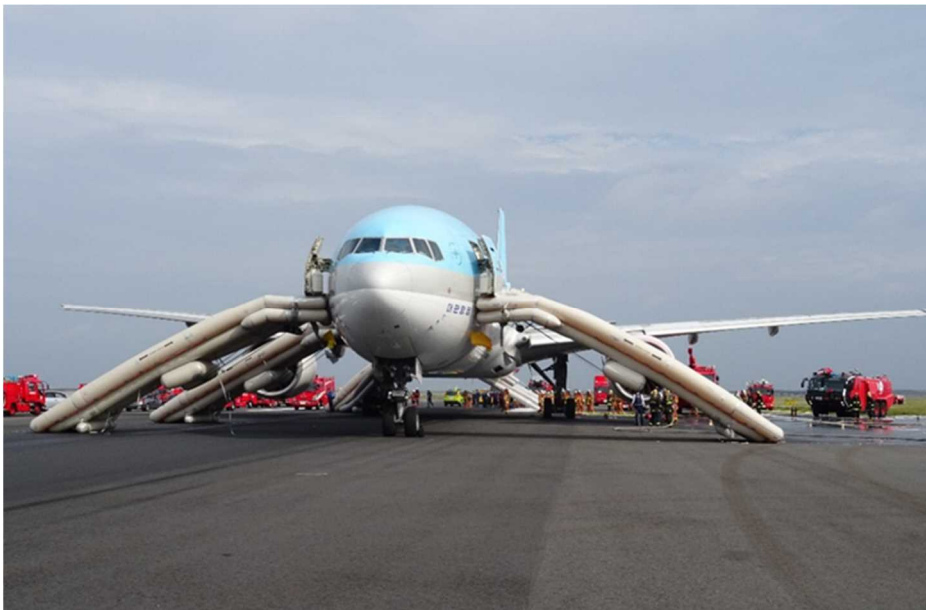
Photo 5. Emergency Evacuation Slides

According to the statements of the cabin attendants, they had deployed the doors at five locations of the right side of the Aircraft and attempted to evacuate, but the R5 door at the most rear side (hereinafter referred to as “R5 door”) was not fully deployed. For the door at the left side of the Aircraft, L1 door at the most front side had only the slide deployed, but it was not used. (See Photo 5. Emergency Evacuation Slide.) Furthermore, the situation of the emergency evacuation was recorded by the Monitoring camera at the Airport, it was confirmed that there were passengers with baggages to evacuate and no assistances at the bottom of the slide when the evacuation was started. Photo 6. shows the comparison of deploying R5 slide at the normal situation and at the accident.

Photo 7. shows the deploying situations of R3, R4 and R5 slides of the Aircraft at the time of the accident. Furthermore, the R3 slide is narrower in width and shorter in length compared to the R4 and R5.

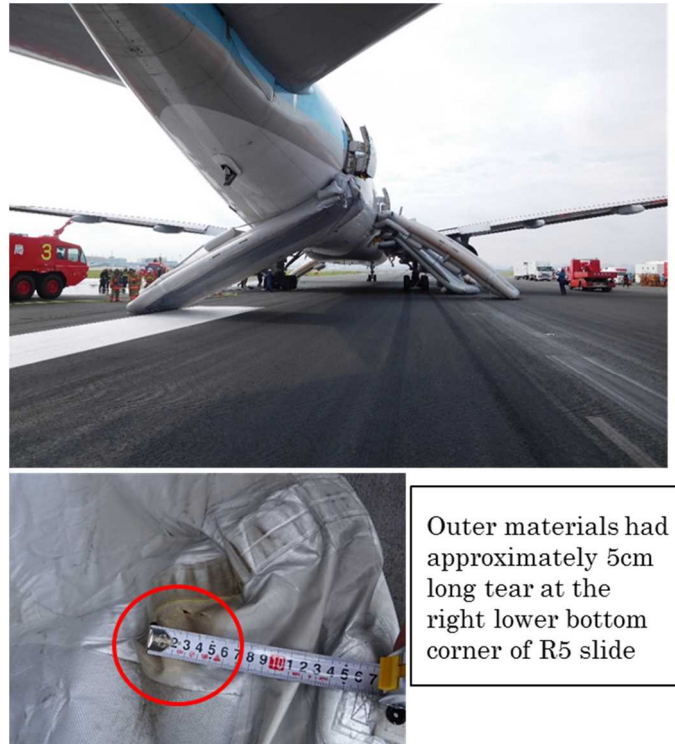
Photo 8. R5 Slide

Approximately 5 cm long tear was confirmed at the right lower corner (at the right corner topside of the side of ground) of R5 slide outer material. As the results of investigating the details at the Aircraft Manufacturer factory, R5 slide had no other anomaly other than that. (See Photo 8. R5 slide.)

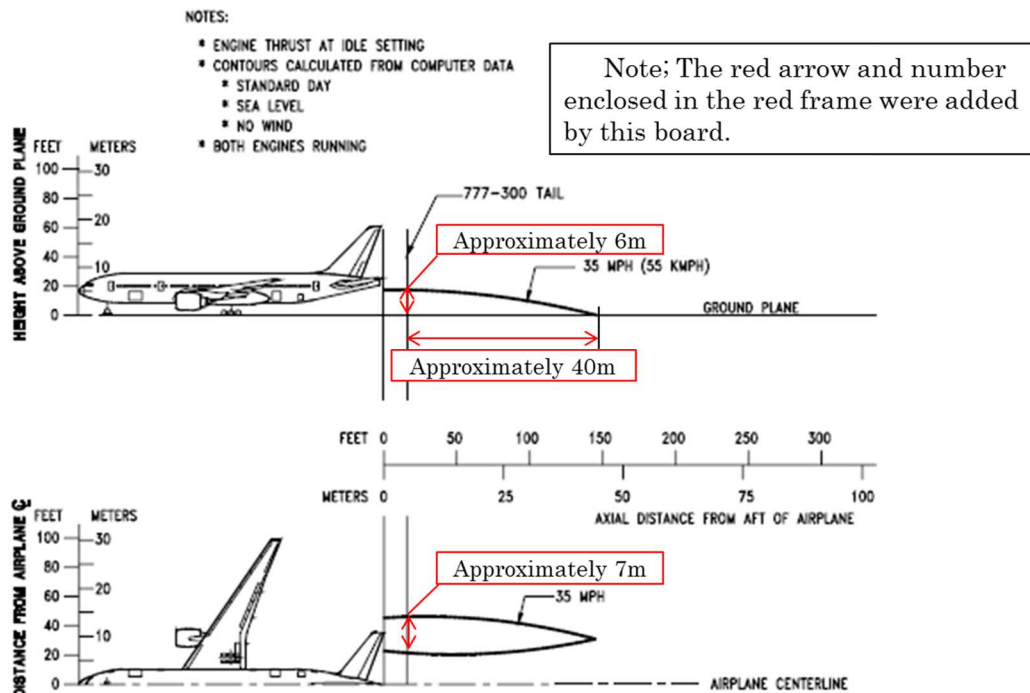
Figure 7. Predicted Engine Exhaust Velocity Contours – Idle Thrust

According to the materials concerning the engine exhaust air flow by the Aircraft manufacturer, B777-300 Engine Exhaust velocity contours at idle thrust are 55 km/h and reach approximately 40 m from the rear of the Aircraft and narrows in width. (See Figure 7. Predicted Engine Exhaust Velocity Contours – Idle Thrust.)

As described in 3.7.2, when deploying R5 slide, the No.2 engine was at idle thrust. As described in 2.14.2.4, according to the materials (Figure 7 Predicted Jet Engine Exhaust Velocity Contours – idle thrust) of the manufacturer of the Aircraft, the predicted jet engine exhaust velocity contours at idle thrust is 7 m wide at the rear end of the Aircraft, extends to the approximately 40 m ahead while being tapered at the level of approximate 6 m high and the wind velocity is about 30 kt. Calculating the resultant wind from the wind of the jet engine exhaust blow at setting of the heading at 335° as described in 2.10 with the wind direction 060° and velocity about 20 kt at the time of the accident described in 2.7, was resulting in the wind direction 007° and the velocity about 37.5 kt. The velocity is 1.5 times of the allowable limit which is 25 kt for the velocity to make a slide have normal deployment as described in 2.14.2.1. Because of this resultant wind's effect, it is somewhat likely that R5 slide which is at most rear end and the spacing to the ground is the longest, slipped under the rear end of the Aircraft by folded, deployed with its top caught by the runway therefore could not return to a normal standing position spontaneously as the effect of wind gone.

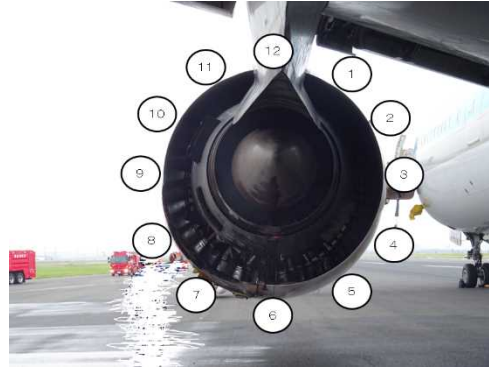
The No.1 engine of the Aircraft was as follows. Furthermore, the following sentence uses the clockwise numbering shown on the periphery of the rotating axis of the engine as its center as looking from aft of the Aircraft to forward. The left and right of the engine are indicated as seeing from aft of the Aircraft to forward. (See Photo #1.)

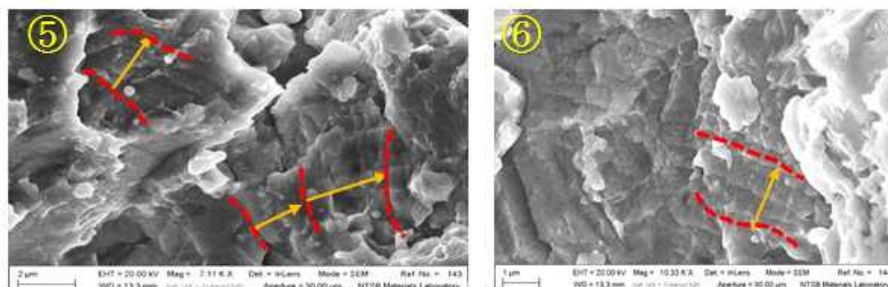
Photo ③ : Crack propagates from originating point at the aft side of the disk to the forward side. The fractured surface exhibited significant mechanical damage. The fatigue progression exhibited a bluish heat tint.

Photos ⑤ and ⑥ was the pictures enlarged and photographed parts enclosed by yellow lines shown in Photo ④ via Scanning Electron Microscope (SEM) and striation which is a characteristics of fatigue fracture surface was confirmed.
