# Accident Investigation Final Report

**State File Number:** 950330EPMOF  
**Type of Occurrence:** Accident  
**Date of Occurrence:** June 19<sup>th</sup> 2016  
**Place of Occurrence:** Khark Island Airport  
**Aircraft Type:** BAe146-300  
**Registration:** EP-MOF  
**Operator:** Mahan Airlines

Aircraft Model: BAe146-300

Registration: EP-MOF

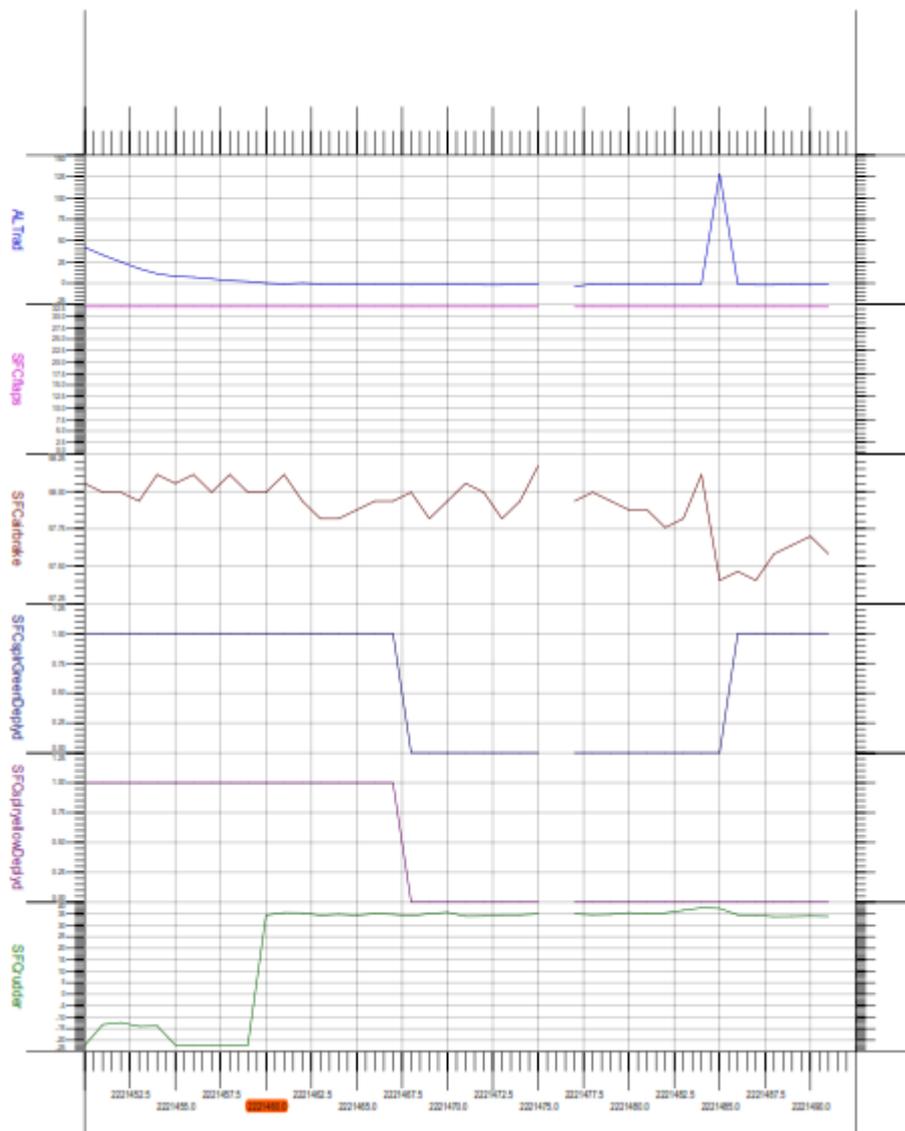
**At Touchdown**, due to an un-stabilized approach (high target speed, altitude higher than normal glide path), touchdown occurs after passing long distance from beginning of RWY 13 optimistically with IAS 121 knots, N<sub>1</sub> RPM 34%, 38%, 36% & 34% in normal sequence. The vertical acceleration of touch down was 1.07 in the normal value.

Spoilers had opened on IAS 112 after 7 seconds
