FINAL REPORT

B777-300ER, REGISTRATION 9V-SWB ENGINE FIRE

AIB/AAI/CAS.122

**Transport Safety Investigation Bureau
Ministry of Transport
Singapore**

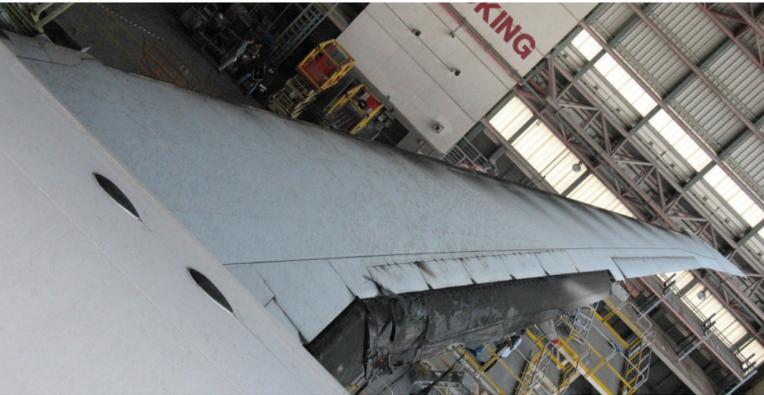
S/No	Description	Damage
3	Wing rear spar area and system components installed immediately behind and outboard of the right hand engine sustained fire damage

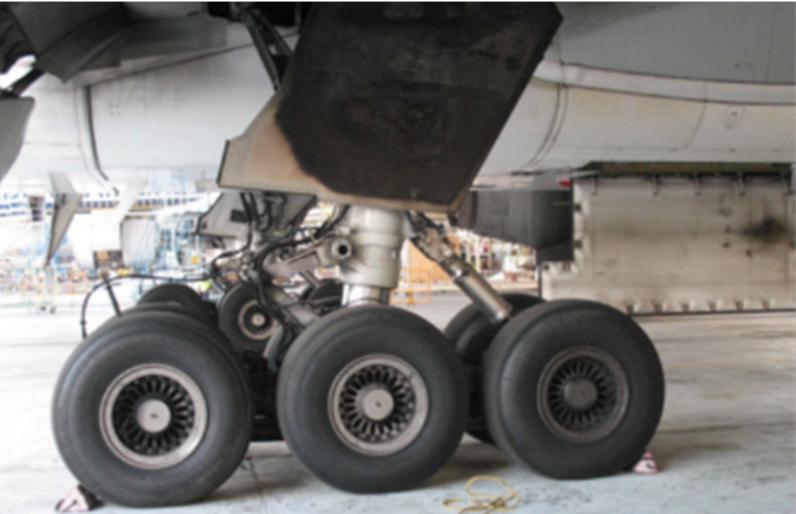
<p data-bbox="755 1218 1291 1260">Inner portion of right hand outboard flap</p>
8	Outboard facing side of right main landing gear shock strut door sustained heat damage
